# National Transportation Safety Board

CEN24FA042

## VIDEO STUDY

Location: Plano, Texas  
Date: November 21, 2023  
Time: 1748 Central Standard Time  
Aircraft: Mooney M20C

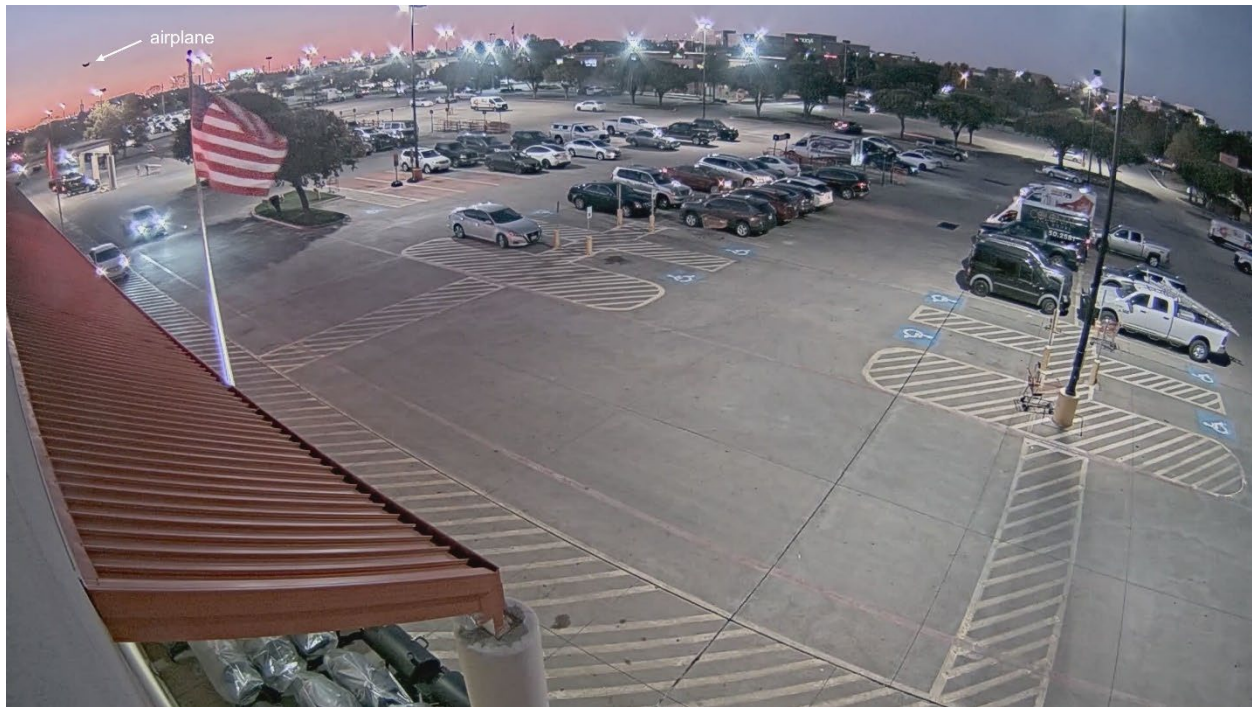
The estimation of camera model parameters is based on references that are visible both in video frames such as the one in Figure 1 and in aerial images such as the one in Figure 2. The references used for camera model calibration included markings on the ground, light poles, and buildings seen near the top of the video frame in Figure 1.

**Figure 1.** Video frame recorded at video time 12:21.54

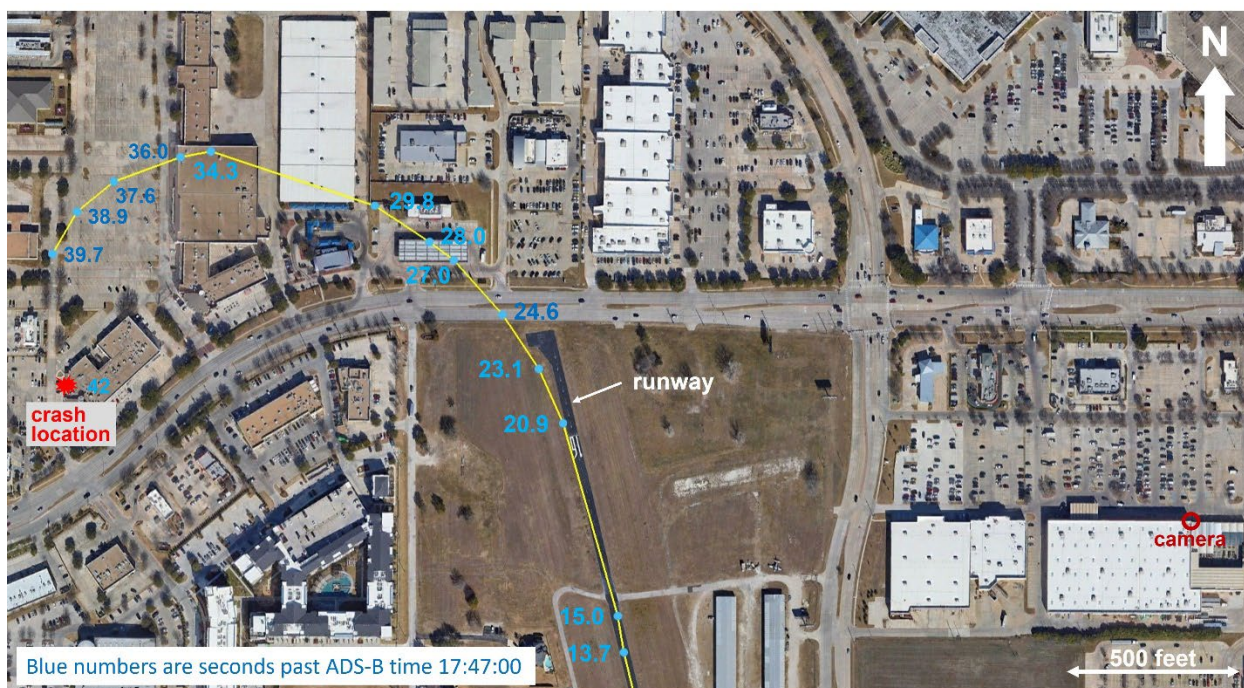
Figure 2 shows an aerial view of the accident area. The airplane was in the process of a go around while attempting to land at the Air Park-Dallas Airport (F69). The blue markers are the airplane ground locations available from ADS-B data. The blue numbers are the times corresponding to the ADS-B locations. Time is shown as seconds past ADS-B time 17:47.00. The figure also shows the location of the camera and the location of ground impact. The altitude available from ADS-B was not accurate. Therefore, the altitude was estimated based on the video as detailed below.

**Figure 2.** Aerial view of the accident area

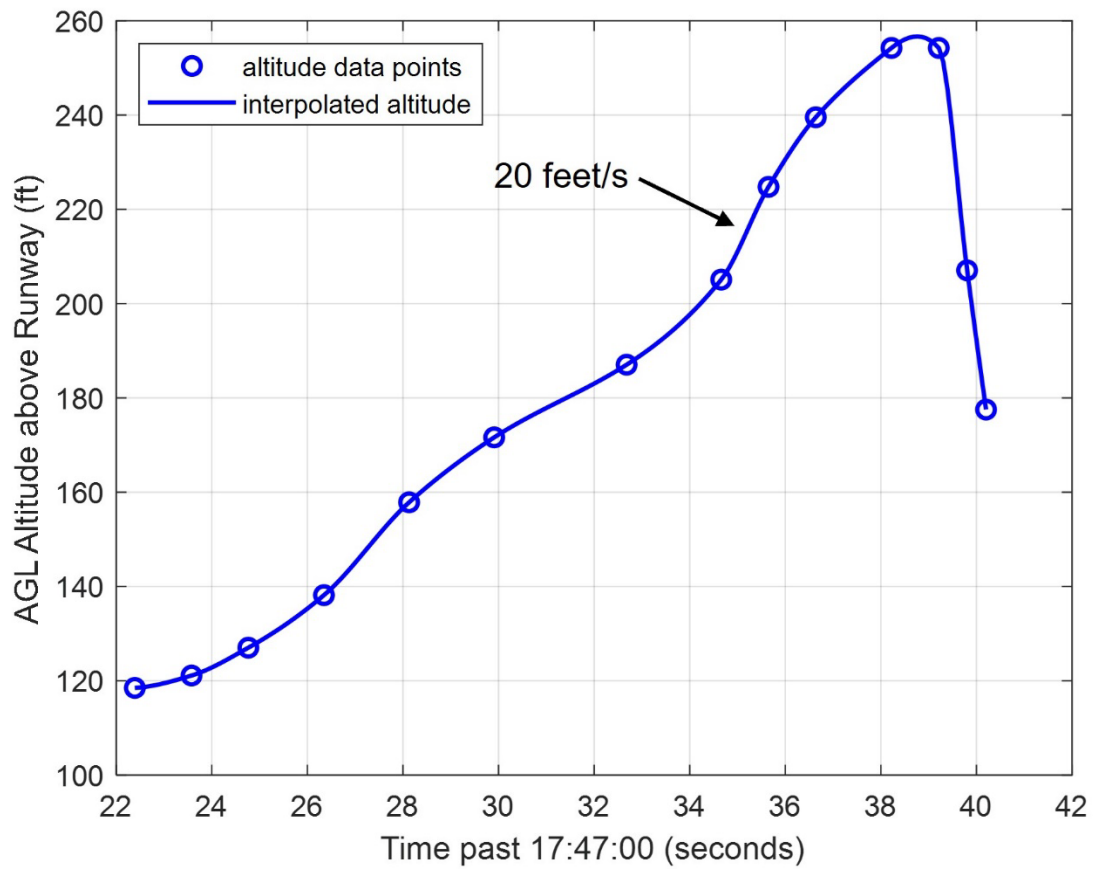
Figure 3 shows the estimated AGL altitude of the airplane. It is shown relative to the runway elevation. As mentioned above, the ground X-Y locations of the airplane were known from ADS-B data. In most accident cases, the airplane yaw, pitch and roll angles can also be estimated in the process used to estimate the altitude. In this case, however, estimating the angles was not possible because of the distance of the airplane from the camera and low visibility. The visibility at the time of the accident was low because the accident occurred after sunset. Consequently, the image of the airplane in the video did not show the details that are needed for estimation of the orientation angles with reasonable accuracy.

Figure 3 shows that the airplane was climbing at a moderate climb rate till about time 17:47:33. Past time 17:47:33, the climb rate was significantly higher, peaking at 20 feet/second or 1200 feet per minute in the time segment centered at about 35 seconds. There is no visible evidence in the video to explain the cause of the increased climb rate. There is more than one possible explanation for the higher climb rate. It could have been intentional to facilitate the go around maneuver. It also could have been caused by a mechanical failure. Unintentional pilot command caused by high acceleration affecting the pilot is not likely because the lateral acceleration before time 17:47:33 was only 0.26 g. However, a medical condition unrelated to acceleration is a possibility.

**Figure 3.** Estimated altitude of the airplane

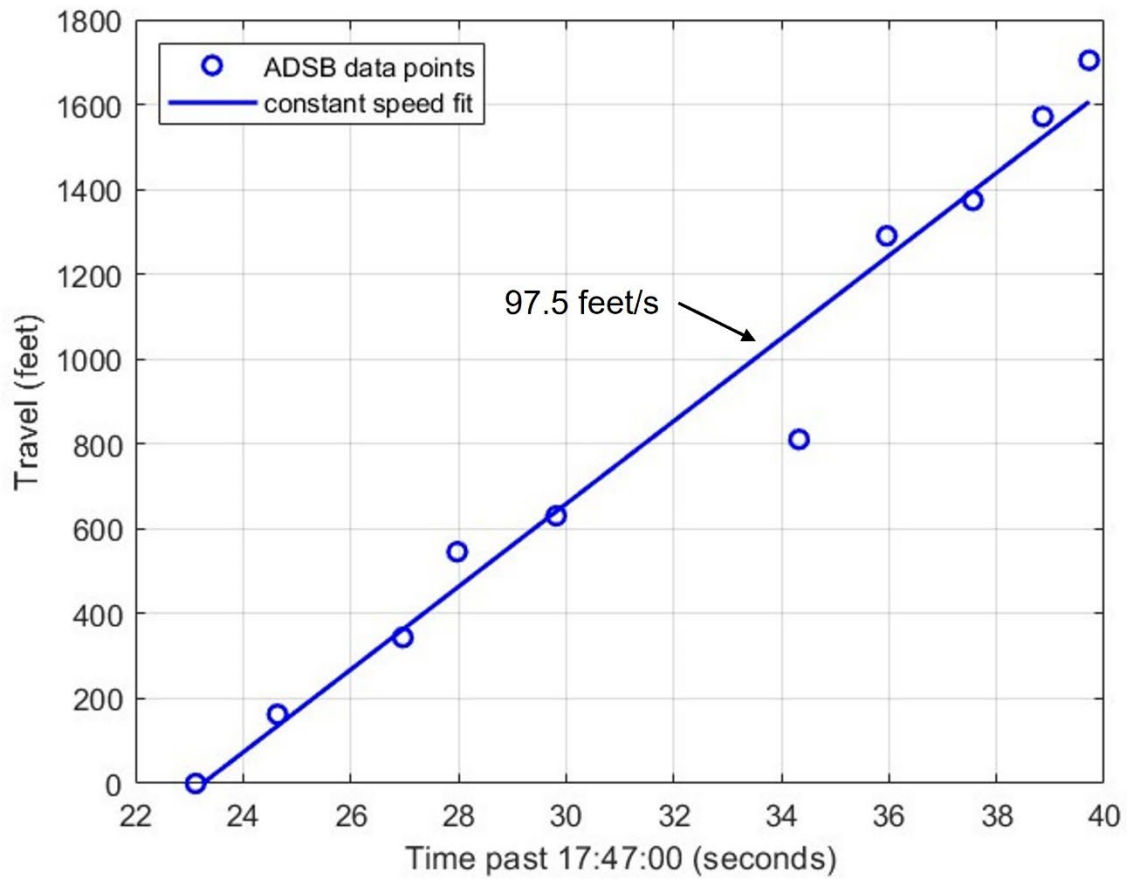
Figure 4 shows the ground distance, based on ADS-B data, flown by the airplane between time 17:47:23.1 seconds and time 17:47:39.7 seconds. The blue line is a constant-speed fit to the data points. The slope of the line indicates speed is 97.5 feet/second or 57.8 knots, near the stall speed of the Mooney M20C.

**Figure 4.** ADS-B based ground travel and ground speed of the airplane
