# National Transportation Safety Board

CEN24FA042

## EXAMINATION SUMMARY STATEMENT

Location: Plano, Texas  
Date: November 21, 2023  
Time: 1748 CST  
2347 UTC  
Airplane: Mooney M20C N1204X

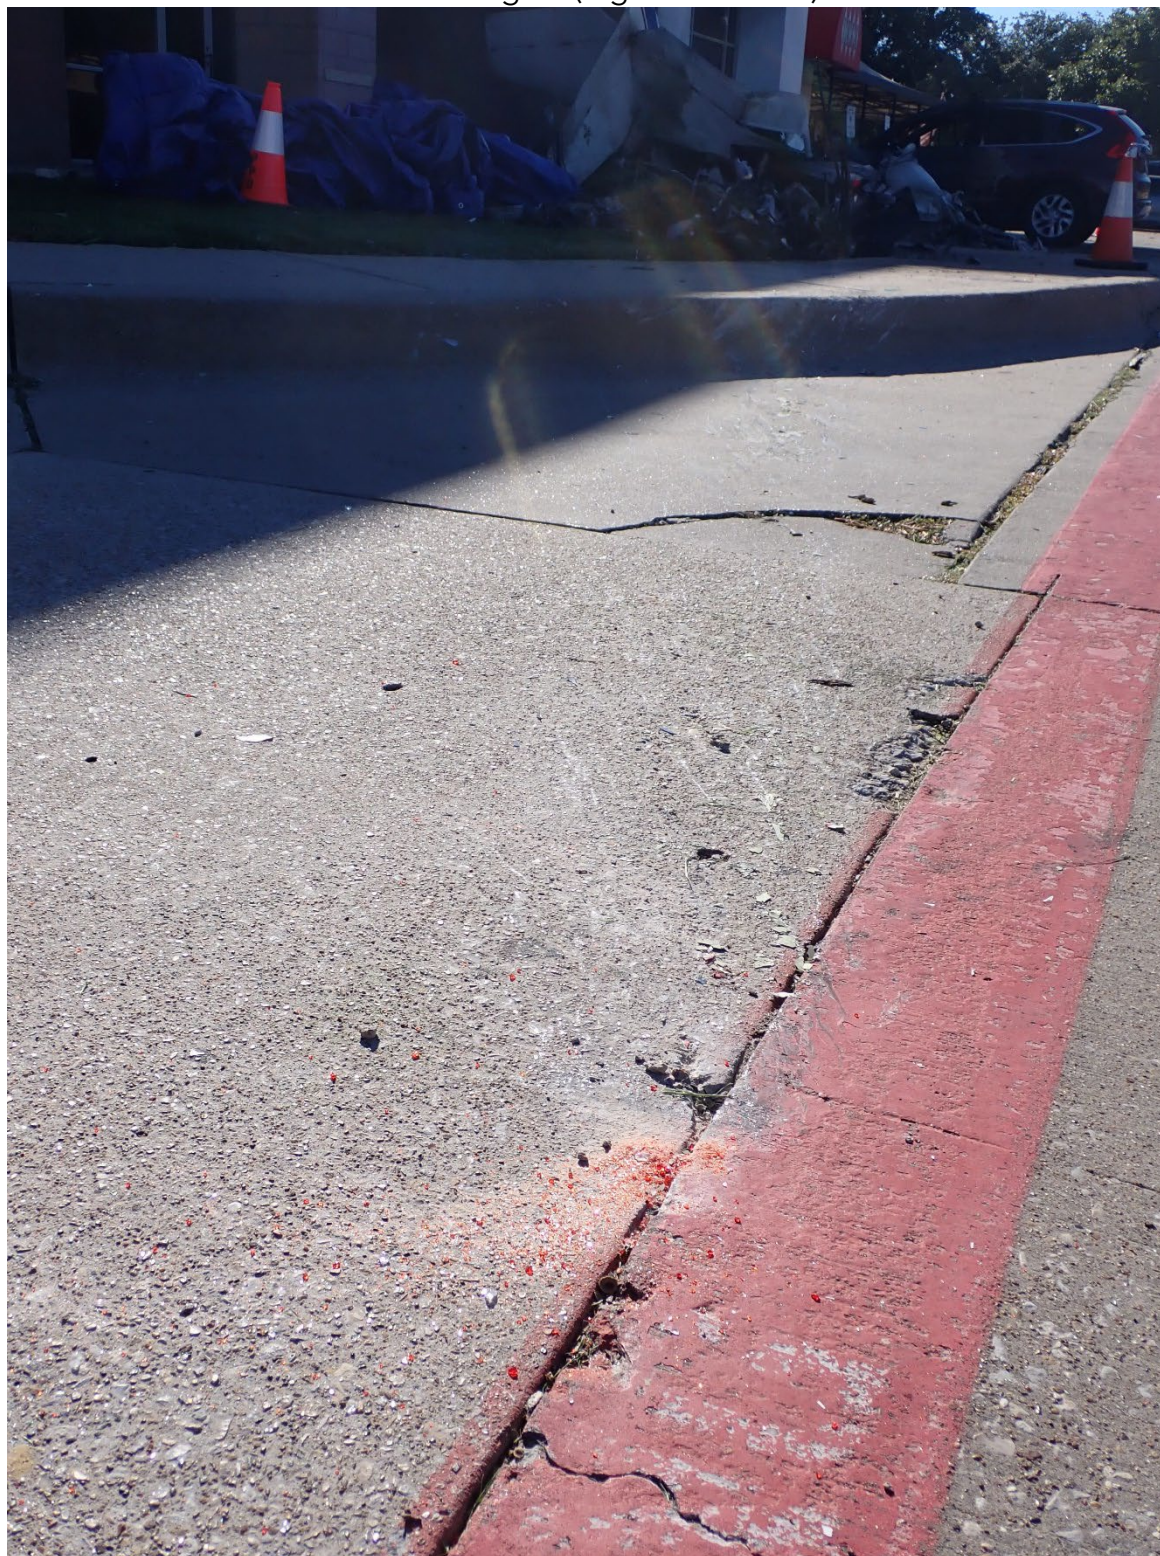
The airplane impacted a shopping center parking lot. A post-impact fire ensued and spread to an unoccupied parked vehicle. The adjacent building was damaged by the airplane impact and post-impact fire. The main wreckage came to rest inverted. The engine, propeller, instrument panel, and flight control yokes were embedded about 2 feet in the ground about 30 ft north of the main wreckage. Ground scars and paint transfer consistent with wing leading edges extended in both

directions from the embedded engine (Figures 1 and 2).

Figure 1: Wing witness marks

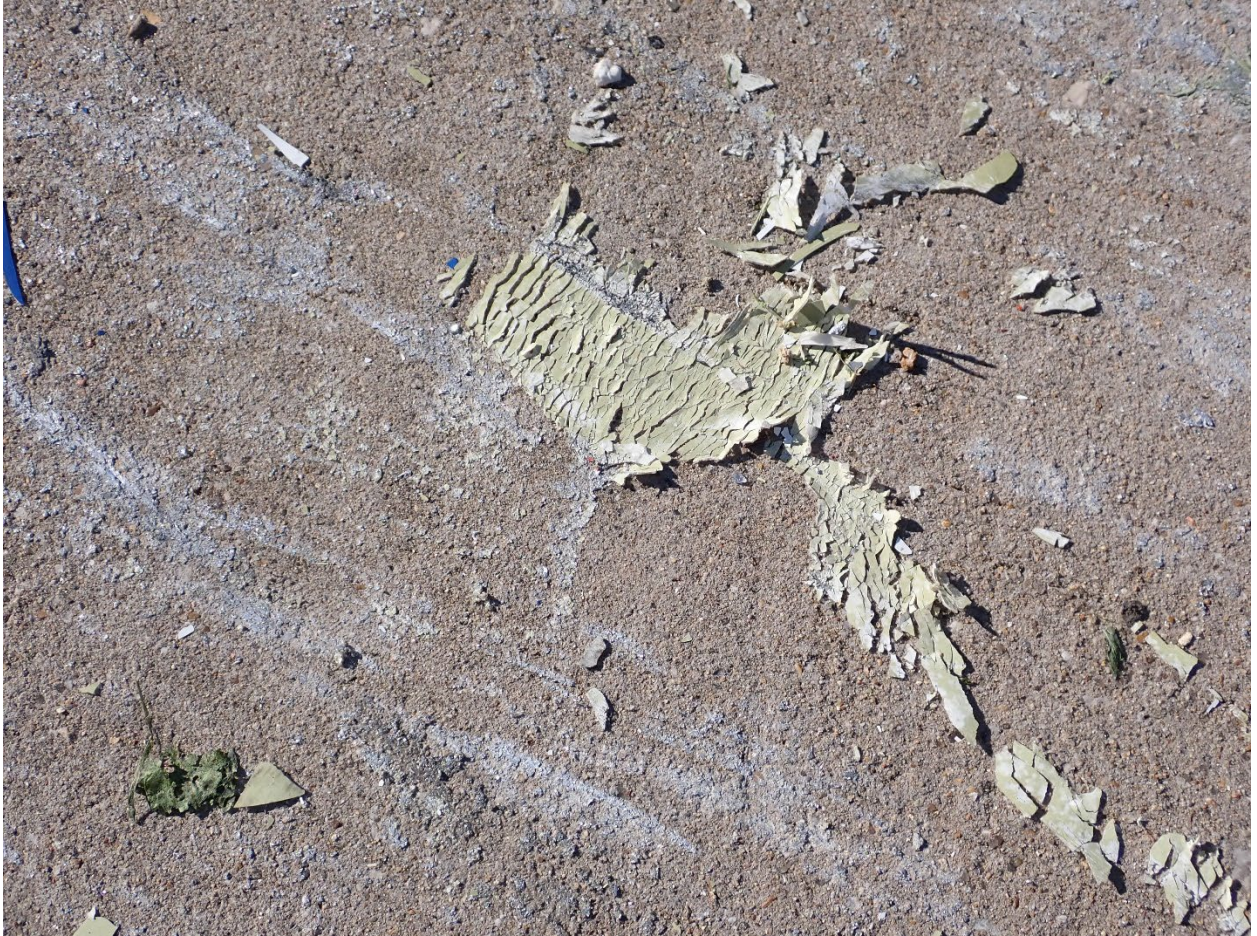
Figure 2: Leading edge paint transfer

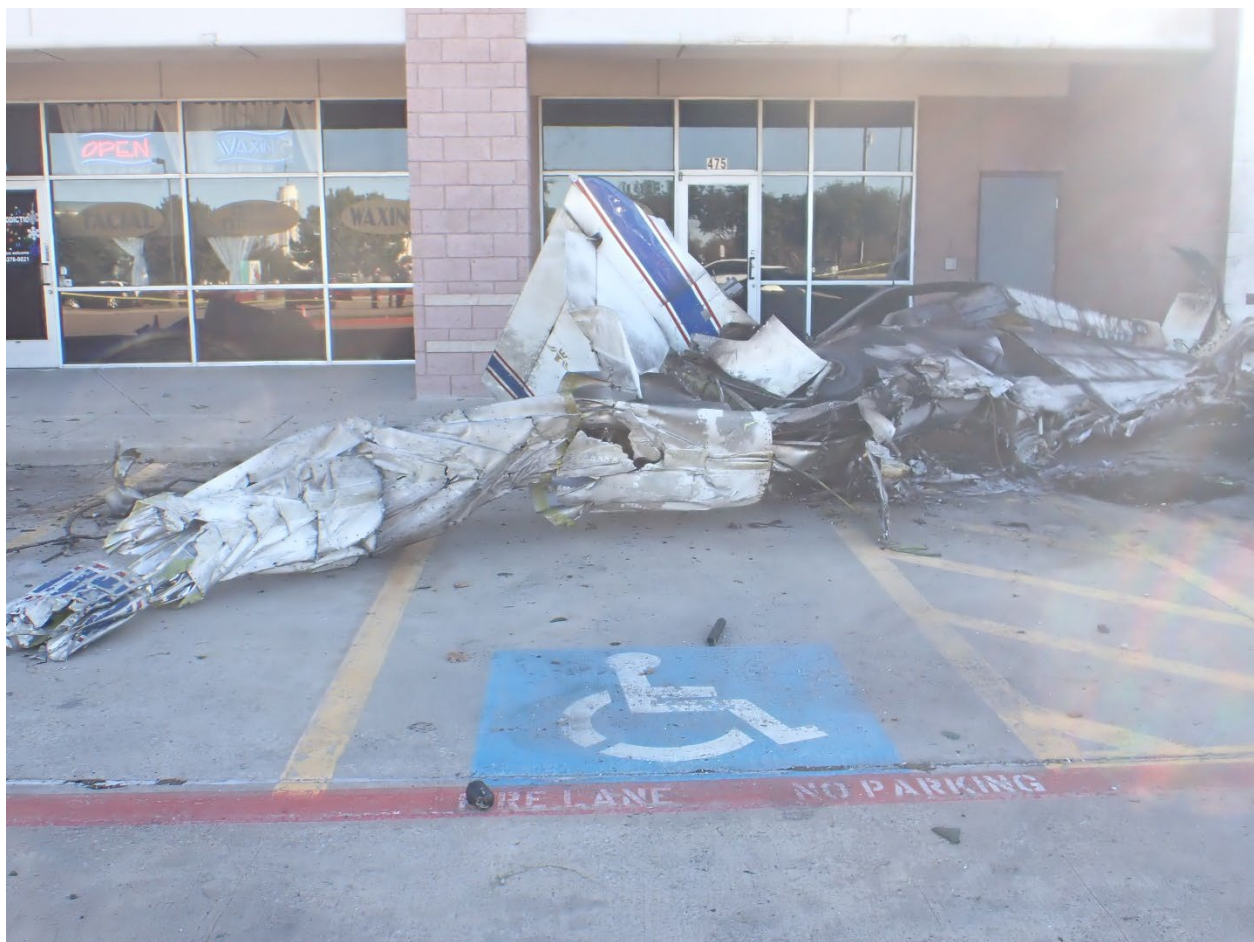
The fuselage came to rest inverted and was impact damaged. It was charred, melted, and partially consumed by fire (Figure 3).

The empennage remained attached to the aft fuselage and included the vertical stabilizer, rudder, and stabilator (Figure 3). The elevator trim jackscrew was found in a position consistent with the elevator trim in the takeoff position (Figure 4)

The wings remained attached to the fuselage and exhibited accordion crushing along the leading edges (Figure 3). The wings were impact and fire damaged. The right aileron and right flap remained attached to the right wing. The right aileron control tubes were impact and fire damaged. The left aileron remained attached to the left wing. The left flap was partially impact separated. The flap actuator was found impact separated. The hydraulic lines were fractured at the fittings. The flap pushrod was extended about 10.25 inches, of which about 9 inches were impact damaged (Figure 5).

Figure 3: Fuselage, wings, and Empennage

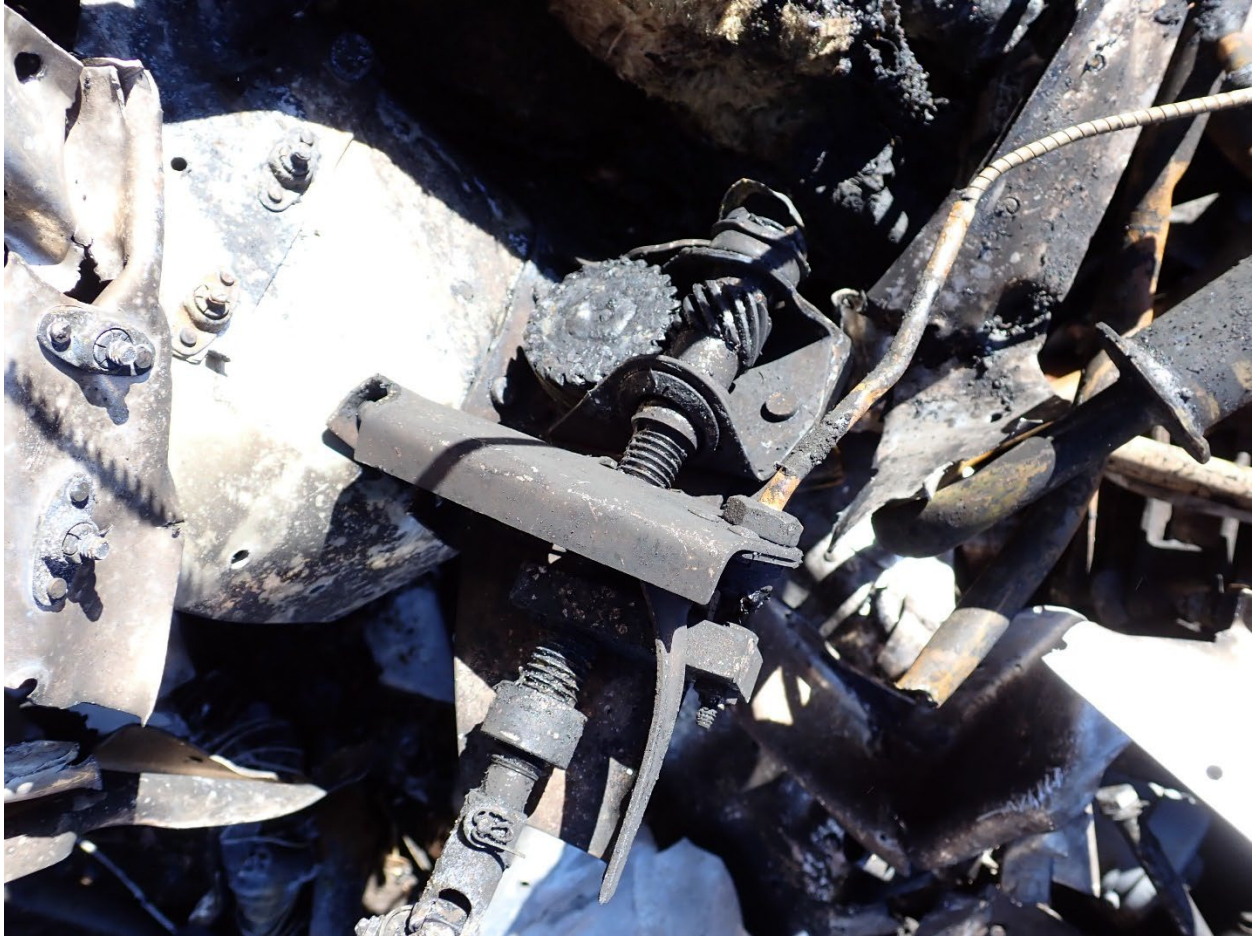
Figure 4: Elevator trim jackscrew

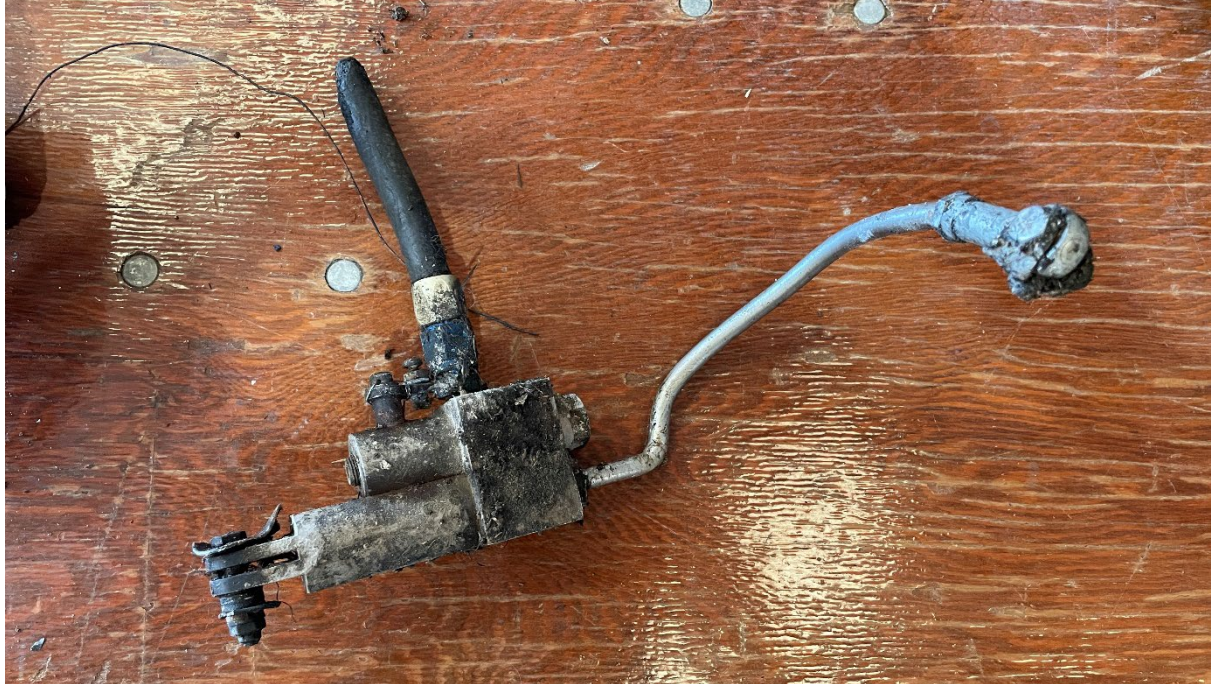
Figure 5: Hydraulic flap actuator

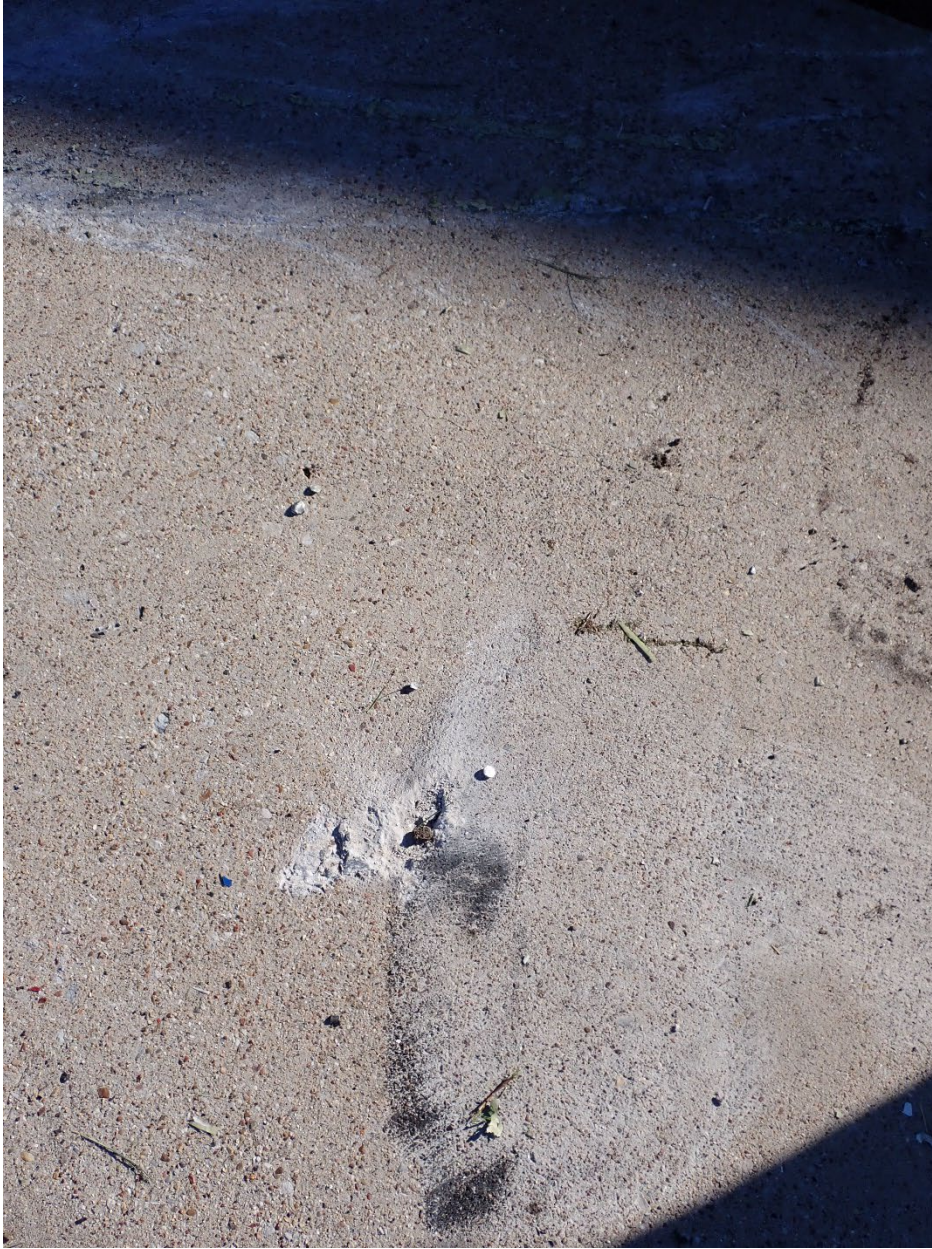
The left main landing gear remained attached to the wing and had impact and fire damage. The right main landing gear was impact separated and located near the right wing and had impact and fire damage. The nose landing gear strut was located with the engine. The nose landing gear wheel and tire were impact separated and located about 150 ft south of the main wreckage. Witness marks consistent with an extended landing gear were found on the pavement (Figure 6).

Figure 6: Right landing gear ground scar and witness mark

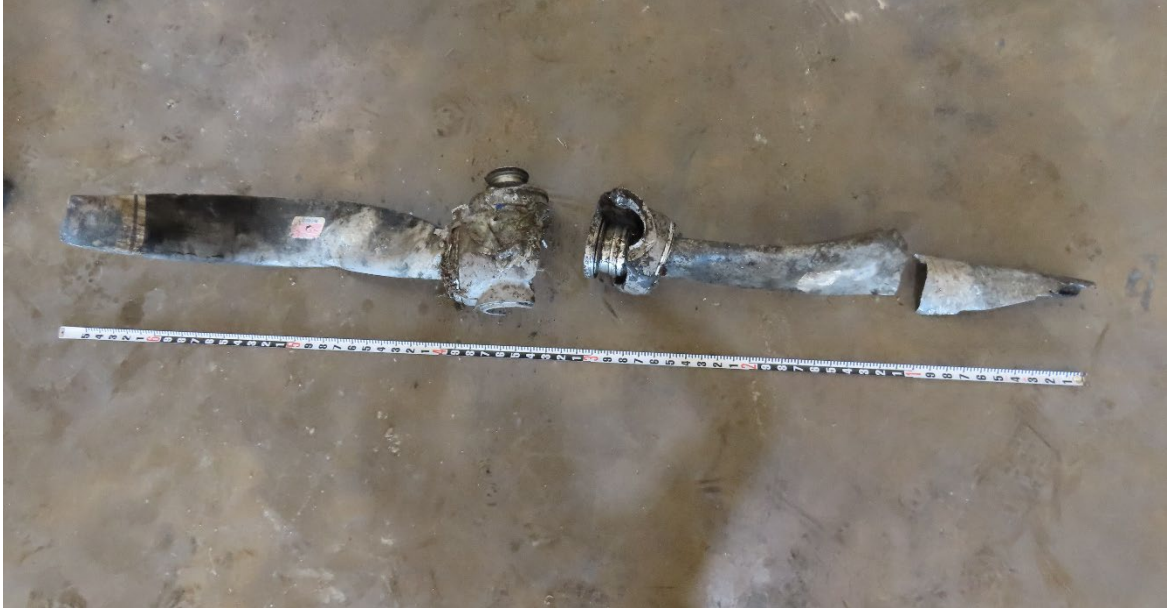
The propeller was a McCauley (s/n C1206YS and 1B024YS). The propeller and hub assembly was impact separated from the crankshaft aft of the propeller flange. Both propeller blades were located with the engine. One blade tip was impact separated. Both blades showed rotational scoring. One blade was bent aft and showed leading edge damage (Figure 7). The propeller governor mount was fractured but remained attached to the accessory case. The propeller governor rotated by hand.

Figure 7: Propeller
