# National Transportation Safety Board

CEN24FA049

## **POWERPLANT CHAIRMAN'S FACTUAL REPORT**

Location: Sterling, Texas  
Date: November 29, 2023  
Time: 1430 central standard time  
Helicopter: MD Helicopters MD 600N, Registration Number N745MB

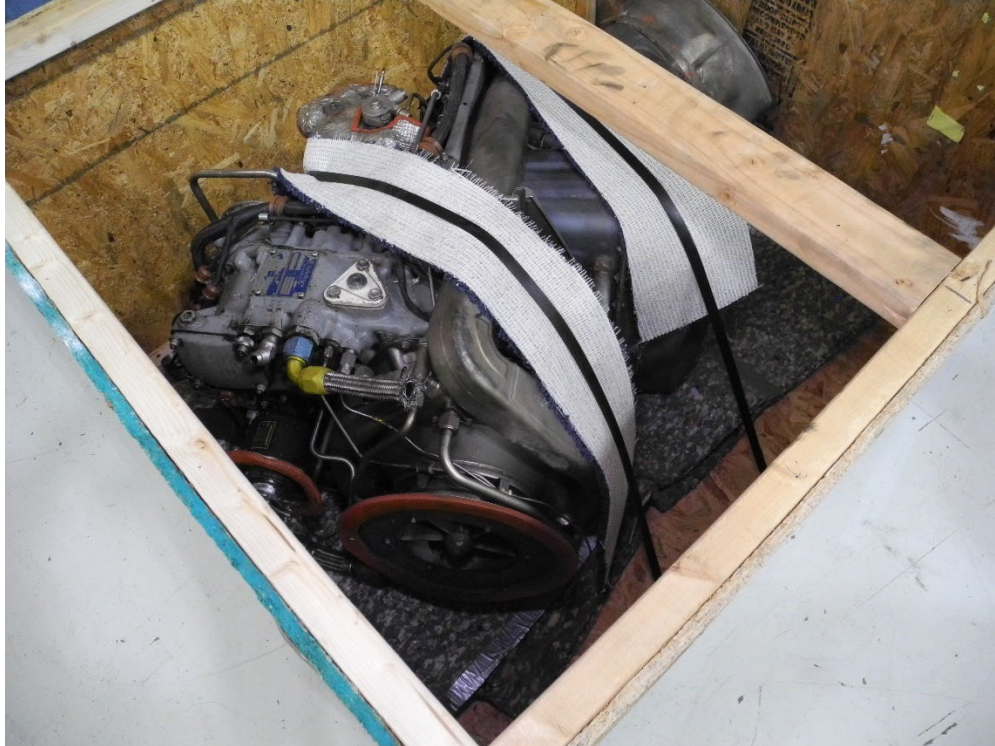
The engine was in a wooden engine container which was opened in the presence of the NTSB ([Photo 1](#)). It was externally generally clean and intact. There was no evidence of an un-containment or external impact or fire.

**Photo 1** - Rolls-Royce M250-C47M S/N CAE-847247- As Received

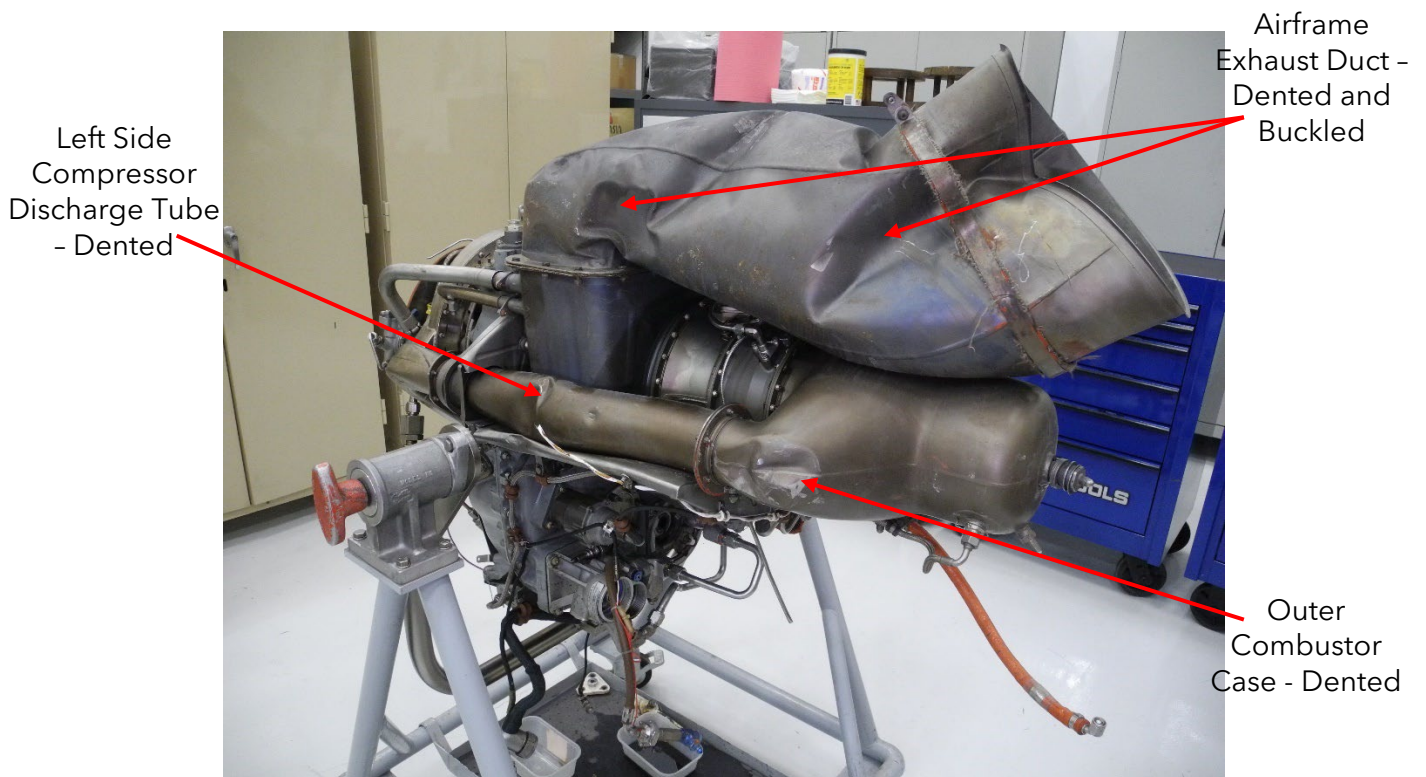
The airframe exhaust duct was still attached to the engine exhaust flange and was buckled inwards ([Photo 2](#)). The inner surfaces of the airframe exhaust duct were dry and clean ([Photo 3](#)). The outer combustor case (OCC) was dented on the left side discharge tube elbow and the left compressor discharge duct was dented on the outer surface ([Photo 4](#)), both consistent with an external impact.

**Photo 2** - Exhaust Duct - Buckled

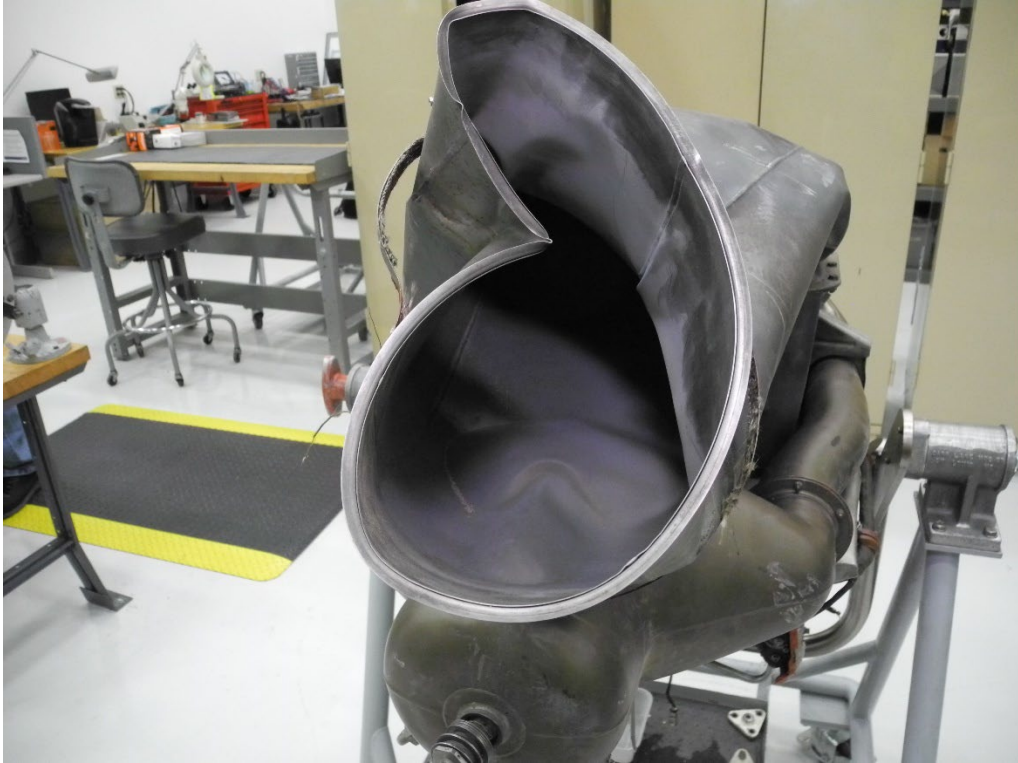
**Photo 3** - Airframe Exhaust Duct - Internal Surfaces Dry

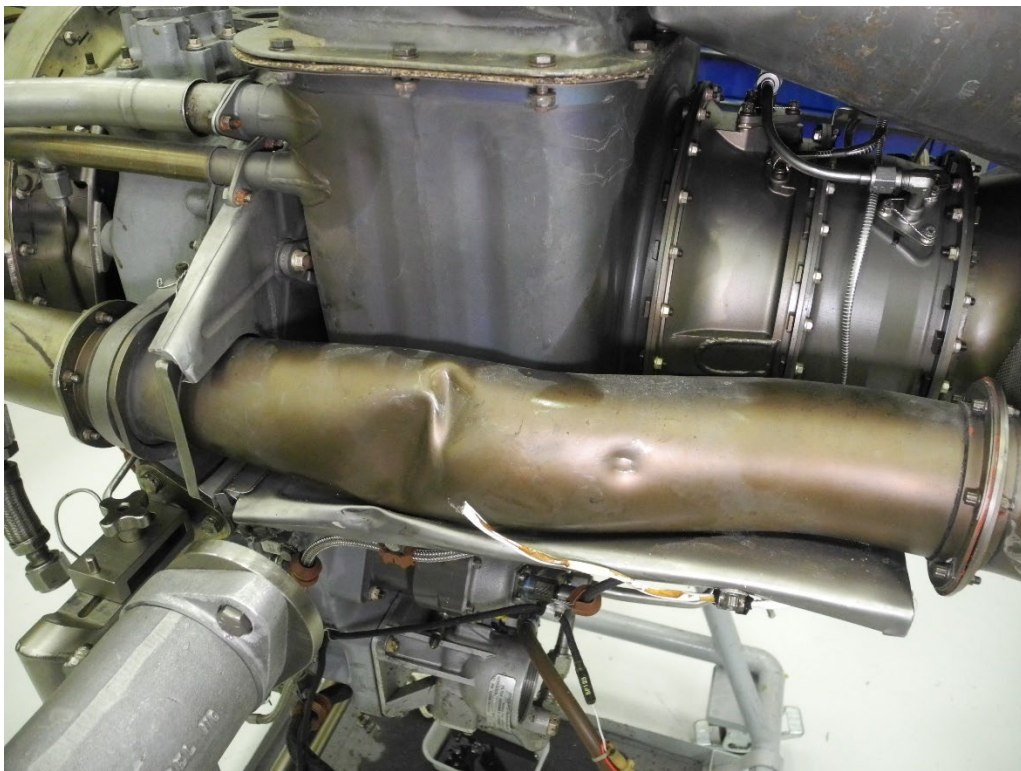
**Photo 4** - Left Side Compressor Discharge Tube - Dents

The OCC was intact; however, it was dented on the left side discharge tube elbow and the left compressor discharge duct due to external impact. The combustor liner was intact and undamaged ([Photo 17](#), [Photo 18](#) & [Photo 19](#)). The fuel nozzle was intact and undamaged ([Photo 20](#)).

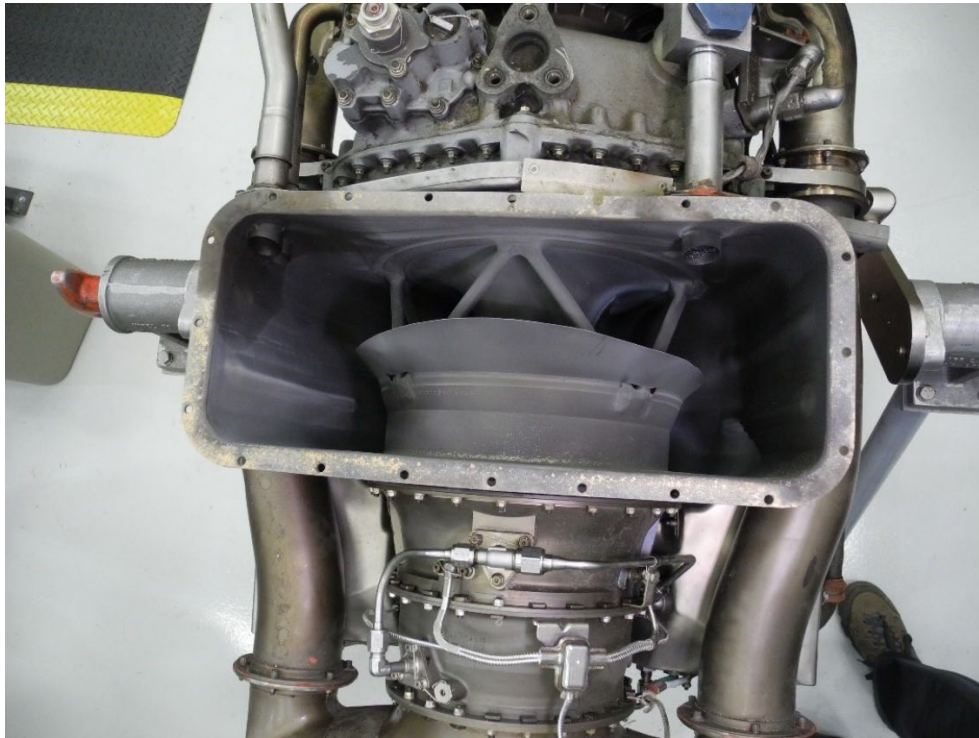
The internal surface of the exhaust collector duct was clean (Photo 5). The 4<sup>th</sup> stage turbine wheel (2<sup>nd</sup> stage power turbine) was clean and undamaged (Photo 6).

**Photo 5** - Exhaust Collector Duct - Clean

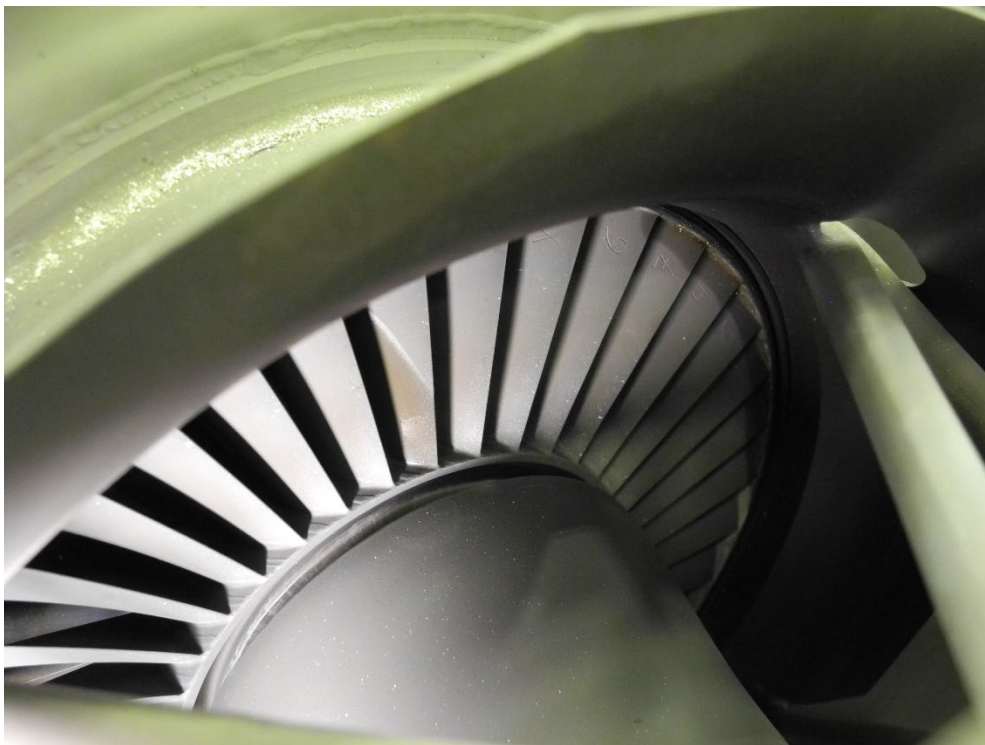
**Photo 6** - 4<sup>th</sup> Stage Turbine Wheel - Undamaged

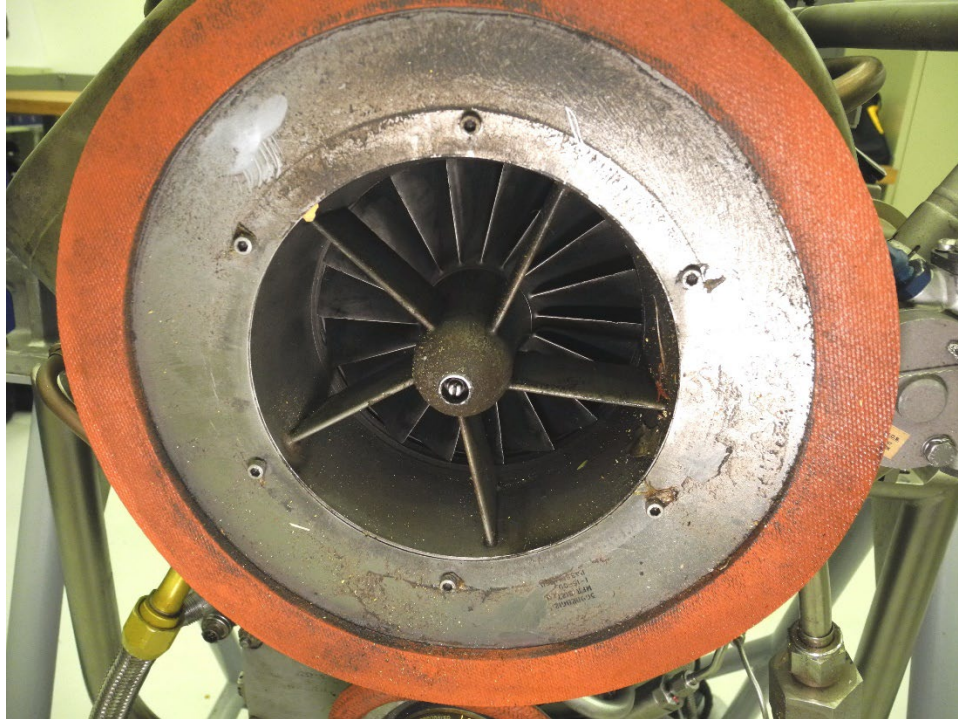
The compressor inlet was clean, and the visible impeller vane leading edges were intact and clean (Photo 7). Both the low-pressure rotor (N1) and the high-pressure rotor (N2) spools could be easily turned with normal hand effort.

**Photo 7** - Compressor Impeller Inlet - Clean

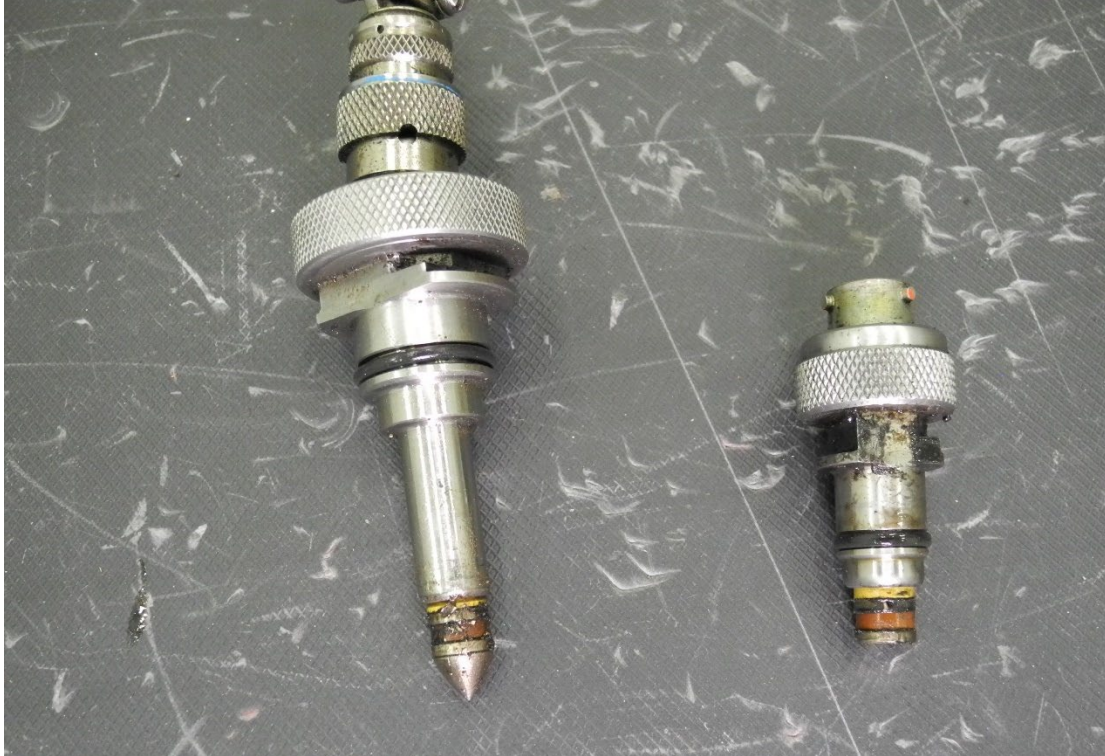
The two chip detectors in the gearbox were clean and oil wetted (Photo 8). The oil filter was clean and oil wetted (Photo 9).

**Photo 8** - Gearbox Oil Chip Detectors - Clean

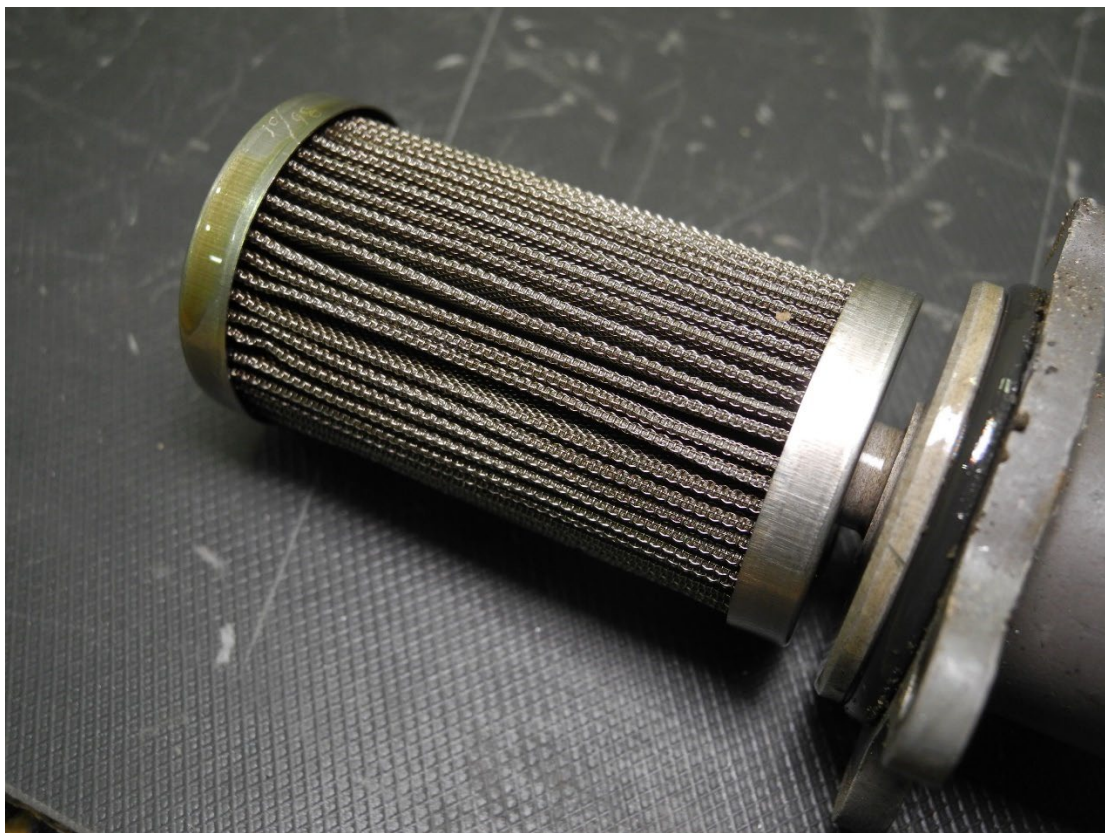
**Photo 9** - Oil Filter - Clean

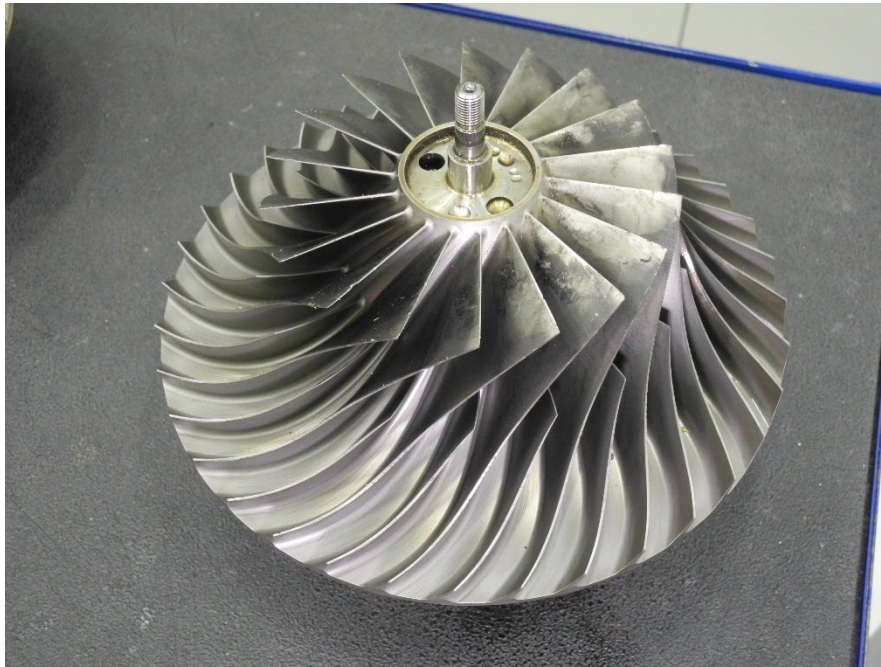
The compressor turned freely, and the Nos. 1 and 2 bearings were clean and oil wetted. The impeller ([Photo 10](#)) was intact; however, there was a buildup ([Photo 11](#)) of transferred material at the last 1½ inches at exducer shroud line, consistent with the rotational scoring observed on the matching shroud location.

**Photo 10** - Compressor Impeller - Intact

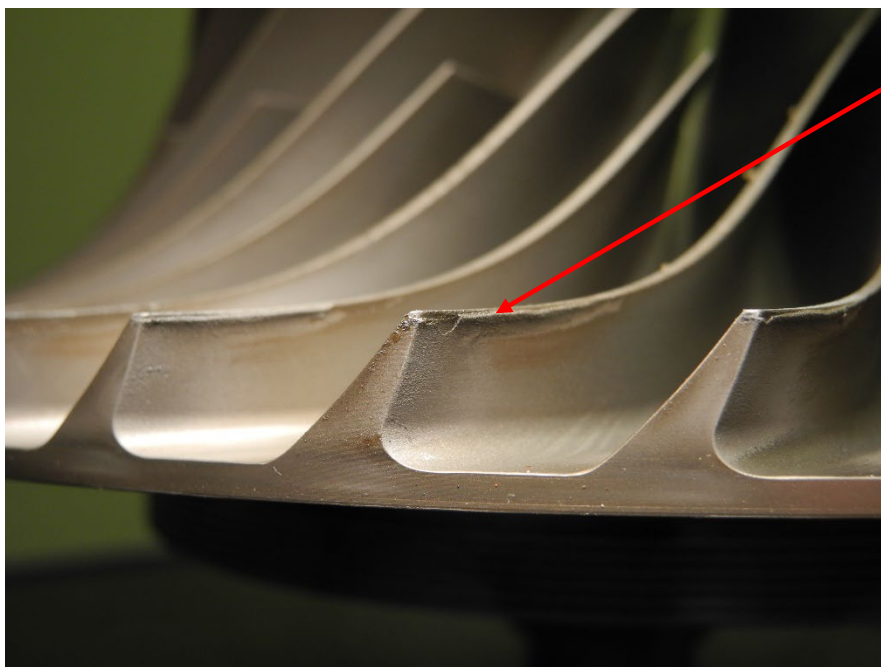
Buildup of  
Transferred  
Material

**Photo 11** - Impeller Exducer - Buildup of Transferred Material

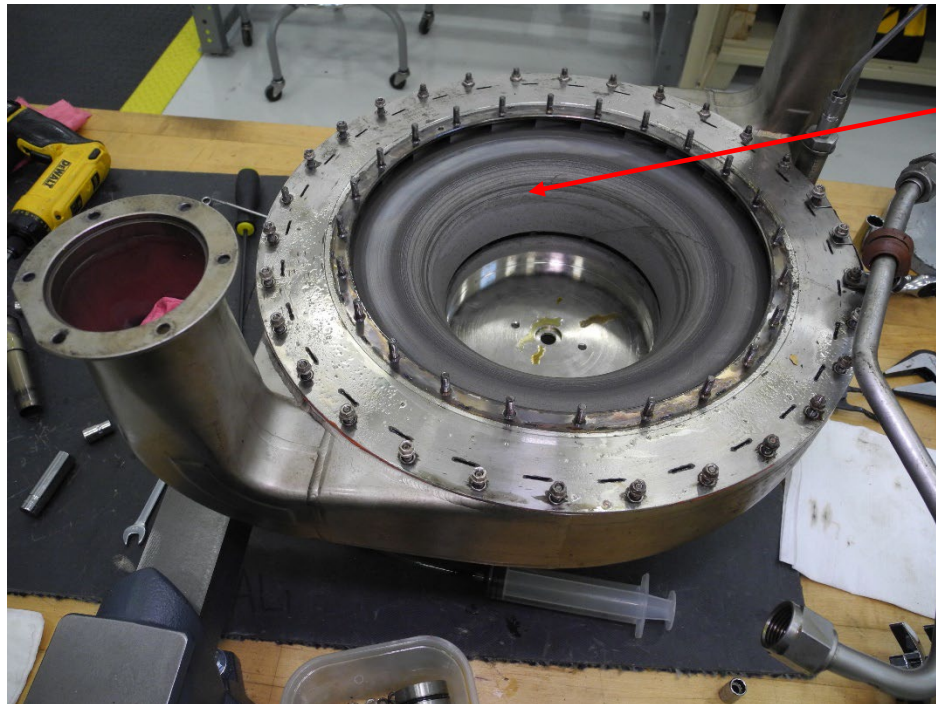
The impeller shroud ([Photo 12](#)) was intact; however, it was heavily rotationally scored, consistent with contact against the rotating impeller vane shroud line ([Photo 13](#) & [Photo 14](#)).

**Photo 12** - Impeller Shroud - Still Installed in Diffuser Housing

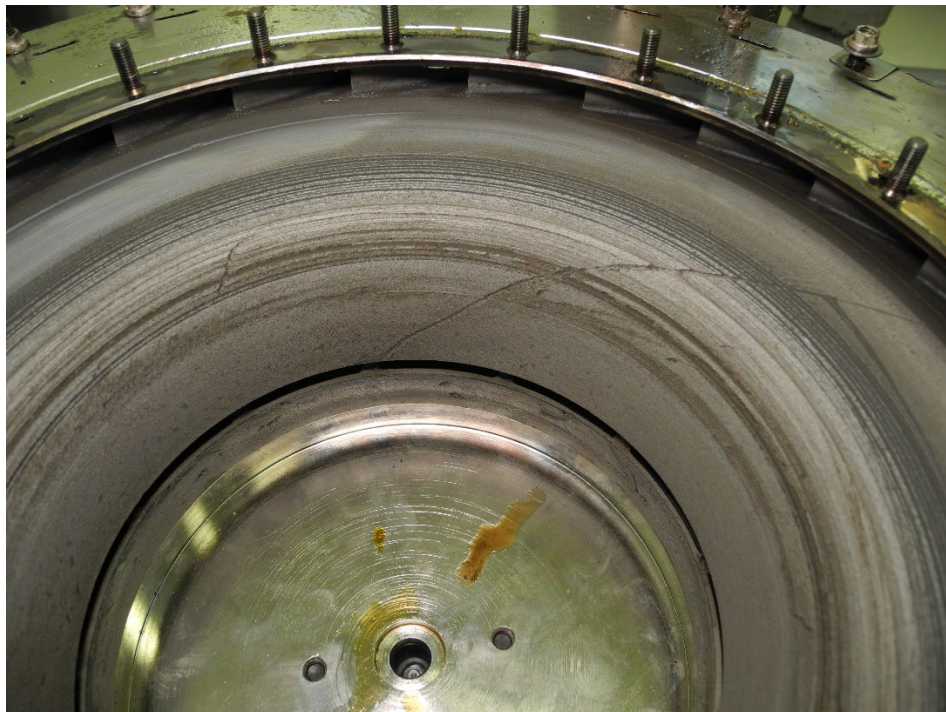
**Photo 13** - Impeller Shroud - Scored

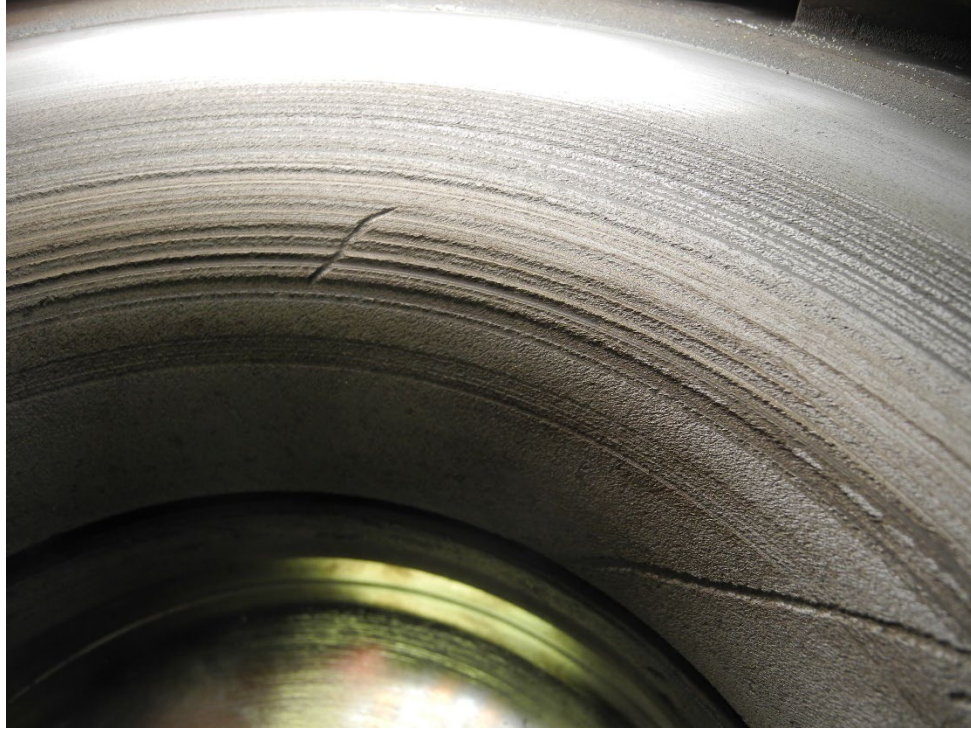
**Photo 14** - Impeller Shroud - Scoring Details

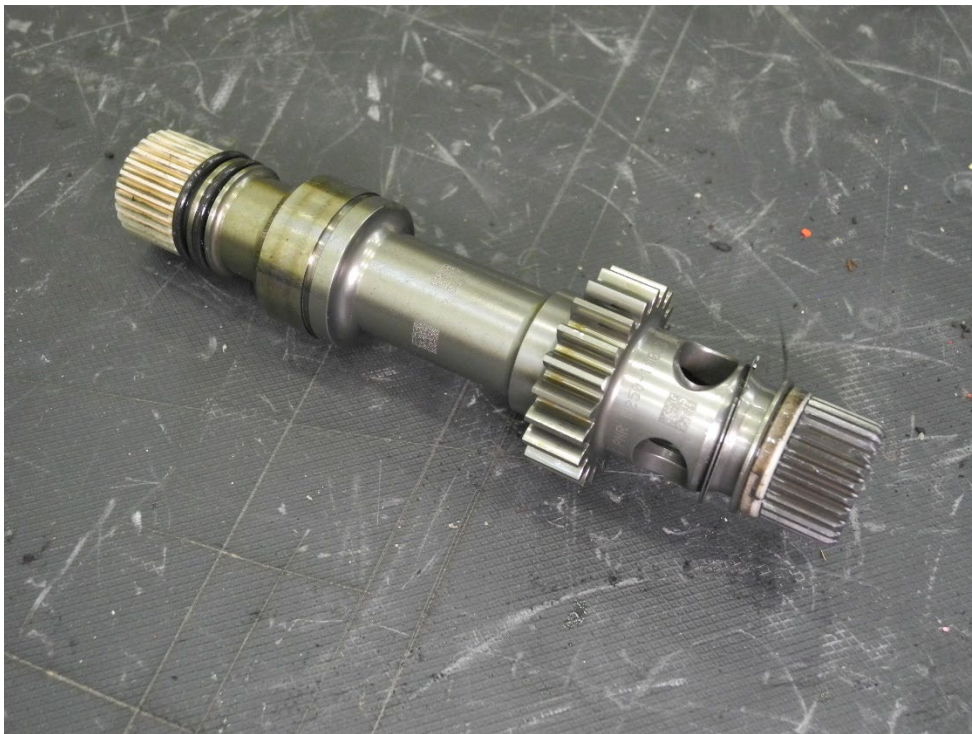
The spur adapter gearshaft was intact and undamaged ([Photo 15](#)).

**Photo 15** - Spur Adapter Gearshaft - Undamaged

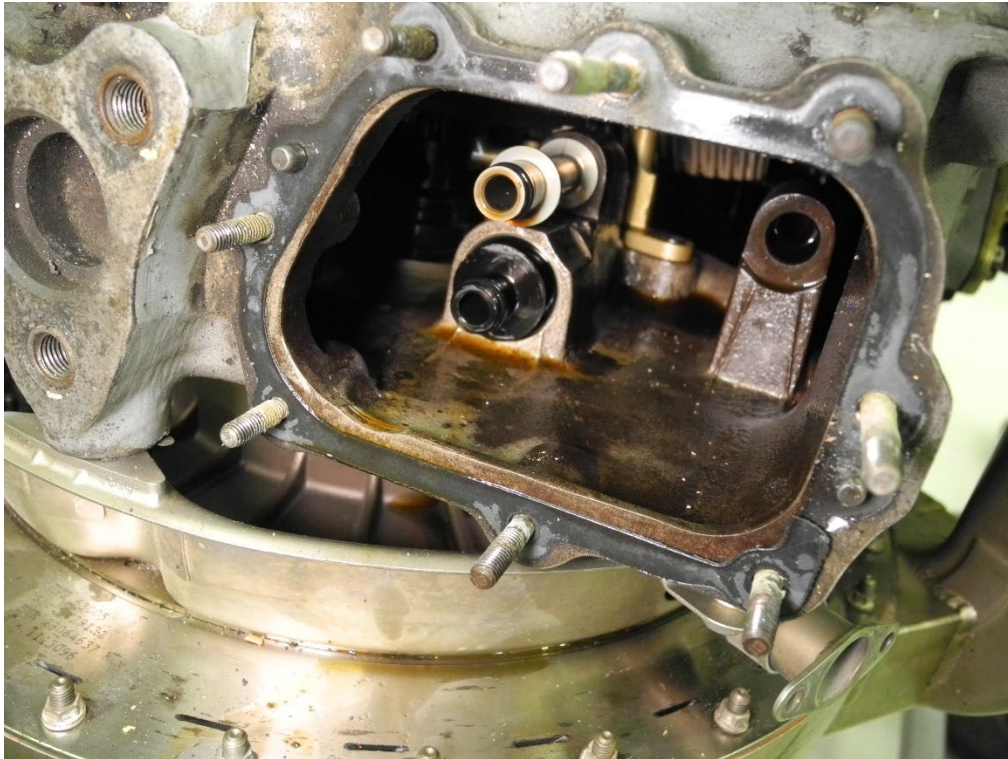
The gearbox was intact and undamaged. The N1 and N2 gear trains turned easily and smoothly using normal effort. When the oil filter housing was removed, an internal examination of the gearbox ([Photo 16](#)) confirmed that all internal components were oil wetted. All the related spline shafts turned in unison, indicating internal continuity and therefore the gearbox was not further disassembled.

**Photo 16** - Gearbox Internal View - Oil Filter Housing Removed

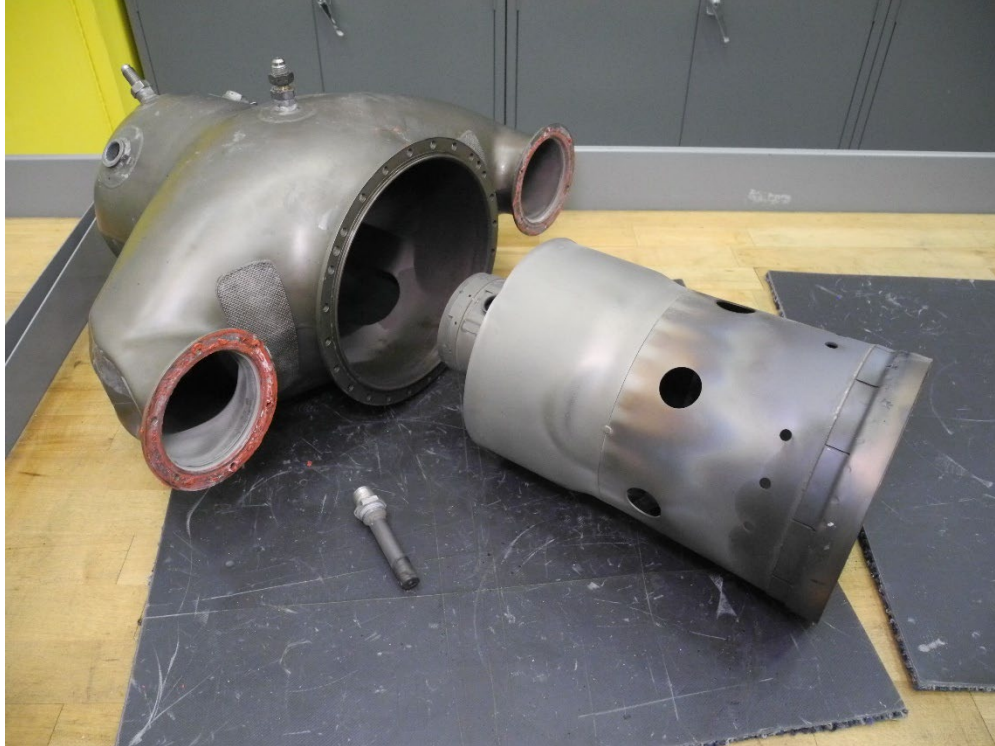
**Photo 17** - OCC and Combustor Liner - Undamaged

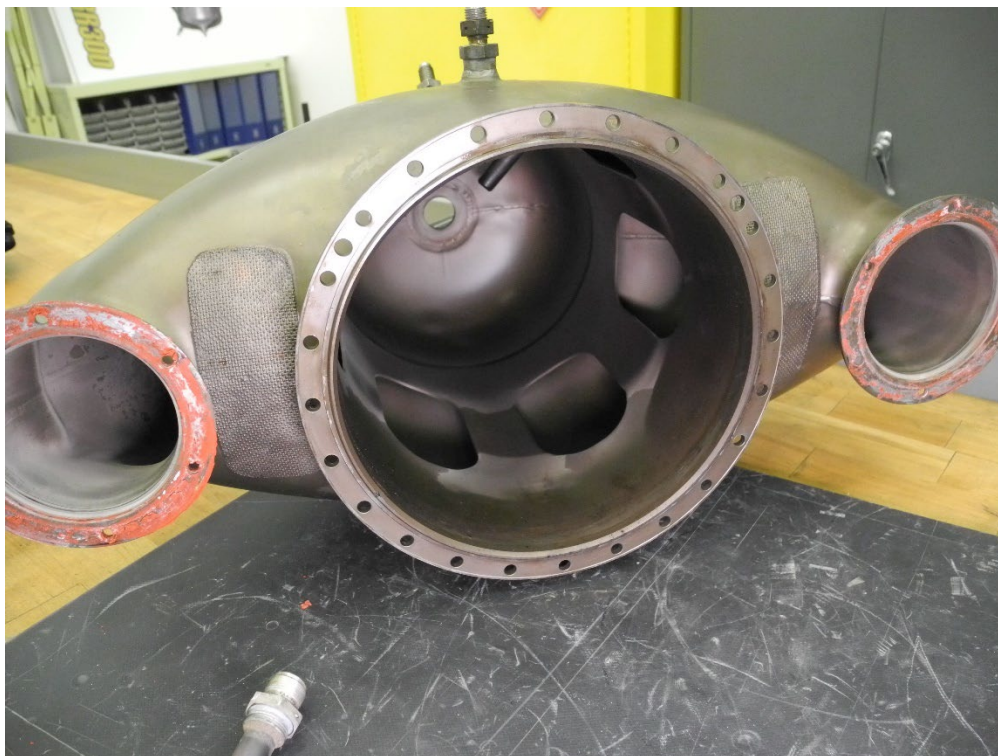
**Photo 18** - OCC Internal View - Undamaged

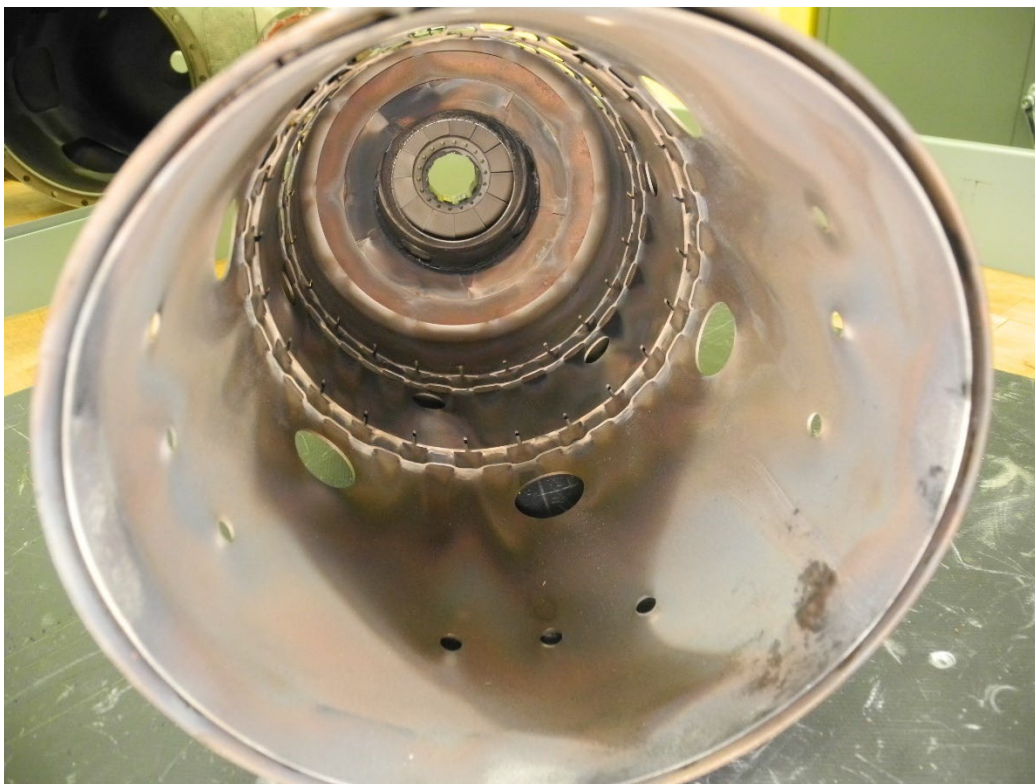
**Photo 19** - Combustor Liner - Inner View - Undamaged

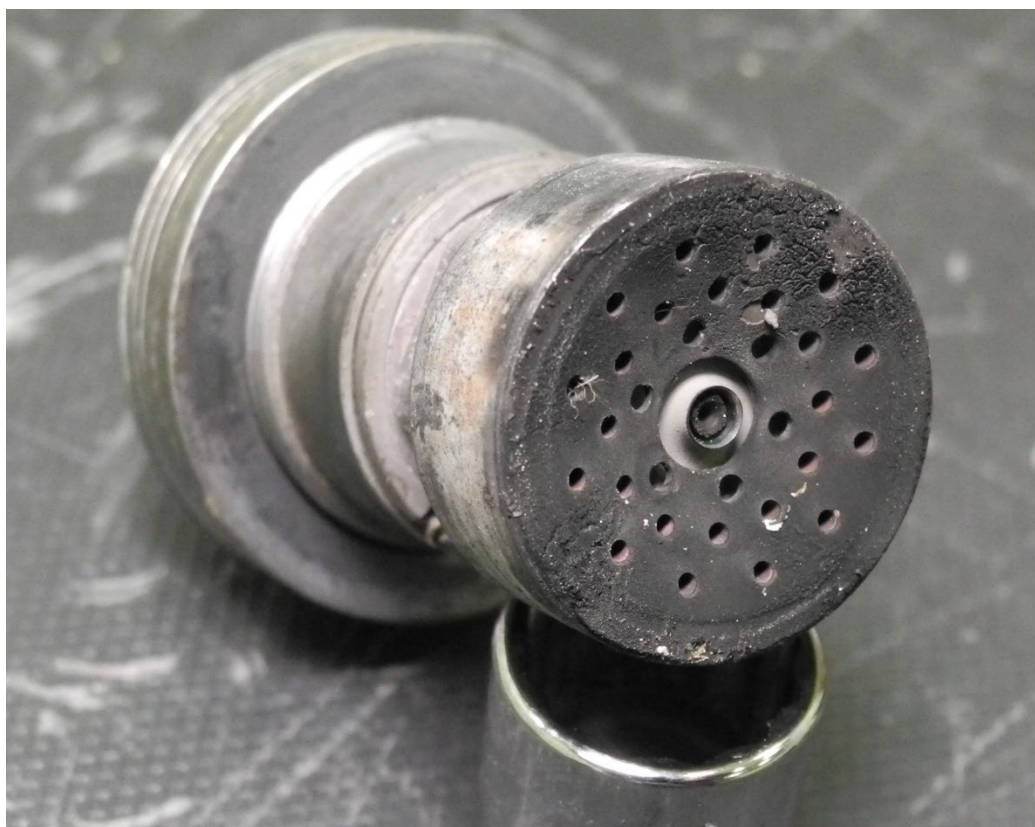
**Photo 20** - Fuel Nozzle - Undamaged

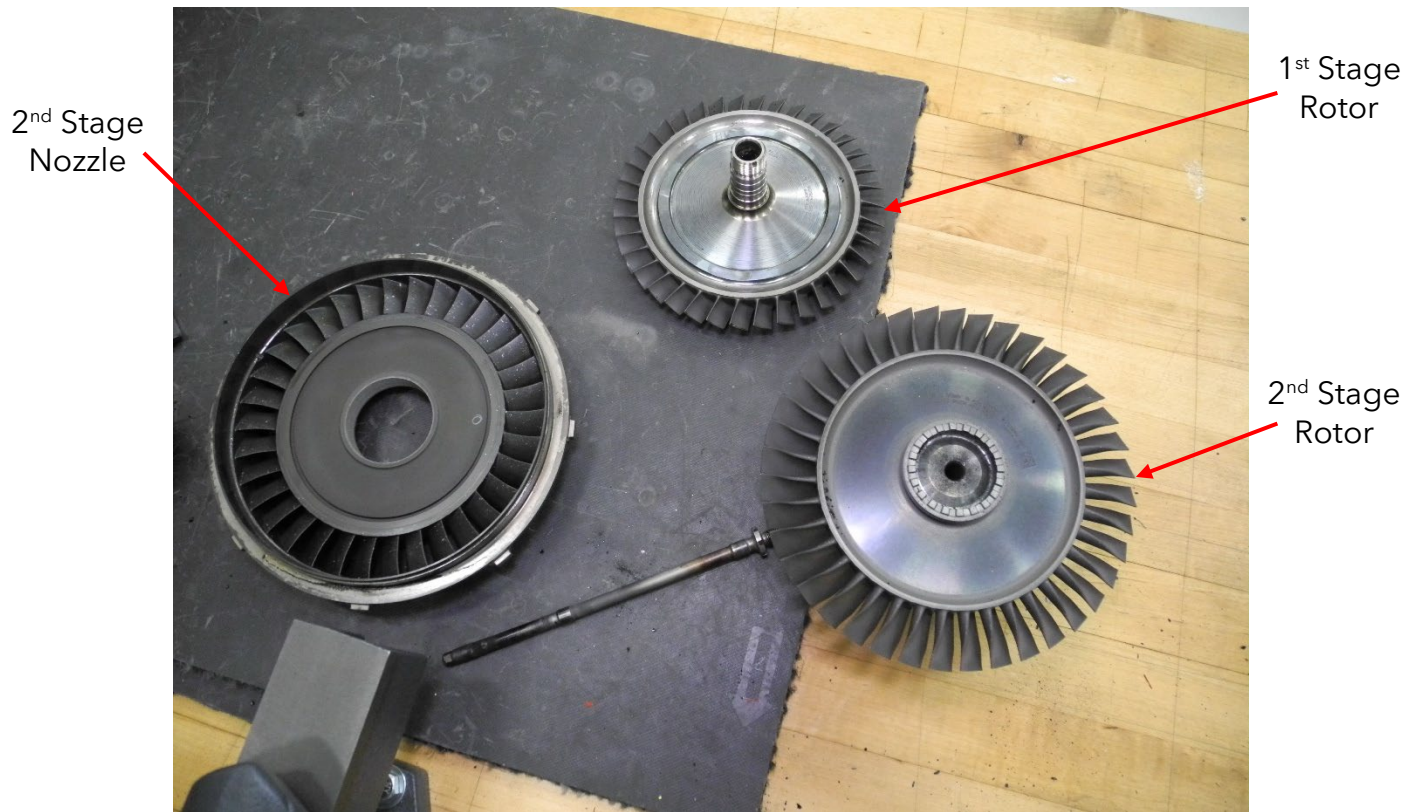
The 1<sup>st</sup> stage nozzle and 1<sup>st</sup> stage rotor were intact and undamaged ([Photo 21](#)).

**Photo 21** - Compressor Turbines

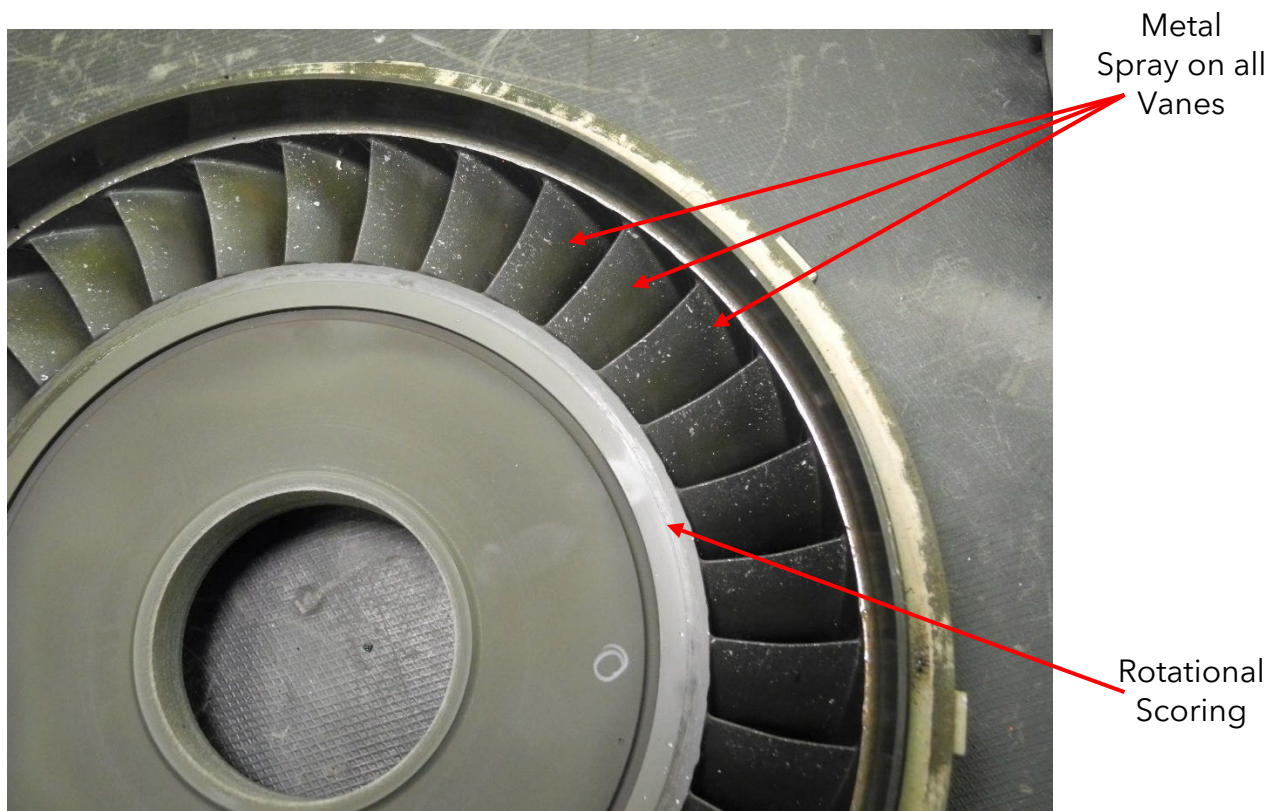
The 2<sup>nd</sup> stage nozzle was intact; however, it exhibited metal spray on the convex side of all the vanes and rotational scoring on the aft face (downstream side) of the vanes platform ([Photo 22](#)), consistent with contact against the rotating 2<sup>nd</sup> stage rotor blade platform ([Photo 23](#)). The 2<sup>nd</sup> stage rotor was otherwise intact.

**Photo 22** - 2<sup>nd</sup> Stage Nozzle

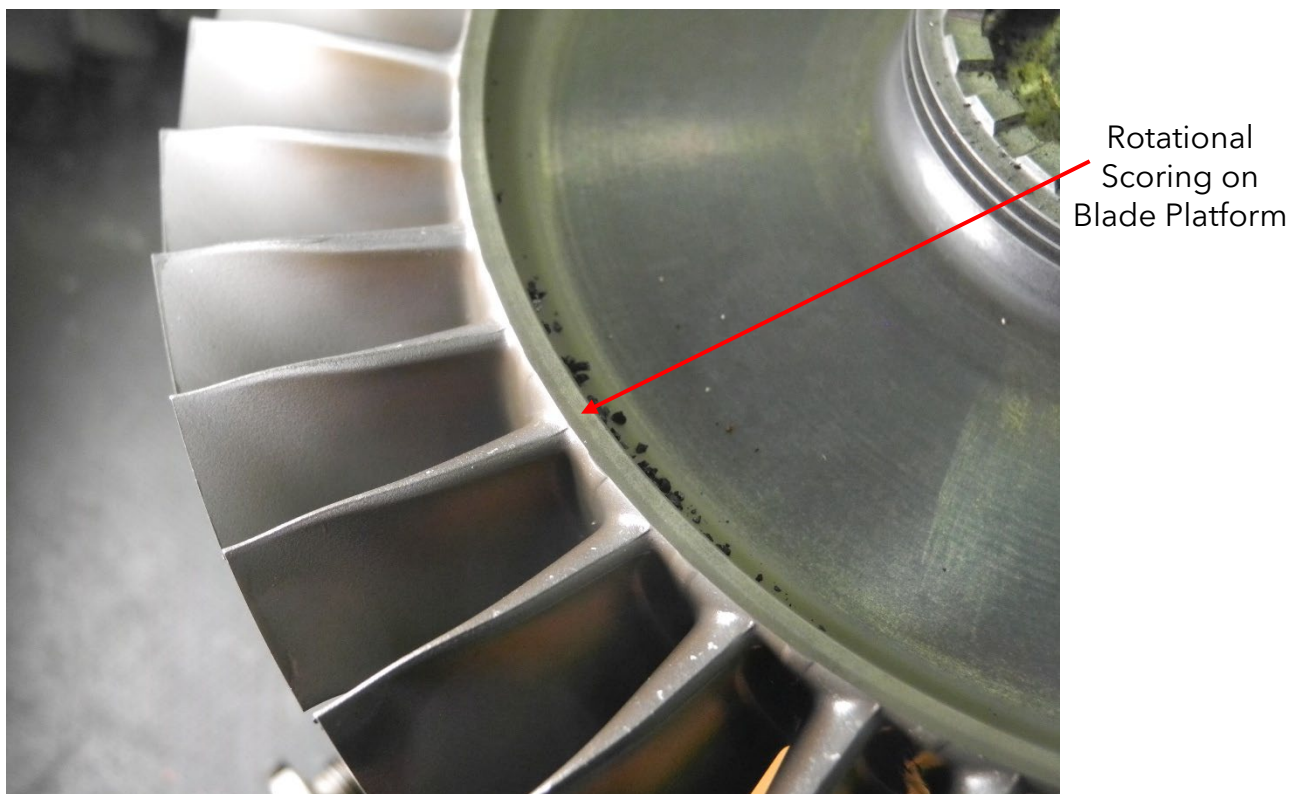
**Photo 23** - 2<sup>nd</sup> Stage Turbine Rotor - Rotational Scoring

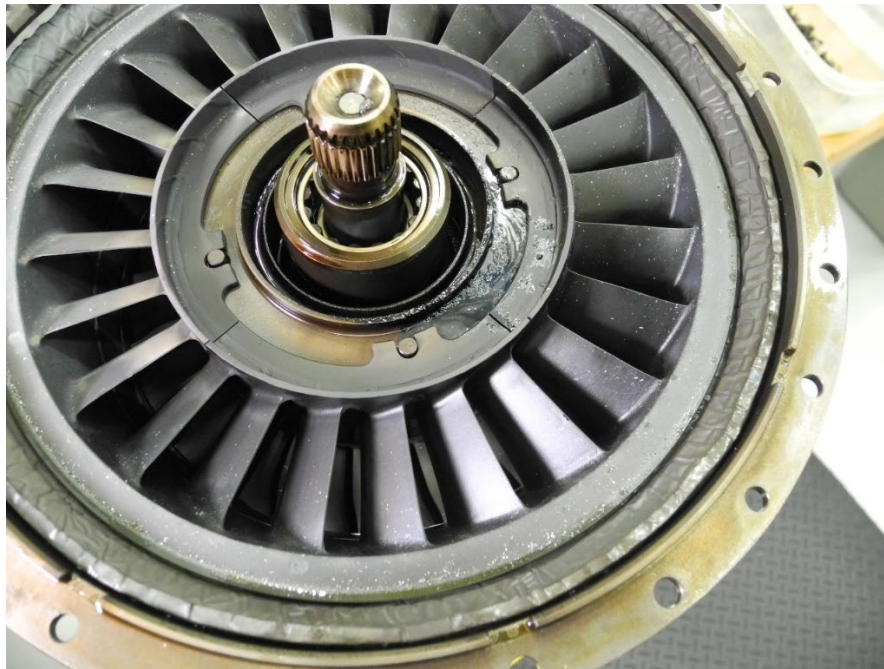
The 3<sup>rd</sup> stage nozzle (Photo 24) and 3<sup>rd</sup> stage turbine were intact and undamaged. The 3<sup>rd</sup> stage nozzle exhibited metal spray on all the convex sides of the vanes (Photo 25).

**Photo 24** - 3<sup>rd</sup> Stage Nozzle - Undamaged

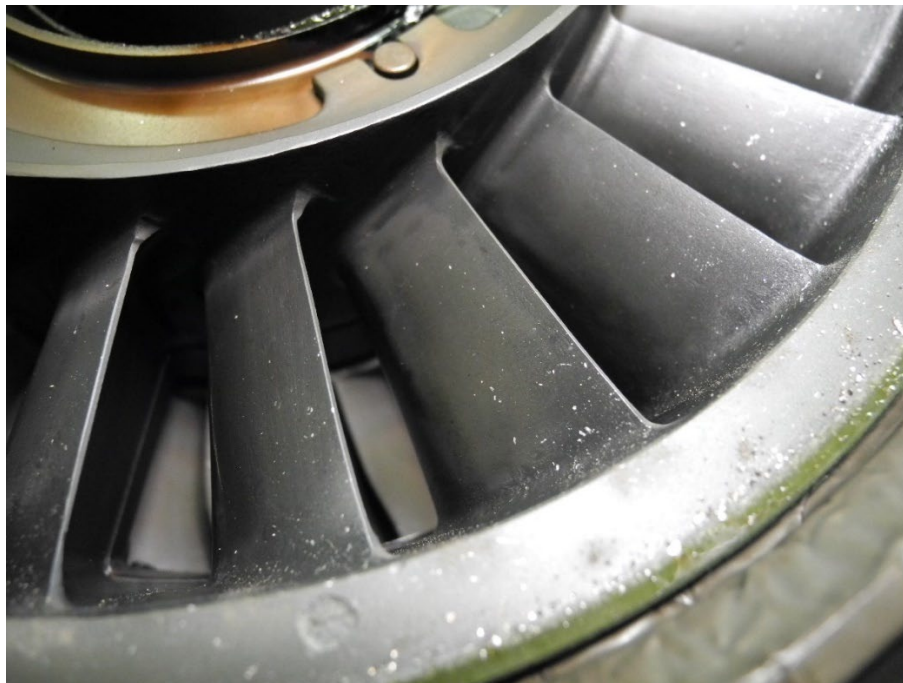
**Photo 25** - 3<sup>rd</sup> Stage Nozzle - Metal Spray Details

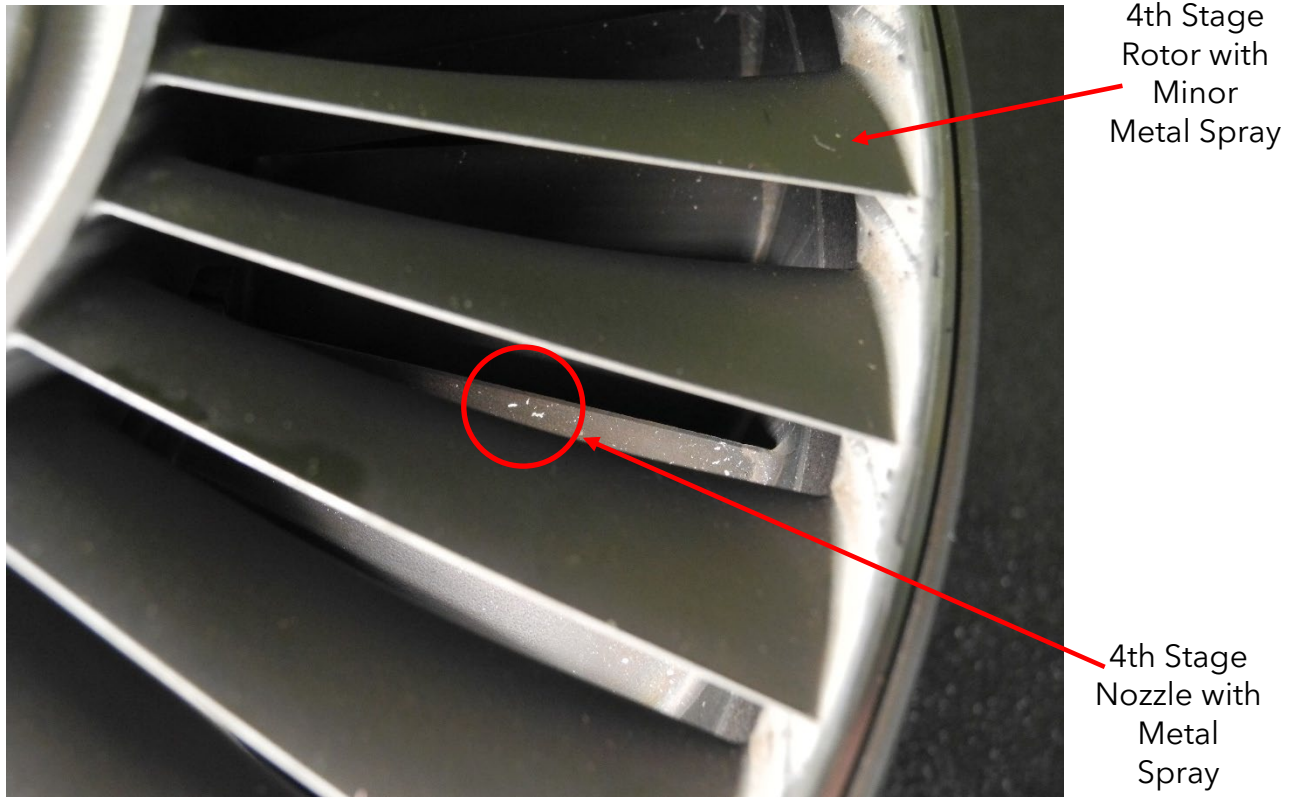
The 4<sup>th</sup> stage nozzle and 4<sup>th</sup> stage rotor were intact and undamaged. The 4<sup>th</sup> stage nozzle exhibited metal spray on most of the convex sides of the vanes ([Photo 26](#)).

**Photo 26** - 4<sup>th</sup> Stage Rotor & Nozzle - Metal Spray
