# National Transportation Safety Board

CEN24FA049

## **AIRWORTHINESS**

Location: Sterling City, Texas  
Date: November 29, 2023  
Time: 1430 central standard time  
Helicopter: MD Helicopters 600N, registration N745MB

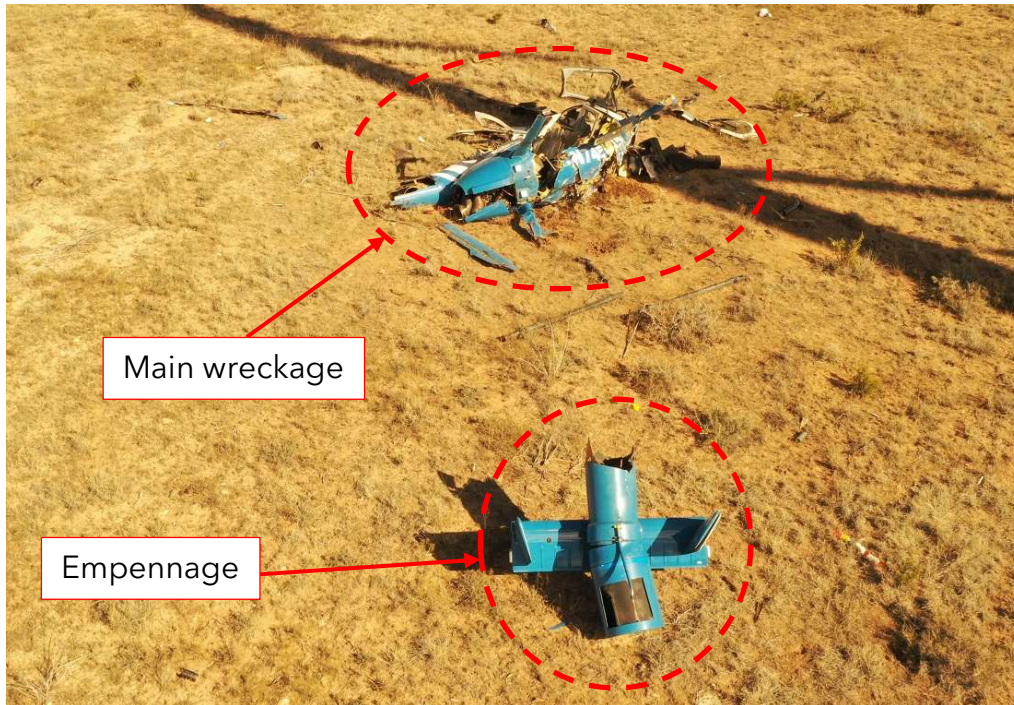
The airframe impacted the ground and came to rest on its left side. The empennage, containing the horizontal stabilizer, left and right vertical fins, and the aft end of the NOTAR, was found separated from the main wreckage (**Figure 1**). Multiple linear impact marks, in short succession of each other, were present on the static arm of the pole next to the accident site (**Figure 2**). The wreckage was subsequently recovered to Air Salvage of Dallas in Lancaster, TX. From April 9-10, 2024, the airframe wreckage was examined by three NTSB investigators, including the author of this report, at Air Salvage of Dallas.

**Figure 1.** The helicopter at the accident site.

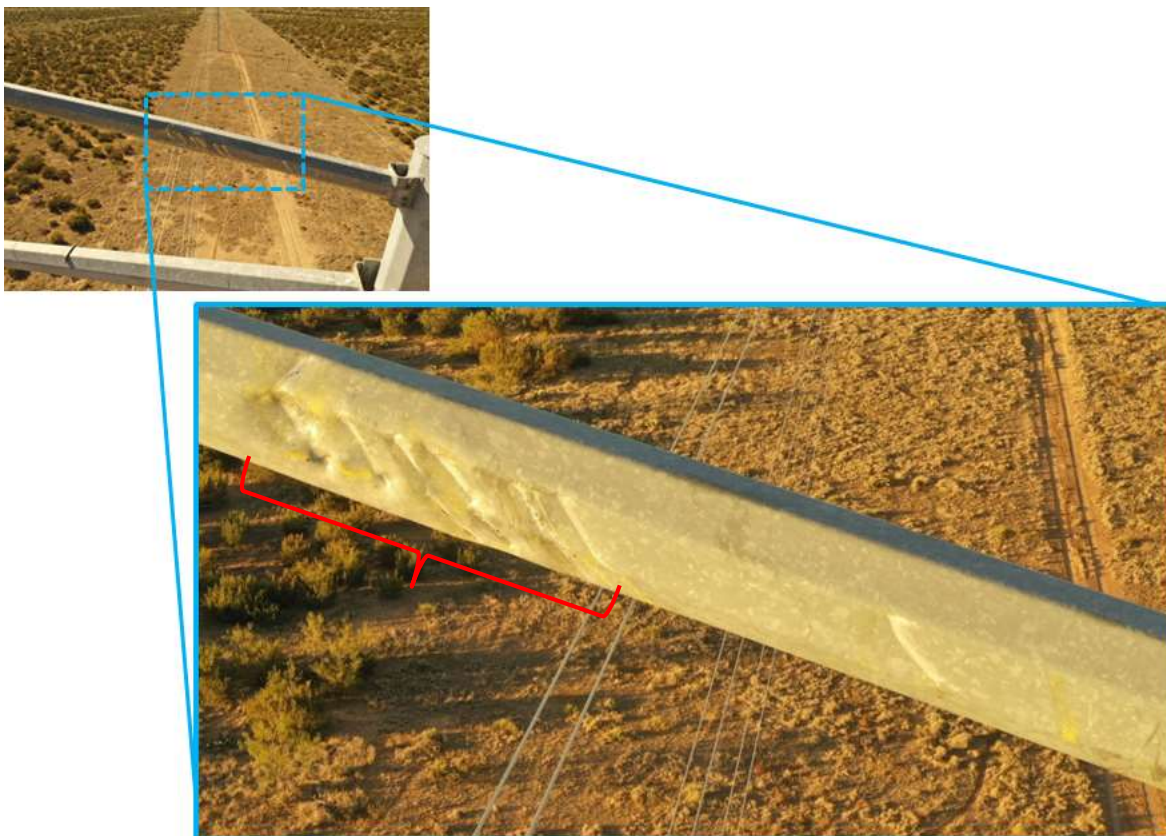
**Figure 2.** Multiple linear impact marks (red bracket) on the static arm of the pole next to the accident site.

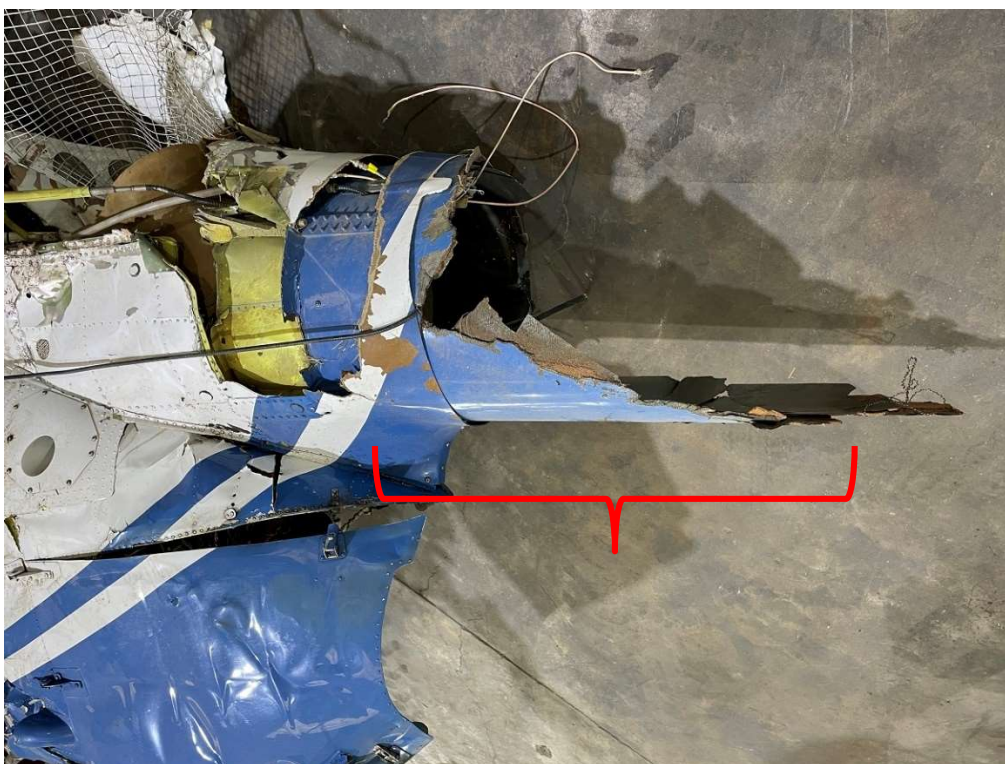
The airframe had separated in three distinct groups: 1) the cockpit and cabin floor, 2) the transmission deck and aft cabin/engine compartment, and 3) the empennage. The fuselage wreckage exhibited significant deformation and crushing damage primarily to its forward and left sides. The forward portion of the tail boom exhibited an angled fracture (**Figure 3**). An angled fracture of the tail boom can be a signature of the main rotor contacting the tail boom. The landing gear aft struts remained attached to the fuselage but the forward struts and both longitudinal tubes were fractured and separated from the fuselage.

**Figure 3.** The forward end of the tail boom exhibiting an angled cut mark.

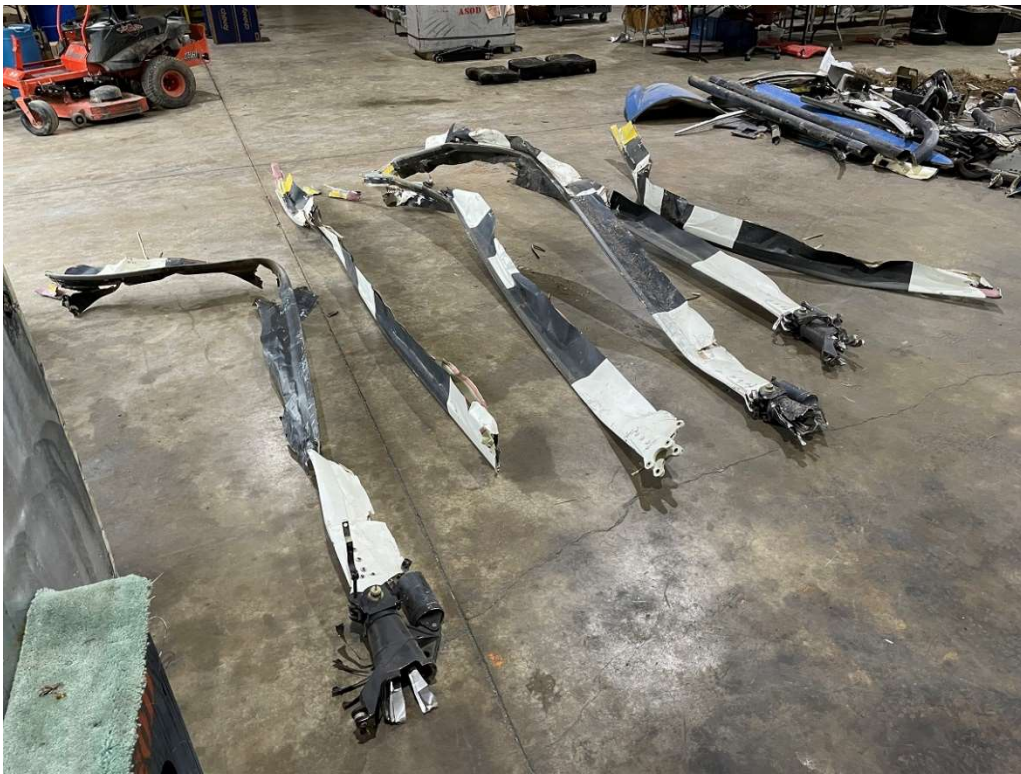
All six main rotor blades exhibited significant deformation, fractures, and fragmentation of their outboard ends (**Figure 4**). All fractures observed exhibited signatures consistent with overload. The leading edges of two main rotor blades exhibited blue-colored paint transfer that was a close color match to the paint scheme of the tail boom (**Figure 5**). Three of the six main rotor blade tip weights were recovered at the accident site and exhibited impact damage. The remaining three tip weights were not found at the accident site.

**Figure 4.** The recovered main rotor blades.

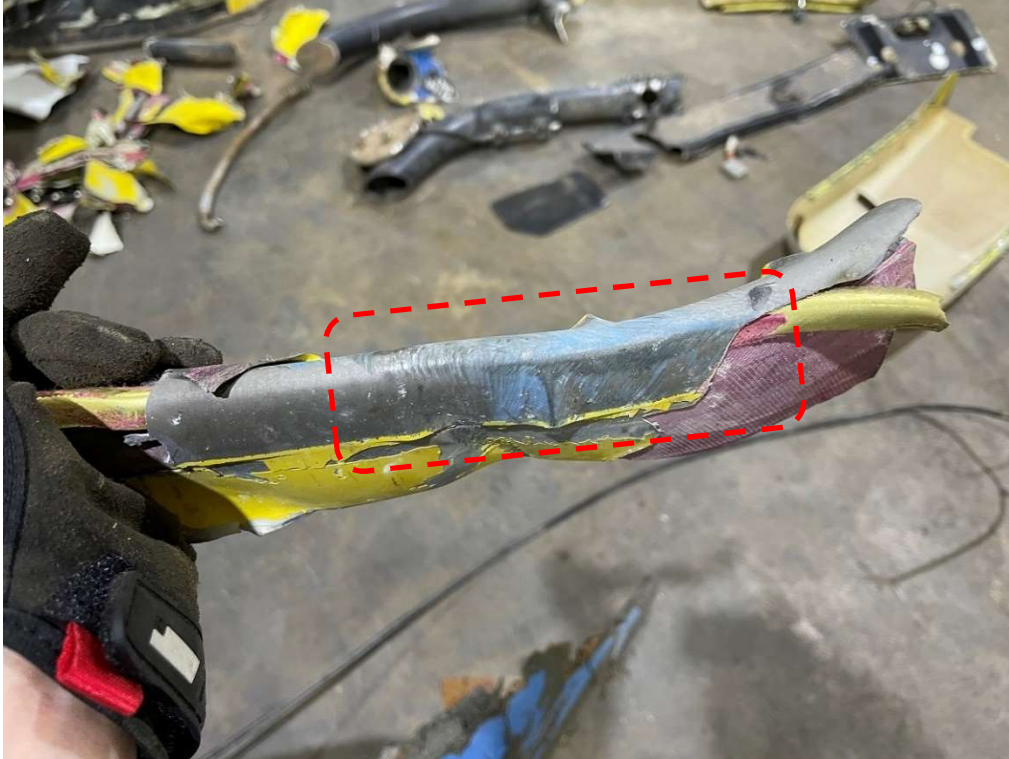
**Figure 5.** Paint transfer observed on the leading edge of main rotor blade fragments.

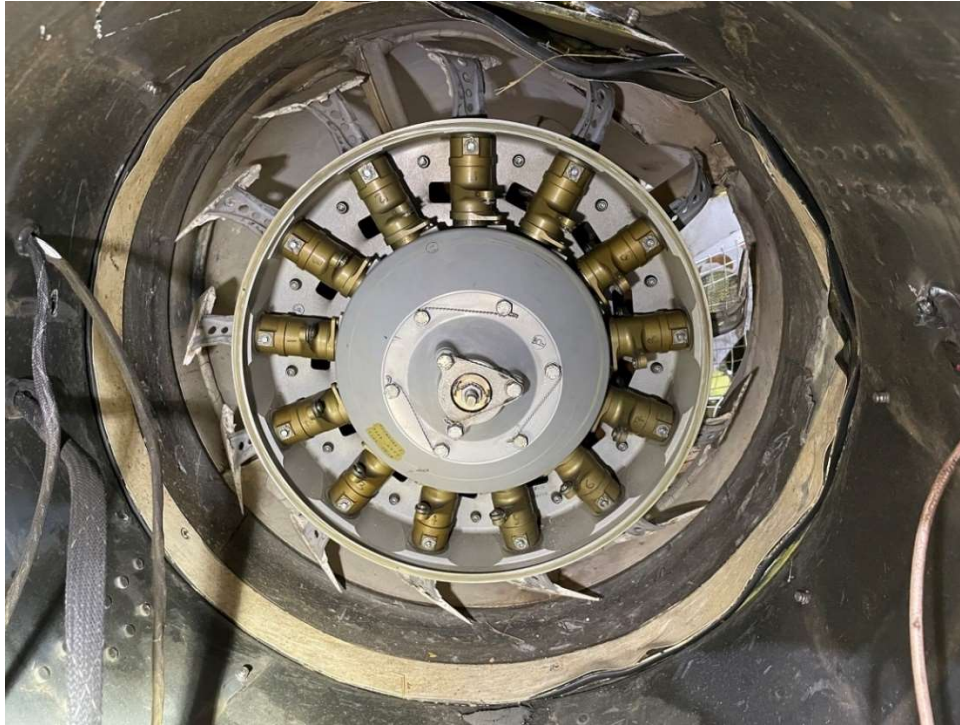
The fan gearbox drive shaft was present but its forward flexible coupling's flex plates had fractured with signatures consistent with overload. The fan gearbox drive shaft was connected at its aft end to the fan gearbox input flange. The fan gearbox remained installed on the airframe and the fan interconnecting drive shaft was continuous to the antitorque fan assembly. The antitorque fan assembly remained installed on the airframe. The fan blades remained connected to its hub, but all blade spars were deformed in the forward direction (**Figure 6**). Additionally, all blade airfoils were missing from their root end to about  $\frac{1}{2}$  to  $\frac{3}{4}$  of their spans, with all tip ends present. Scoring and gouging was observed around the circumference of the fan shroud. The diffuser stator/cone was recovered separated from the airframe, and the majority of the stator vanes were fractured and separated from their root ends.

**Figure 6.** The antitorque fan assembly (aft looking forward).

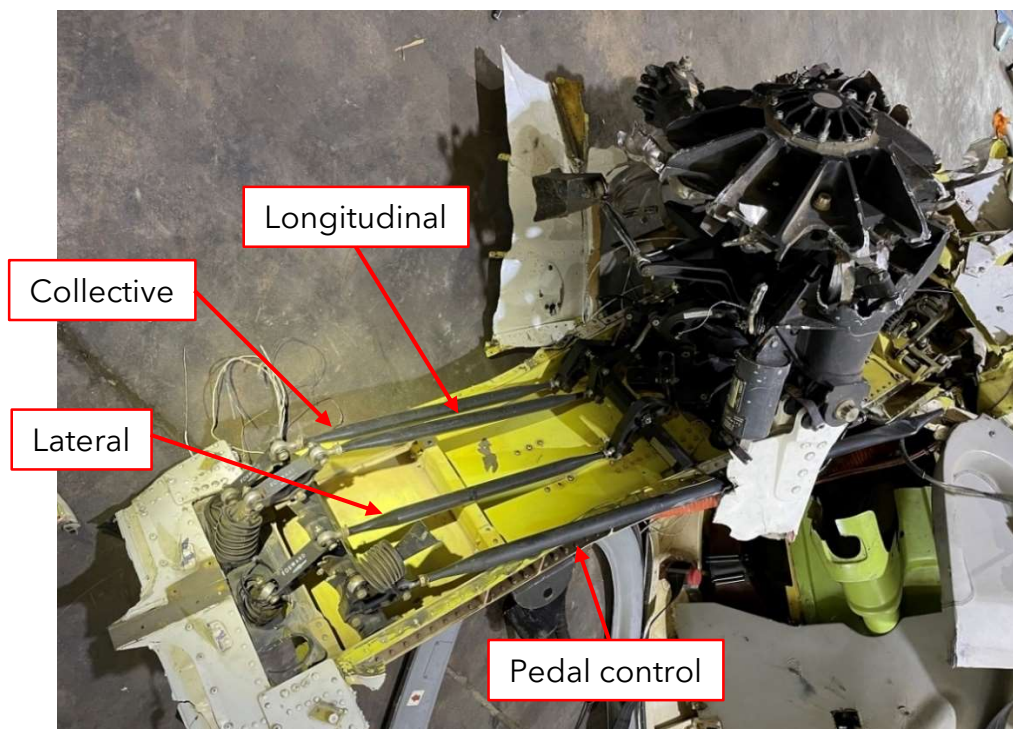
The upper bellcranks, immediately behind and above the cockpit seats, were present but the longitudinal cyclic and the lateral cyclic bellcrank attachments were separated from the upper bellcrank support; the fractures exhibited signatures consistent with overload. The four control tube from the upper bellcranks to the transmission bellcranks, immediately forward of the main transmission, were continuous and installed on both ends except for the pedal control tube, which was fractured at its aft rod end (**Figure 7**). The two trim motors remained installed at their upper ends.

**Figure 7.** The upper flight controls leading to the swashplate assembly.

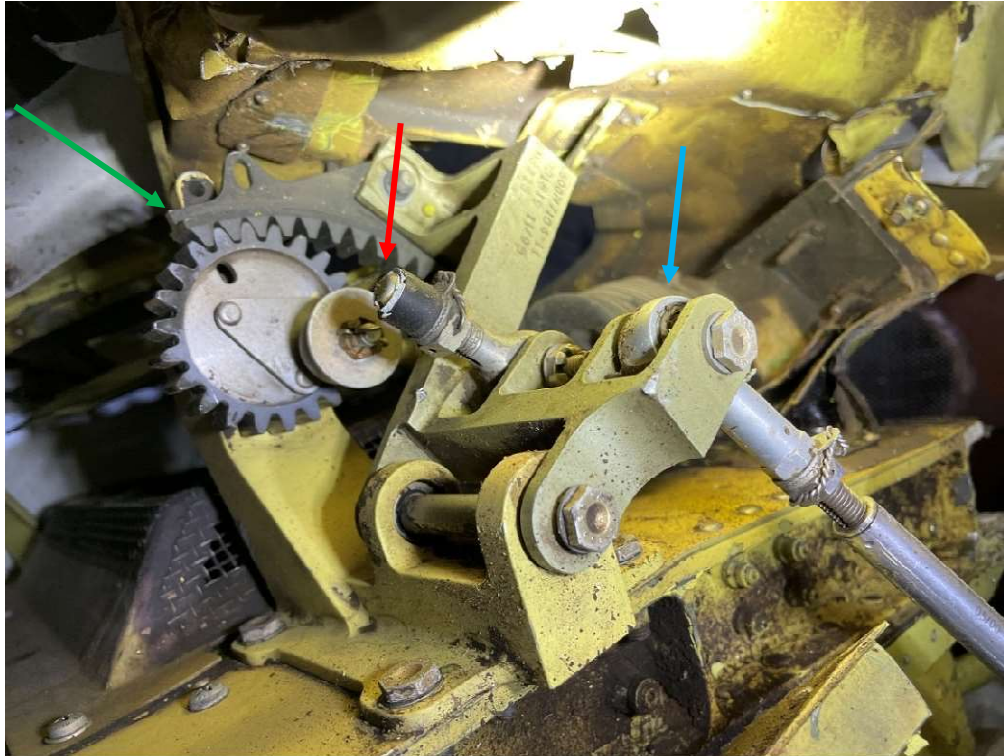
The NOTAR splitter assembly, located to the aft and left of the main transmission, remained installed on the airframe (**Figure 8**). The longitudinal control tube, normally routed to the left of the main transmission, was present but had fractured near its aft rod end; the aft rod end remained connected to the splitter assembly. The pitch change control gear [for the anti-torque fan] remained installed and connected to the splitter assembly and the intermediate control tube, but the intermediate control tube was fractured near its forward end with signatures consistent with overload. The intermediate control tube's aft end remained connected to the bellcrank near frame station (STA) 137.5. The fan pitch control tube remained connected to bellcrank near STA 137.5. Manual pitch changes to the fan blades resulted in a corresponding movement of the intermediate control tube.

**Figure 8.** The splitter assembly. The green arrow points to the pitch change control gear. The red arrow points to the aft rod end of the longitudinal control tube. The blue arrow points to the forward cable connection to the splitter assembly.

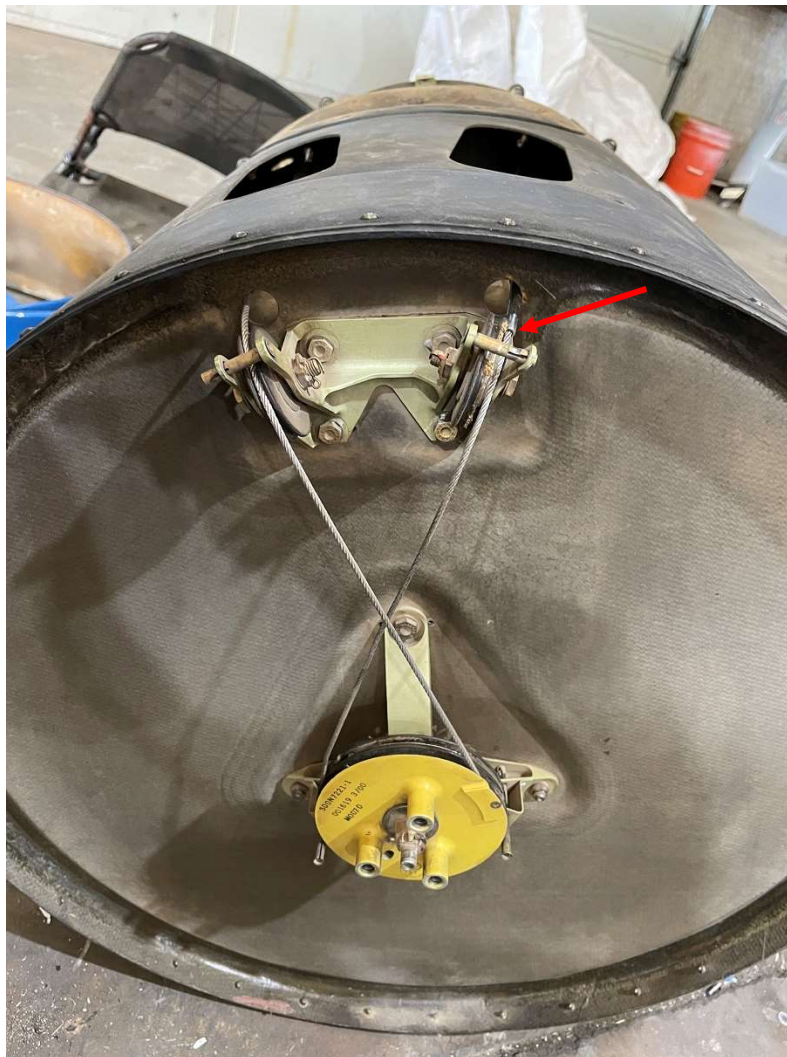
anomalous damage. The pulley cable was routed correctly through the drum assembly pulley (**Figure 9**). Rotation of the sector assembly resulted in a corresponding rotation of the drum assembly. The yaw stability augmentation system (YSAS) actuator remained installed on the right side of the horizontal stabilizer and remained connected to the right vertical stabilizer.

**Figure 9.** The pulley cable installation for the drum assembly, after removal of the drum (aft looking forward). The yellow-colored pulley on the lower portion of the image is the drum assembly pulley. The red arrow points to the damaged idler pulley.
