# National Transportation Safety Board

CEN24FA049

## **N745MB - AIRFRAME AND ENGINE EXAMINATION REPORT**

Location: Sterling City, Texas  
Date: November 29, 2023  
Time: 1430 Central Time  
Helicopter: N745MB, MD Helicopters 600N

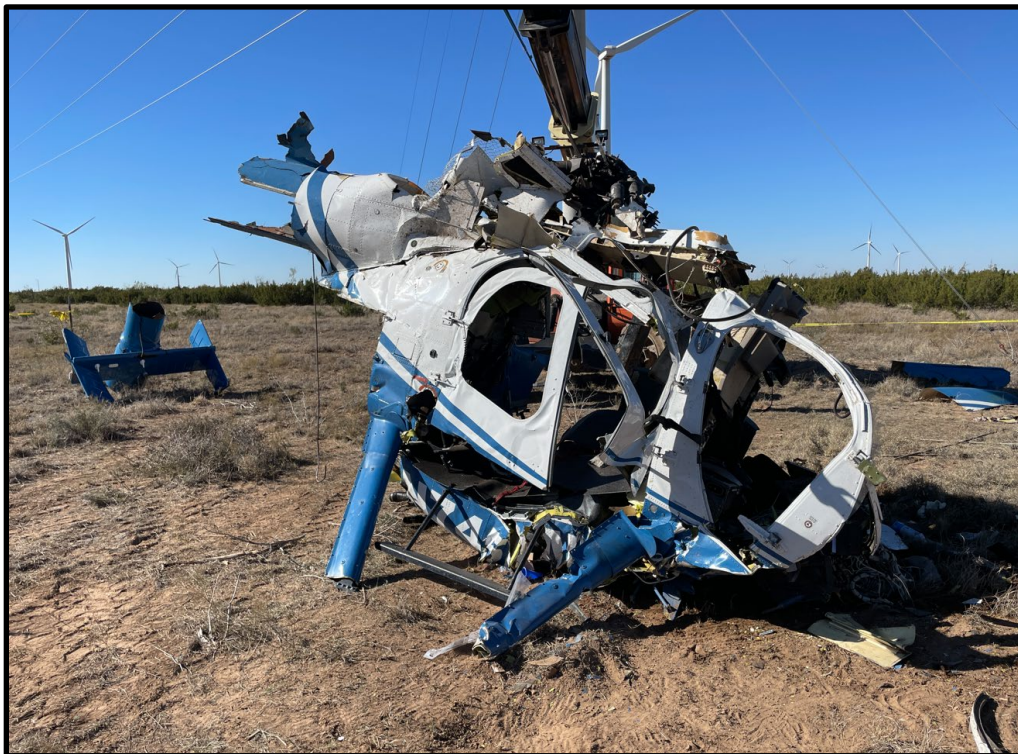
The wreckage was located between two sets of power lines that ran from the northeast to the southwest. The distance between the two sets of power lines, from pole to pole, was about 120 ft.

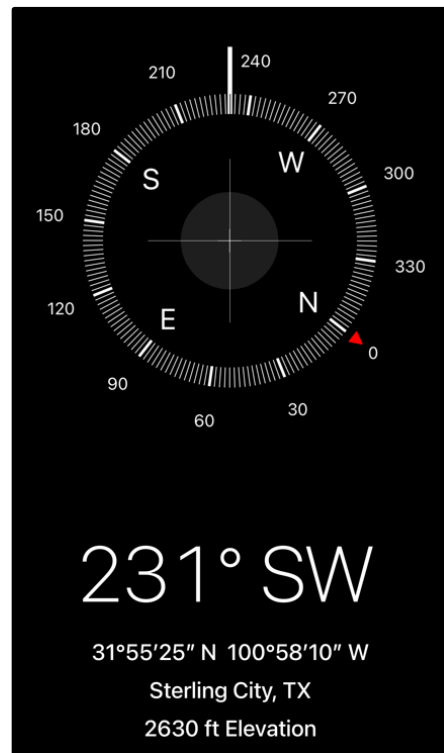
The initial impact point was a steel mono angle pole that is about 133 ft tall. Various impact marks were observed on an OPGW (optical ground wire – fiber) static arm,

that was about 12 ft long. The static arm had impact damage, about 4 ft from the base of the arm. The entire structure was found intact. Here are the coordinates for the initial impact point:

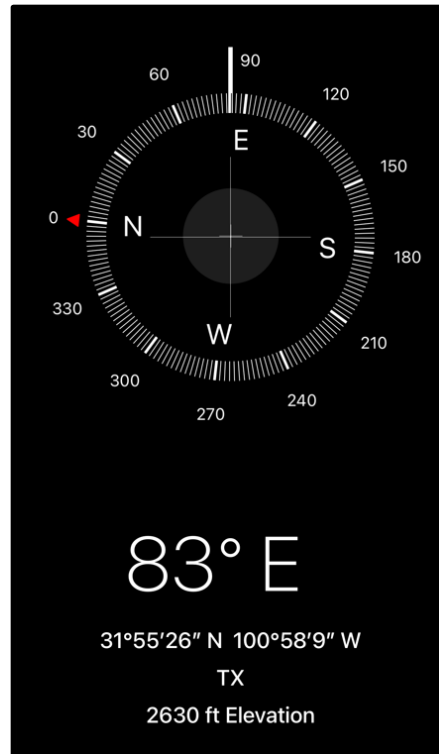
From the initial impact point to the final resting point of the wreckage, the heading was about 09° and about 103 ft (from the static arm impact point to the final resting point).

The helicopter came to rest on a heading of about 83°. The helicopter came to rest on the left side of fuselage. The accident site elevation was about 2,630 ft above mean sea level. There was no additional impact points observed. There were no signs that the helicopter impacted any other obstacles (besides the static arm) prior to impact. Here are the coordinates for the final resting point:
