CEN24FA049

## INVESTIGATION PHOTOGRAPHS

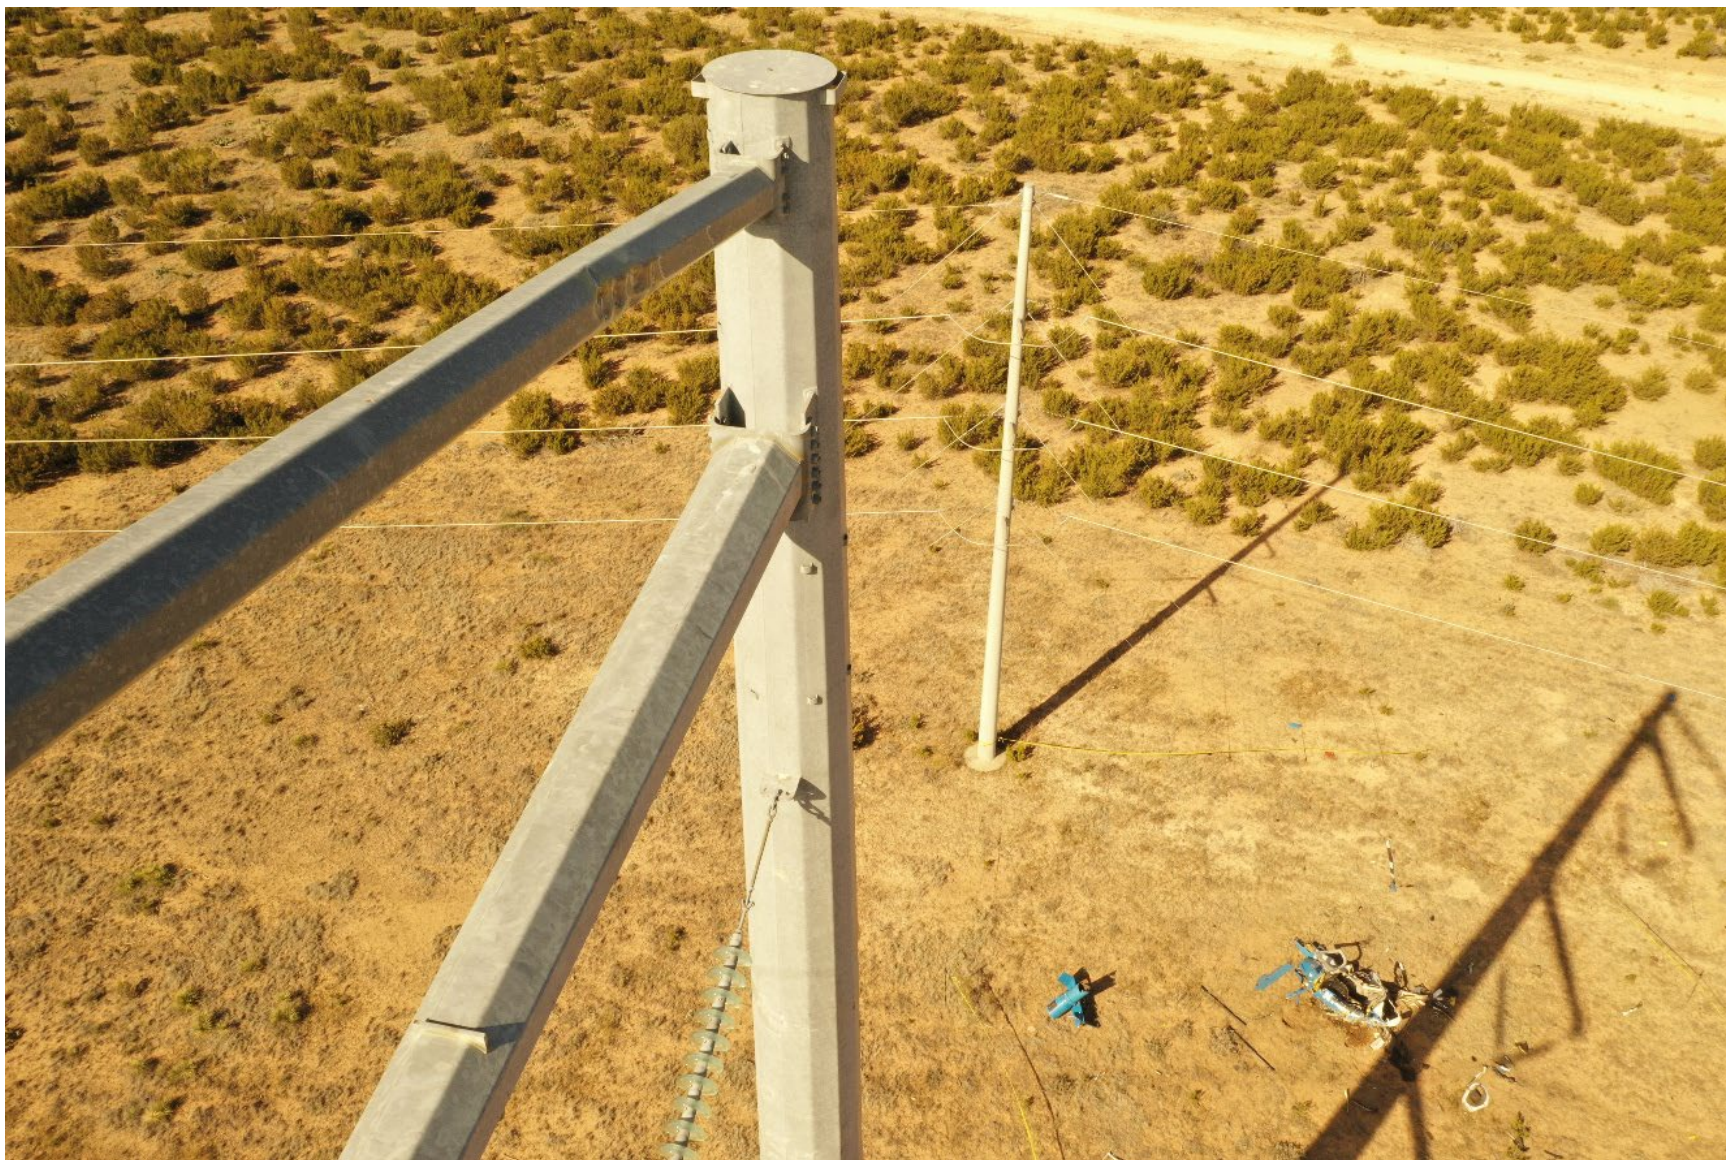
**Photograph 1 - Aerial view of the static arm that was impacted by the helicopter (courtesy of Brim Aviation)**

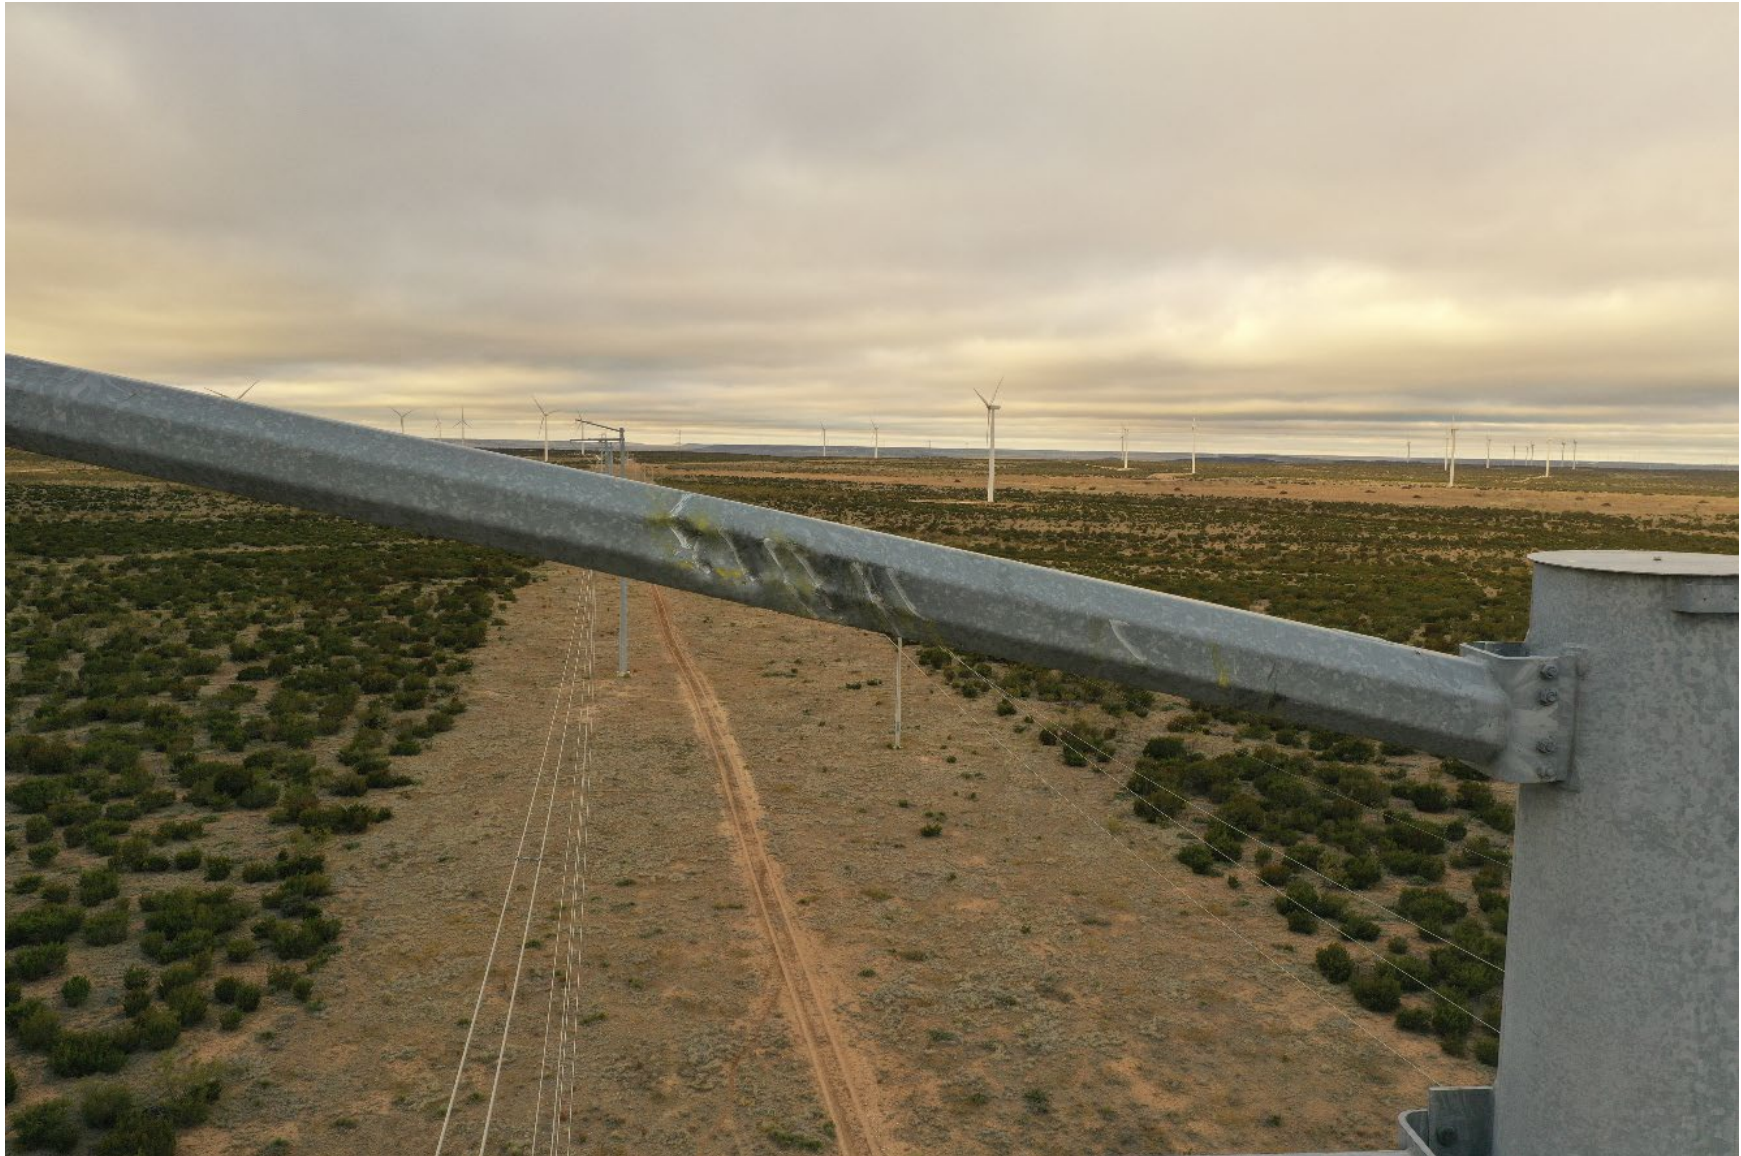
**Photograph 2 - Aerial view of the static arm that was impacted by the helicopter (courtesy of Brim Aviation)**

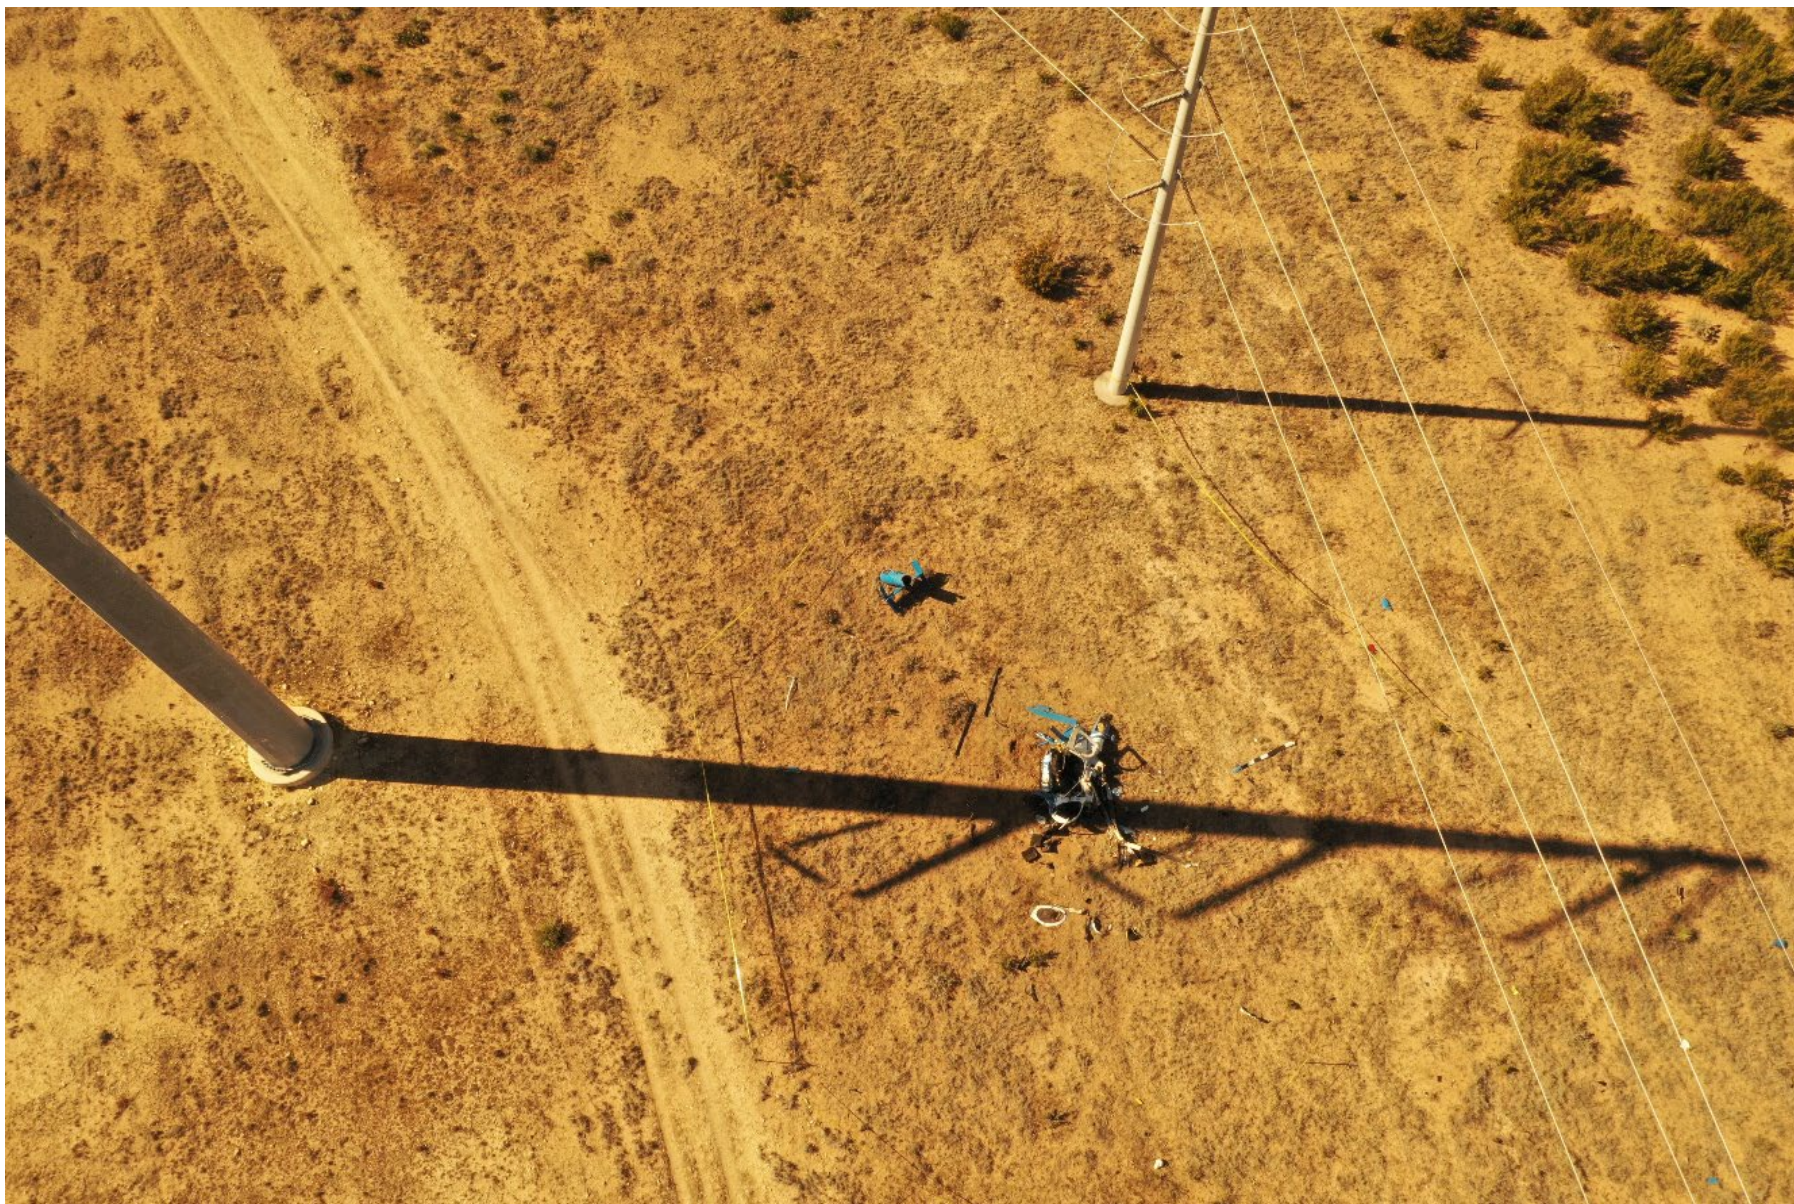
**Photograph 3 - Aerial view of the helicopter (courtesy of Brim Aviation)**

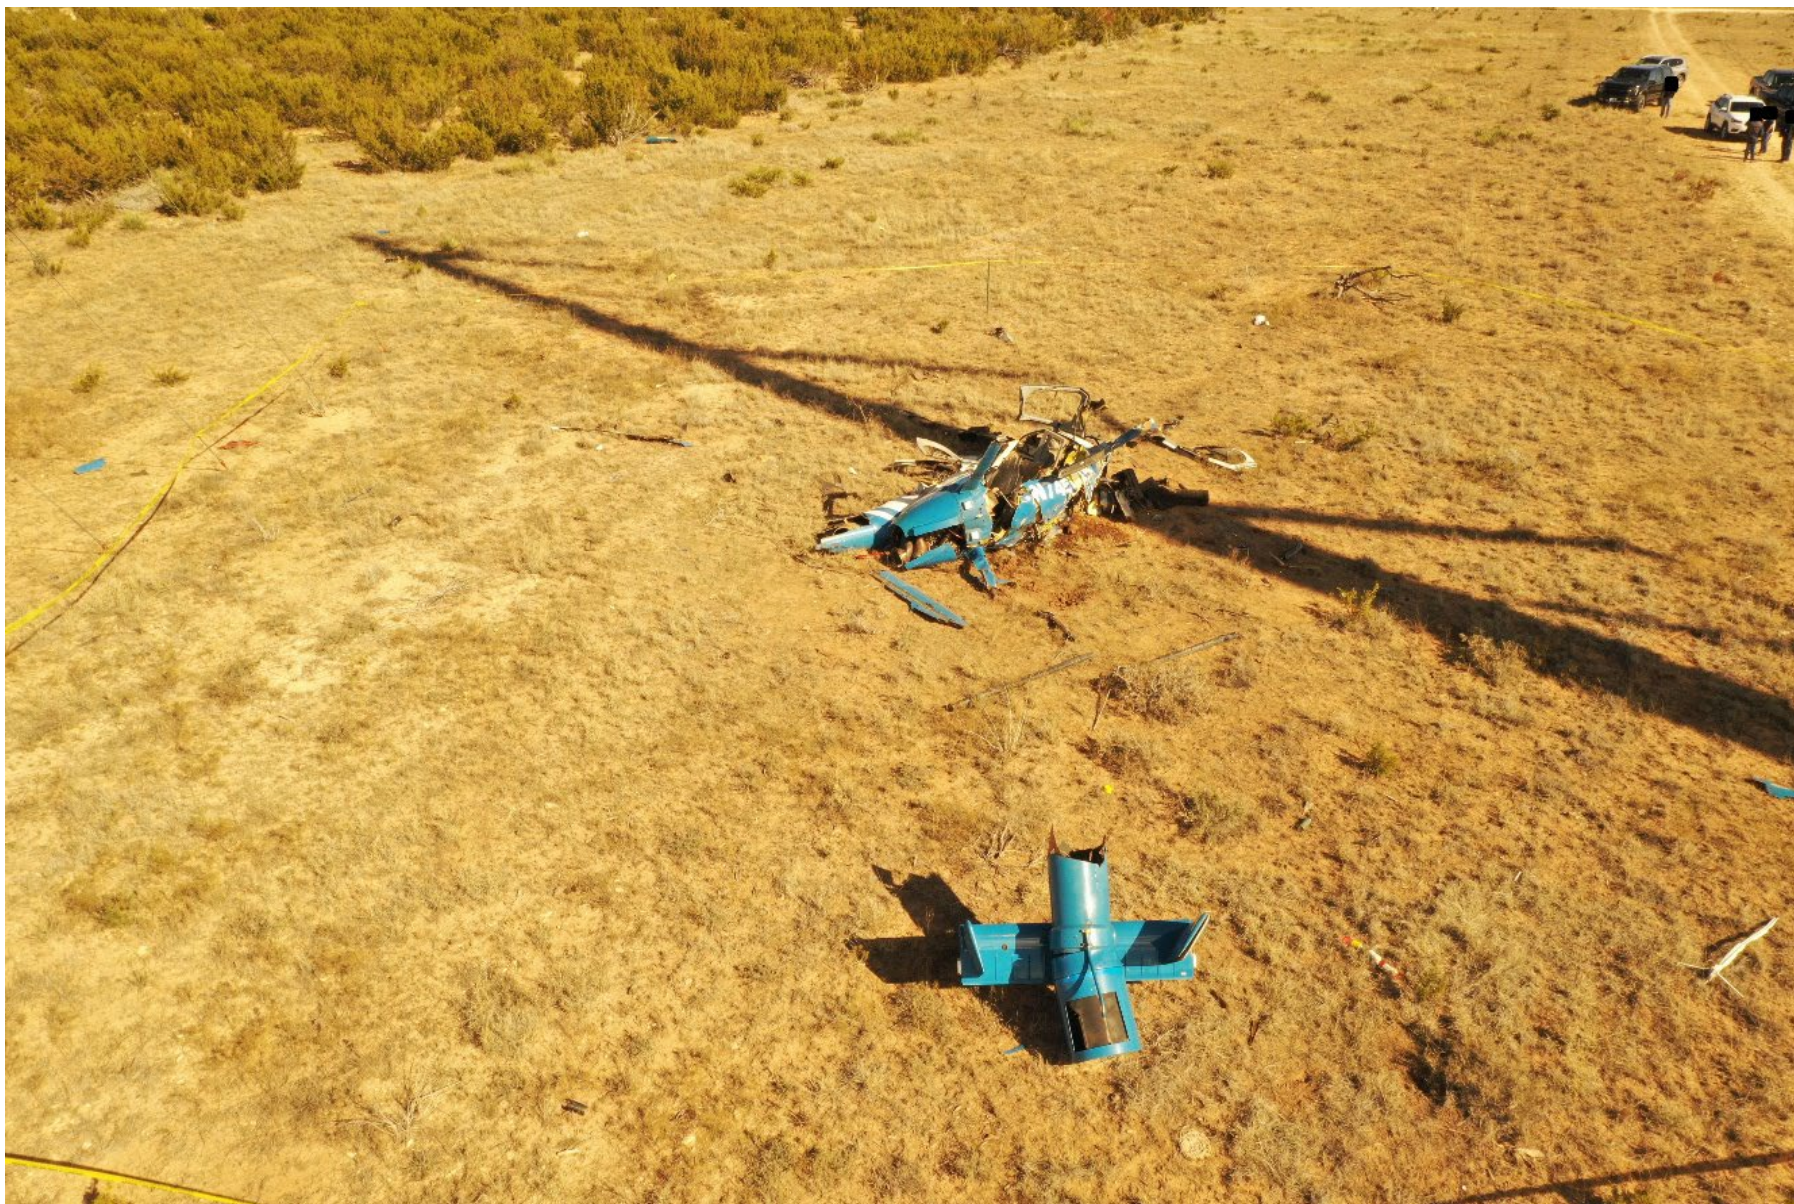
**Photograph 4 - Aerial view of the helicopter (courtesy of Brim Aviation)**

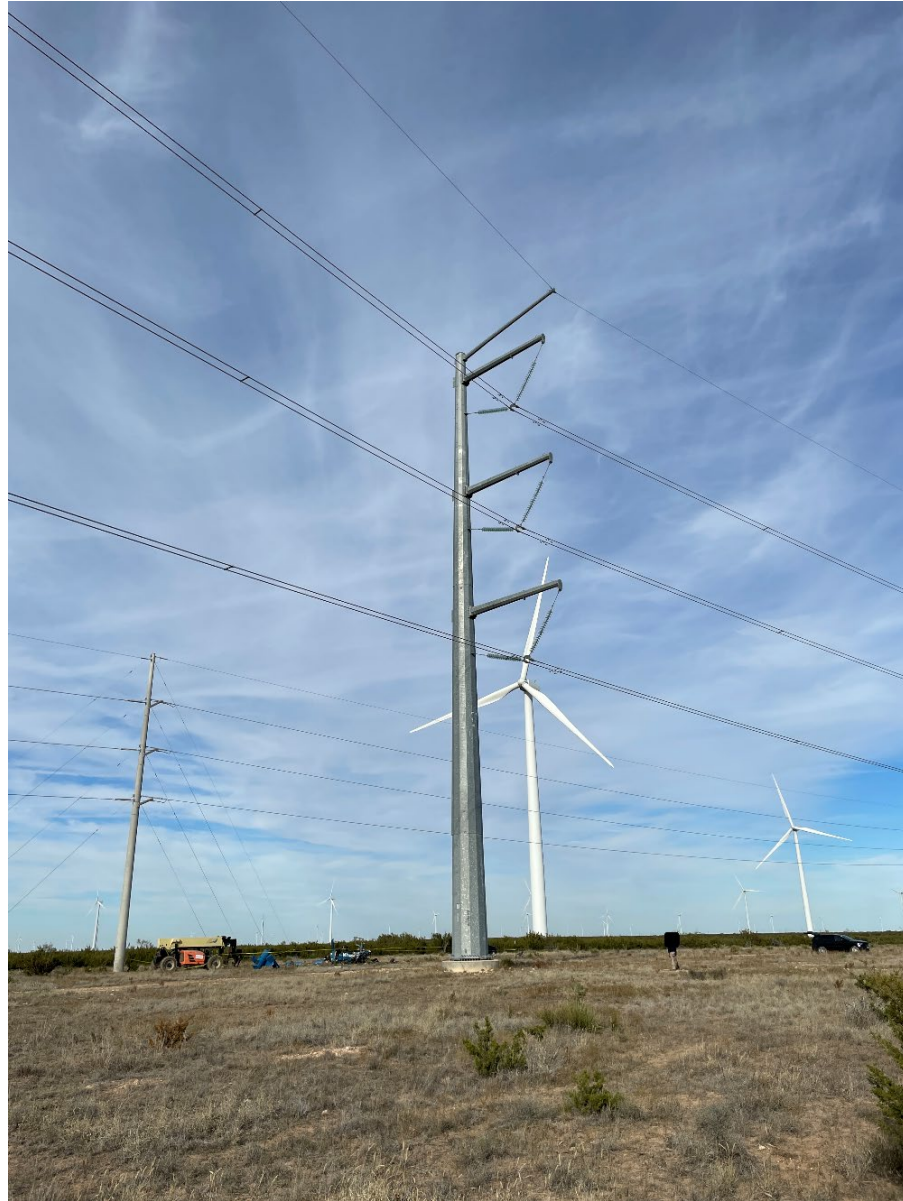
**Photograph 5 - View of the pole that the static arm is connected to**

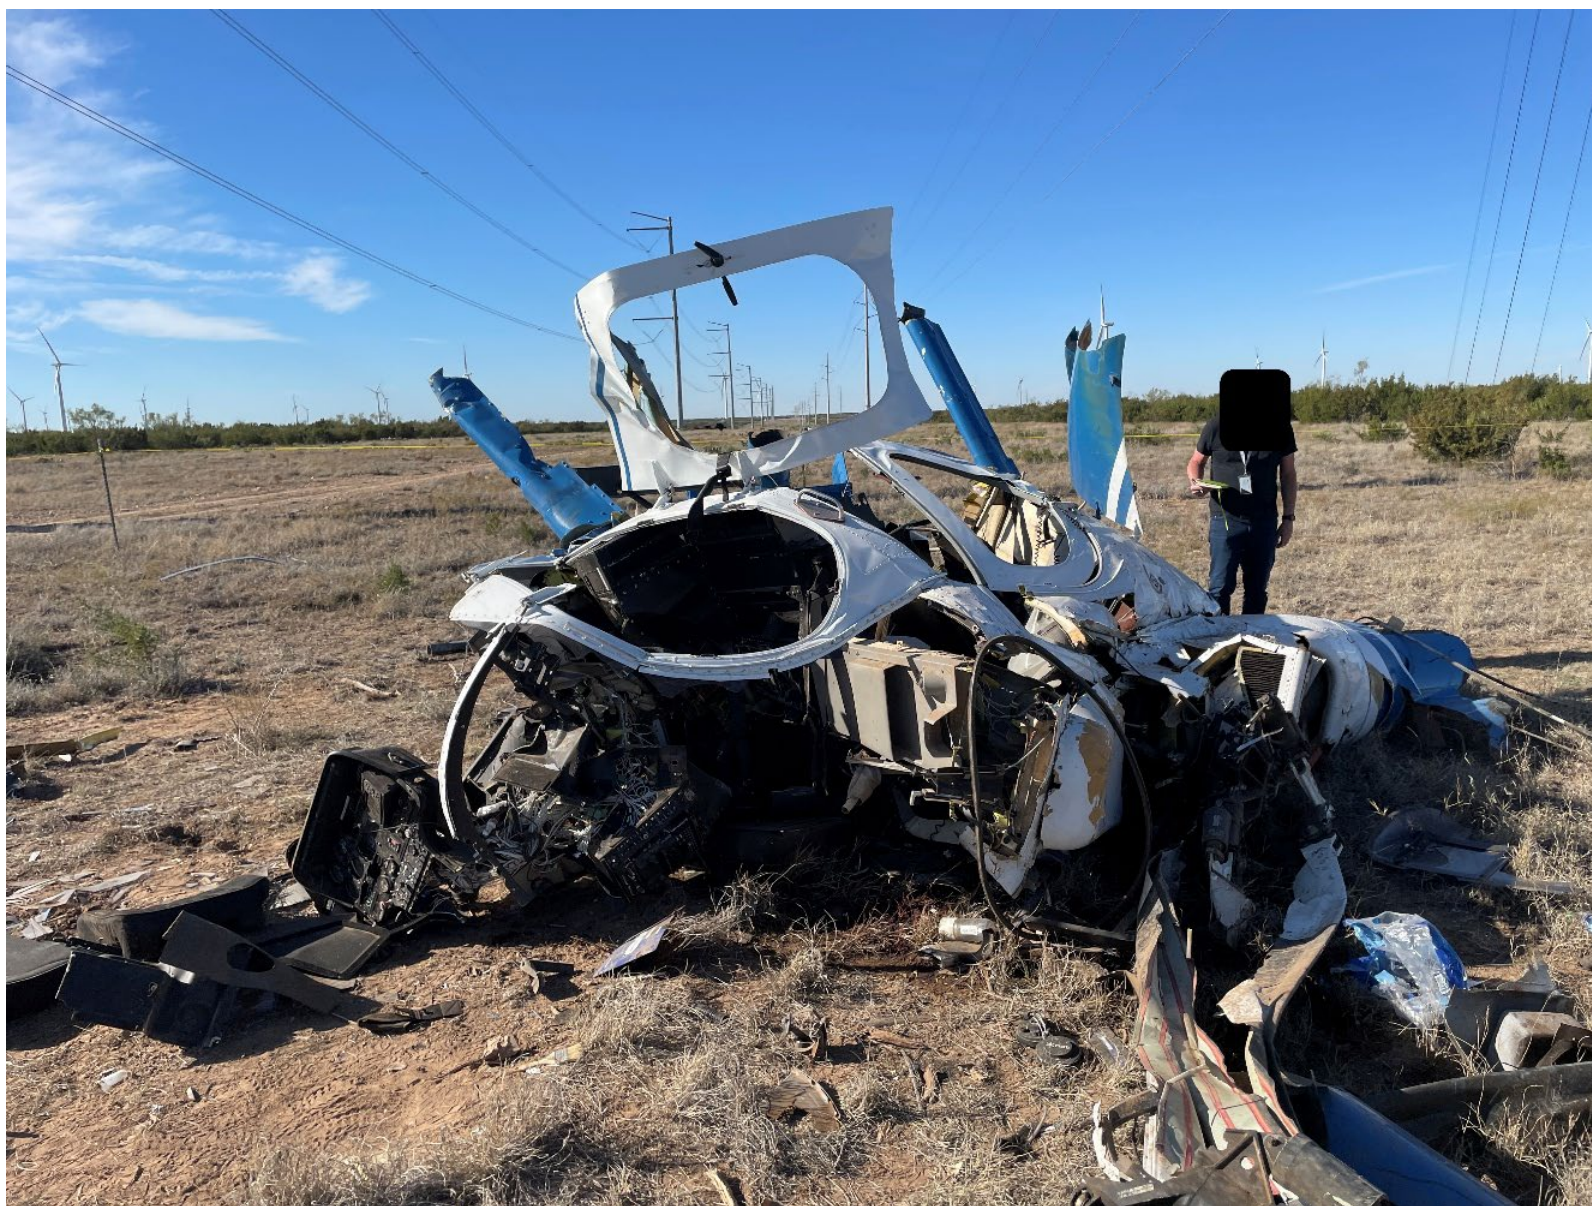
**Photograph 6 - View of the front of the helicopter**

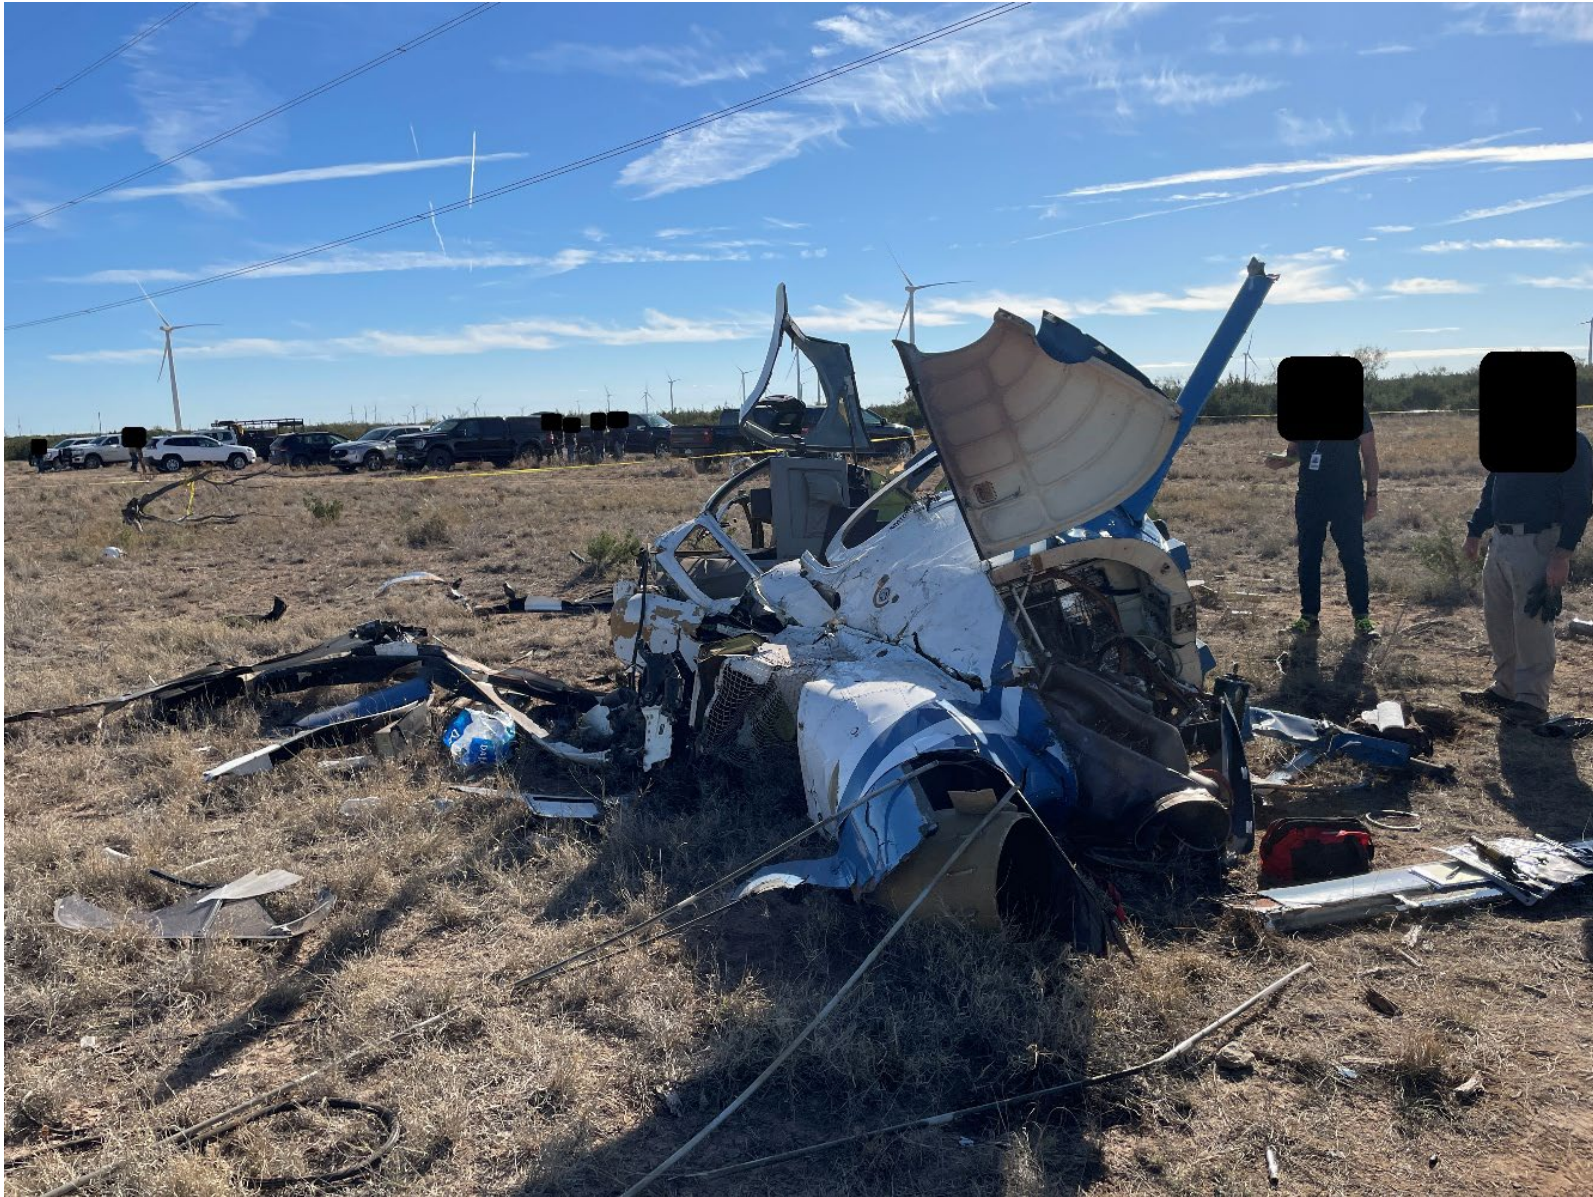
**Photograph 7 - View of the rear of the helicopter**

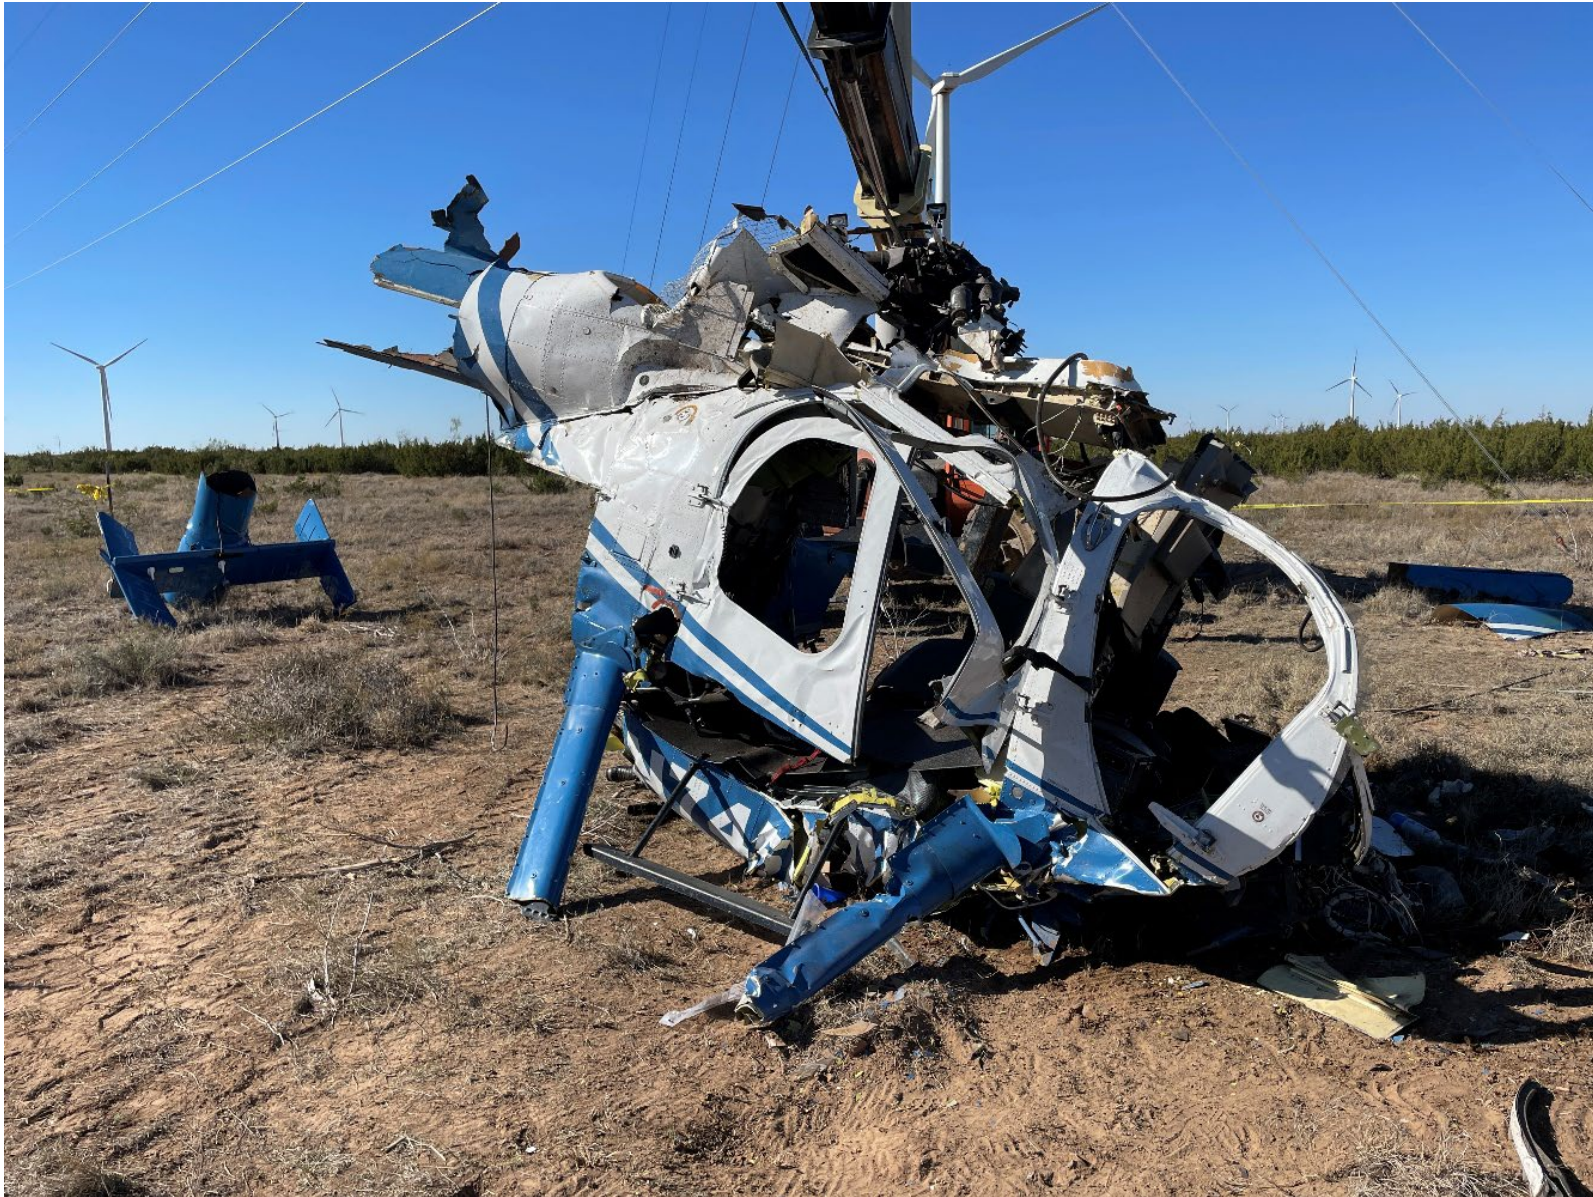
**Photograph 8 - View of the helicopter during the recovery operation**

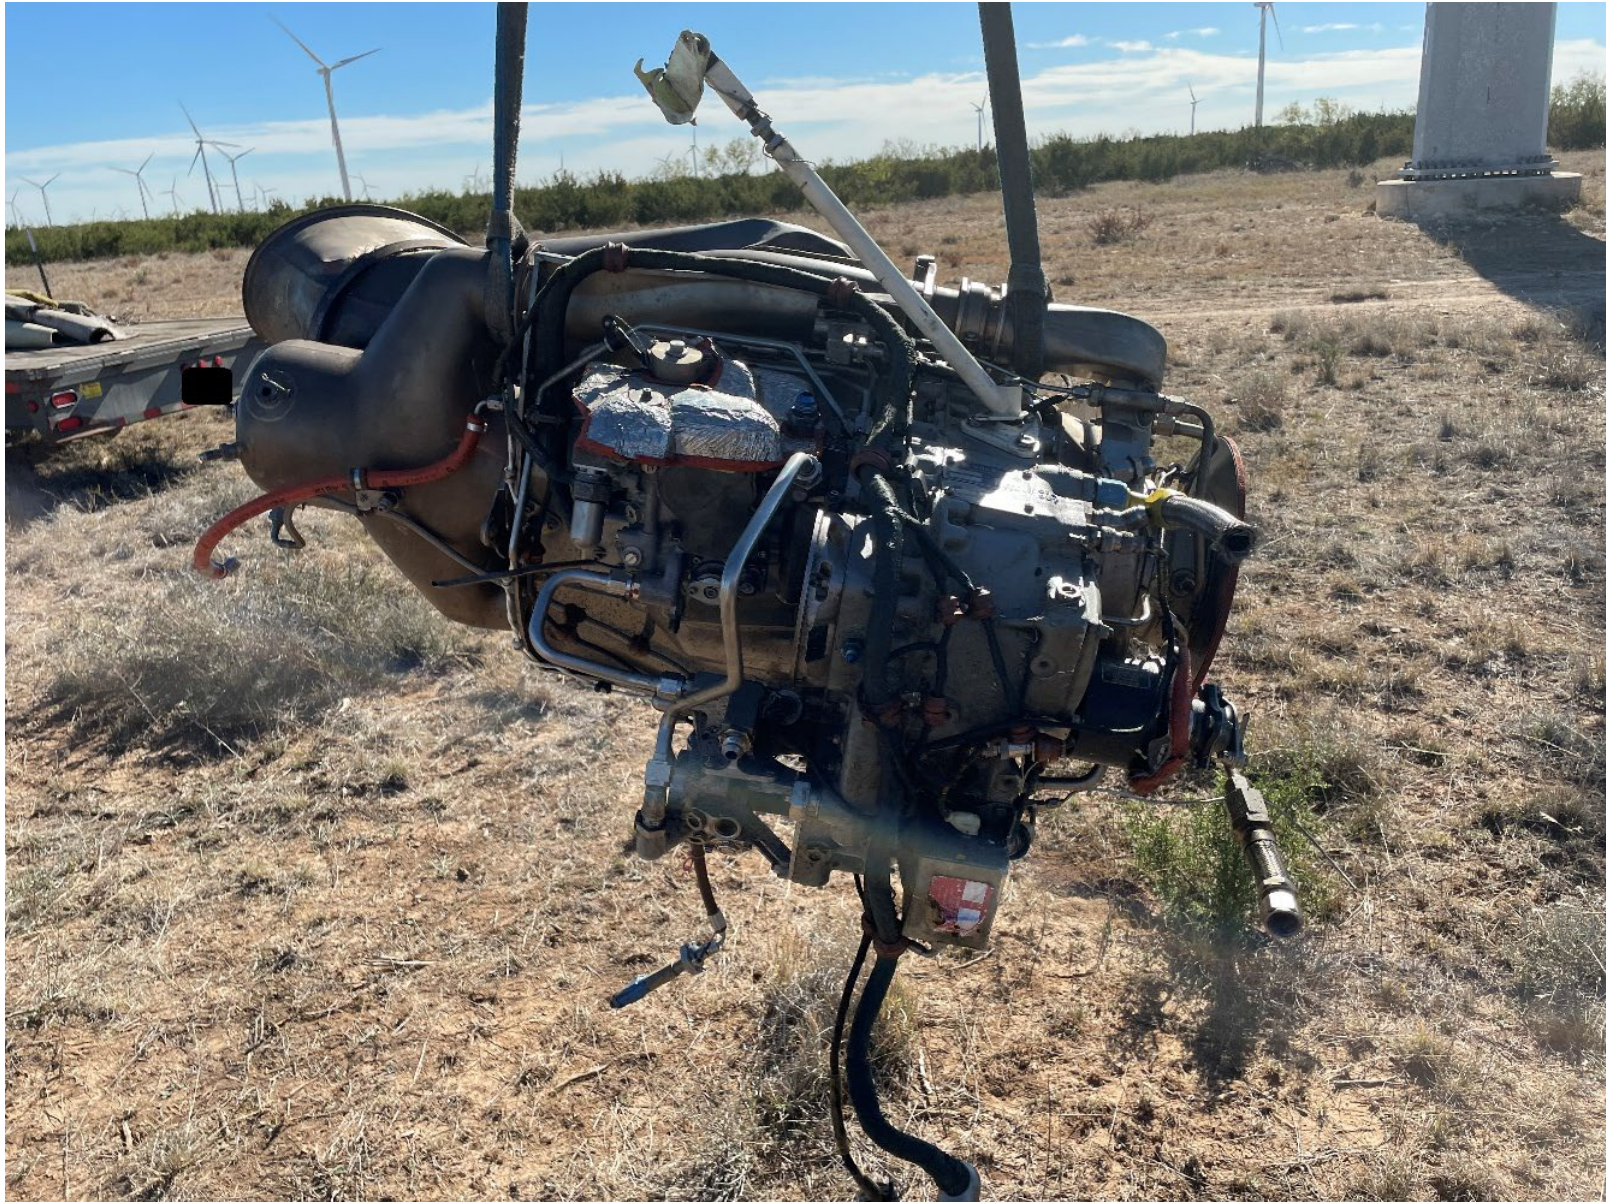
**Photograph 9 - View of the engine during the recovery operation**

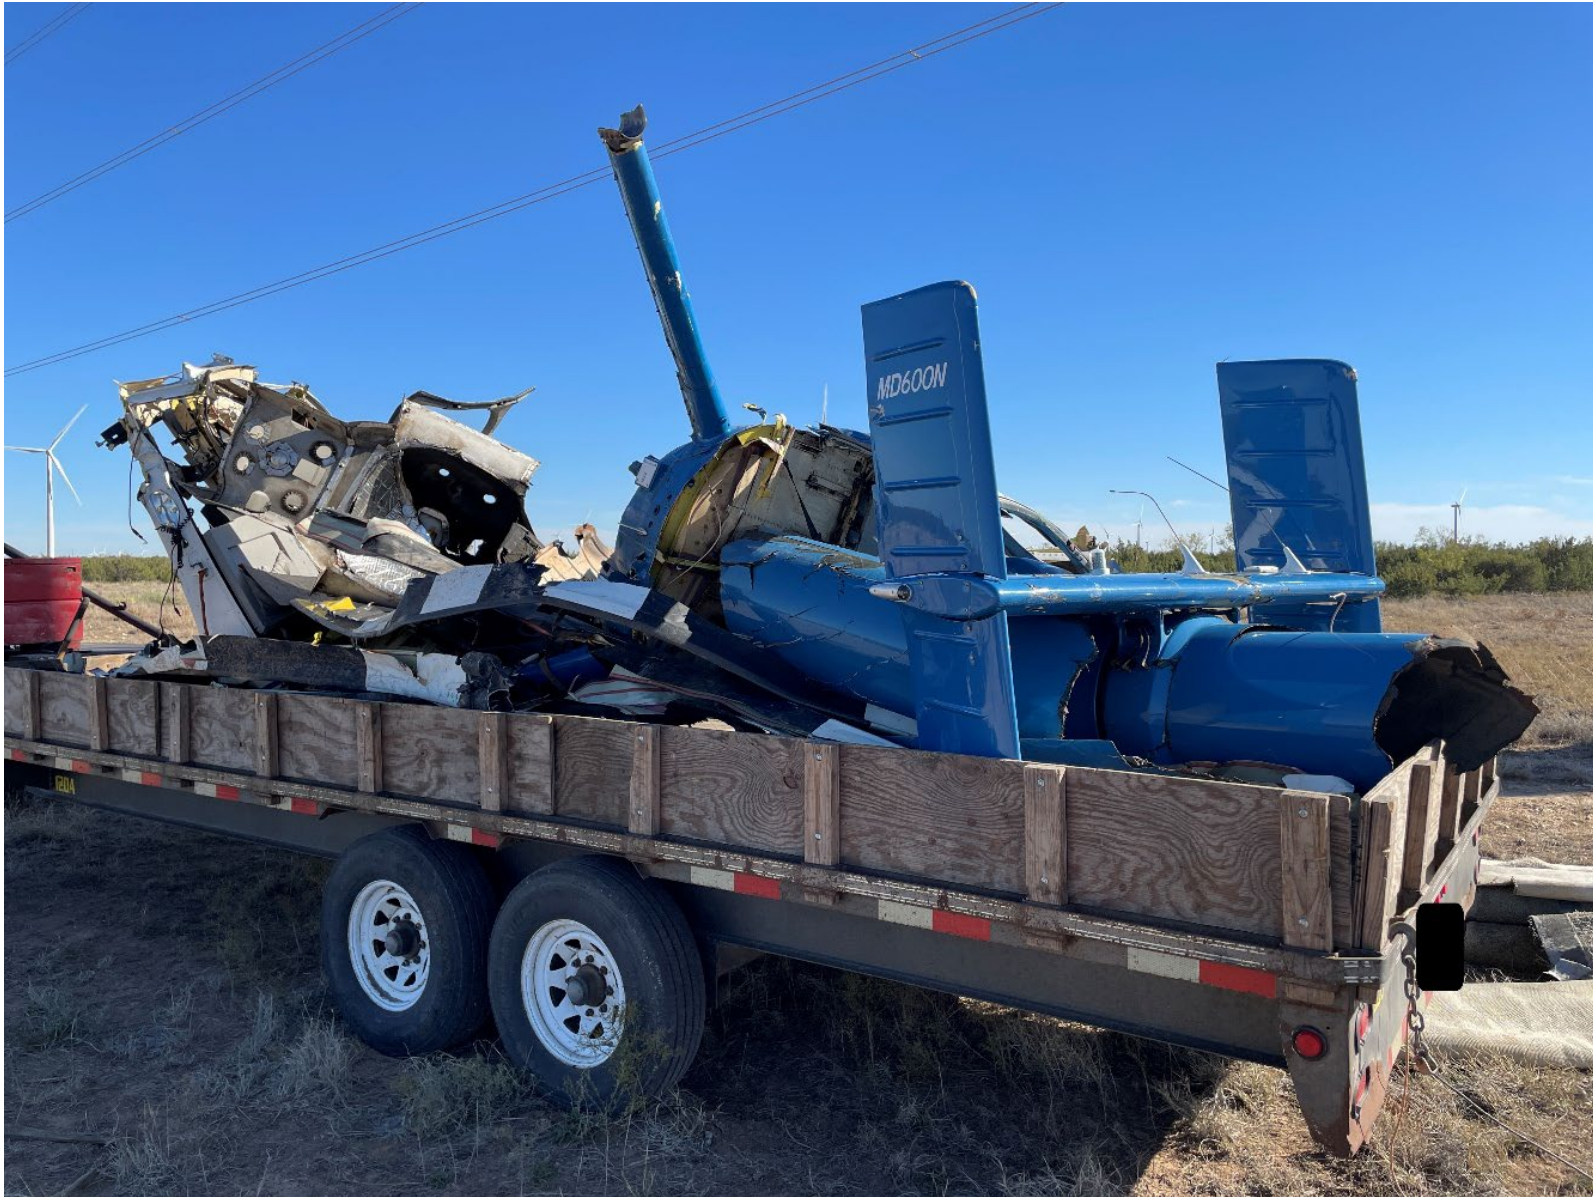
**Photograph 10 - View of the helicopter secured in a trailer during the recovery operation**
