# National Transportation Safety Board

CEN24FA083

## **AIFRAME & ENGINE EXAMINATION**

Location: Delores, Colorado  
Date: January 6, 2024  
Time: 0945 Mountain Standard Time  
1645 UTC  
Airplane: Just Highlander Airplane

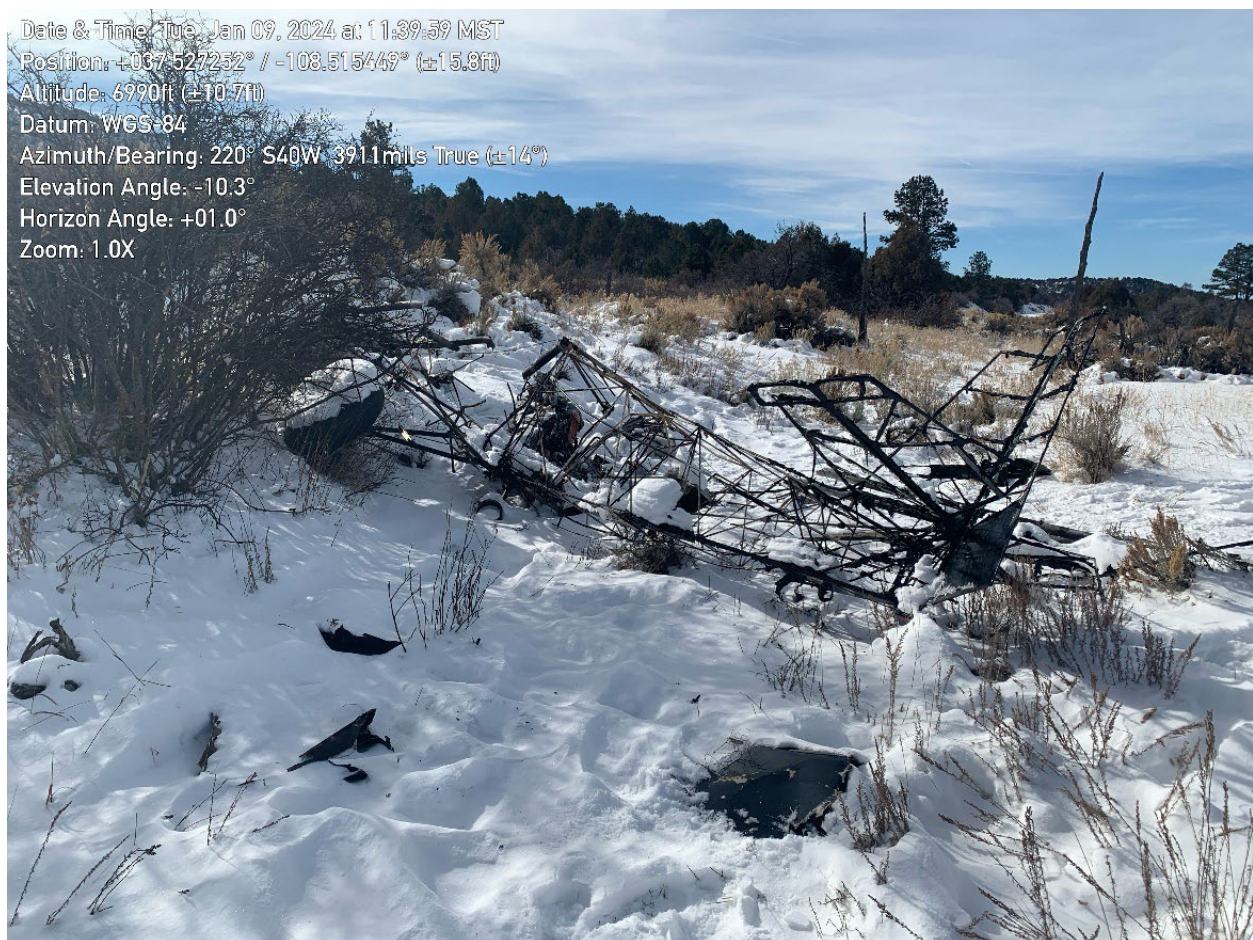
Figure 1. Airplane Wreckage.

On January 7, about 1400, the airplane wreckage was located by local law enforcement beyond the departure end of the private runway. A severe post-impact fire consumed most of the airplane. See Figure 1. Detailed examination of the accident site showed that the airplane went off the end of the runway, impacted a 3-wire barbed wire fence, and came to rest upright about 610 ft. beyond the departure end of the snow-covered dirt runway, heading about 175°. The approximate runway heading was 250°. The length of the runway was about 1,800 ft, and its width was about 30 ft.

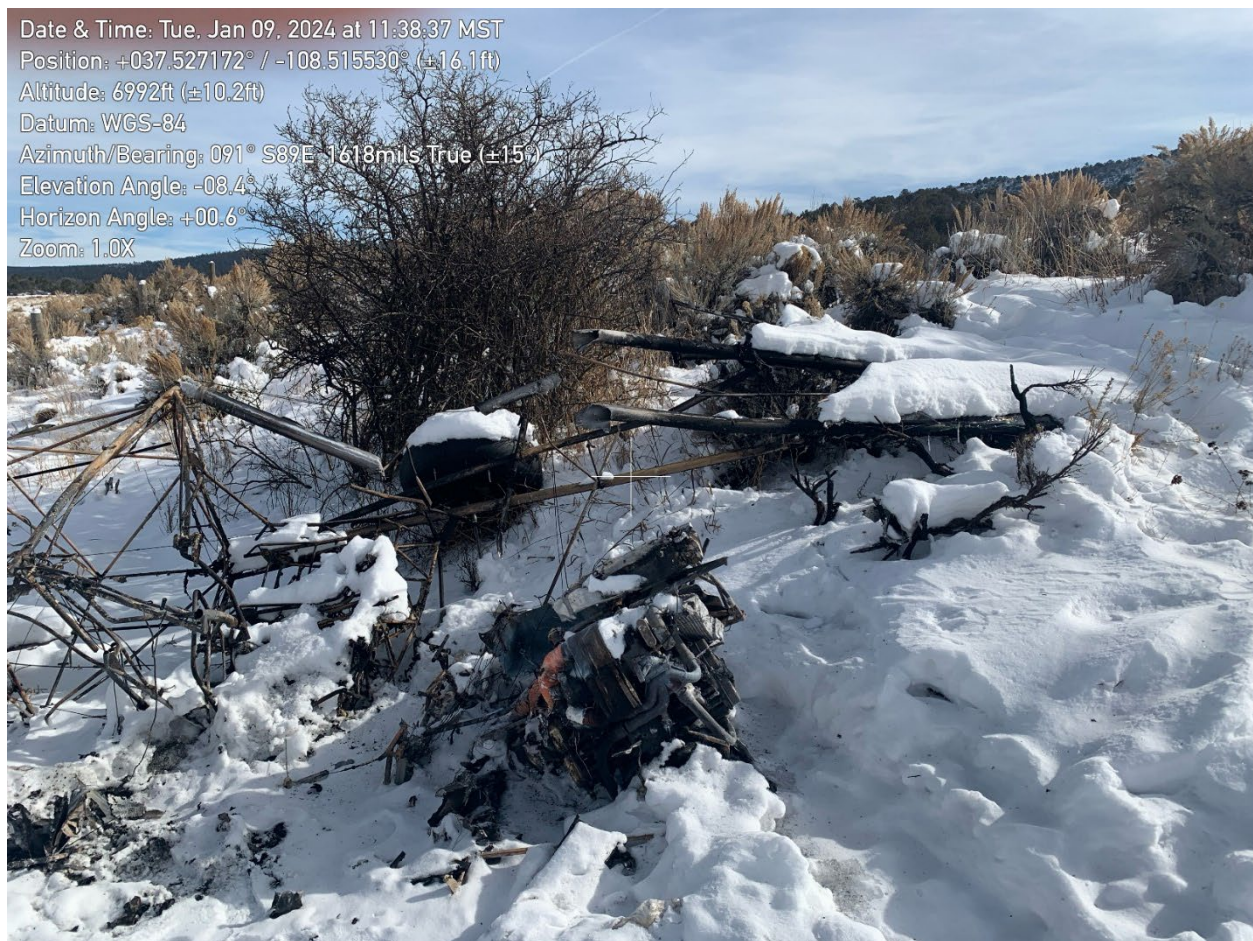
Figure 2. Airplane Engine.

Severe fire damage consumed all the fabric flight control surfaces, and all the cockpit instruments. Other than damage from impact forces and fire, examination of the flight controls and airframe did not reveal any pre-impact anomalies. Flight control continuity from the cockpit to the ailerons, elevator, and rudder was confirmed. The flap position could not be confirmed due to severe fire damage. The tubular frame structure was mostly intact, but fire damaged. The engine was separated from the fuselage and displayed severe fire damage. See Figure 2. The 3-bladed propeller assembly was found separated from the engine. It was located behind the empennage and did not have fire damage. Two of the composite propeller blade's spans were damaged, and one of the blades had about 3 turns of the barbed wire wrapped around its root, consistent with rotation at the time of impact with the fence. See Figure 3. The airplane wreckage was recovered to a secure facility near Denver, Colorado.

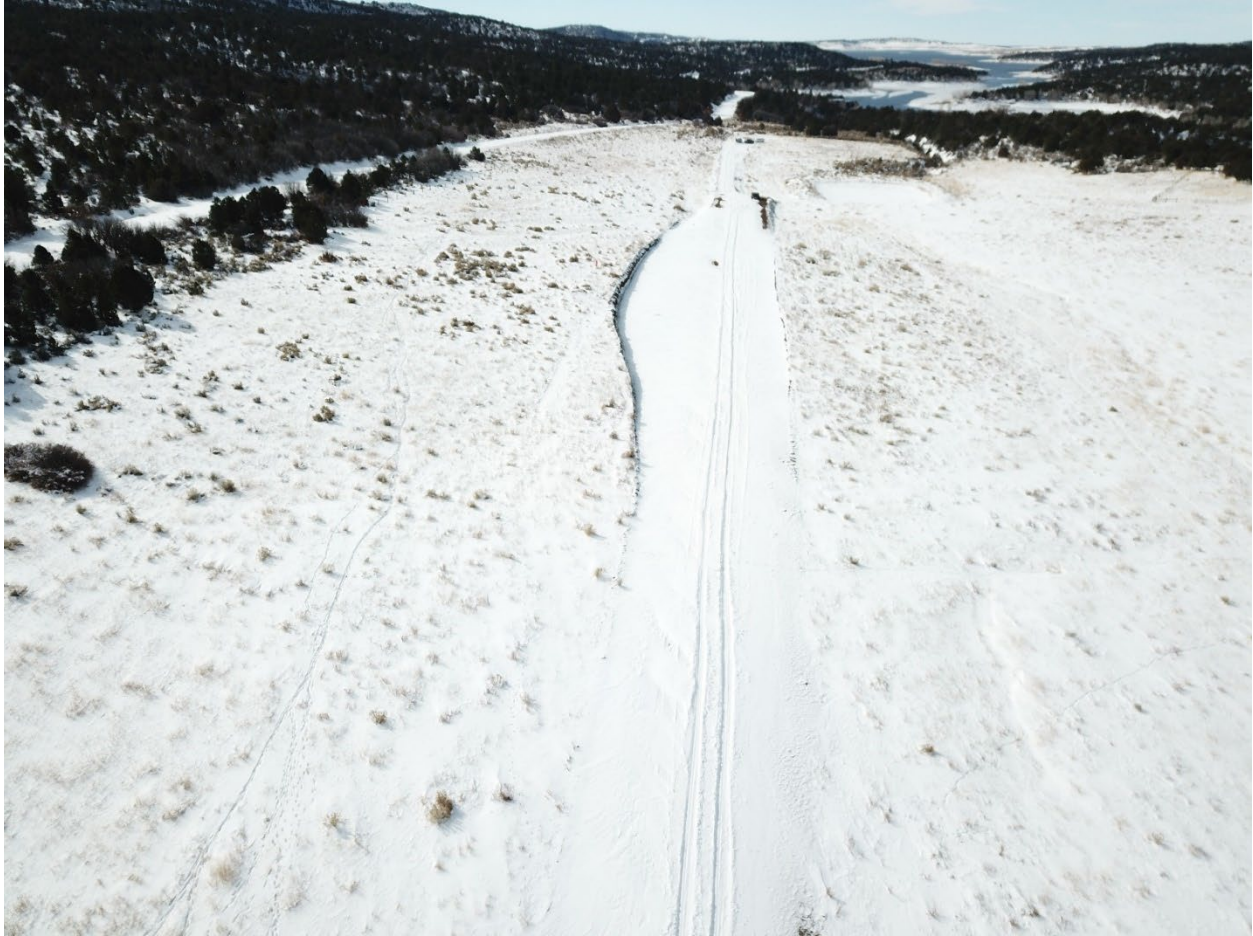
Figure 4. Airstrip and Tire Marks.

There were no witnesses to the accident. A local pilot that was flying in the area reported that he and his pilot-rated-passenger saw 3 tire tracks on the snow-covered dirt runway near the estimated time that the accident occurred. See Figure 4. Since the airplane departed from CEZ on January 4, until it took off from the private runway on the morning of January 6, temperatures were mostly below freezing. Cycles of snow and sun melting that resulted in areas of surface ice prevailed throughout the area. The weather conditions were confirmed by reports of residents who lived in the area, and a preliminary National Transportation Safety Board weather study.

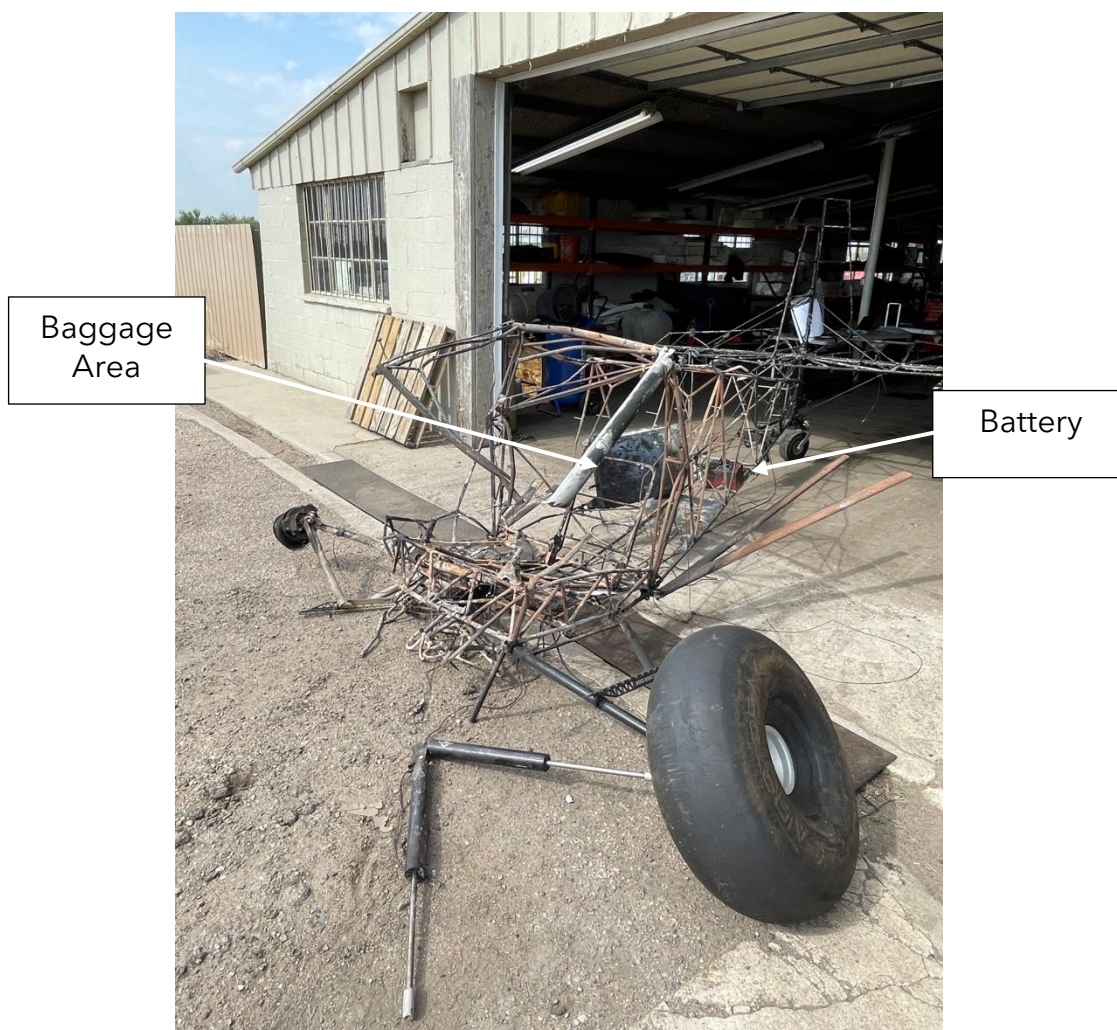
Figure 6. Fuselage Frame, Battery, and Baggage Compartment

The fuselage fabric was consumed by fire. The tube frame was intact but charred and melted. The battery was charred and melted. See Figure 6. The baggage area was broken, burned, and partially consumed. The cabin area to include the instrument panel, engine controls, and control yokes was consumed by fire. The push-pull tube to the elevator, the control tubes to the ailerons, and the cables to the elevator trim and rudder were intact but showed fire damage. The flap lever was charred and melted. The lever was in the flaps up position. See Figure 7. The main landing gear were bent upward. The left main landing gear tire and brake lines were intact. Both showed fire damage. The right main landing gear was bent upward and sustained fire damage. The right main tire was consumed by fire.

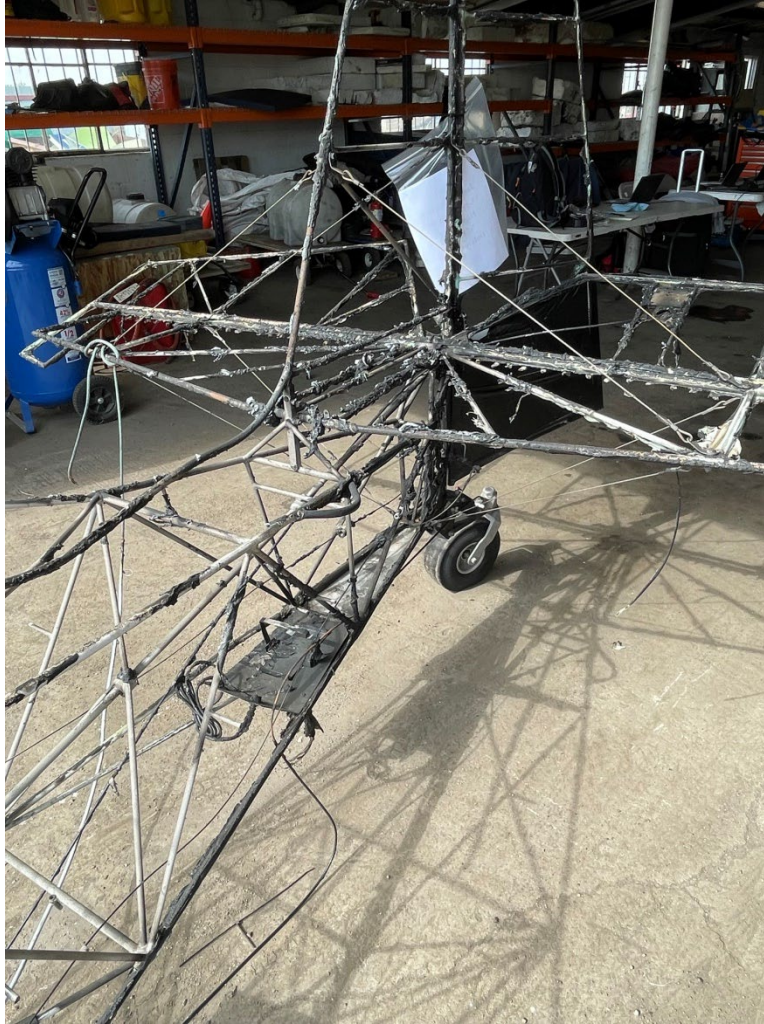
Figure 8. Empennage Frame and Tailwheel.

The rudder and vertical stabilizer skin was mostly consumed by fire. The frame remained but was charred and melted. Control continuity was established from the cabin to the rudder. The elevator and horizontal stabilizer skin was consumed by fire. The frame remained but was charred and melted. Control continuity was established from the cabin to the elevator and the elevator trim tab. The tailwheel was undamaged. Cables from the tailwheel to the rudder pedals were intact and showed continuity. See Figure 8.

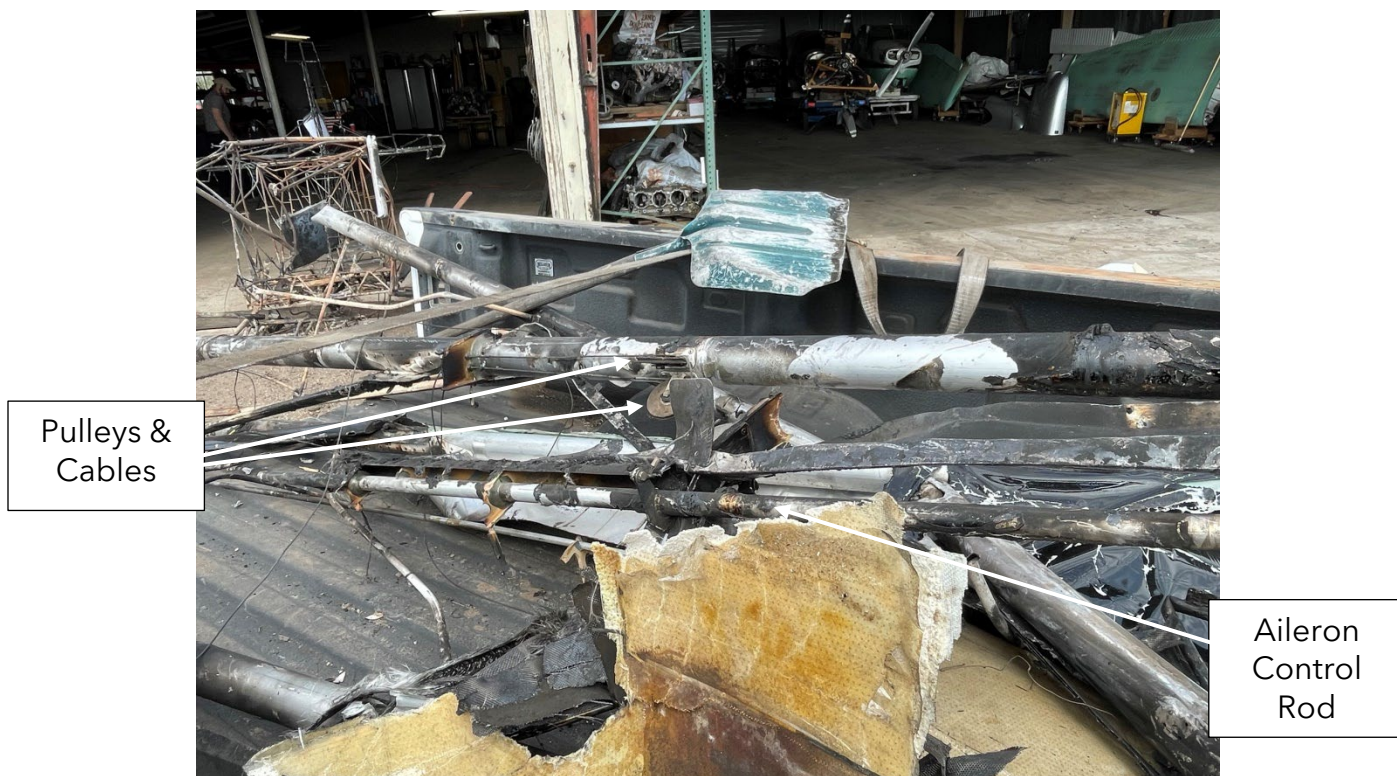
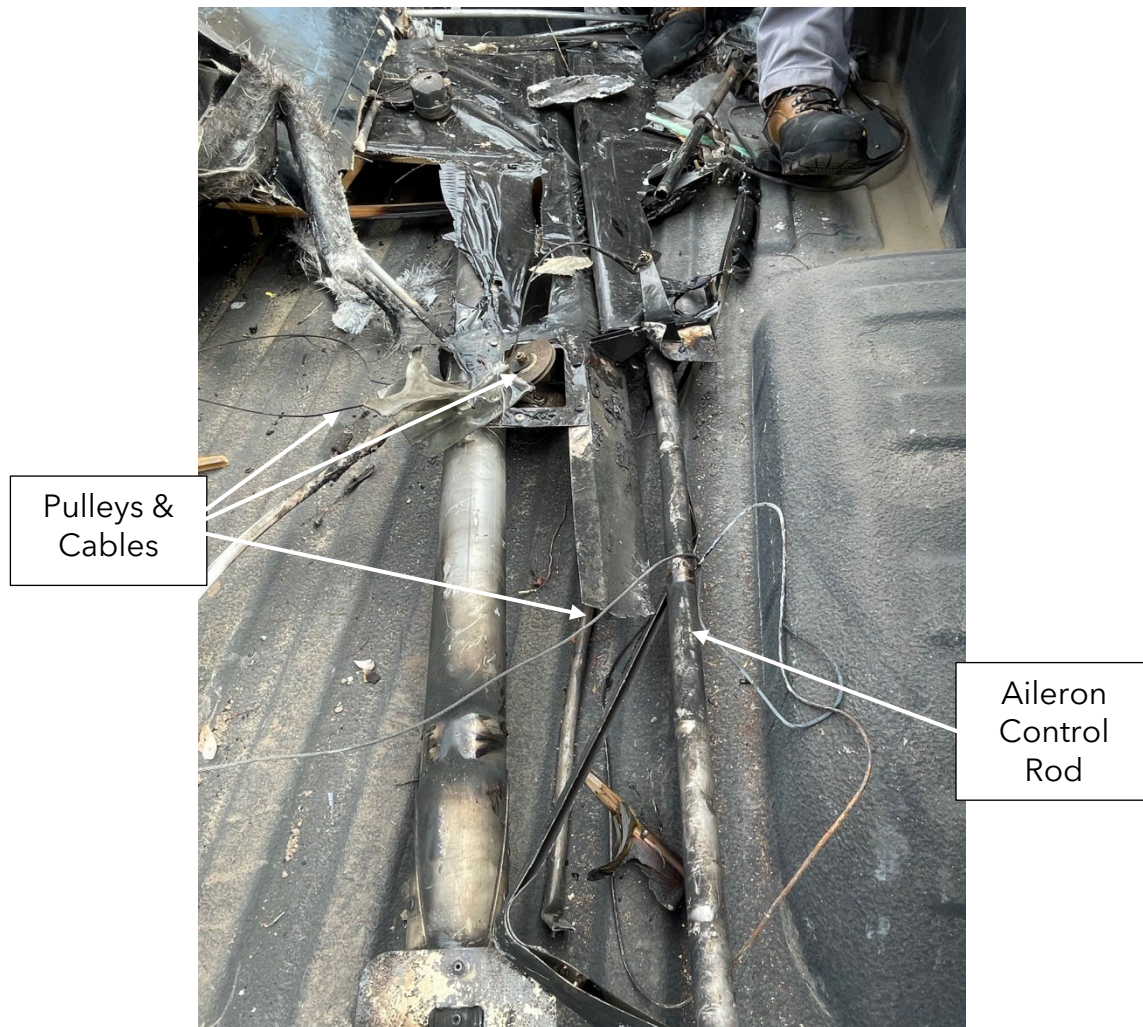
The wings were separated at the fuselage. The fabric was consumed by fire. The struts were observed cut for transport. The forward and aft wing spar tubes were charred and melted; the ribs were consumed by fire. The control tube and cables to the ailerons were intact, charred and melted. The cables and pulleys were intact, and the cables showed overload failures near the wing roots. Control continuity to the ailerons was confirmed. The fuel tanks were consumed by fire.

Figure 9. Right Wing Spar Tube, Aileron pulleys and Cables.

Figure 10. Right Wing Spar Tube, Aileron pulleys and Cables.

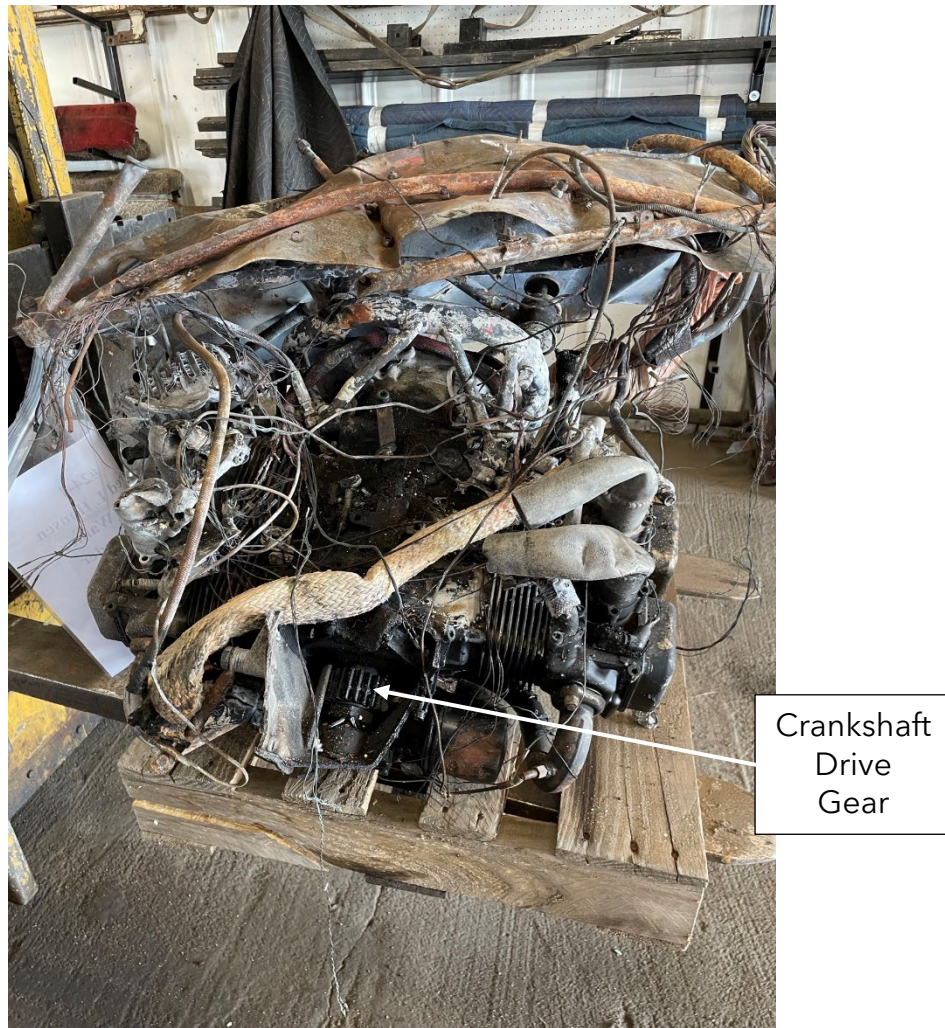
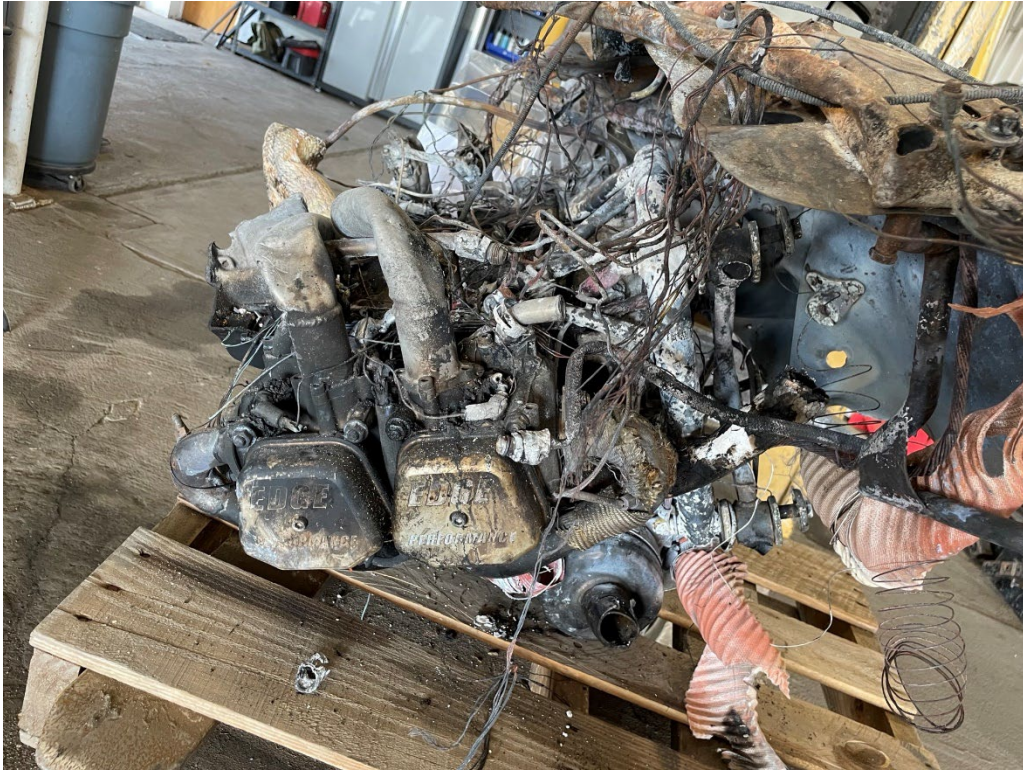
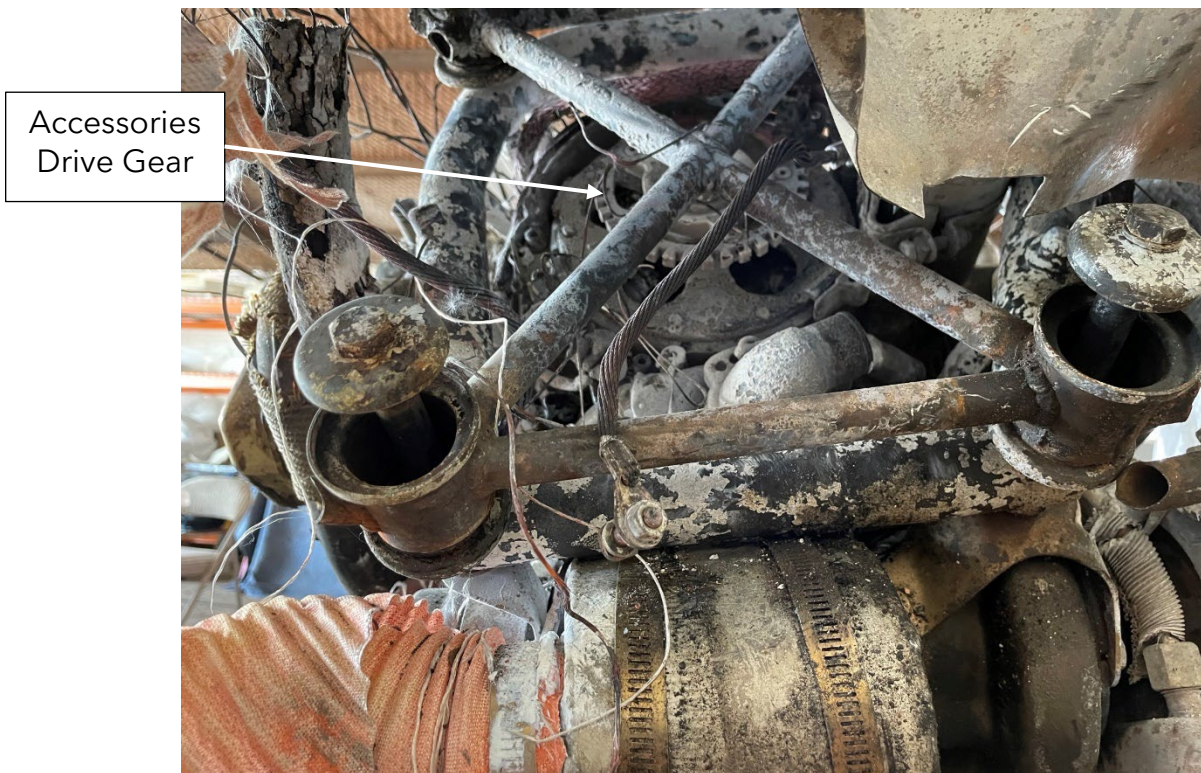
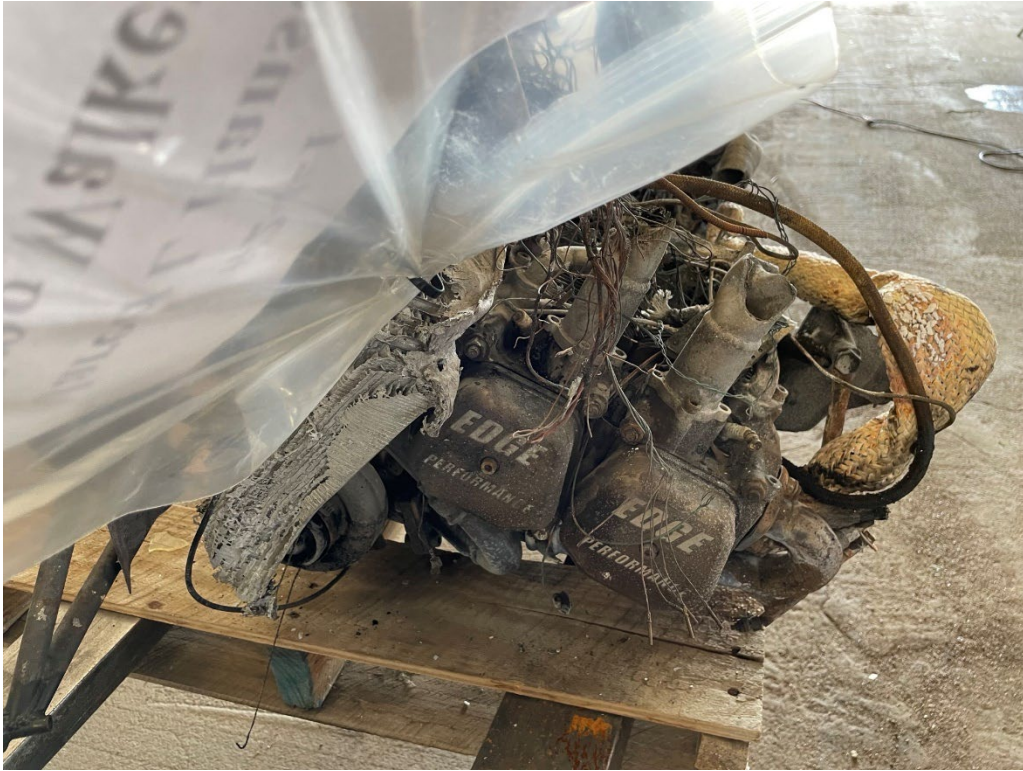
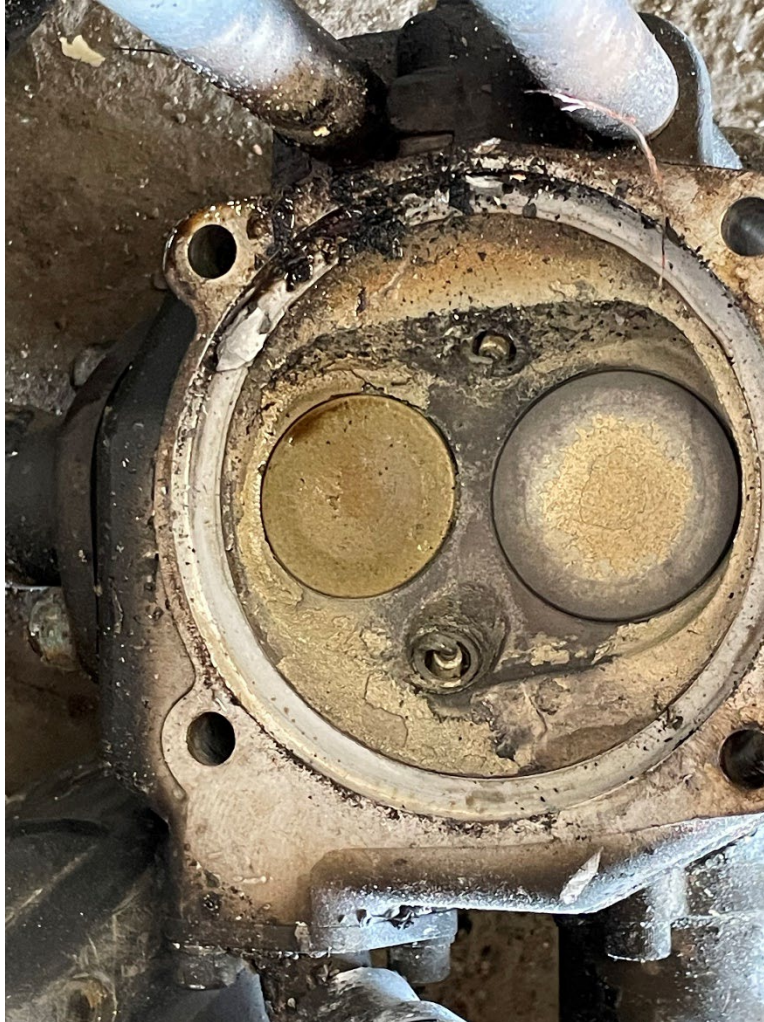
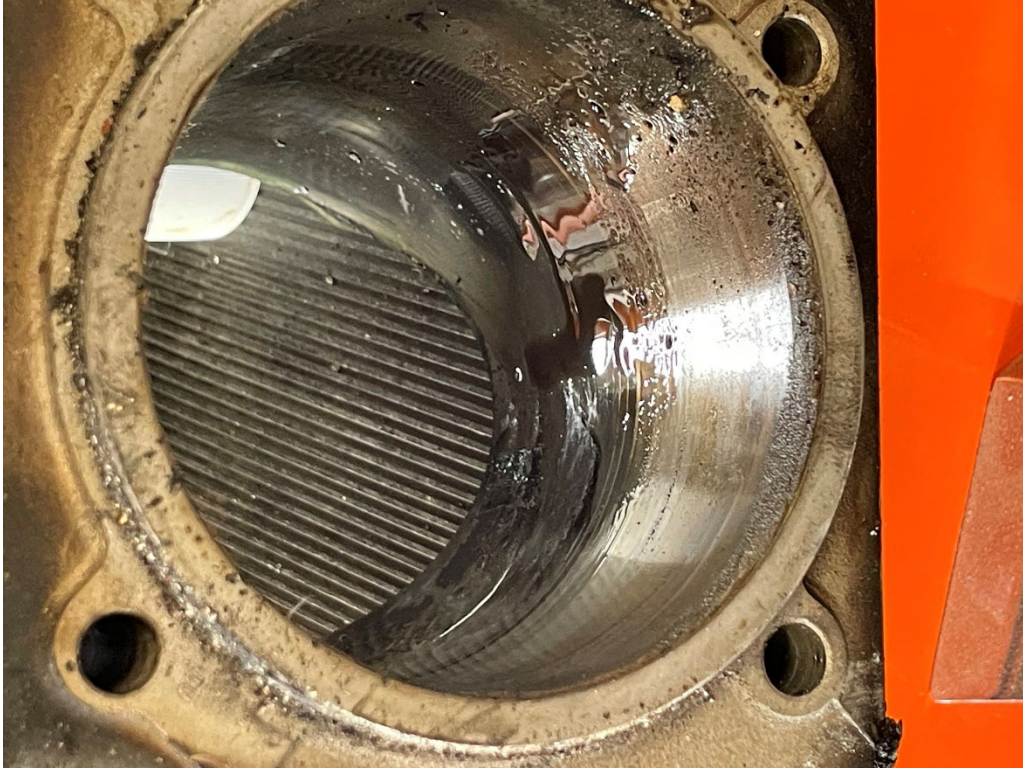
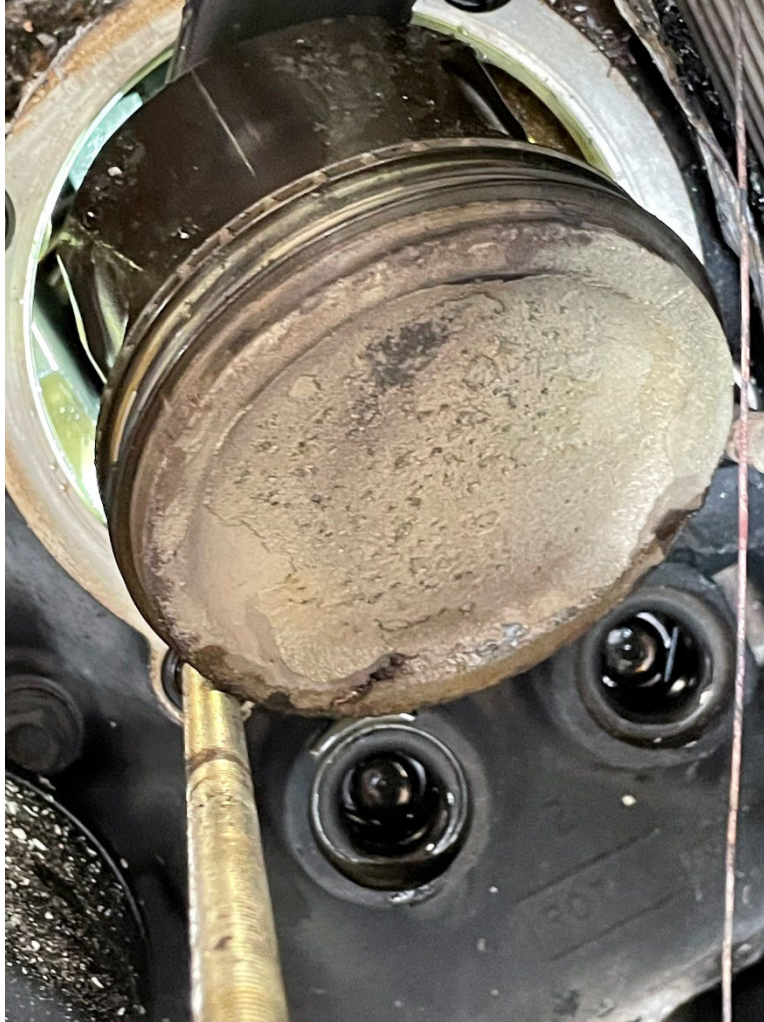
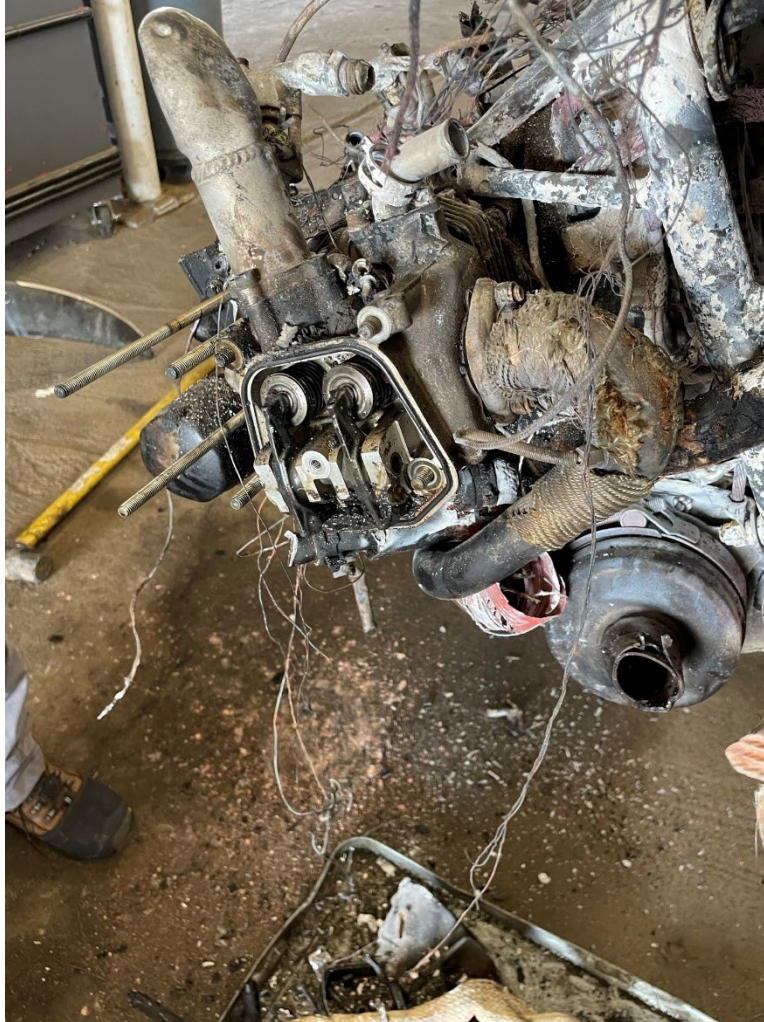
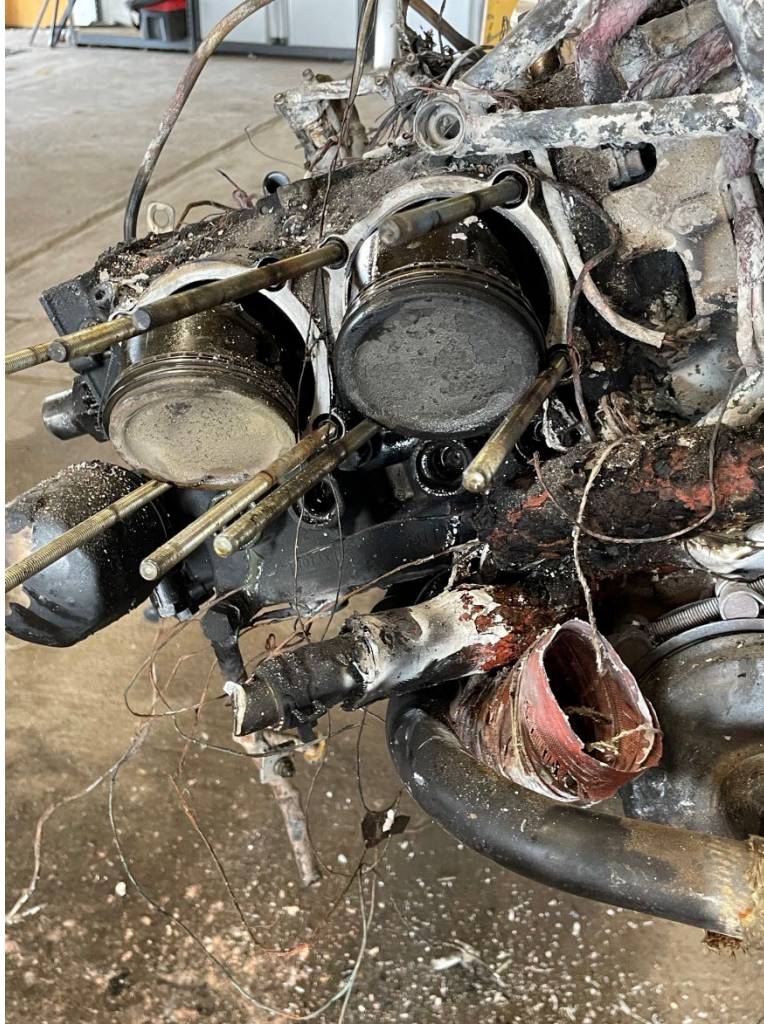
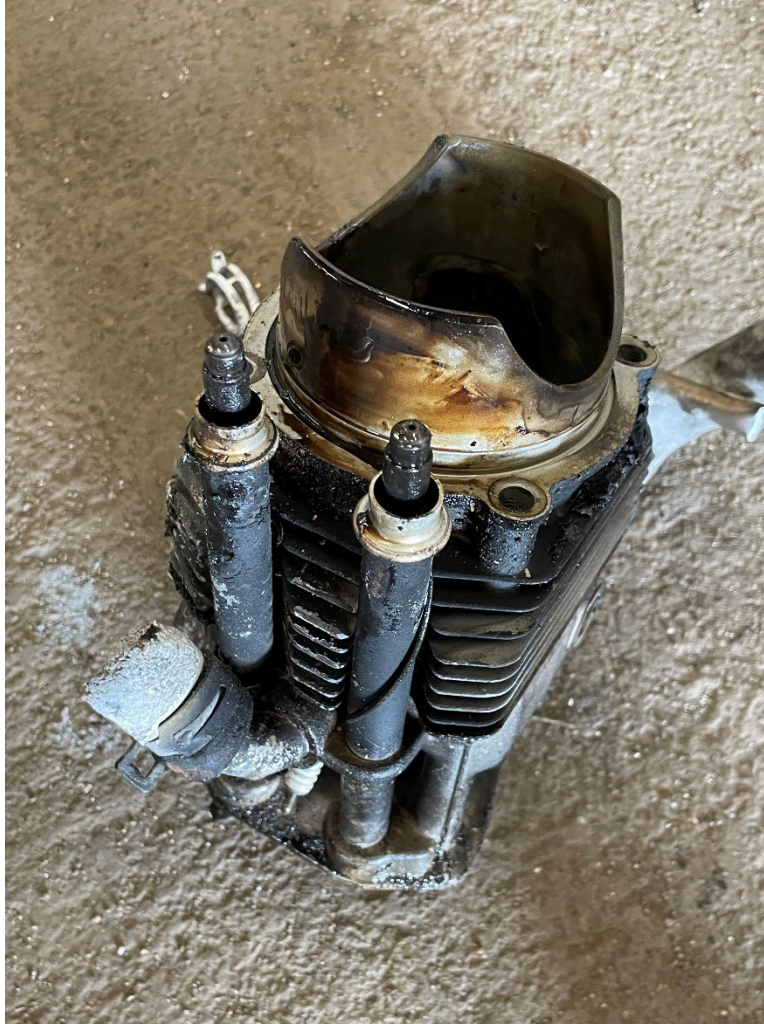
The 4-cylinder Rotax 914UL engine, Serial No. 6770317, was separated from the fuselage at the firewall. The firewall remained with the engine and was broken and bent over the engine mounts and the aft portion of the engine. All of the engine components were separated from the engine. The ignition system was consumed by fire. The accessory drive gear was melted into the back of the engine. The intake and exhaust tubing to the cylinders showed impact and fire damage. Much of the tubing was consumed by fire. The remainder of the reduction gear drive housing was removed to expose the drive gear from the crankshaft.

The rocker box covers were removed from all four cylinders. The valve springs and rockers were intact and showed no damage. An attempt was made to rotate the engine. The engine crankshaft would move only slightly. The left side cylinders were removed from the engine case. The valves were intact and seated properly and showed heat signatures. The push rods to the rockers were intact and straight. The

pistons were intact and showed slight heat signatures. Oil was present in the cylinders. The piston rods and crankshaft journals were intact. The piston rods showed some corrosion. All observations of the engine and surviving components confirmed that there were no preaccident mechanical failures or malfunctions with the engine that would have precluded its normal operation.

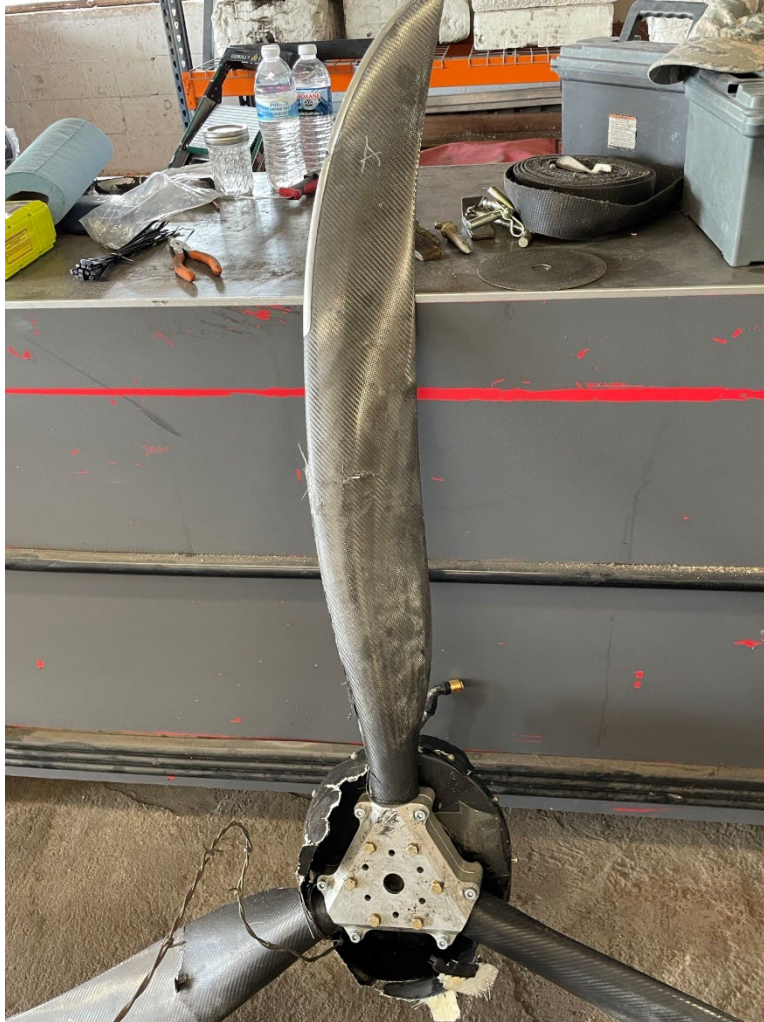
Figure 21. Propeller Blade A.

Blade A, Serial No. V2461 showed leading edge fractures and splinters. A large nick was observed in the metal leading edge stripping 6 inches inboard of the blade tip. See Figure 21 and 22.

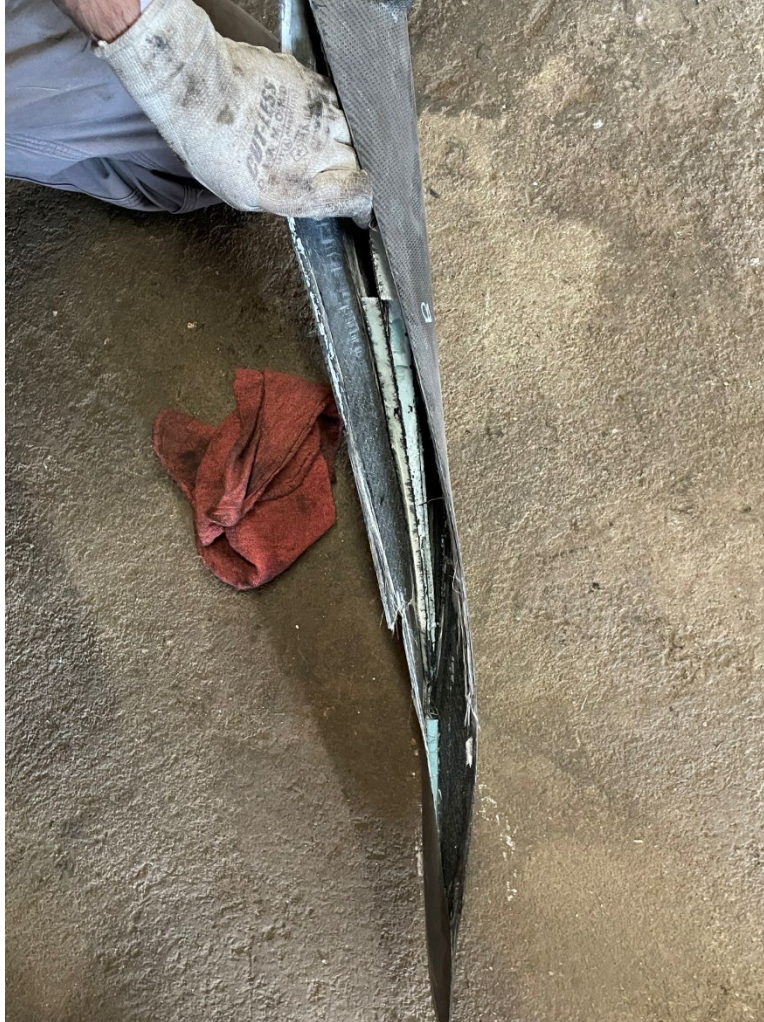
Figure 23. Propeller Blade B Trailing Edge.

Blade B, Serial No. V2459, showed leading edge nicks and splinters. The blade trailing edge was split from the root to the tip. See Figure 23. There was a tear in the composite front face of the blade approximately 8 inches outboard of the hub. See Figure 24. A 4-foot length of barbed wire was observed wrapped around the blade at the hub. See Figure 25.

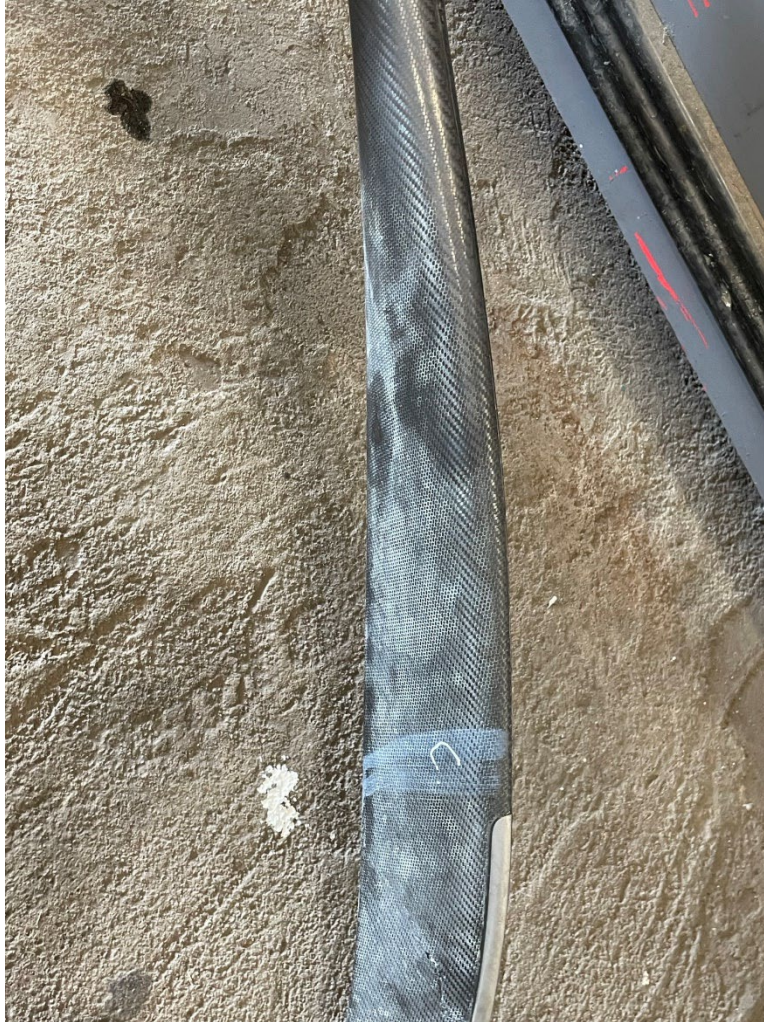
Figure 26. Propeller Blade C.

Blade C, Serial No. V2460, was intact and showed aft bending. See Figure 26. A deep nick was observed in the metal leading edge strip 8 inches inboard of the blade tip. A face fracture was observed approximately 9 inches inboard of the blade tip. See Figure 27.
