# National Transportation Safety Board

CEN24FA083

## ON SCENE SUMMARY

Location: Dolores, Colorado  
Date: January 6, 2024  
Time: 0945 Mountain Standard Time (MST)  
Helicopter: Just Highlander N712DG

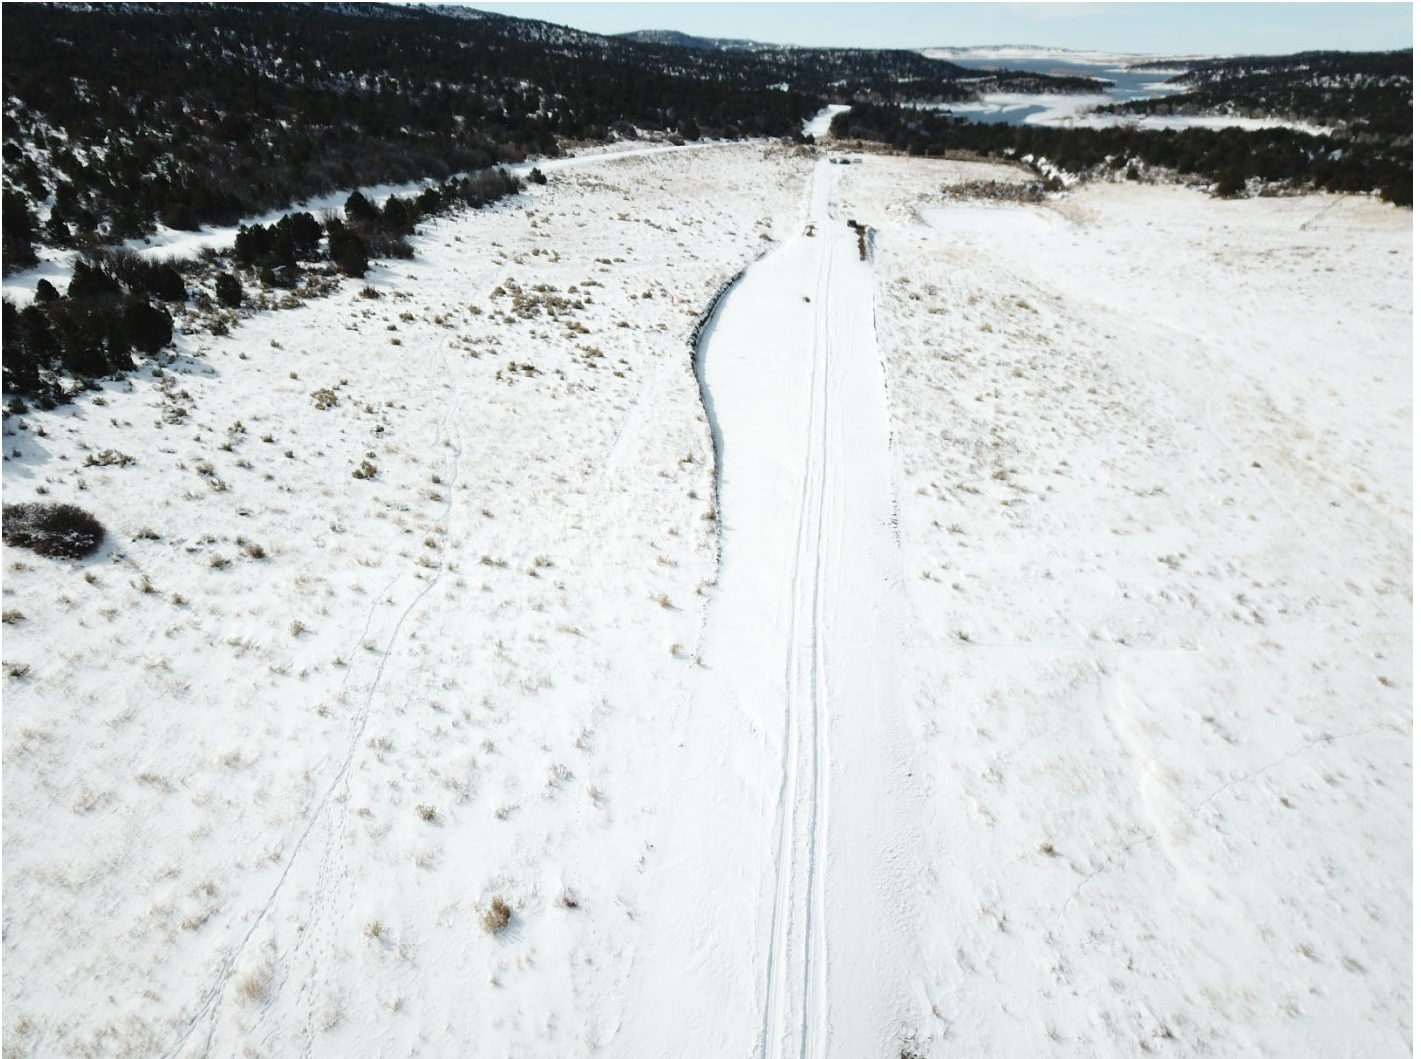
### **Accident Scene/General**

Detailed examination of the accident site showed that the airplane went off the end of the runway, impacted a 3-wire barbed wire fence, and came to rest upright about 610 ft. beyond the departure end of the snow-covered dirt runway, heading about 175°. The approximate runway heading was 250°. The length of the runway was about 1,800 ft, and its width was about 30 ft.

No preimpact mechanical anomalies were found with the flight controls, airframe, or engine at the accident site. It should be noted that 8-12 inches of snow covered the area including the wreckage. Brooms were used to brush off the snow to examine the airplane. The wreckage was recovered to a secure facility in Denver.

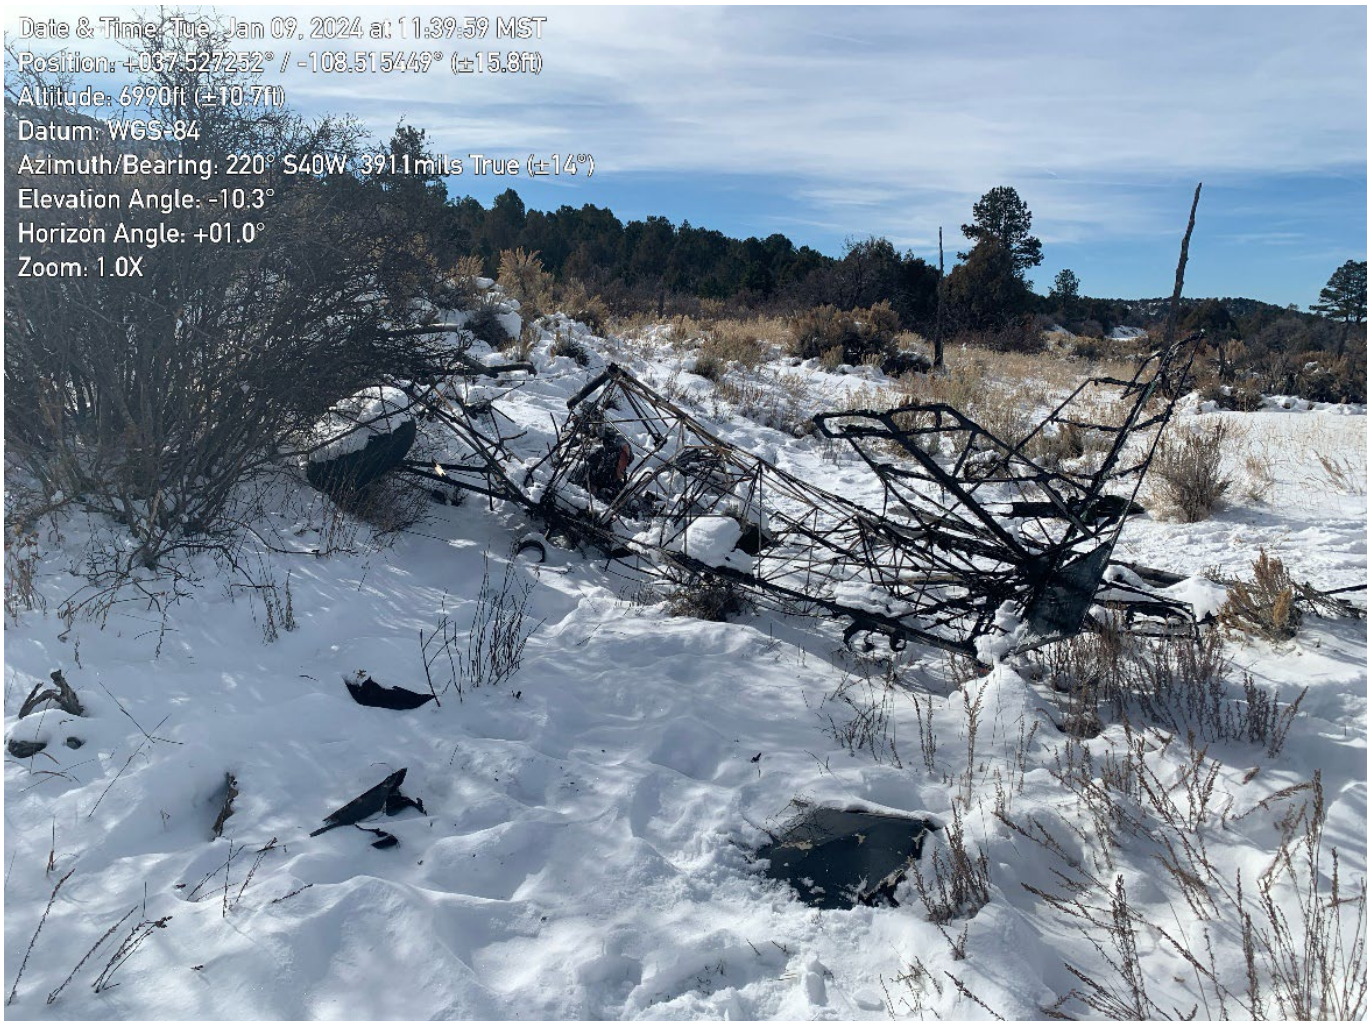
Severe fire damage consumed all the fabric flight control surfaces, and all the cockpit instruments. Other than damage from impact forces and fire, examination of the flight controls and airframe did not reveal any pre-impact anomalies. Flight control continuity from the cockpit to the ailerons, elevator, and rudder was confirmed. The flap position could not be confirmed due to severe fire damage. The tubular frame structure was mostly intact but had severe fire damaged.

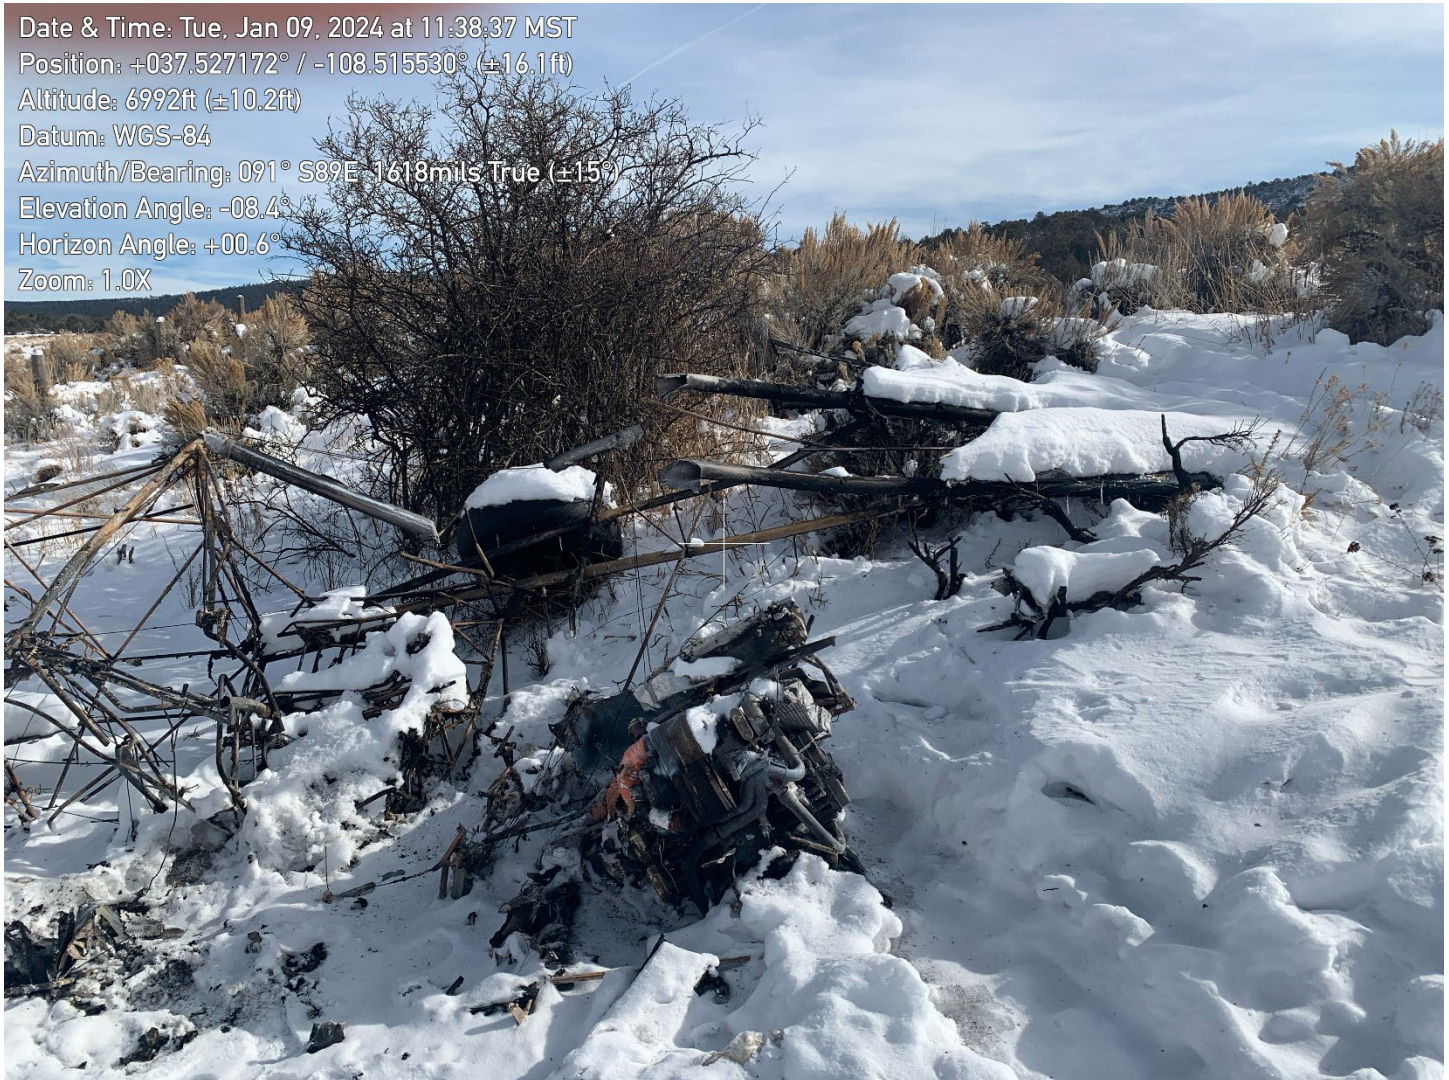
### Engine/Propeller (On Scene)

The engine was separated from the fuselage and displayed severe fire damage. The 3-bladed propeller assembly was found separated from the engine. It was located behind the empennage and did not have fire damage. Two of the composite propeller blade's spans were damaged, and one of the blades had about 3 turns of the barbed wire wrapped around its root, consistent with rotation at the time of impact with the fence.
