# National Transportation Safety Board

CEN24FA095

## EXAMINATION SUMMARY

Location: Little Rock, Arkansas  
Date: January 21, 2024  
Time: 1320 CST  
1920 UTC  
Airplane: N255JP, Cirrus SR-22, S/N 3084

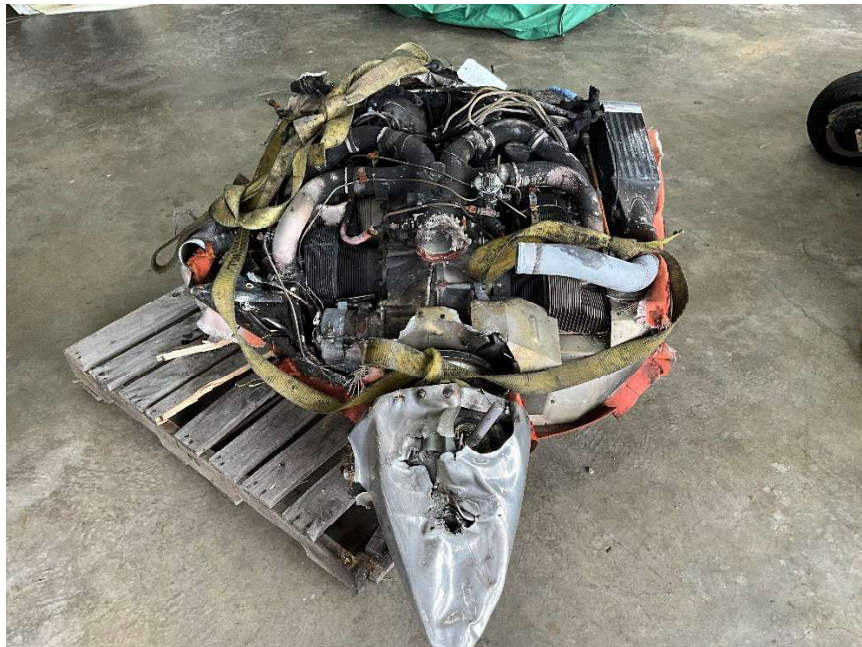
Visual examination of the engine prior to teardown showed no issues or abnormalities beyond fire and impact related damage. The air intake system was missing up to the throttle assembly/metering valve. The exhaust system was missing aft of both turbochargers. The engine also had upward crush damage to the exhaust pipes and turbo system consistent with ground impact. The propeller spinner had crush damage inward along with a slight upward bend to the entire propeller assembly. The right magneto was separated from the accessory system gear drive. The right-side turbo system had upward crush damage and the turbocharger power section housing was missing. The accessory system had fire damage to all components. The oil filter was found to be missing with the mount intact. The turbo system manifold controller was found separated and attached only by the associated oil lines. The oil sump had upward crush damage with the drain plug missing from impact damage.

Figure 1. Engine prior to examination teardown

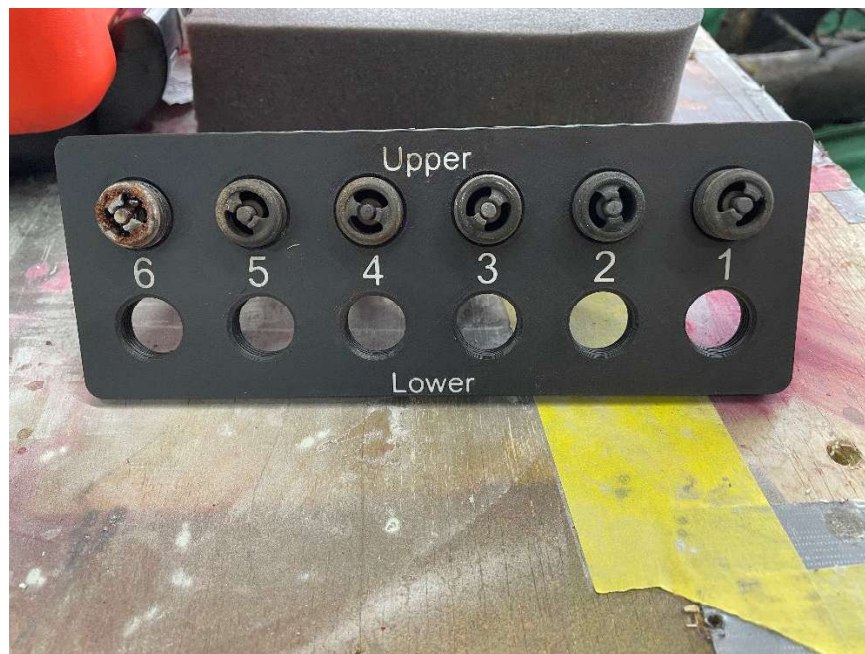
The upper spark plugs were removed and observed to be all normally worn, except the spark plugs of Cylinder #6, as compared with the Champion Spark Plug Card. The upper spark plug from Cylinder #6 had debris and lead fouling along with rust deposits. The upper spark plugs electrode gap distance were examined with a Spark Plug Gap Gauge and found to be severely worn with all exceeding .022, except the spark plug of Cylinder #5 which was .019. The Continental Maintenance Manual, *Table 6-9 Spark Plug Application Chart*, recommends an electrode gap of .016 to .021 for the URHB32E.

The lower spark plugs were not removed due to crush damage of the exhaust and turbo system. The spark plugs were examined with a video borescope and observed to be all normally worn, except the spark plug of Cylinder #6, as compared to the Champion Spark Plug Card. The lower spark plug of Cylinder #6 had debris and rust deposits covering the entirety of the plug electrode.

Figure 2. Upper Spark Plugs

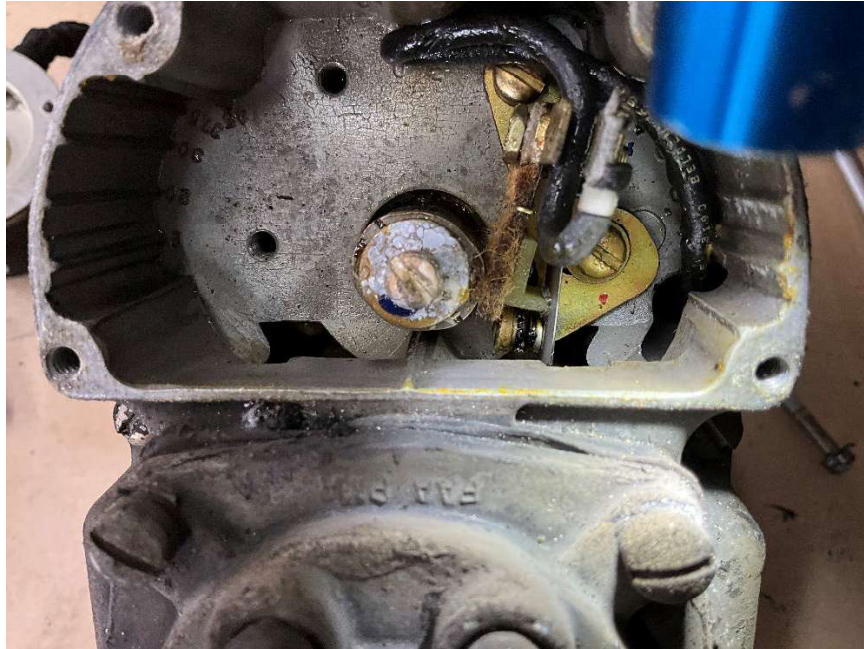
magneto, TCM P/N 10-500556-101 S/N D08BA315, had impact damage on the drive side of the unit. However, the spark was produced, with the harness cap removed, using a section of safety wire on all distributor terminals. The right magneto, TCM P/N 10-500556-101 S/N D08RA876 had impact damage to the distributor gear, a foreign black wet substance covering both contacts, and water present inside the housing. Once the contacts were cleaned and dried, spark was produced on one contact when the magneto was rotated by hand. Spark on the second contact was unable to be produced due to the damaged distributor gear.

Figure 3. Right Magento contacts prior to cleaning.

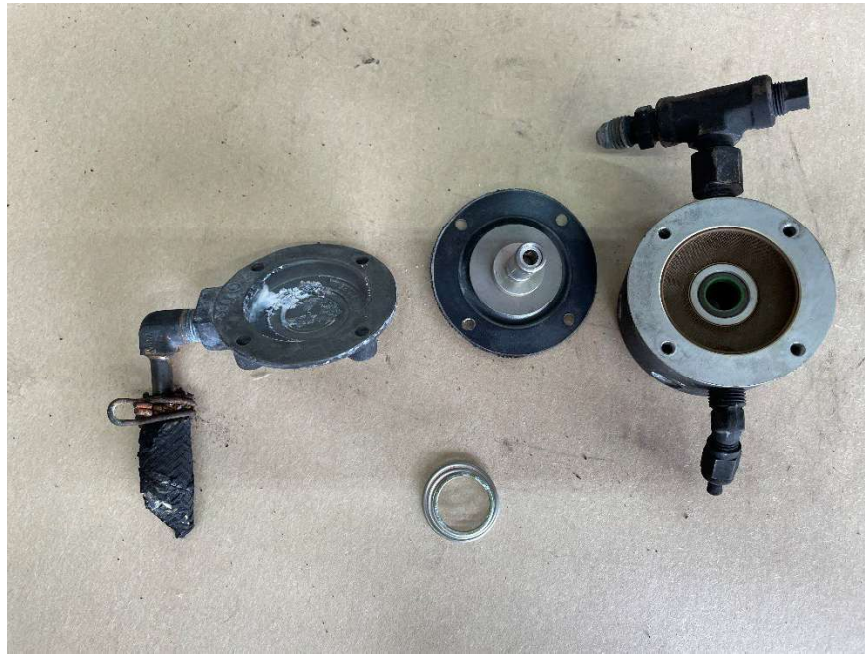
The fuel manifold, P/N 646433-9A4 S/N C086A025, was removed and examined with no observed abnormalities. The fuel screen was clean and the gasket intact and flexible. All fuel injector lines were attached and secured with no debris or blockages observed. All six fuel injectors were removed and examined for blockages and general condition. The fuel injectors were STC General Aviation Modifications, Inc (GAMI) with a fuel flow code of 19B. The fuel injector passage was examined by holding the injector to a flashlight. No abnormalities were observed. All fuel lines aft of the engine accessory section had fire damage and were separated from the engine driven fuel pump.

Figure 4. Fuel Manifold

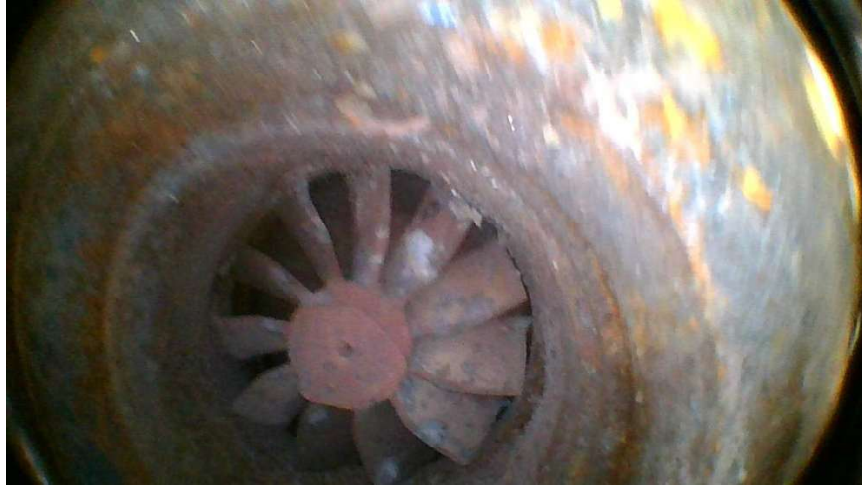
The right-side turbocharger, waste gate and cooler, were unable to be examined due to impact related damage. The turbocharger power section housing was missing along with all exhaust tubes. The turbocharger was unable to be rotated by hand or with tool assistance. The compressor section was examined using a video borescope. No rotational witness marks were observed on the compressor housing due to fire damage and the compressor had bending of the blades.

Figure 5. Right-side Turbocharger Compressor

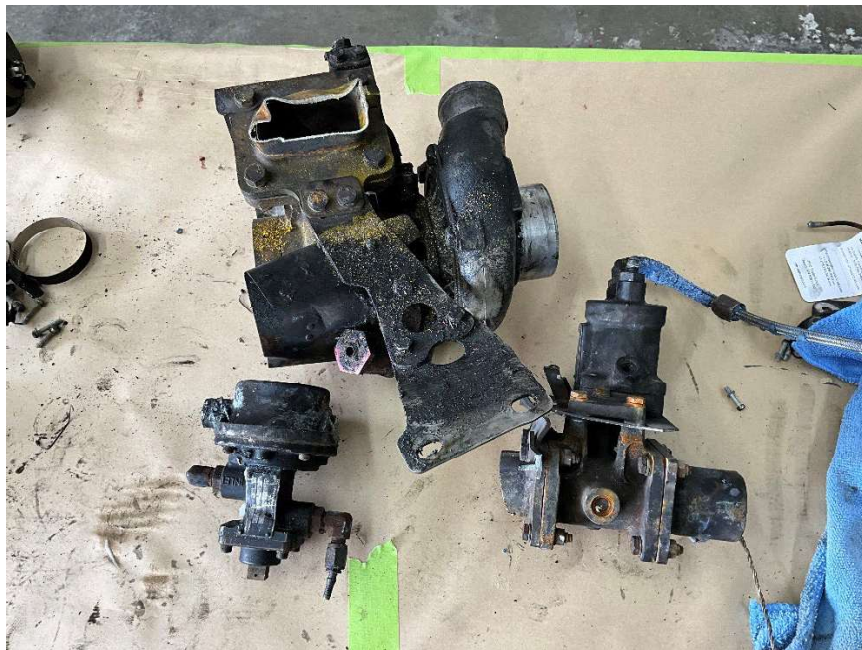
The left-side turbocharger P/N 466304-003 S/N KLL-0144\*\*, waste gate P/N 470842-0004\*\*, and system controller, P/N 470688-0010 S/N H-AFN003\*\*, were removed and examined. The system controller part number is listed by Tornado Alley as not compatible with Cirrus Aircraft. The turbocharger had fire damage and was unable to be rotated by hand or with tool assistance. The waste gate had fire damage and sooting on the exterior surface and was separated from the turbocharger. The waste gate control arm was bent from impact related damage and unable to be rotated by hand. The controller had fire damage and sooting on the exterior surface and was also separated from the engine accessory section. All removed parts were boxed for future examination, if needed.

Figure 6. Left-side Turbocharger System, as removed.

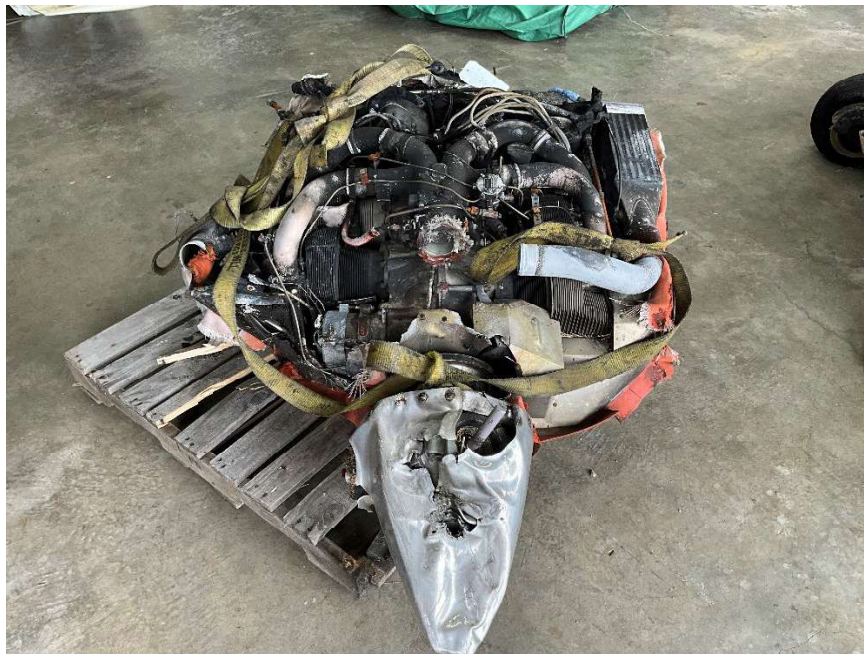
The propeller assembly was found attached to the crankshaft with a slight upward bend. The spinner had inward crush damage from the tip to the bulkhead and all three blades were missing at the root with damage consistent with overload. The spinner was removed and the propeller cylinder was found with inward crush damage consistent with ground impact. Oil was observed in the cylinder when the propeller was rotated by hand. The propeller was a Hartzell PHC-J3YF-1N S/N FP6801B and a McCauley propeller governor P/N C290-D3R/123 S/N 072010 was installed.

Figure 7. Propeller damage
