# National Transportation Safety Board

CEN24FA095

**AVIATION**

Location: Little Rock, Arkansas  
Date: January 21, 2024  
Time: 1320 central standard time  
1920 UTC  
Airplane: Cirrus SR22 N255JP

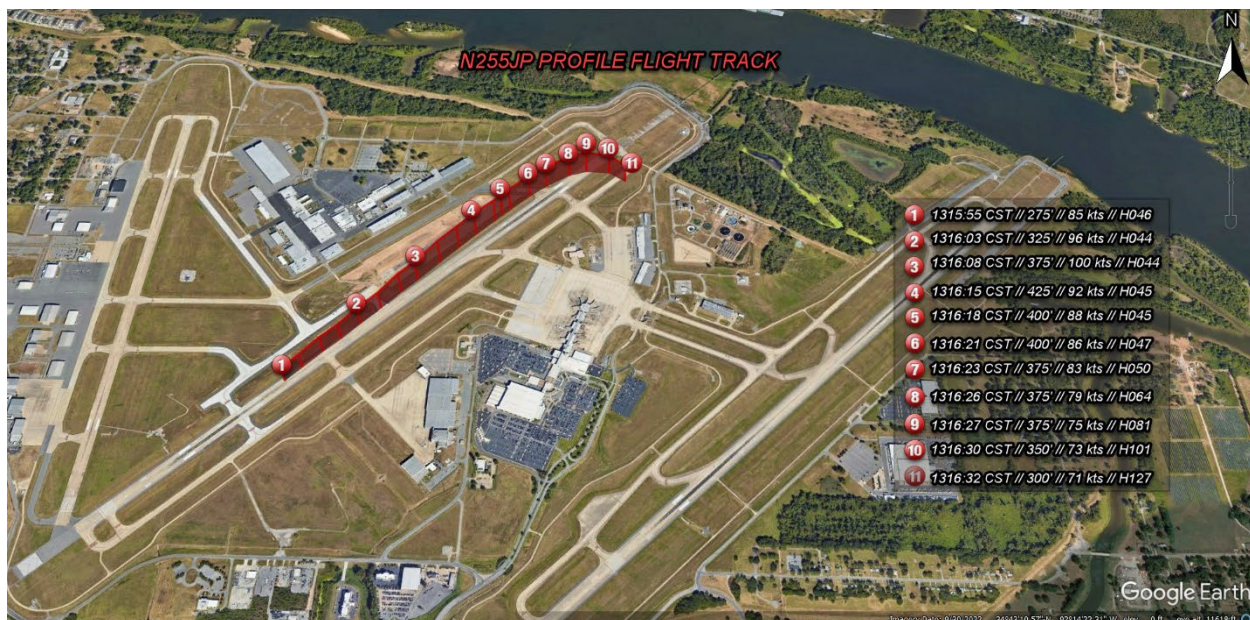
The flight departed runway 4L and reached a maximum altitude of approximately 425 ft mean sea level, shown in Figure 1. During the departure climb, the pilot transmitted that he lost the engine. The airplane entered a bank, descended, and impacted the ground near the airport fire station.

Figure 1 – Airplane Departure Flight Track with Speeds and Altitudes

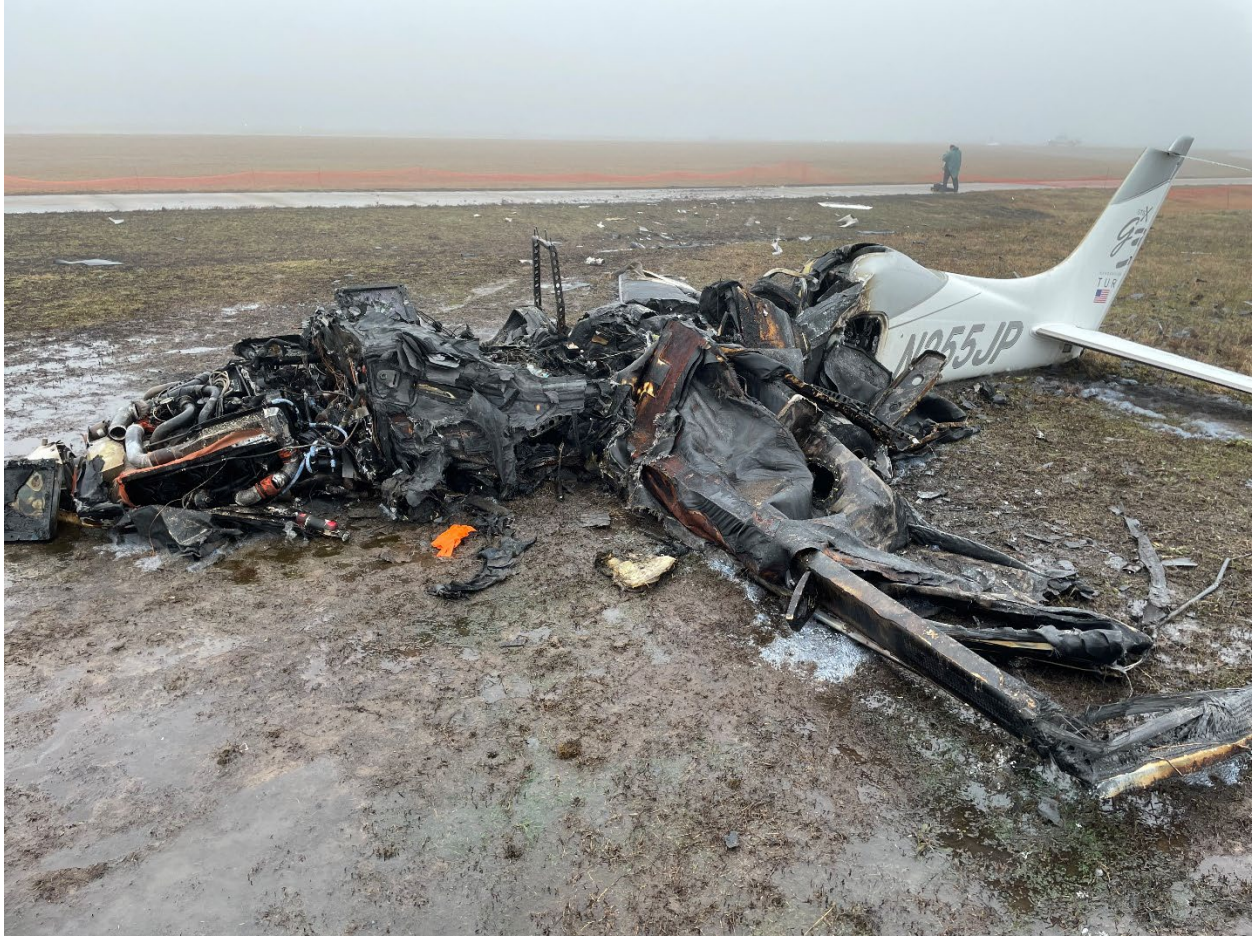
The aircraft, shown in Figure 2, was located on the airport at coordinates: 34 degrees 44 minutes 7 seconds North and 92 degrees 13 minutes 3 seconds West at GPS elevation 260 ft.

Figure 2 - Accident Site

The tail to nose heading was 229 degrees. The preceding wreckage path extended to the initial impact point, which was a hole, at coordinates: 34 degrees 44 minutes 9 seconds North and 92 degrees 13 minutes 3 seconds West at GPS elevation 260 ft. The heading from the initial impact point to the main wreckage was 171 degrees. Two of the three propeller blades were along the wreckage path and the third propeller blade was about 100 ft west of the initial impact point.
