# National Transportation Safety Board

CEN24FA101

## EXAMINATION SUMMARY

Location: Ranchitos Las Lomas, Texas  
Date: January 29, 2024  
Time: 1441 CDT  
Airplane: N315GW- Aircam, S/N AC283-3

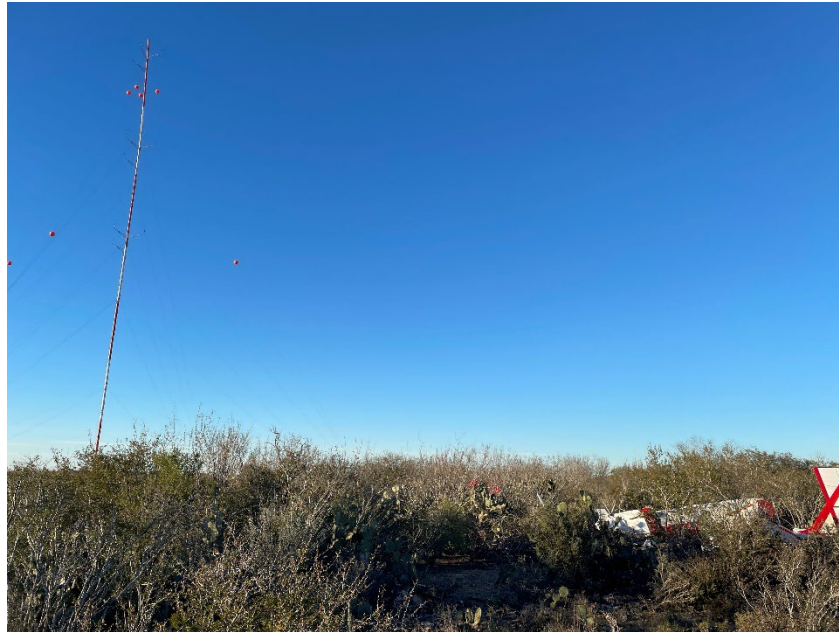
Figure 1: Accident site

- Location is +027.641949° / -099.112511°
- Location is 238 ft about 134° MH from a 197 ft MET Tower
- Airplane came to rest on about a 171° MH.
- Altitude is about 605 ft MSL.
- Wreckage was located in a flat desert with scrub brush and mesquite trees.

The fuselage, right wing, and inboard section of the left wing came to rest together inverted in desert scrub brush.

The debris path measured about 238 ft in length on a heading of 134° MH. The first impact point was along the top 28 ft section of a steel pole meteorological evaluation tower. According to local authorities and the land owner, the top guy wire with marker ball was pulled and separated from the tower and found in a rough coil at the guy wire footer. The guy wire had bird caging consistent with overload. The outboard 2.5 ft of the left flap was found 57 ft from the base of the tower. Numerous paint and airplane fragments were found between the tower to the main wreckage site. The outboard 9 ft and 6 in of the left wing along with an additional 33 in of attached aft spar was found separated and in the canopy of a low mesquite tree 25 ft behind the fuselage in the direction of the tower.

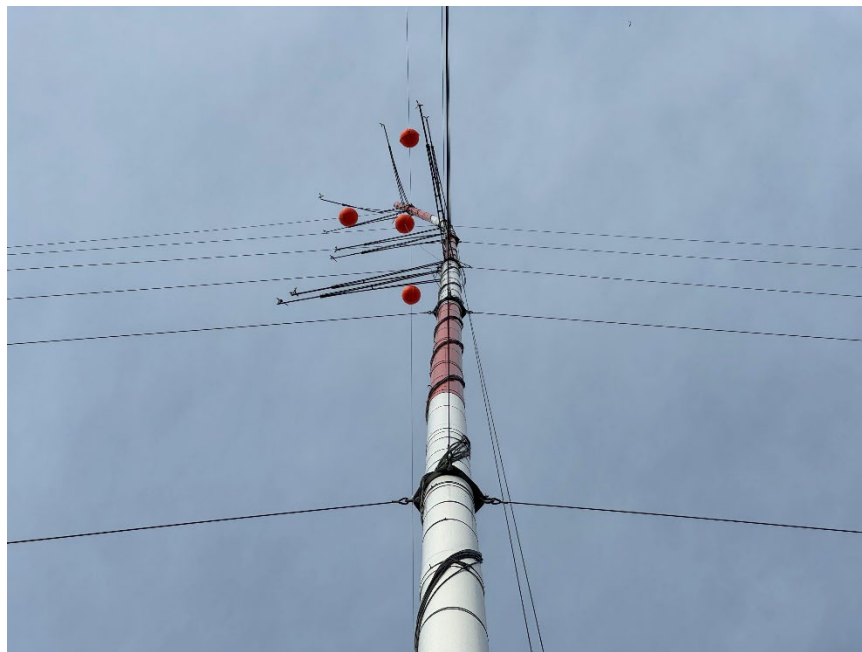
Figure 1: Damage MET Tower

The top painted section of the tower was bent in the south direction towards the wreckage. The sixth north guy wire was separated near the upper marker ball. The upper separated section of wire with the marker ball was still attached to the cradle and on the south side of the tower. The remaining section of the guy wire along with the lower marker ball was found on the ground. The west 58 m weather anemometer structure was bent towards the tower in a south direction.

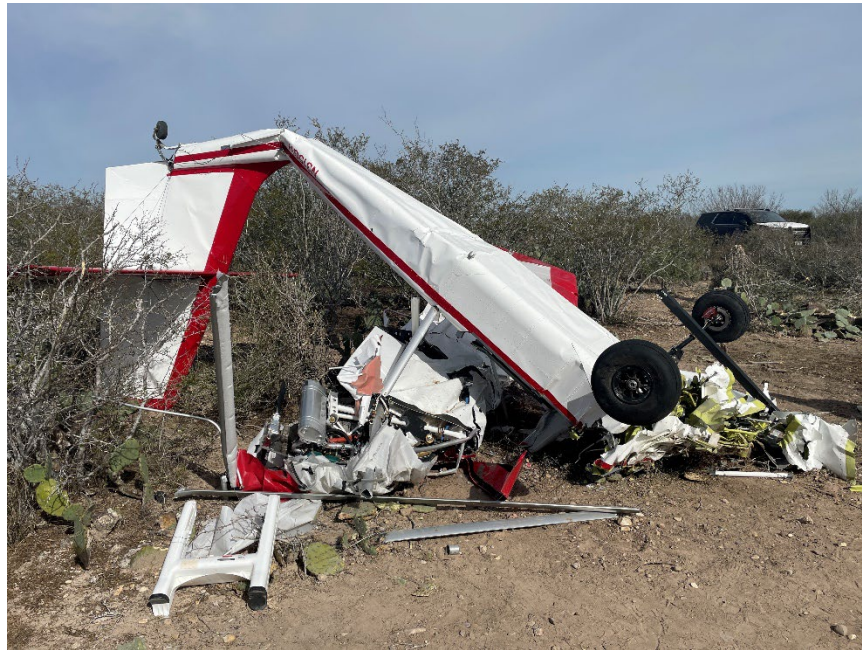
Figure 2: Accident airplane

The fuselage came to rest inverted. The left struts and forward spar were cut during victim recovery by first responders. The forward fuselage consisted of the instrument panel, forward flight controls, and forward seat. The forward fuselage had crush deformation of the structure forward to the main landing gear. The rear occupant seat, rear flight controls, and cargo bin were intact with crush damage present.

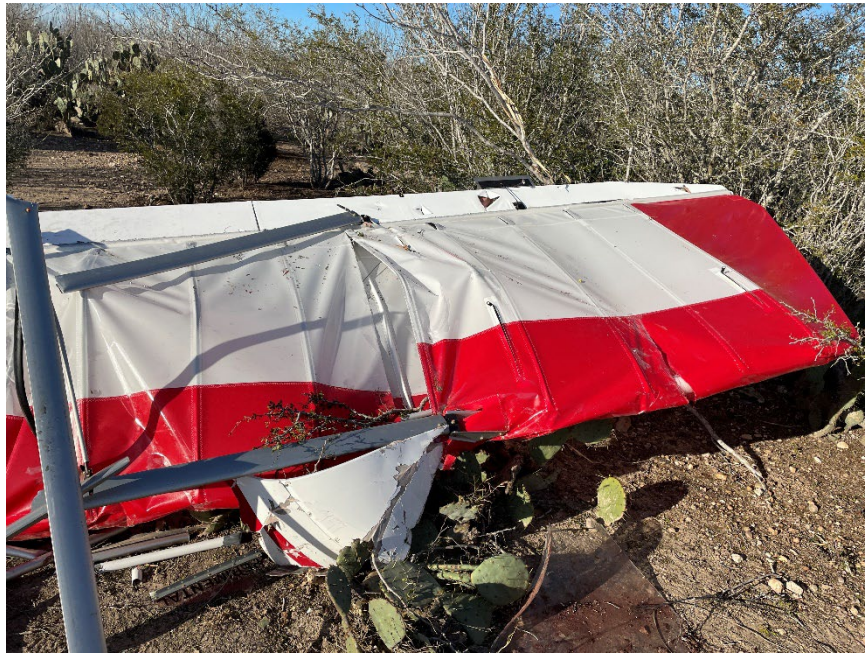
Figure 3: Right wing

Found attached to the wing carry through structure with recovery separations of both lift struts. The entire leading edge had crush damage and separation of the fabric. The forward spar was found separated consistent with overload separation at the lift strut attachment bracket.

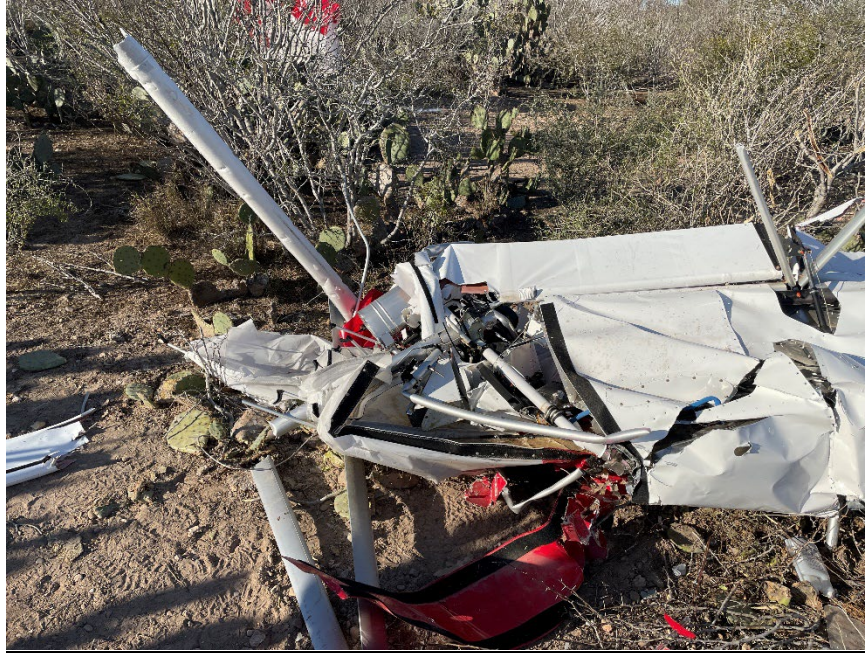
Figure 4: Inboard left wing

Inboard 5 ft of structure was found attached to the wing carry through structure with recovery separations of both lift struts and fuselage to carry through connection strut. The inboard structure had crush damage of the skin to the engine mount with separated fabric from the engine to the separation point. Forward and aft spar fracture surfaces were consistent with overload at the separation point.

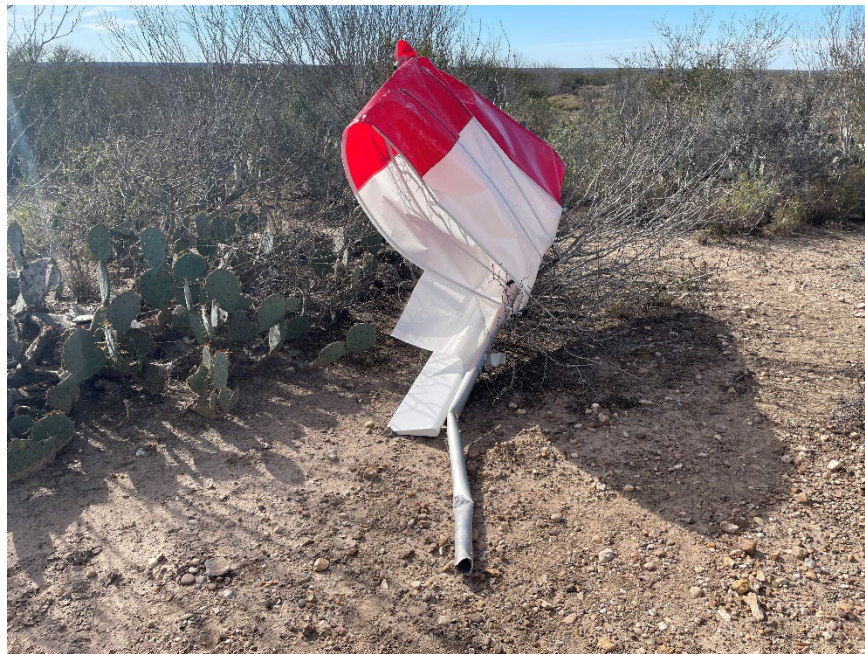
Figure 5: Outboard Left Wing

Outboard 9 ft and 6 in was found separated from the main wing structure. An additional 33 in of aft spar was also found still attached to the separated wing structure. The leading edge from the wing tip inboard about 2 ft had crush damage along with separation for the forward spar. The fracture surfaces of the forward spar had damage consistent with overload. The aft spar had crush damage about 1 ft from the separation fracture with witness marks. The fabric skin was observed to be intact through out the rest of the wing structure. A separated control cable was found in a nearby tree with consistent with overload.

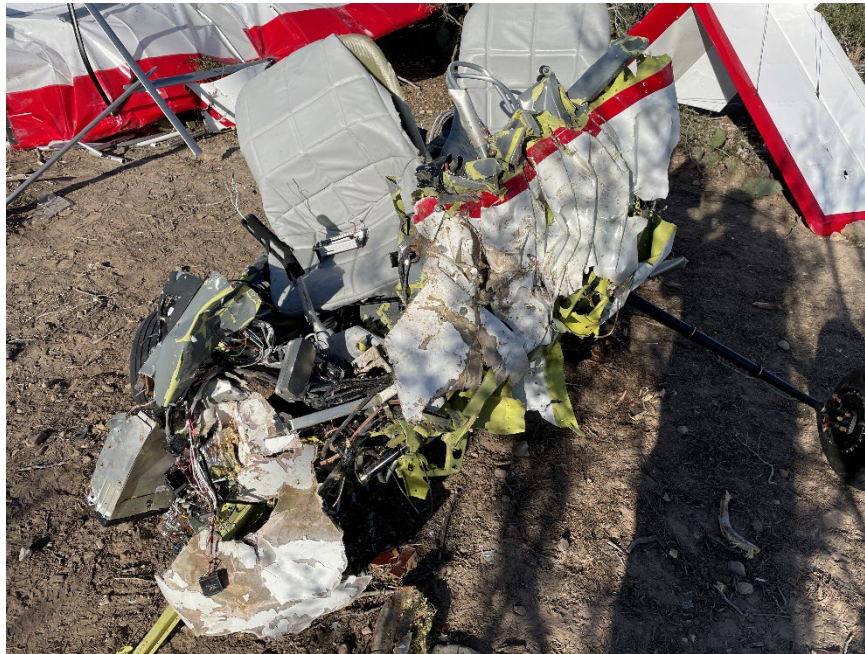
Figure 6: Cabin and instrument panel

Crush damage prevented verification of the majority of the flight instruments. The altimeter was found intact with the altimeter of 30.36" inHg selected in the Kollsman window. The airspeed indicator needle was found at 92 MPH with the faceplate broken. An oil pressure gauge was found with the needle at 160°F with the faceplate separated. The right engine coolant gauge was found with the needle at 240°F with the faceplate separated. All other readable gauges with needles were found at their respective minimum limits. The forward seat left and right throttle were found in MID position. The aft seat left and right throttle were found loose within the assembly. Both occupant seat harnesses were found attached with recovery cuts and both seatbelts were found separated with recovery cuts. Both lower control stick structures were found with crush damage. Both seat rudder control pedals were found attached and connected to their respective rudder cable.

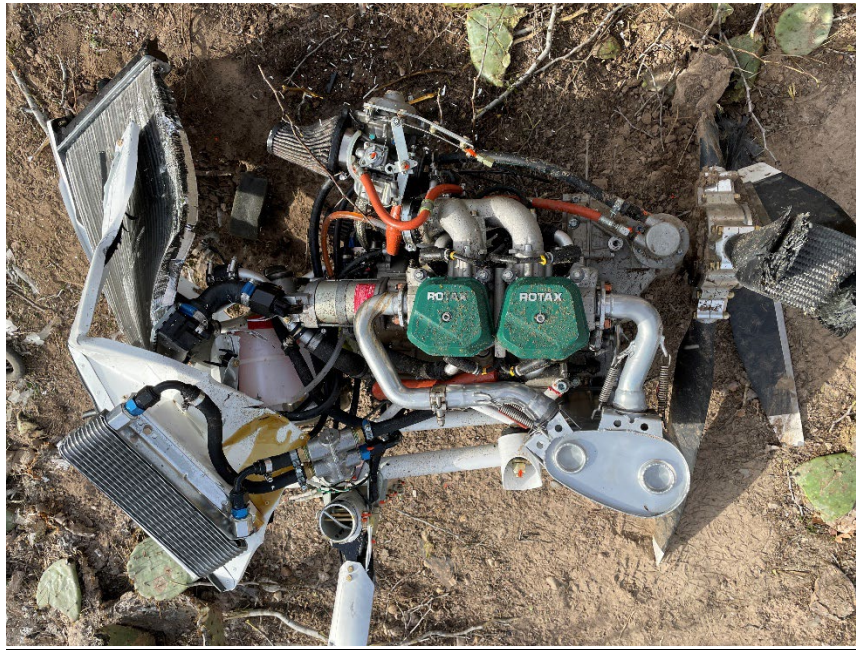
Figure 7: Right engine and propeller

The right engine remained attached to the engine mount and was inverted. The engine had crush damage and impact damage of various components. A large electrical cable was found pulled free from the connector with no damage to the cable. The 3 bladed propeller was found attached to the propeller flange. The engine was retained and a follow-up examination with the manufacturer will be performed at a later date.

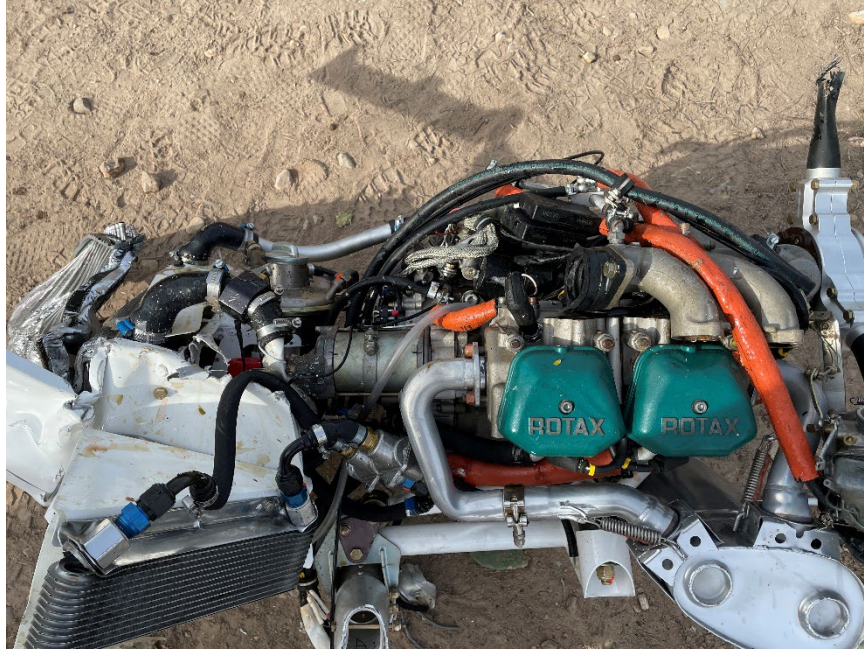
Figure 8: Left engine

Found attached to the engine mount and in an inverted position. The engine had crush damage and impact damage of various components. The 3 bladed propeller was found attached to the propeller flange. The engine was retained and a follow-up examination with the manufacturer will be performed at a later date.

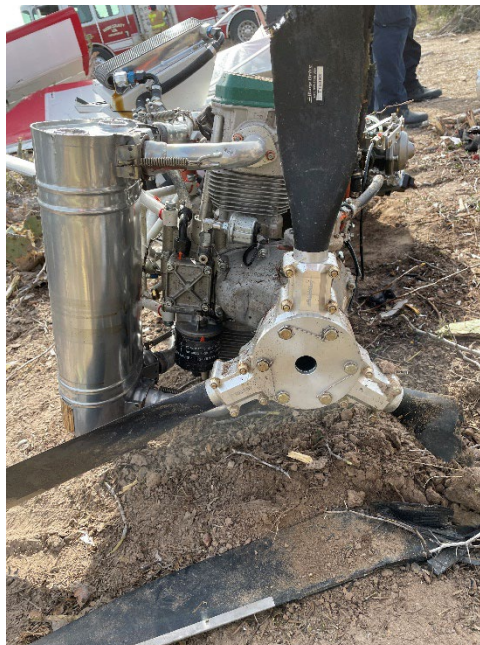
Figure 9: Right propeller

The propeller blades were identified from right to left as A, B, and C for documentation purposes. All three blades were found attached to the hubs. Blade A had a no damage with no scuffing of the leading edge. Blade B was fractured midspan with some scuffing of the leading edge. Blade C was fractured and separated at the hub with some scuffing of the leading edge. The fractured portion was at the ground level in the opposite direction of flight when the airplane was in the accident resting position.

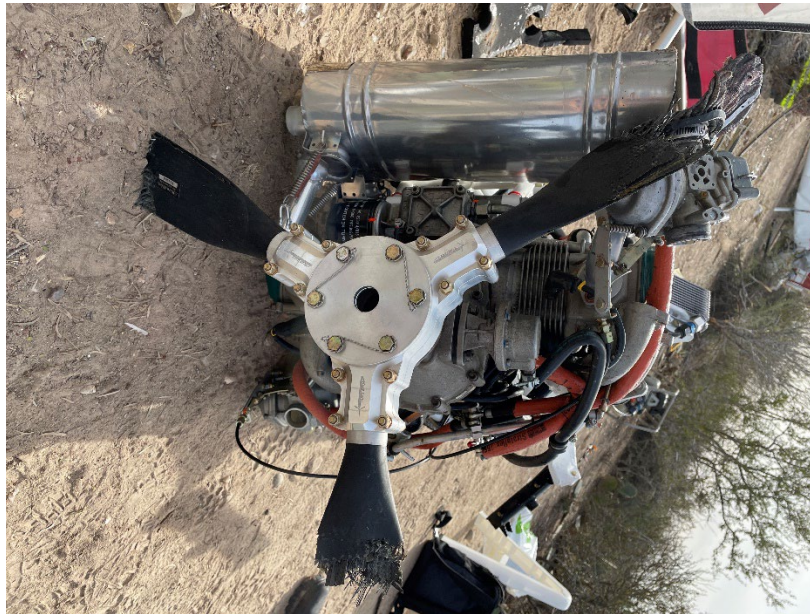
Figure 10: Left propeller

The propeller blades were identified from right to left as A, B, and C for documentation purposes. All three blades were found attached to the hubs and separated. All three blades had scuffing of the leading edges and one separated blade and a separated tip.
