# National Transportation Safety Board

CEN24FA160

## **STRUCTURES**

Group Chair's Factual Report

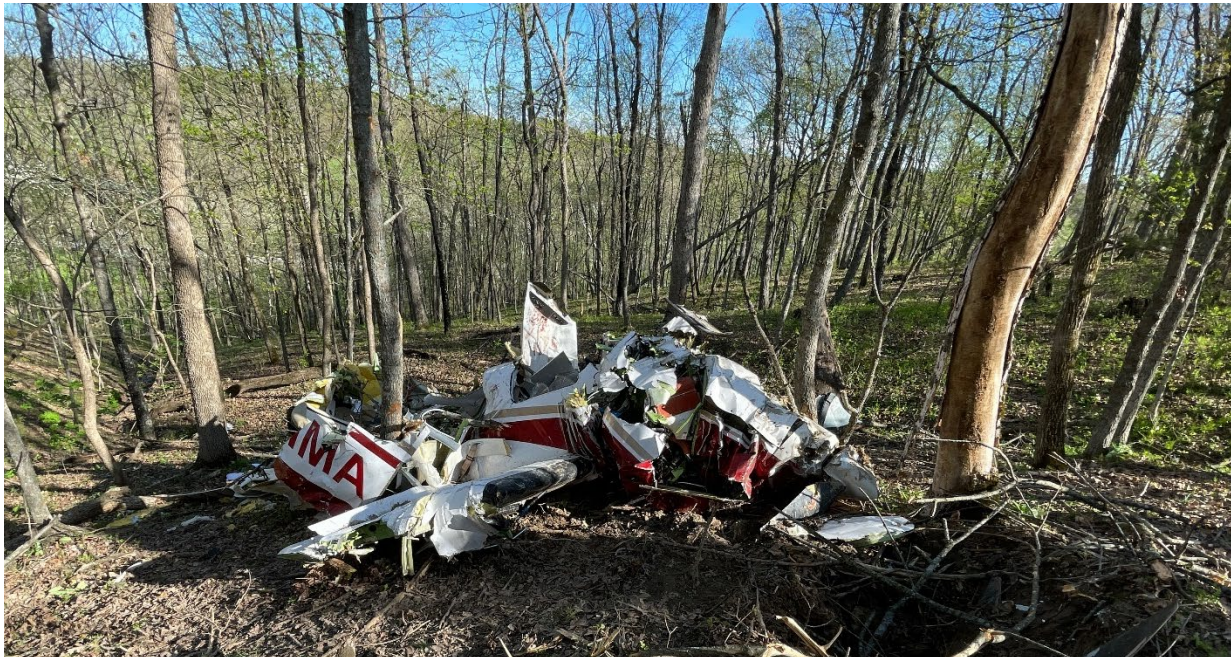
The main wreckage consisted of the airplane's fuselage which came to rest on a wooded hillside next to a pasture (figure 3). The tree canopy was mostly undisturbed and the few broken tree limbs suggested a near vertical descent and impact with the ground. The fuselage was resting upright. The engine was pushed rearward and the forward fuselage exhibited accordion crushing into the area of the forward baggage compartment. The inboard 4 ft of each wing remained attached to the fuselage. The fuselage side over the wing exhibited signs of crush damage. The roof of this area was folded back, presumably by first responders for occupant extraction. The fuselage between the front seats and the rear baggage compartment was fragmented. The aft 8 feet of the fuselage was predominately intact. No tail surfaces were present at the main wreckage site.

**Figure 3.** Accident airplane on site (NTSB photo)

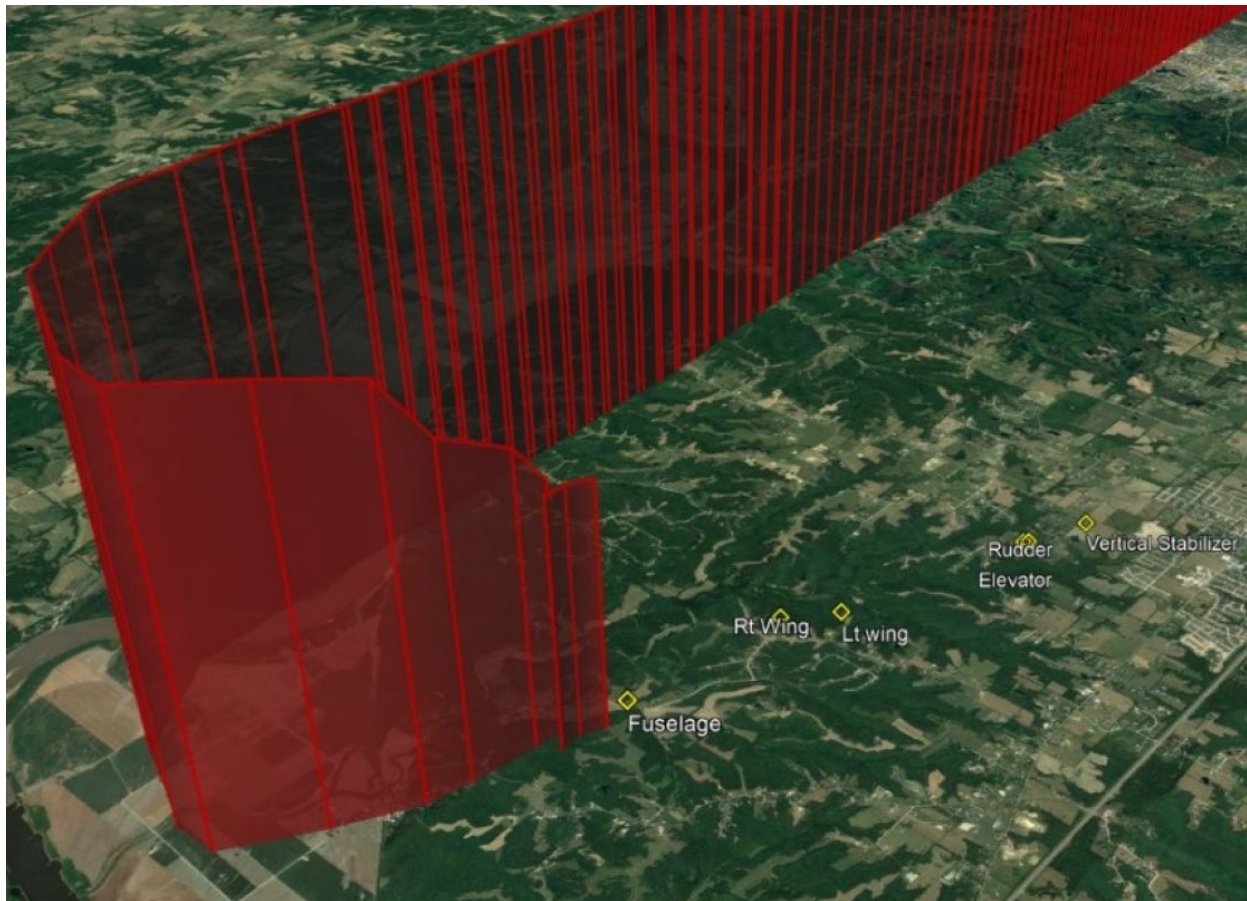
The tail surfaces and both outboard wings had separated from the airplane (figure 4). The wings, elevator, vertical stabilizer, and the rudder were located along a line extending from the fuselage on an 18° heading for about 3.1 nm. The vertical stabilizer was the farthest piece of wreckage located, with the other pieces found between the fuselage and the vertical stabilizer. Most of the horizontal stabilizer pieces were not located.

**Figure 4.** Final portion of the flight path and location of recovered components (NTSB diagram)

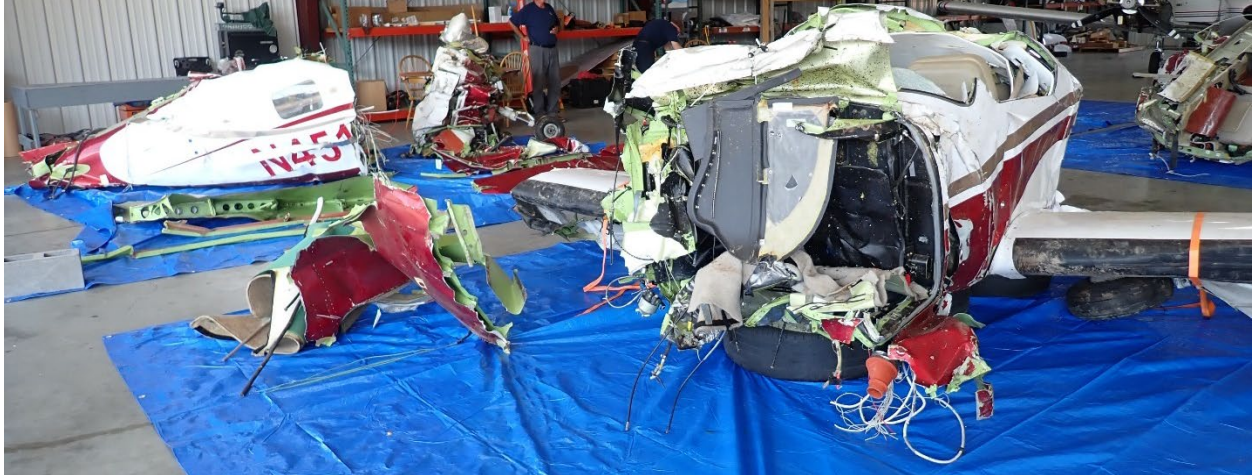
The examination focused on the wings and stabilizers that separated prior to ground impact. There was significant impact damage to the fuselage structure, and it was separated into 3 major pieces (figure 5). Both outboard sections of the wings separated from the airplane near wing station WS 75 at the outboard ends of the main landing gear wheel wells. The inboard wing sections remained attached to the fuselage and the outboard sections were recovered. The horizontal stabilizer, vertical stabilizer, flaps, ailerons, elevator, and rudder separated from the airplane during the event. The right aileron, right flap, and left flap were separated from the wings and recovered. Most of the left and right sides of the horizontal stabilizer aft spar and the center portion of the elevator, about 6 feet long, were separated and recovered. The vertical stabilizer, vertical stabilizer aft spar, and the rudder were separated and recovered.

All the fracture surfaces examined had an angled, dull, grainy appearance consistent with overstress separation. There was no evidence of pre-existing cracking or corrosion noted.

**Figure 5.** Accident airplane (NTSB photo)

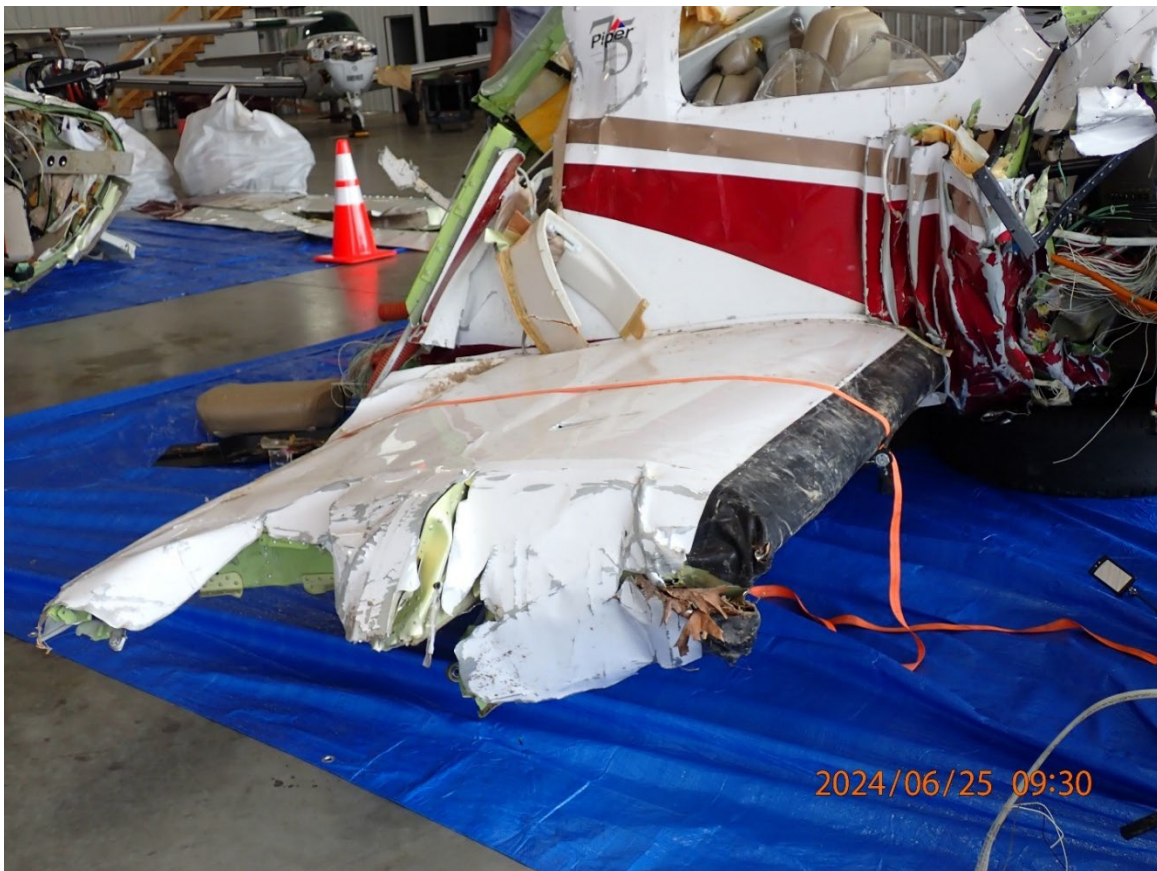
The right wing inboard section remained attached to the airplane (figure 6). The leading edge structure was deformed down and inboard almost 180 degrees between WS 75 and WS 100. The main spar was fractured near WS 89, and the aft spar was fractured near WS 92.

**Figure 6.** Right wing inboard section (NTSB photo)

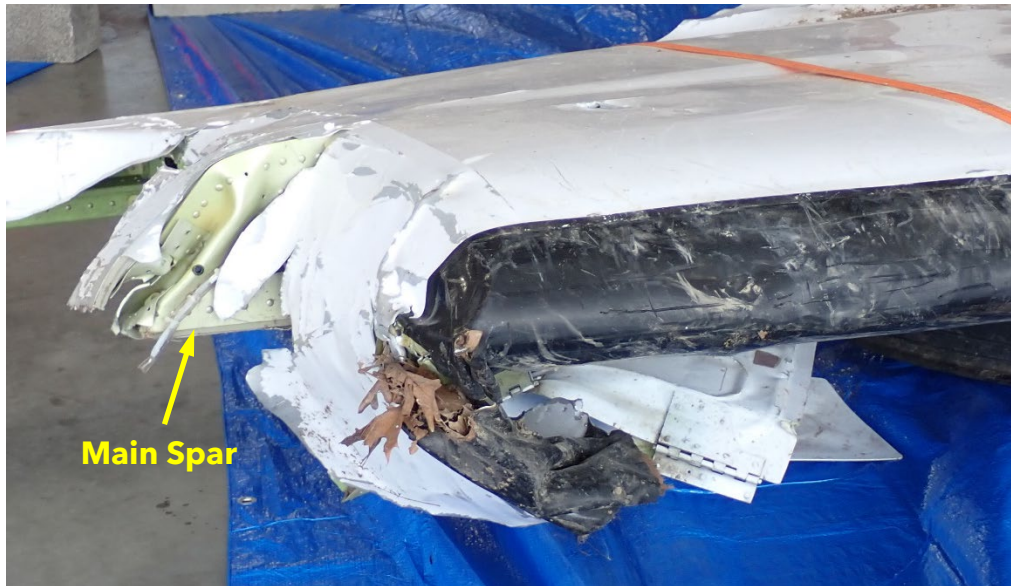
The main spar upper cap was deformed down about 60 degrees and there was no obvious deformation of the lower cap at the fracture location (figure 7).

**Figure 7.** Right wing inboard section fractured leading edge and main spar (NTSB photo)

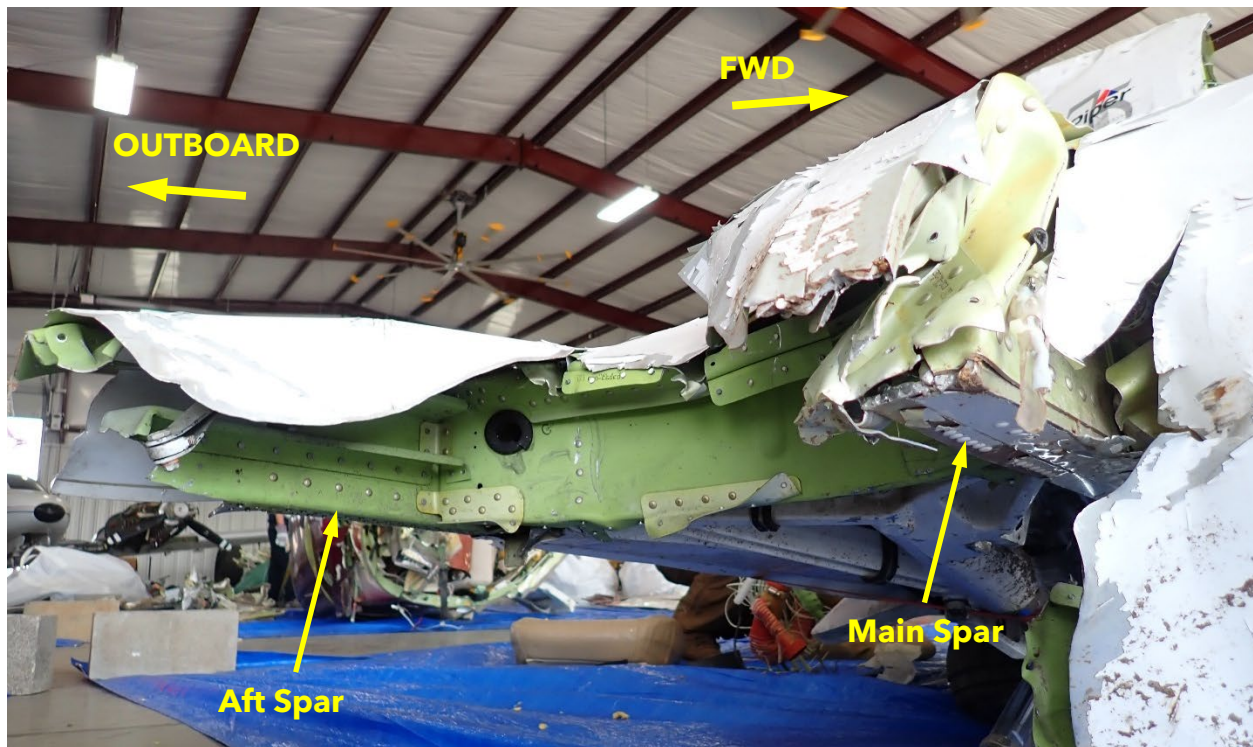
The aft spar upper cap, lower cap, and attached skins were deformed downward at the fracture location (figure 8). The aft spar lower cap fractured approximately 5 inches inboard with respect to the upper cap.

**Figure 8.** Right wing inboard section aft spar fracture (NTSB photo)

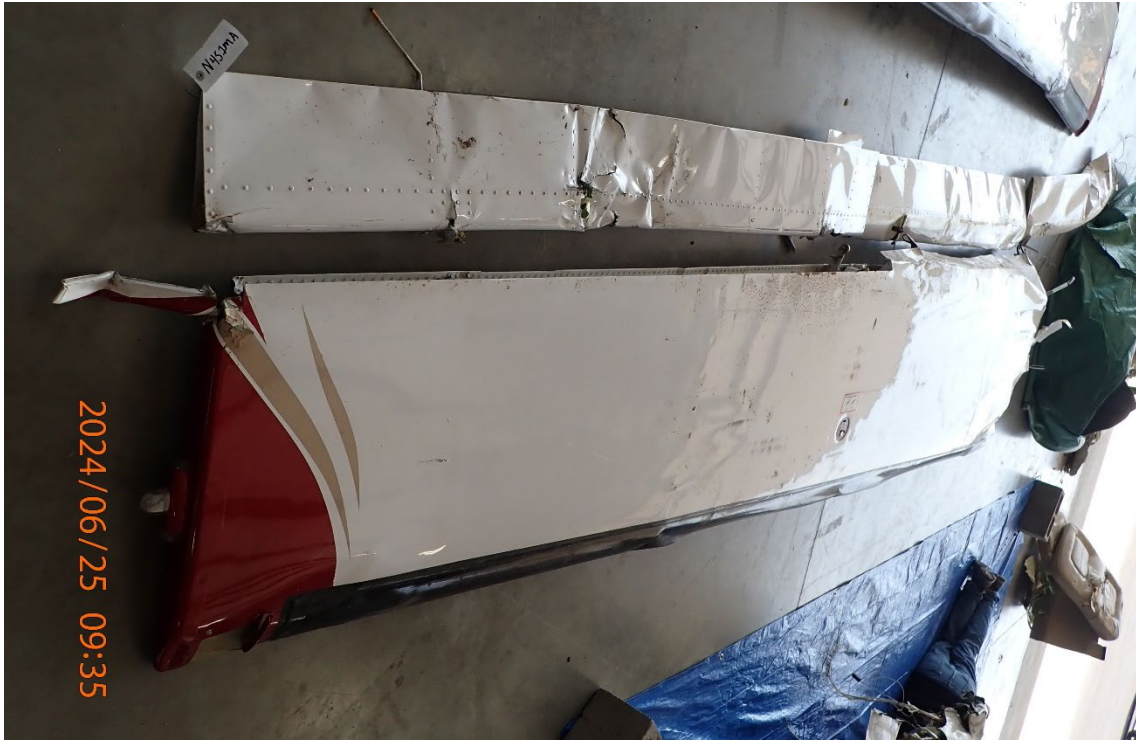
The right outboard wing section separated from the airplane near WS 90 and was recovered (figure 9). The flap and aileron separated from the wing but were recovered. The outboard wing was bent slightly downward, and the arc extended the full length of the section.

**Figure 9.** Right wing outboard section (NTSB photo)

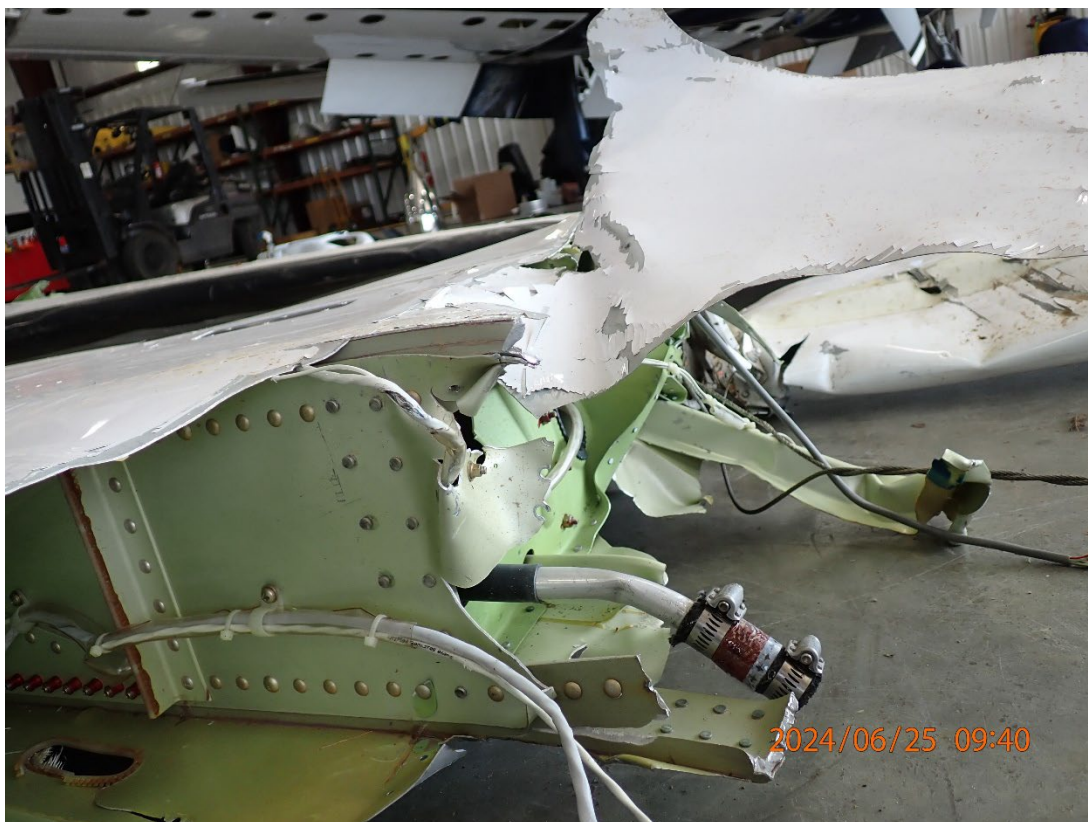
At the fractured area, both main and aft spar were deformed in the downward direction (figure 10).

**Figure 10.** Right wing outboard section main spar fracture (NTSB photo)

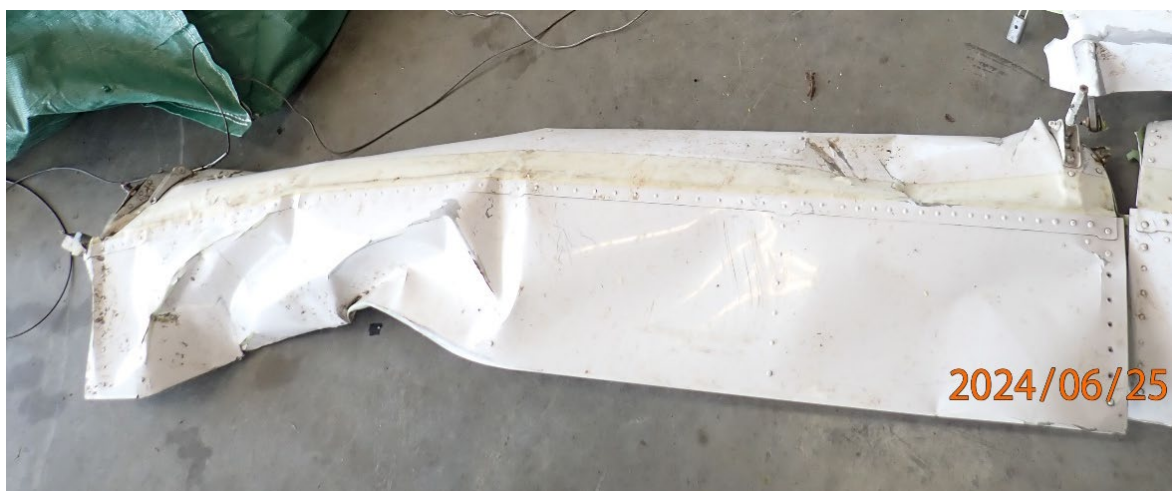
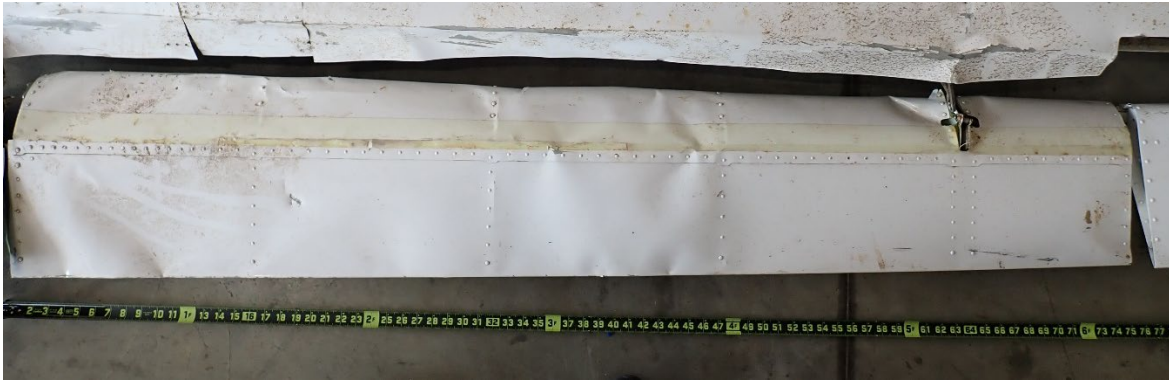
The right flap separated from the airplane and was recovered (figures 11 and 12). The flap was complete but separated in half, at about 77 inches from the outboard end. Both halves buckled and fractured at the flap track attach points.

**Figure 11.** Right flap inboard section (NTSB photo)

**Figure 12.** Right flap outboard section (NTSB photo)

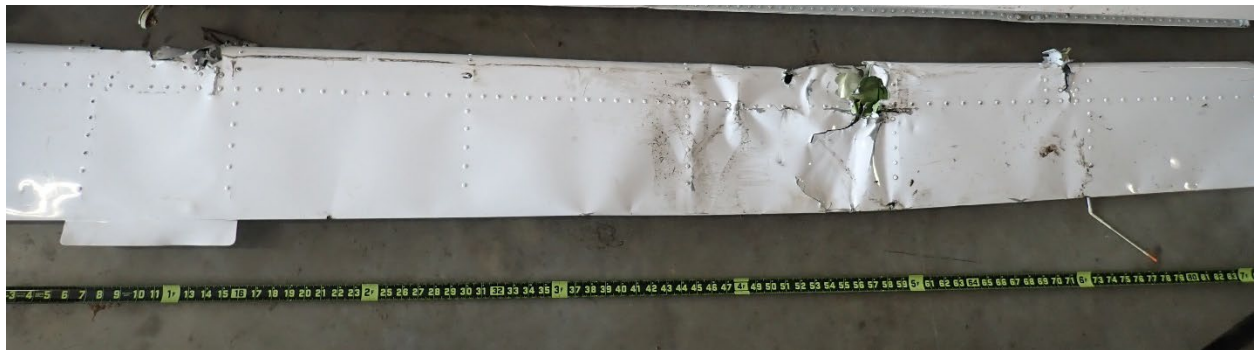
The right aileron separated from the airplane and was recovered (figure 13). The aileron was complete with signs of buckling and impact damage. The aileron hinges were fractured from the wing structure. The largest impact damage was located about 56 inches from the inboard end, and measured to be approximately 3 inches wide and 5 inches long. There was over travel impact damage at the aileron hinge locations.

**Figure 13.** Right aileron (NTSB photo)

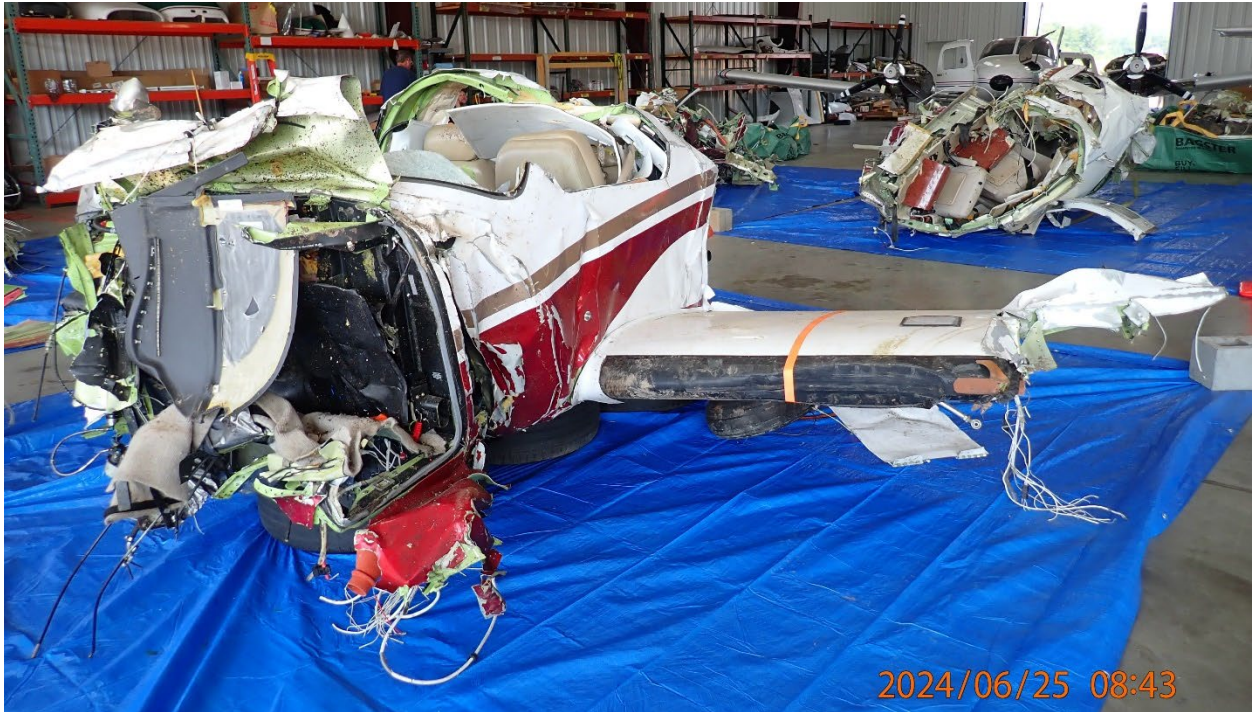
The left wing inboard section remained attached to the airplane (figure 14). The main spar was fractured near WS 78, and the upper and lower caps were deformed downward. The aft spar was fractured near WS 108 and was deformed aft and twisted leading edge down outboard of WS 75.

**Figure 14.** Left wing inboard section (NTSB photo)

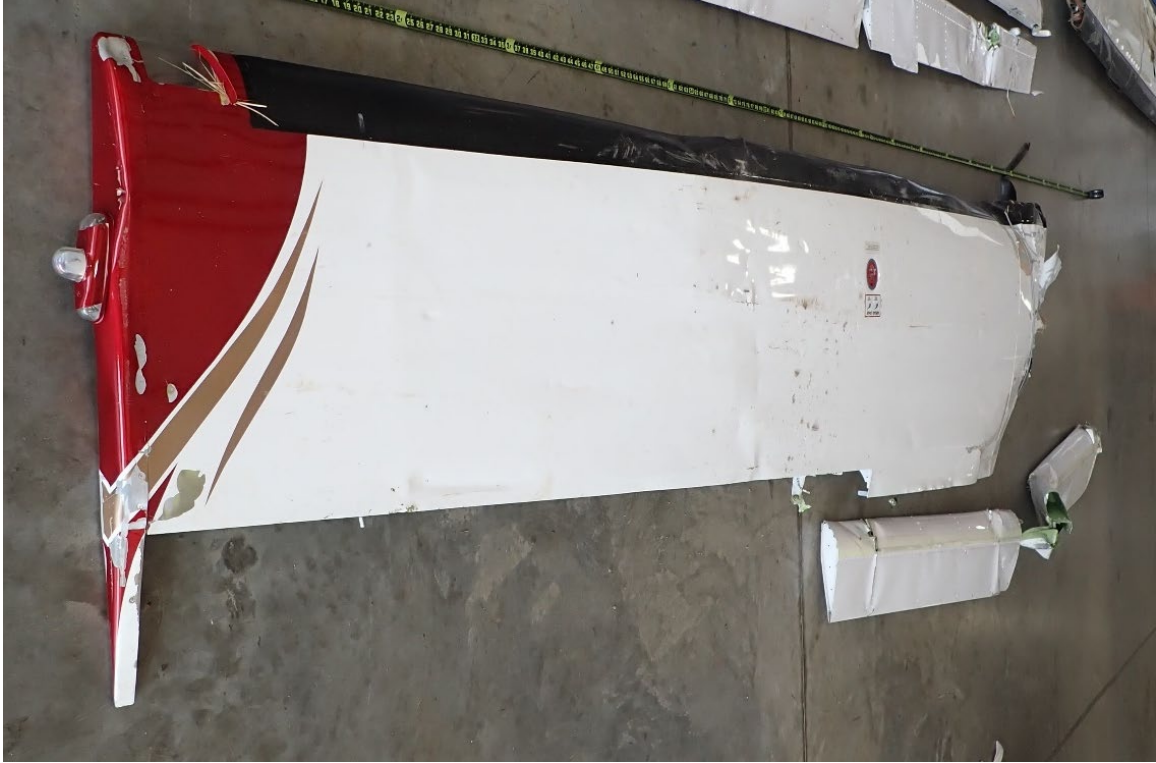
The left outboard wing section separated from the airplane near WS 78 and was recovered (figure 15). The flap and aileron separated from the wing; the flap was recovered, the aileron was not recovered. The outboard wing was bent slightly downward, and the arc extended the full length of the section.

**Figure 15.** Left wing outboard section. (NTSB photo)

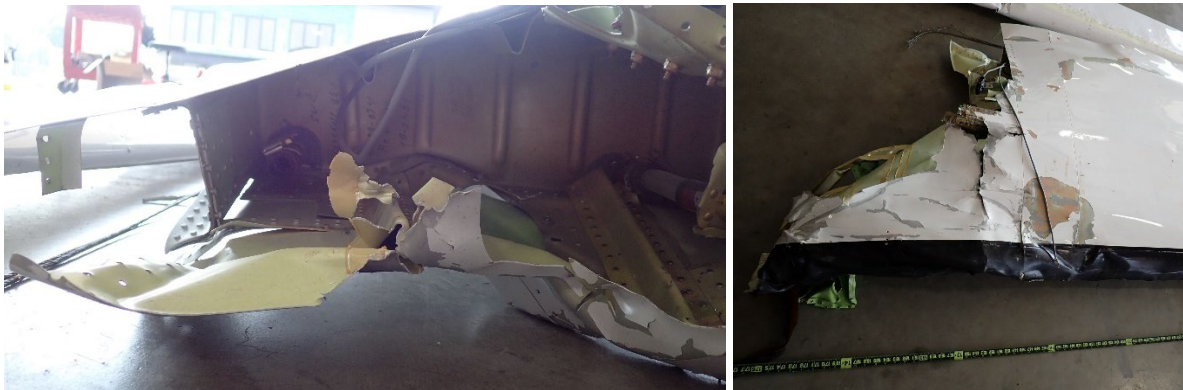
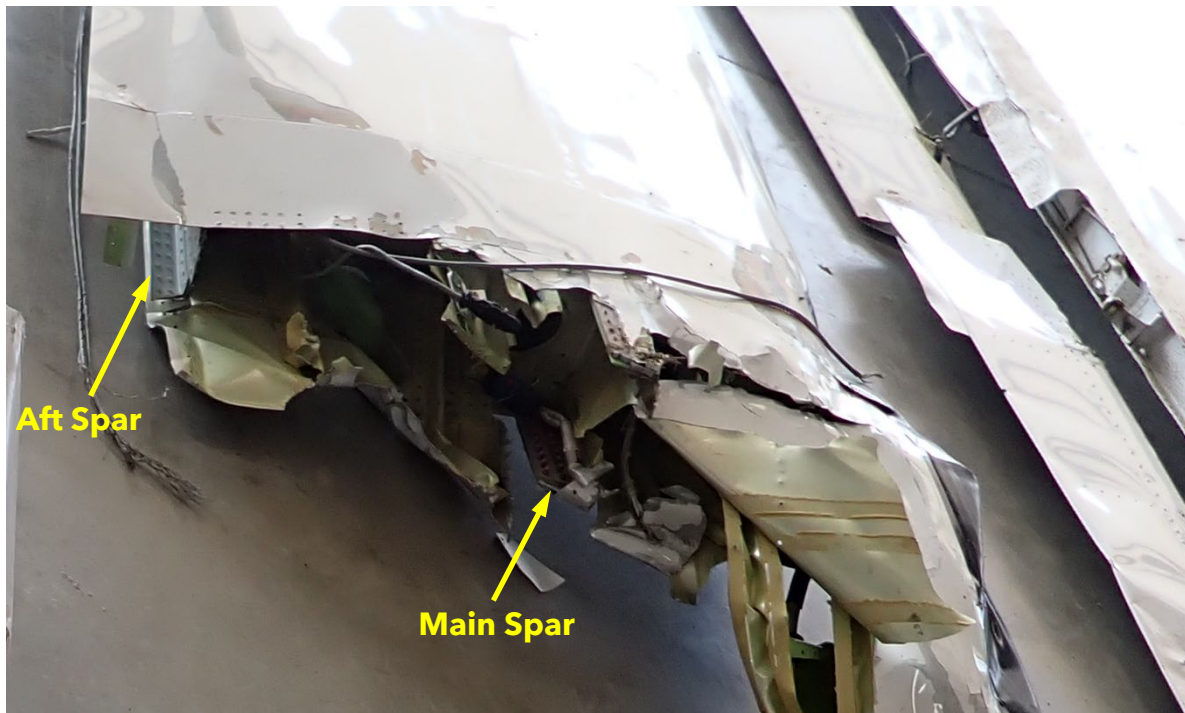
The leading edge and aft spar were deformed downward at the fracture location, and the main spar did not have any obvious deformation (figures 16 and 17).

**Figure 16.** Left wing outboard section aft spar (left) and leading edge (right) (NTSB photos)

**Figure 17.** Left wing outboard section fractured aft spar and main spar (NTSB photo)

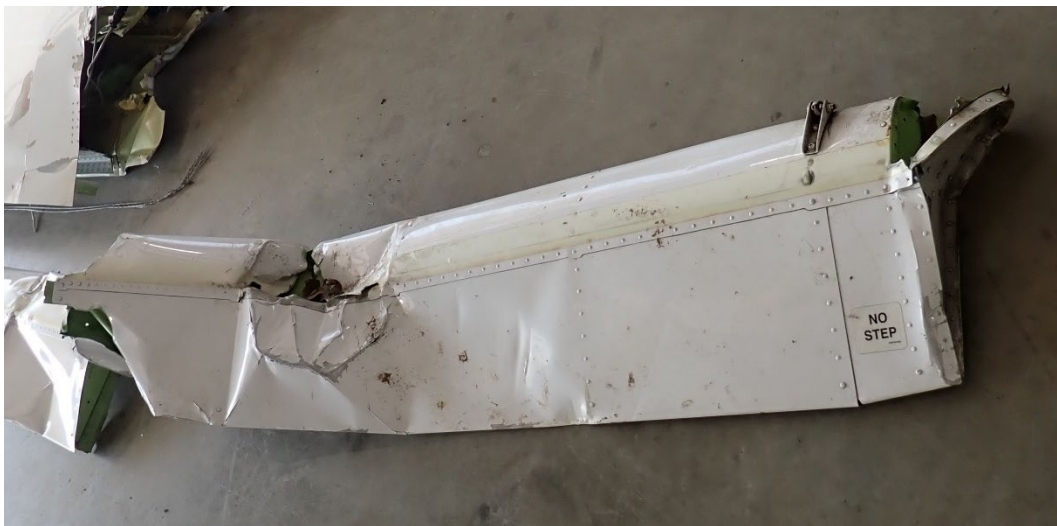
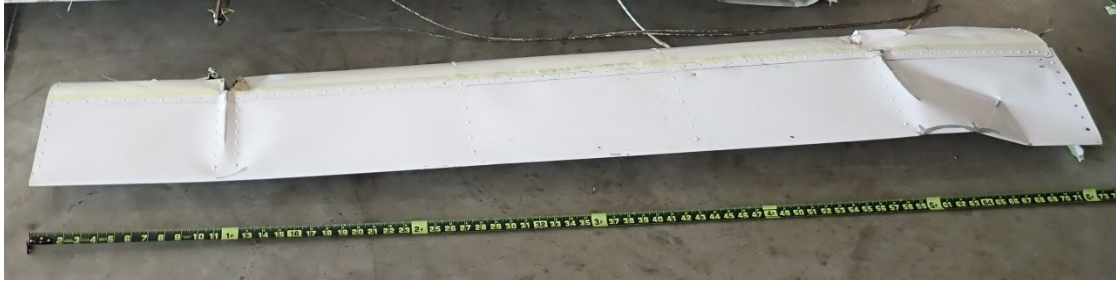
The left flap separated from the airplane and was recovered (figures 18 and 19). The flap was complete but separated in half, at about 77 inches from the outboard end. Both halves buckled and fractured at the flap track attach points.

**Figure 18.** Left flap inboard section (NTSB photo)

**Figure 19.** Left flap outboard section (NTSB photo)

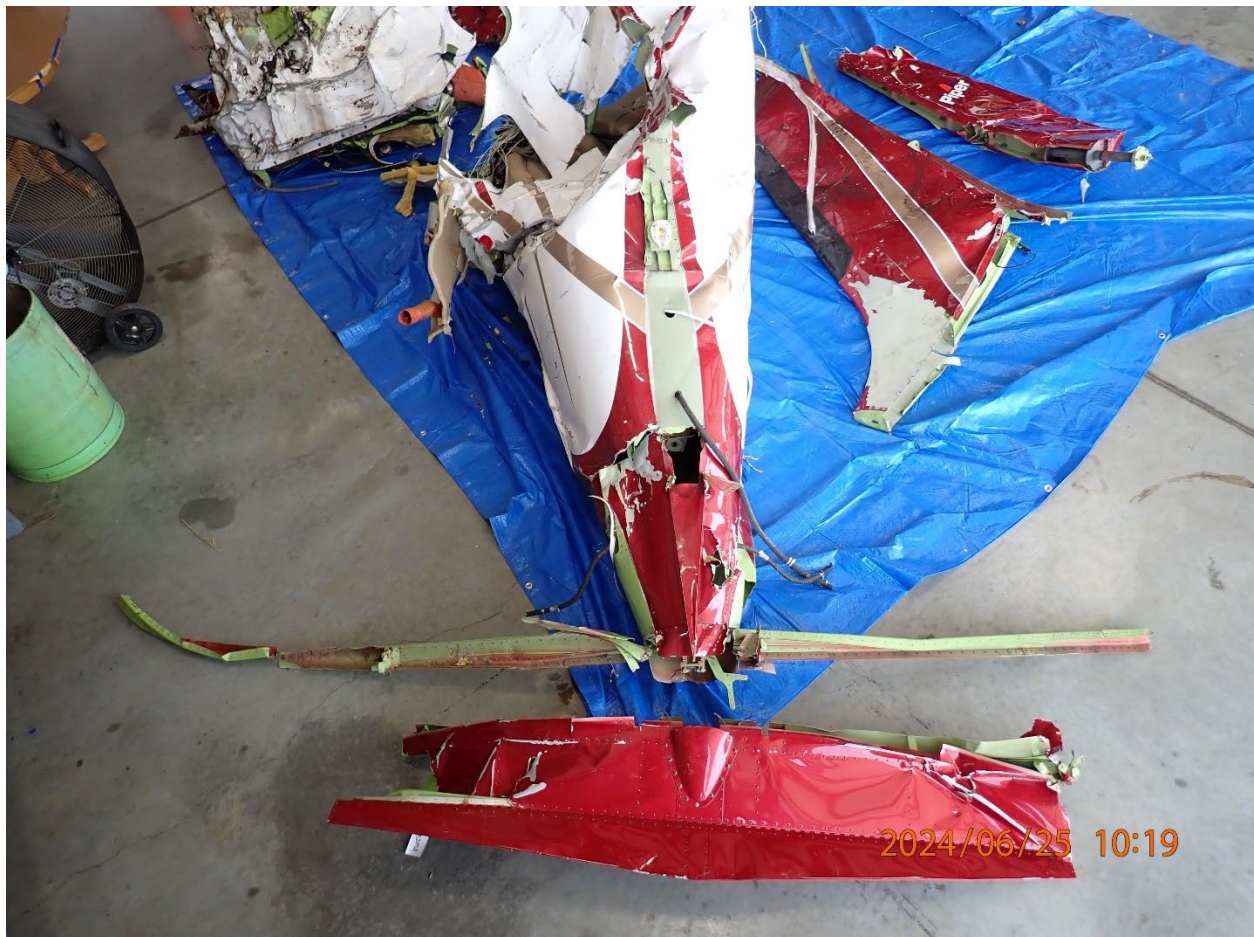
Most of the empennage components separated from the airplane during the event (figure 20). The vertical stabilizer, rudder and a section of the elevator were recovered. Three sections of the horizontal stabilizer aft spar and the aft spar of the vertical stabilizer were also separated and recovered.

**Figure 20.** Empennage wreckage (NTSB photo)

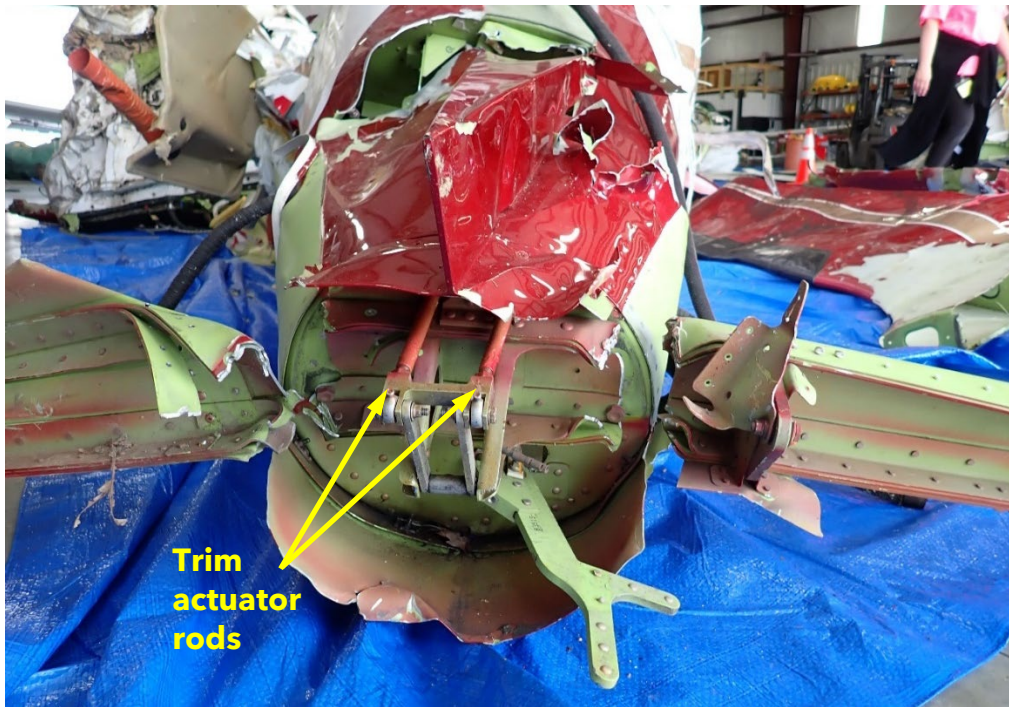
A 9 inch section of the horizontal stabilizer aft spar remained attached to the fuselage (figures 21). The elevator trim actuator rods fractured from the fuselage at the thread of both rod ends.

**Figure 21.** Horizontal stabilizer aft spar fractures (NTSB photo)

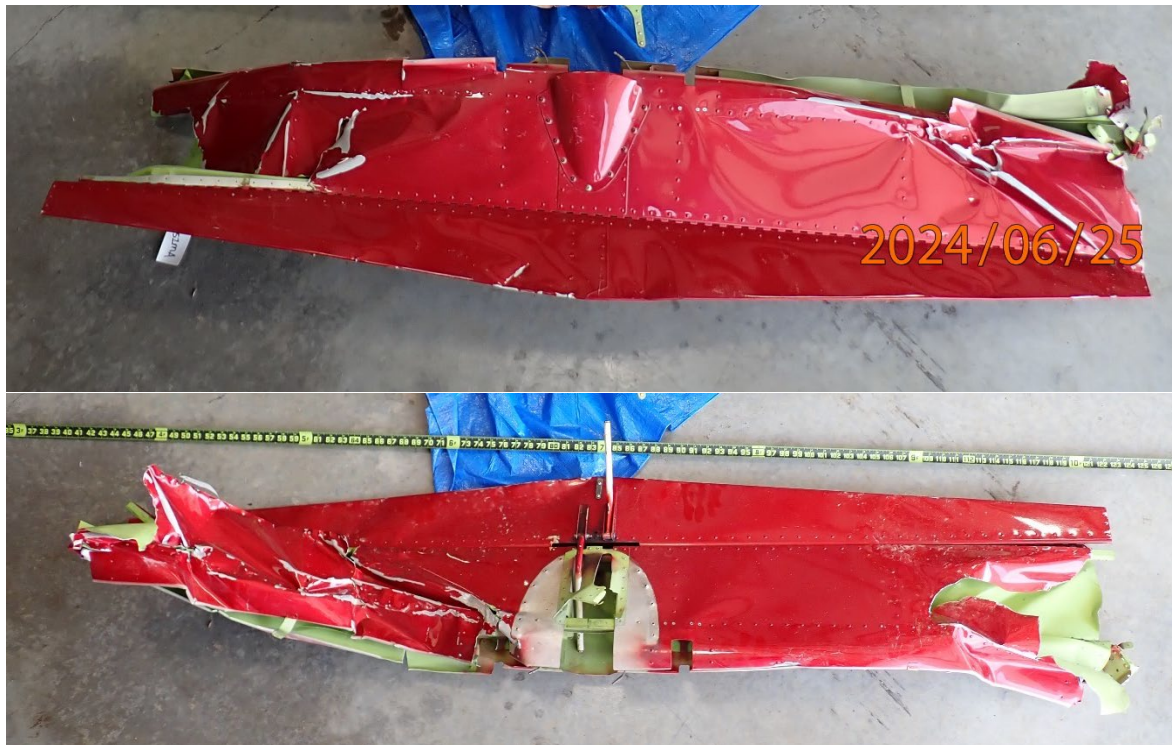
About 6 ft of the center of the elevator was recovered with the trim tab attached (figure 22). This section was deformed downward on the left side and upward on the right side. The elevator trim rods remained attached to the trim tab and were fractured at the forward rod ends.

**Figure 22.** Elevator top side (above) bottom side (below) (NTSB photo)

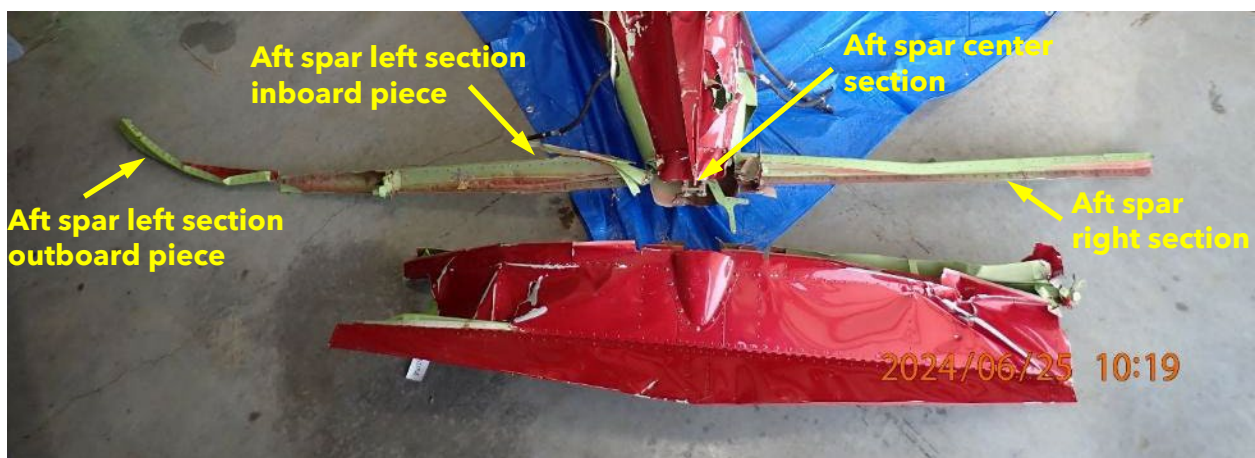
The left and right sides of the horizontal stabilizer separated at the root areas and most of the structure was not recovered (figure 23). Three separate sections of the horizontal stabilizer aft spar were recovered. The damage and deformation of the center section of the aft spar and the adjacent left and right sections was consistent with separation in a downward direction. The right section of the aft spar was approximately 3.5 feet long and the outboard piece was not recovered. The left section of the aft spar was fractured in two pieces, the inboard piece approximately 4 feet long and the outboard piece approximately 2 feet long. The outboard end of the inboard piece and the outboard piece were twisted forward.

**Figure 23.** Horizontal stabilizer with the elevator upside down (NTSB photo)

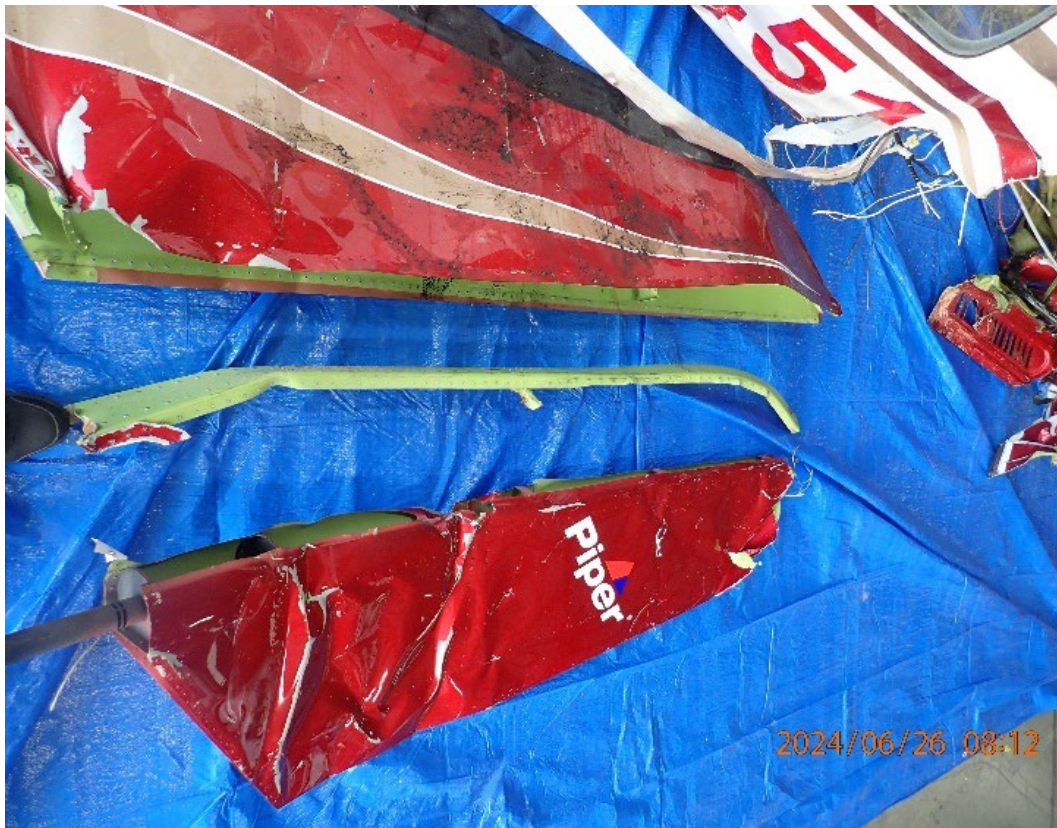
The vertical stabilizer separated from the airplane into three main sections, the vertical stabilizer, the aft spar, and the rudder (figure 24). The vertical stabilizer had bending deformation to the right and the trailing edge was splayed open where the aft spar separated. The forward attach bolt was intact in the vertical stabilizer, and the fuselage fitting was pulled through. The aft spar had an aftward deformation at the fracture point and additional aft bending along its length. The rudder was mostly intact with bending deformation to the right.

**Figure 24.** Vertical stabilizer, aft spar and rudder (NTSB photo)
