# National Transportation Safety Board

CEN24FA160

## **ON SCENE EXAMINATION SUMMARY**

Location: Hartsburg, Missouri  
Date: April 16, 2024  
Time: 1204 CDT  
1704 UTC  
Airplane: N451MA, Piper PA-46-350P

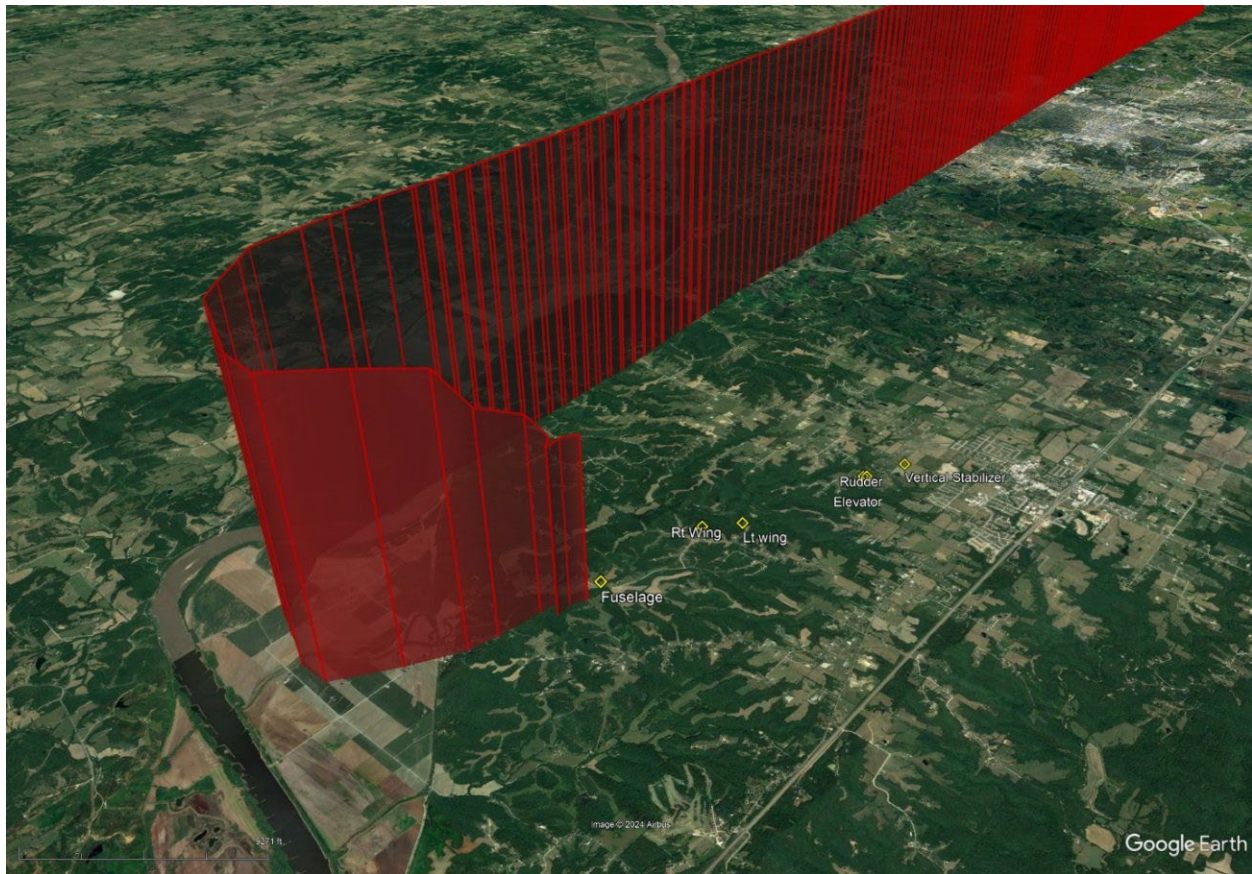
FIGURE 1. Plot of the final portion of the airplane's flight path.

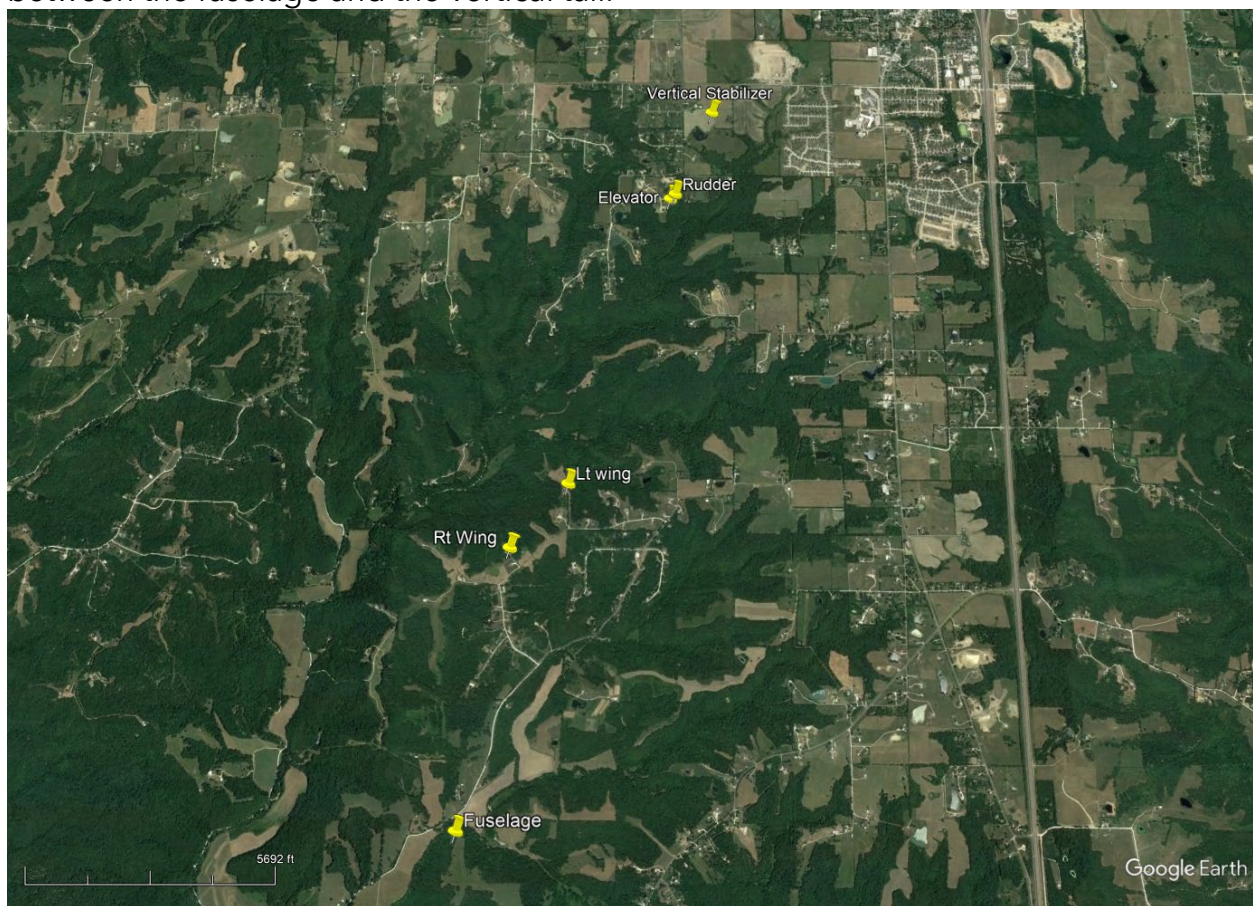
The fuselage came to rest on a wooded hillside next to a pasture. The tree canopy was mostly undisturbed and the few tree limb breaks suggested a near vertical impact with the ground.
