# National Transportation Safety Board

CEN24FA164

## **ON-SCENE EXAMINATION SUMMARY**

Location: Spicewood, Texas  
Date: April 22, 2024  
Time: 1825 central daylight time (CDT)  
2325 coordinated universal time (UTC)  
Airplane: N550NL, Lancair Legacy FG

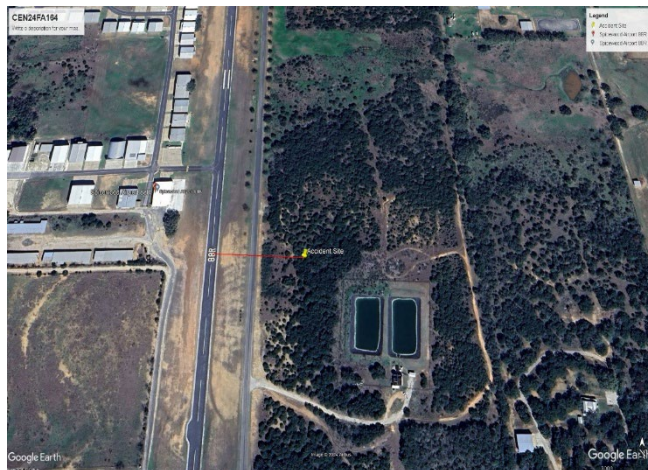
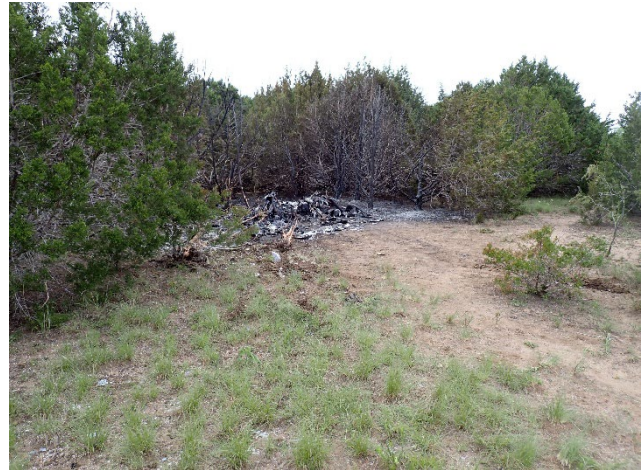
### **1.0 Accident Site**

The accident site was located about 350 ft east of runway at Spicewood Airport (88R), Spicewood, Texas. The airplane was located about 185 ft into a densely wooded area. There were numerous trees surrounding the main wreckage that were damaged from the postimpact fire that ensued.

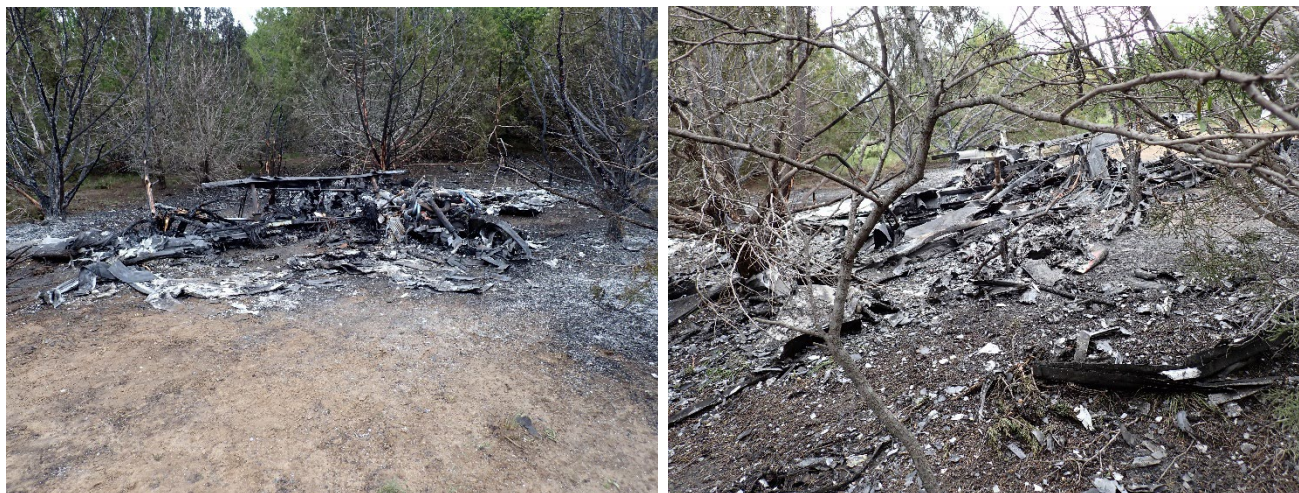
### 3.0 Airframe Examination

Ground scars and wingtip fragments were consistent with the airplane impacting terrain inverted in about a 050° nose down attitude on an approximate 125° magnetic heading. The airplane came to rest in an upright position on about a 210° magnetic heading about 20 ft from its initial point of impact. The airplane was mostly consumed by the postimpact fire that ensued.

The left and right ailerons were partially separated from the wings and exhibited thermal damage. The ailerons push-pull control tubes were thermally separated in various areas and their attachment hardware remained intact. The left and right flaps were destroyed. The flap actuator exposed about 5-1/4 inches of actuator, indicative of a full (40°) flap setting. The horizontal stabilizer, elevator, and vertical stabilizer were destroyed by fire. The elevator's push-pull control tube remained attached to its attach points and was thermally separated about mid-span. The elevator trim system was destroyed. The rudder exhibited thermal damage and was partially separated from its mounts via impact and thermal separations. The right rudder control cable was intact and remained attached to its rudder pedal assembly attach point and thermally separated from its empennage attach point. The left rudder cable was intact, and impact separated from its rudder pedal assembly and empennage attach points. Both pilot and copilot control sticks remained attached to their respective attach points. The supporting structure of the rudder pedal assembly and flight control sticks were thermally destroyed. All primary flight control continuity was established except where impact and thermal separations exist.

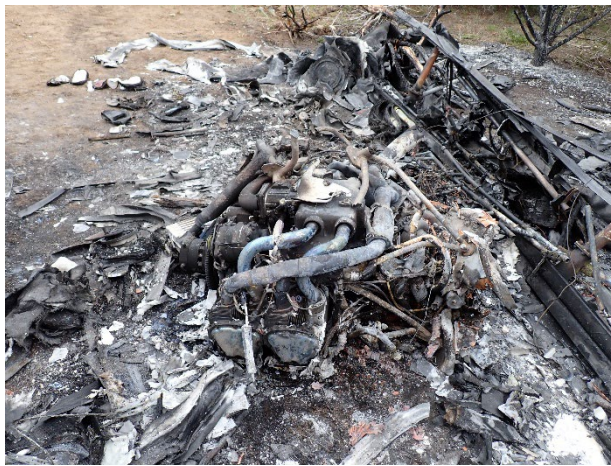
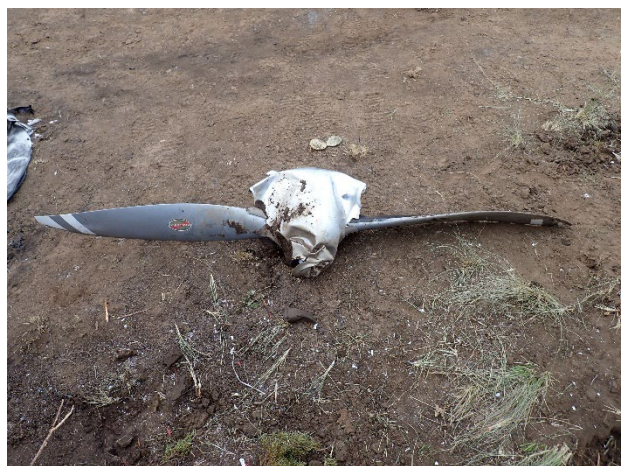
#### **4.0 Engine/Propeller Examination**

The engine was inverted and remained attached to the engine mount. The engine and engine mount exhibited impact and thermal damages. The aft portion of the propeller hub remained attached to the crankshaft flange. Removal of the four upper sparkplugs revealed their electrodes were intact and exhibited normal wear and coloration when compared to the Champion Check-A-Plug card. No anomalies were noted to the interior of the cylinders during visual examination via illuminated borescope. Compression and suction were obtained from all four cylinders during hand rotation of the crankshaft flange. Crankshaft and camshaft continuity to the rear gears were established with no anomalies noted. Residual oil was observed within the engine, and the oil pump suction screen was clear of debris.

The Hartzell aluminum two-bladed variable pitch propeller was impact separated from the engine at its two-piece hub and embedded in the soil at the airplane's initial point of impact, about 20ft from the main wreckage. The propeller blades were labeled "A & B" for descriptive purposes only. Blade "A" exhibited leading-edge damage, chord-wise abrasions, and longitudinal twisting. Blade "B" exhibited leading-edge damage, chord-wise abrasions, and forward deformation about 12 inches from the blade's tip. The propeller spinner remained attached to the propeller and exhibited aft and torsional deformation.

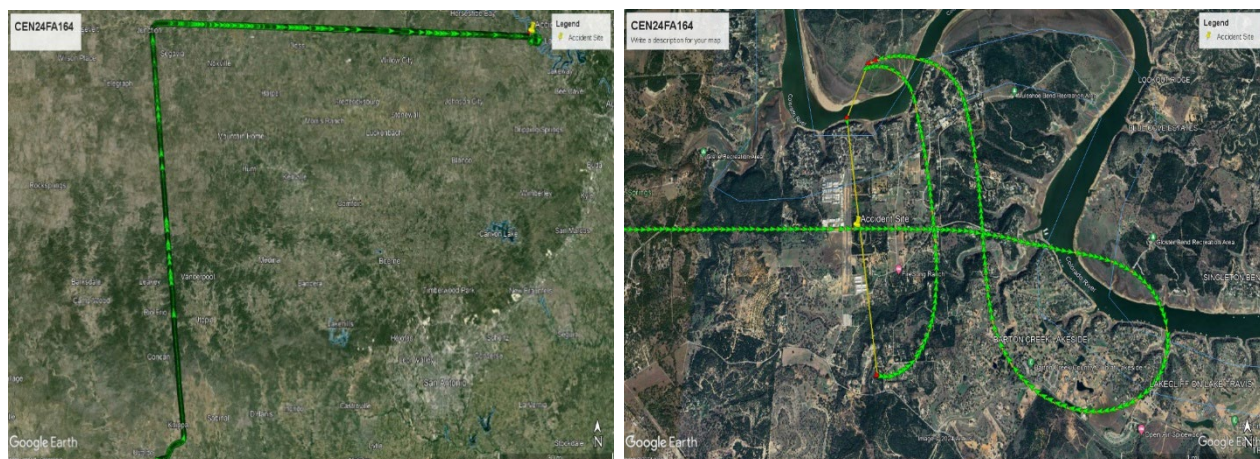
## 5.0 ADS-B Data

ADS-B data from the FAA revealed that the accident flight was the second flight of the day. The accident flight originated from Garner Field Airport (UVA), Uvalde, Texas. The airplane departed from UVA about 1721 CDT and entered the traffic pattern for the Spicewood Airport (88R), Spicewood, Texas about 1820 CDT. The last data point was at 18:25:03 and the airplane was about 550 ft above ground level on a left base for runway 17. The ADS-B data did not capture the second landing attempt and subsequent go-around.
