CEN24FA164

## INVESTIGATION PHOTOGRAPHS

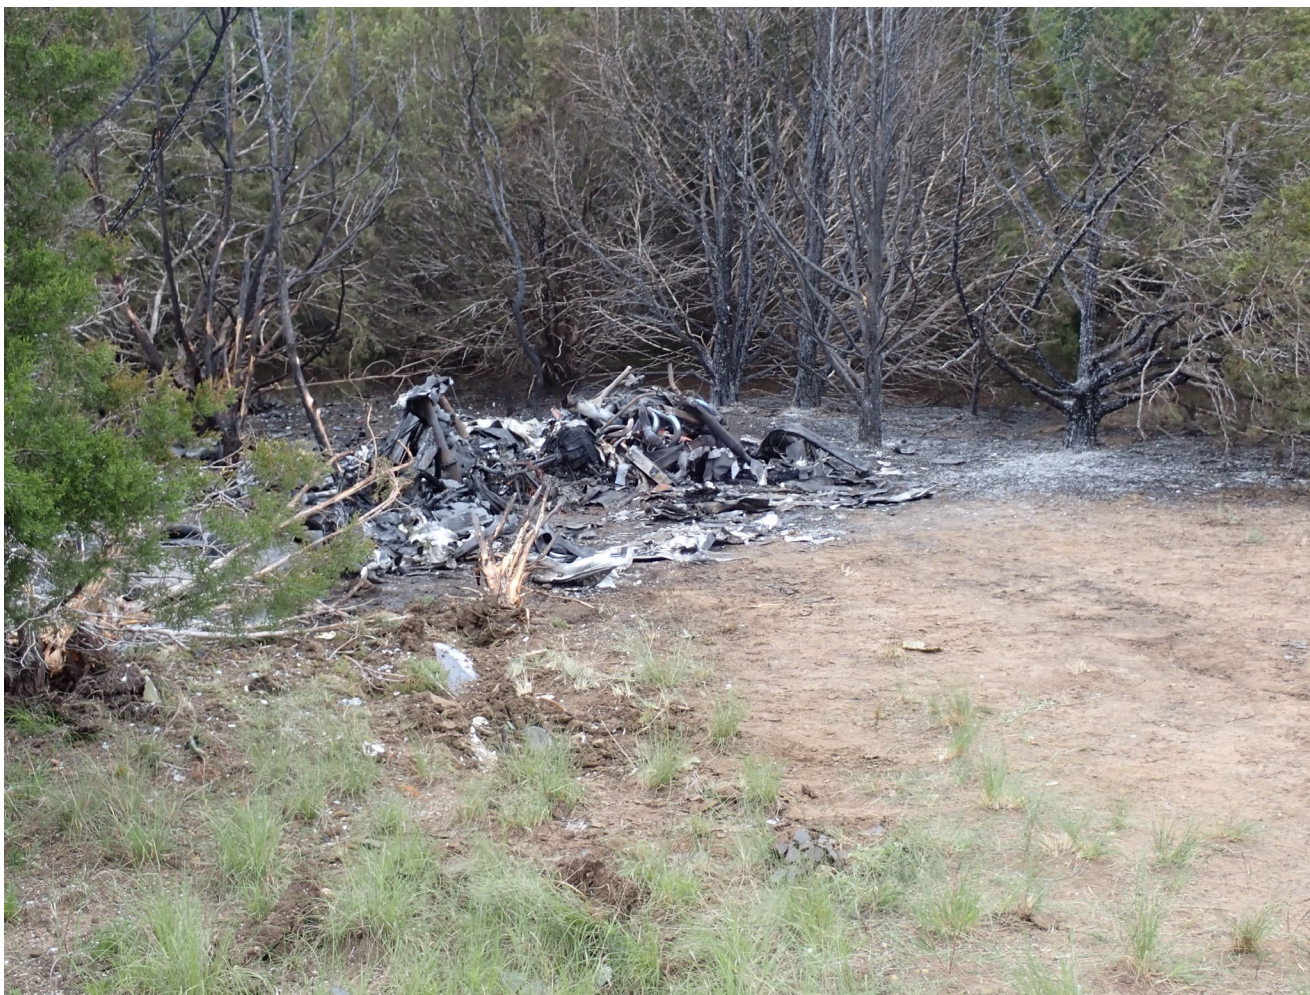
**Photograph 1 -Thermally destroyed main wreckage.**

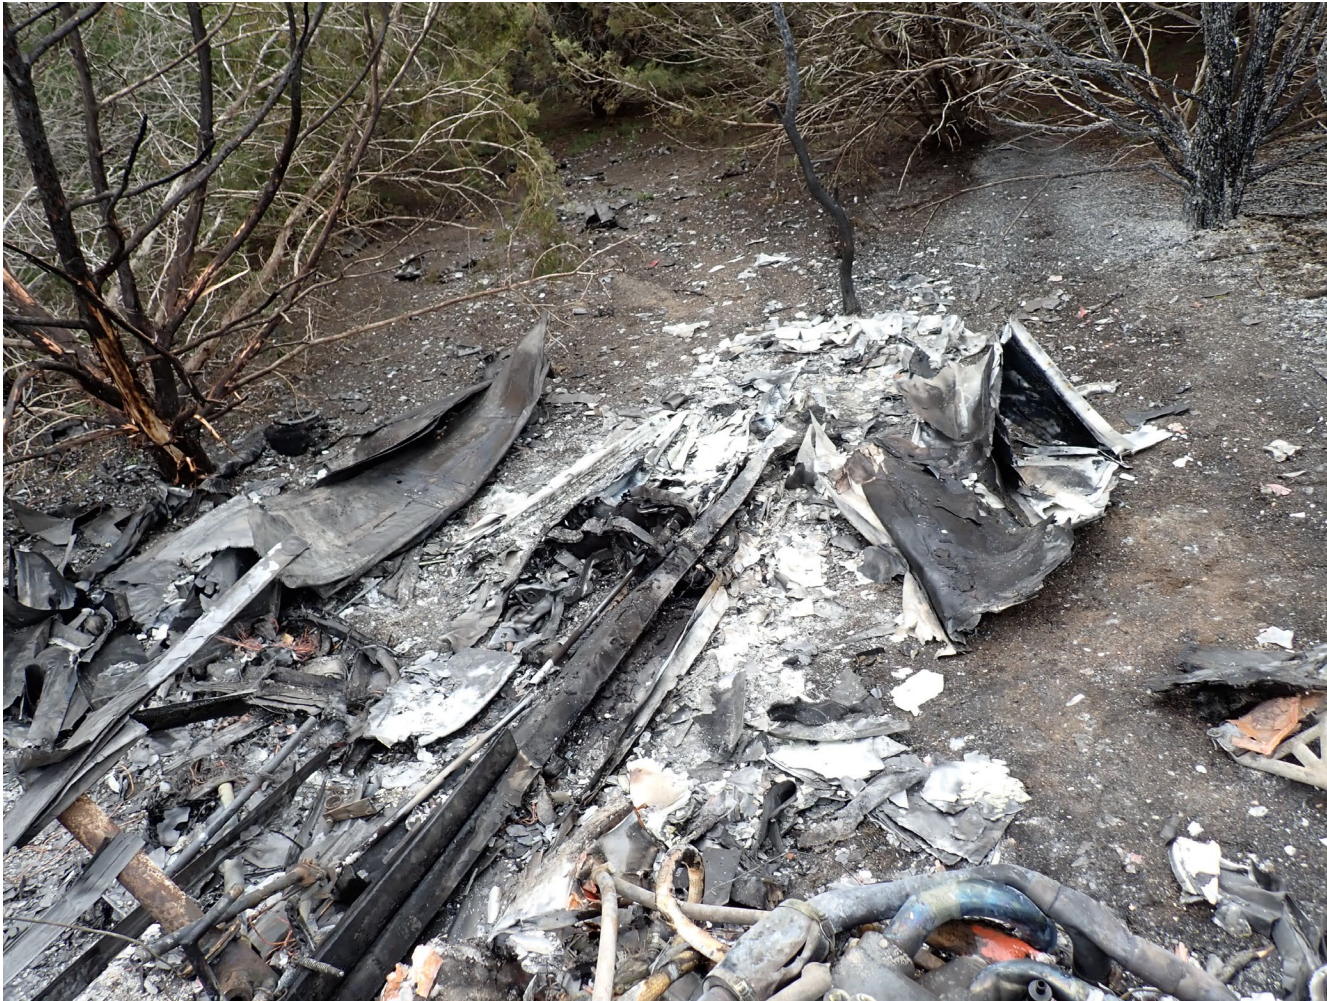
**Photograph 2 - Thermal damage noted to left wing.**

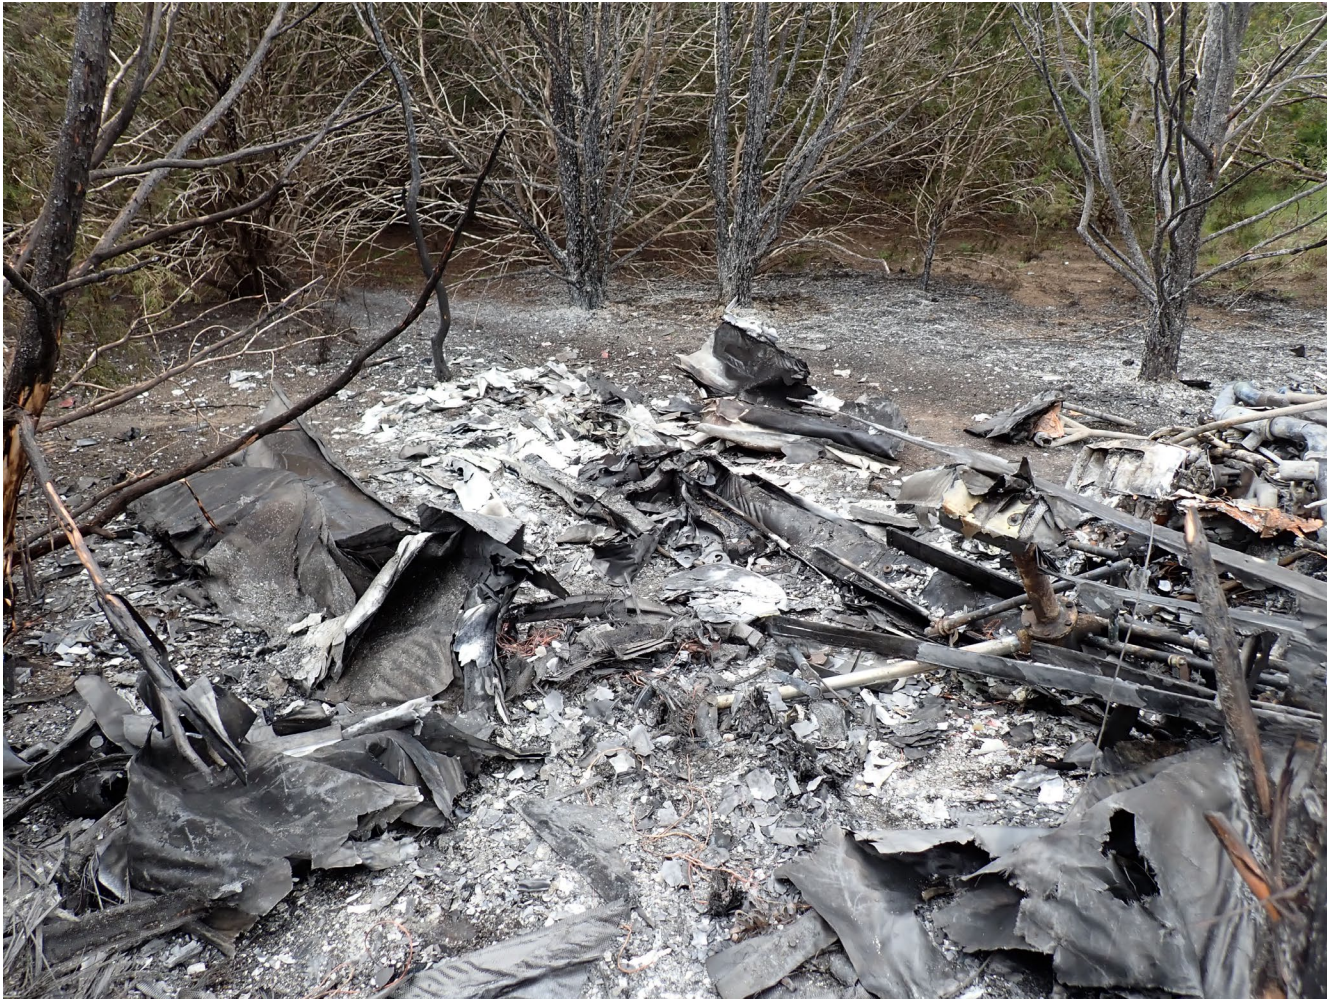
**Photograph 3 - Thermal damage noted to right wing.**

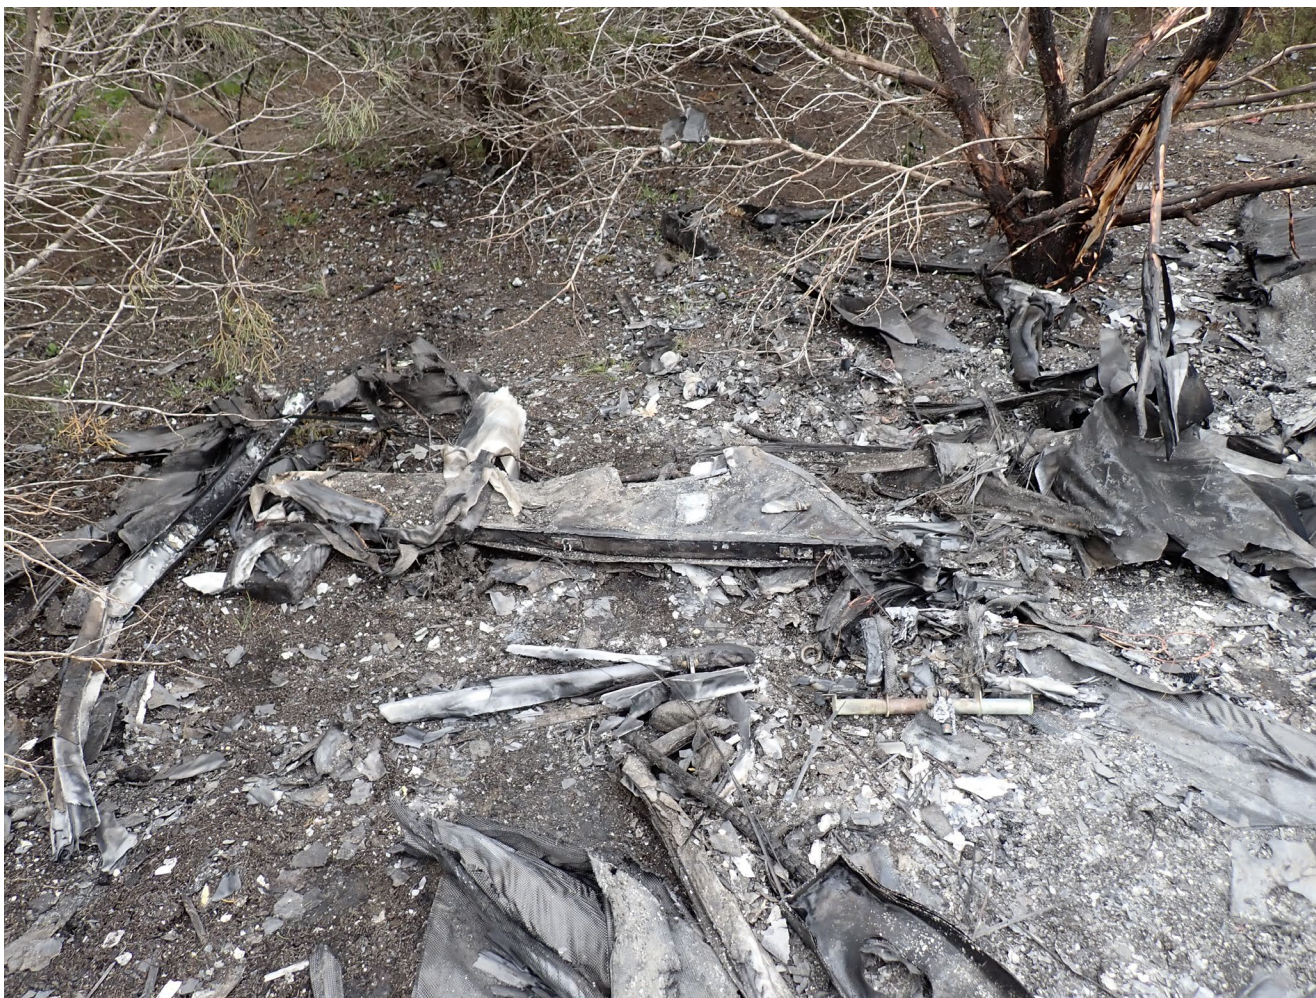
**Photograph 4 - Thermal damage noted to empennage.**

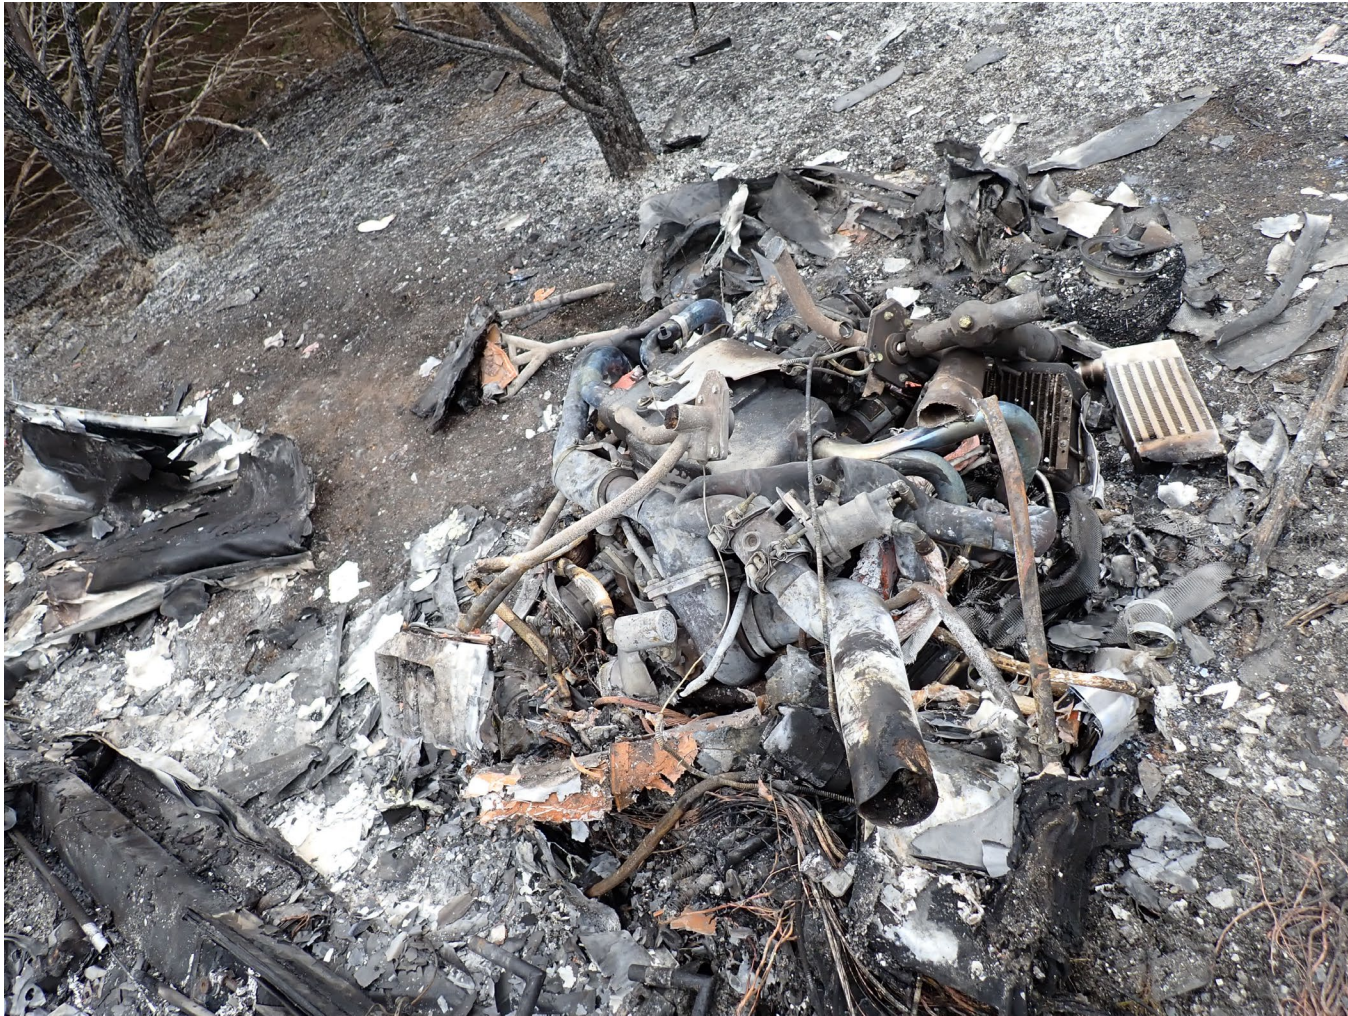
**Photograph 5 - Thermal damage noted to engine.**
