# National Transportation Safety Board

CEN24FA167

## **N829SH - AIRFRAME AND ENGINE EXAMINATION REPORT**

Location: Spring Branch, Texas  
Date: April 29, 2024  
Time: 1513 Central Time  
Helicopter: N829SH, Vertical Aviation Technologies. Hummingbird 260L

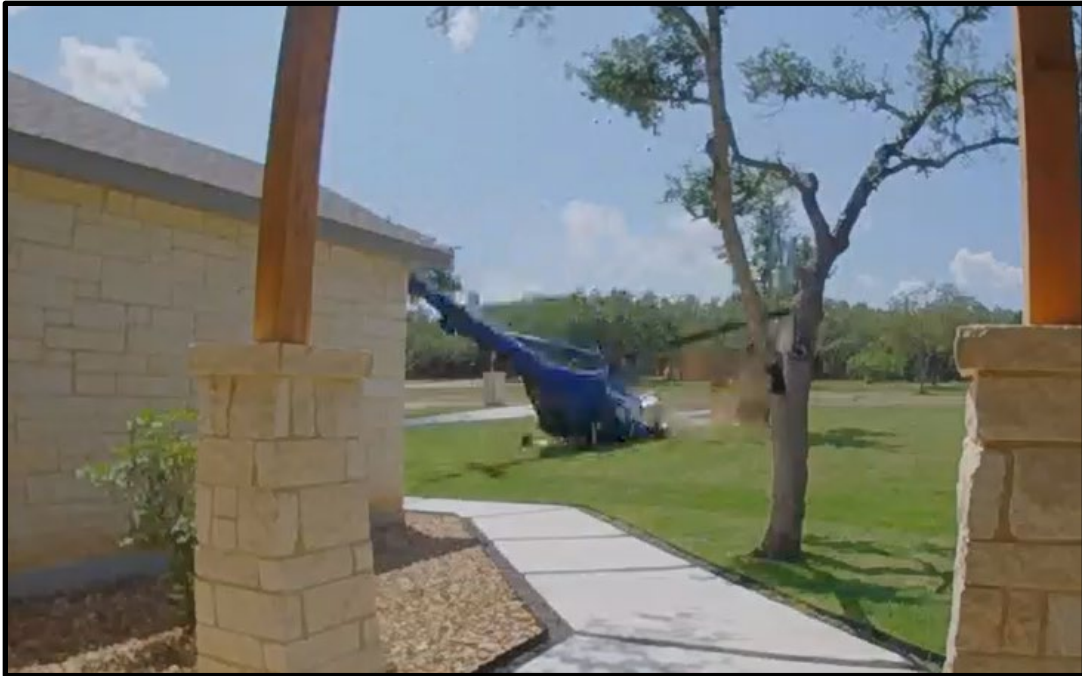
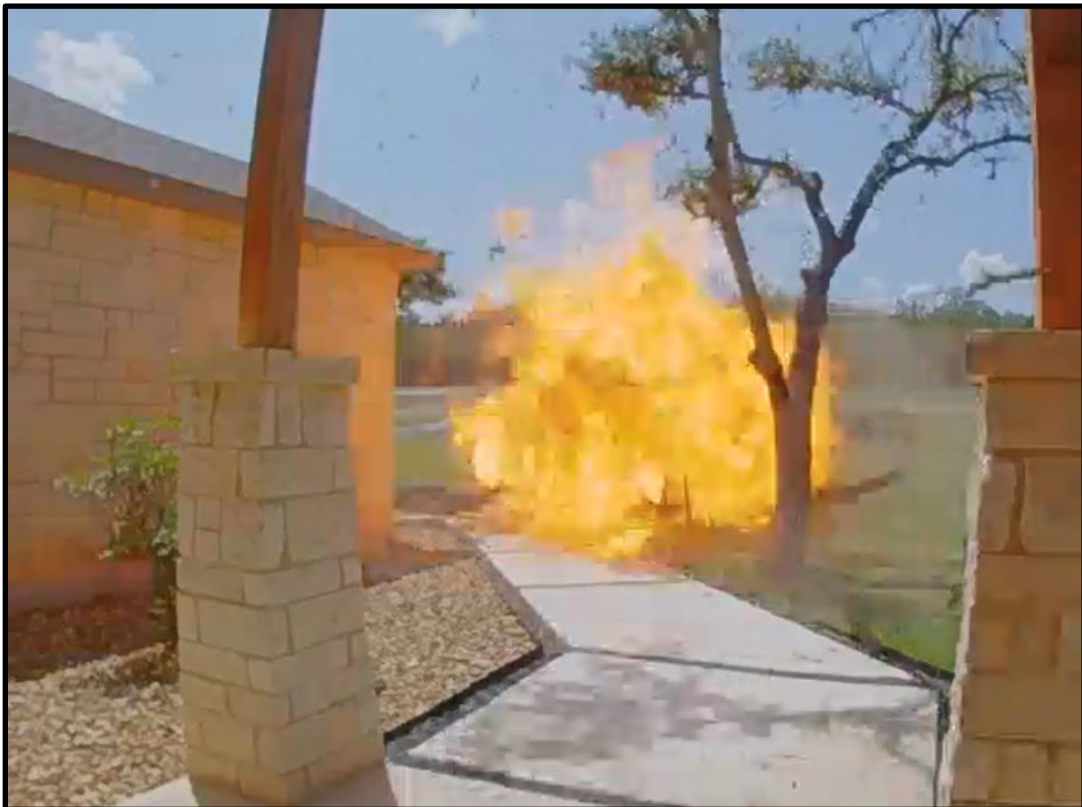
Multiple witnesses observed or heard the helicopter and contacted the NTSB. The owner of the home, for where the helicopter came to rest, provided the investigative team with security camera footage. The investigative team reviewed the camera footage. The video showed the helicopter impact terrain in front of the home, and a postimpact explosion, and a fire occurred. The wreckage was consumed by the fire. The video showed the helicopter was structurally intact prior to impact with no evidence of an inflight fire. The helicopter was destroyed.

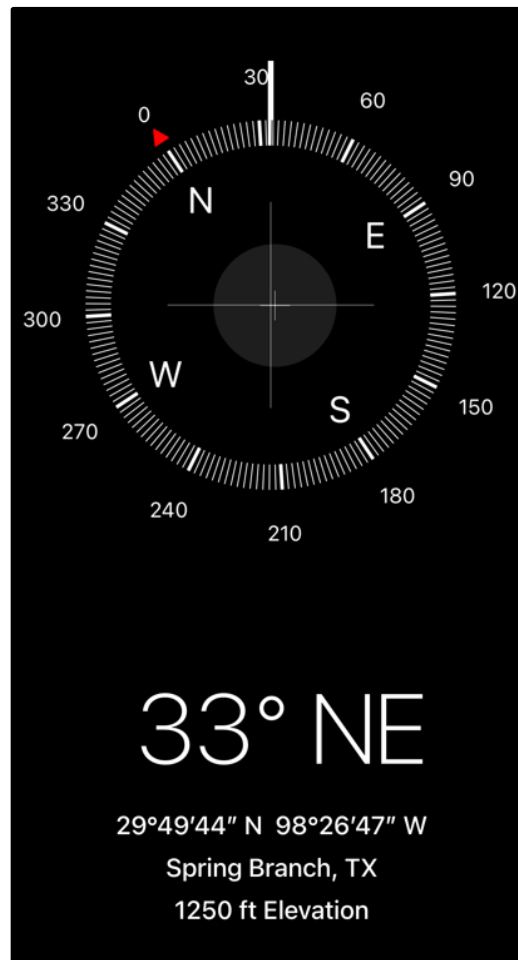
The wreckage came to rest, at one impact point, on a heading of about 33 degrees. The elevation of the accident site was about 1,250 ft above mean sea level.

Just prior to the impact point, and in relation to the flight path, three ground strikes from the main rotor blades were observed on the grass yard. Additionally, a tree strike with a main rotor blade was observed.
