CEN24FA170

## INVESTIGATION PHOTOGRAPHS

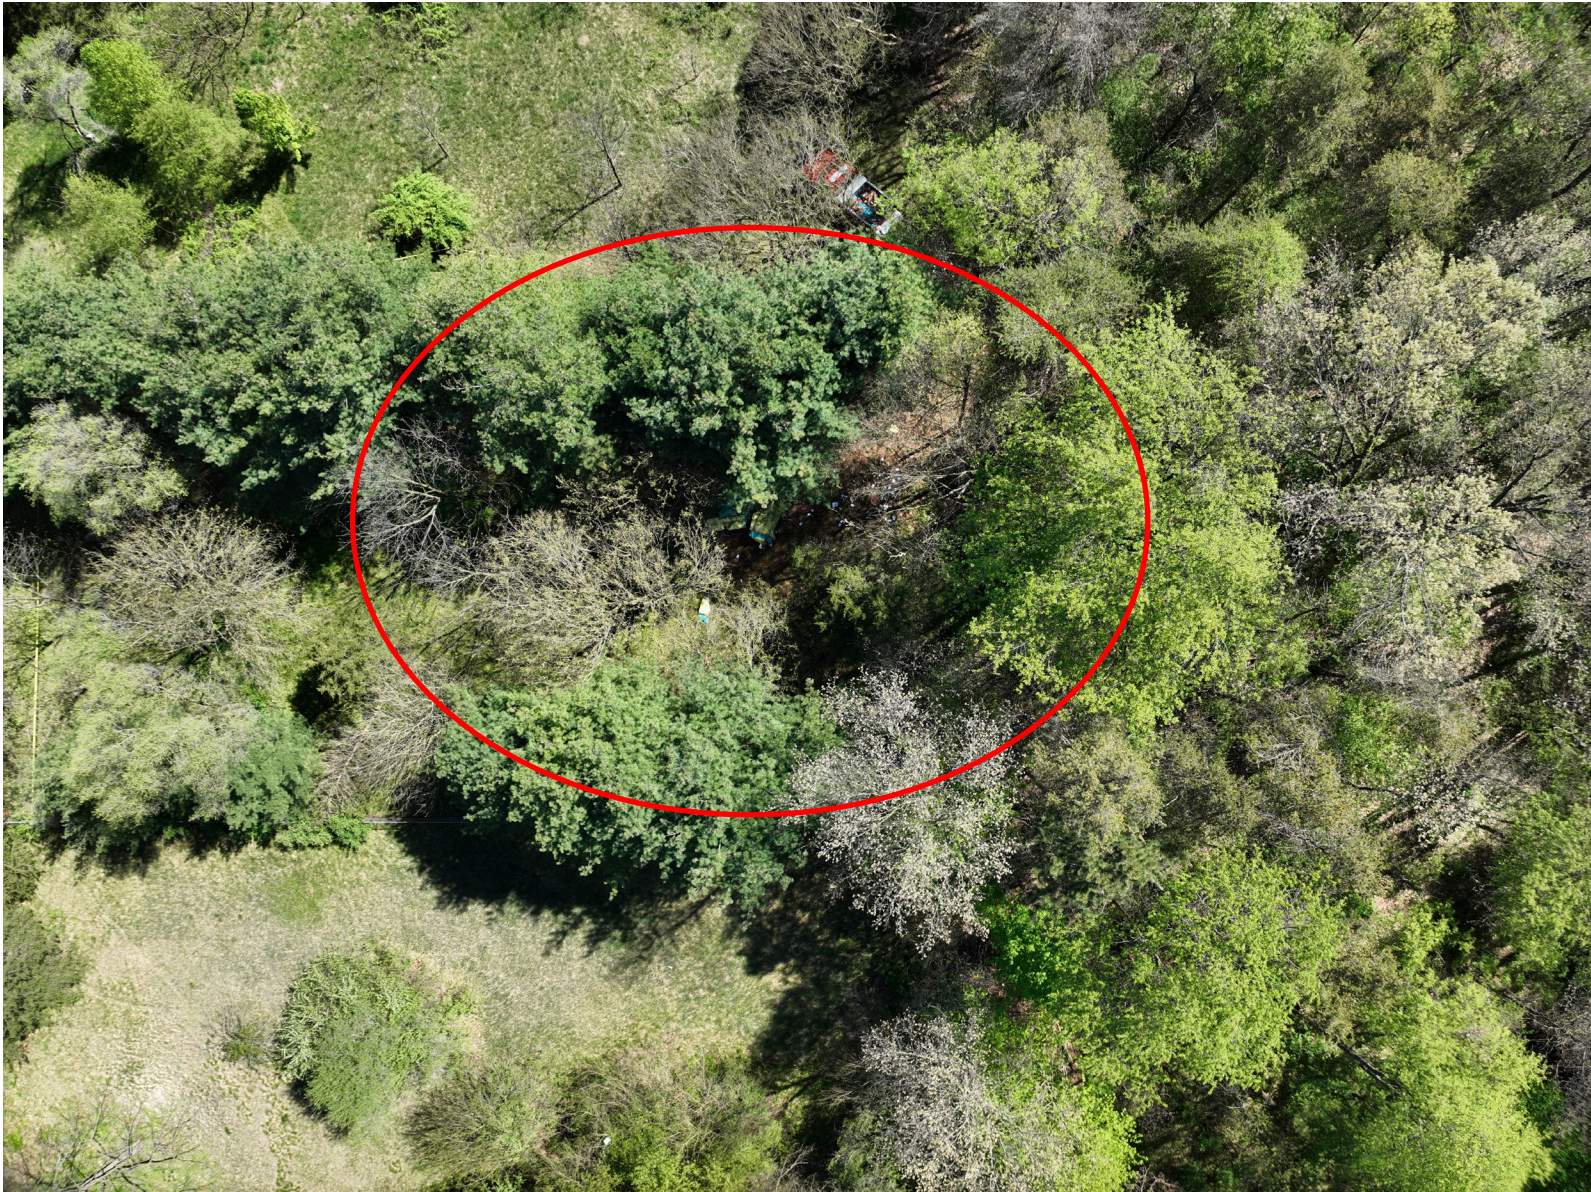
**Photograph 1 - Aerial view of accident site (Courtesy of law enforcement)**

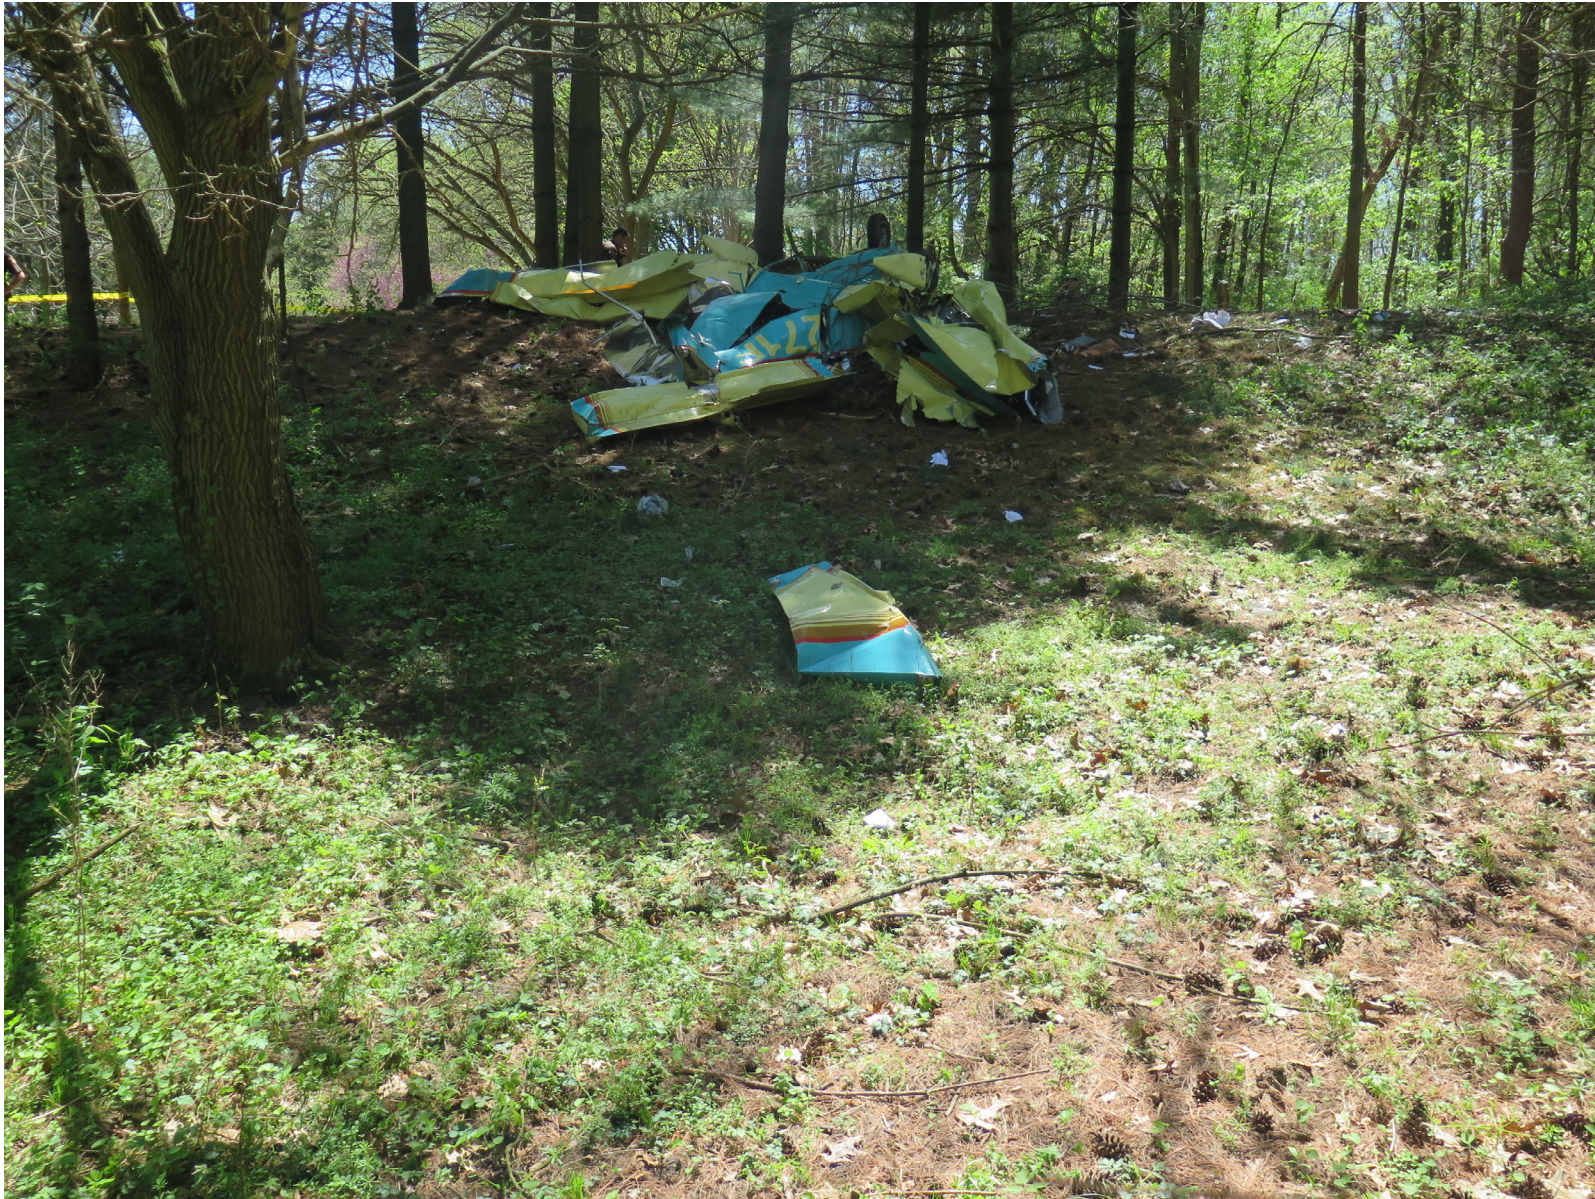
**Photograph 2 - Rear of accident site, wreckage undisturbed (Courtesy of law enforcement)**

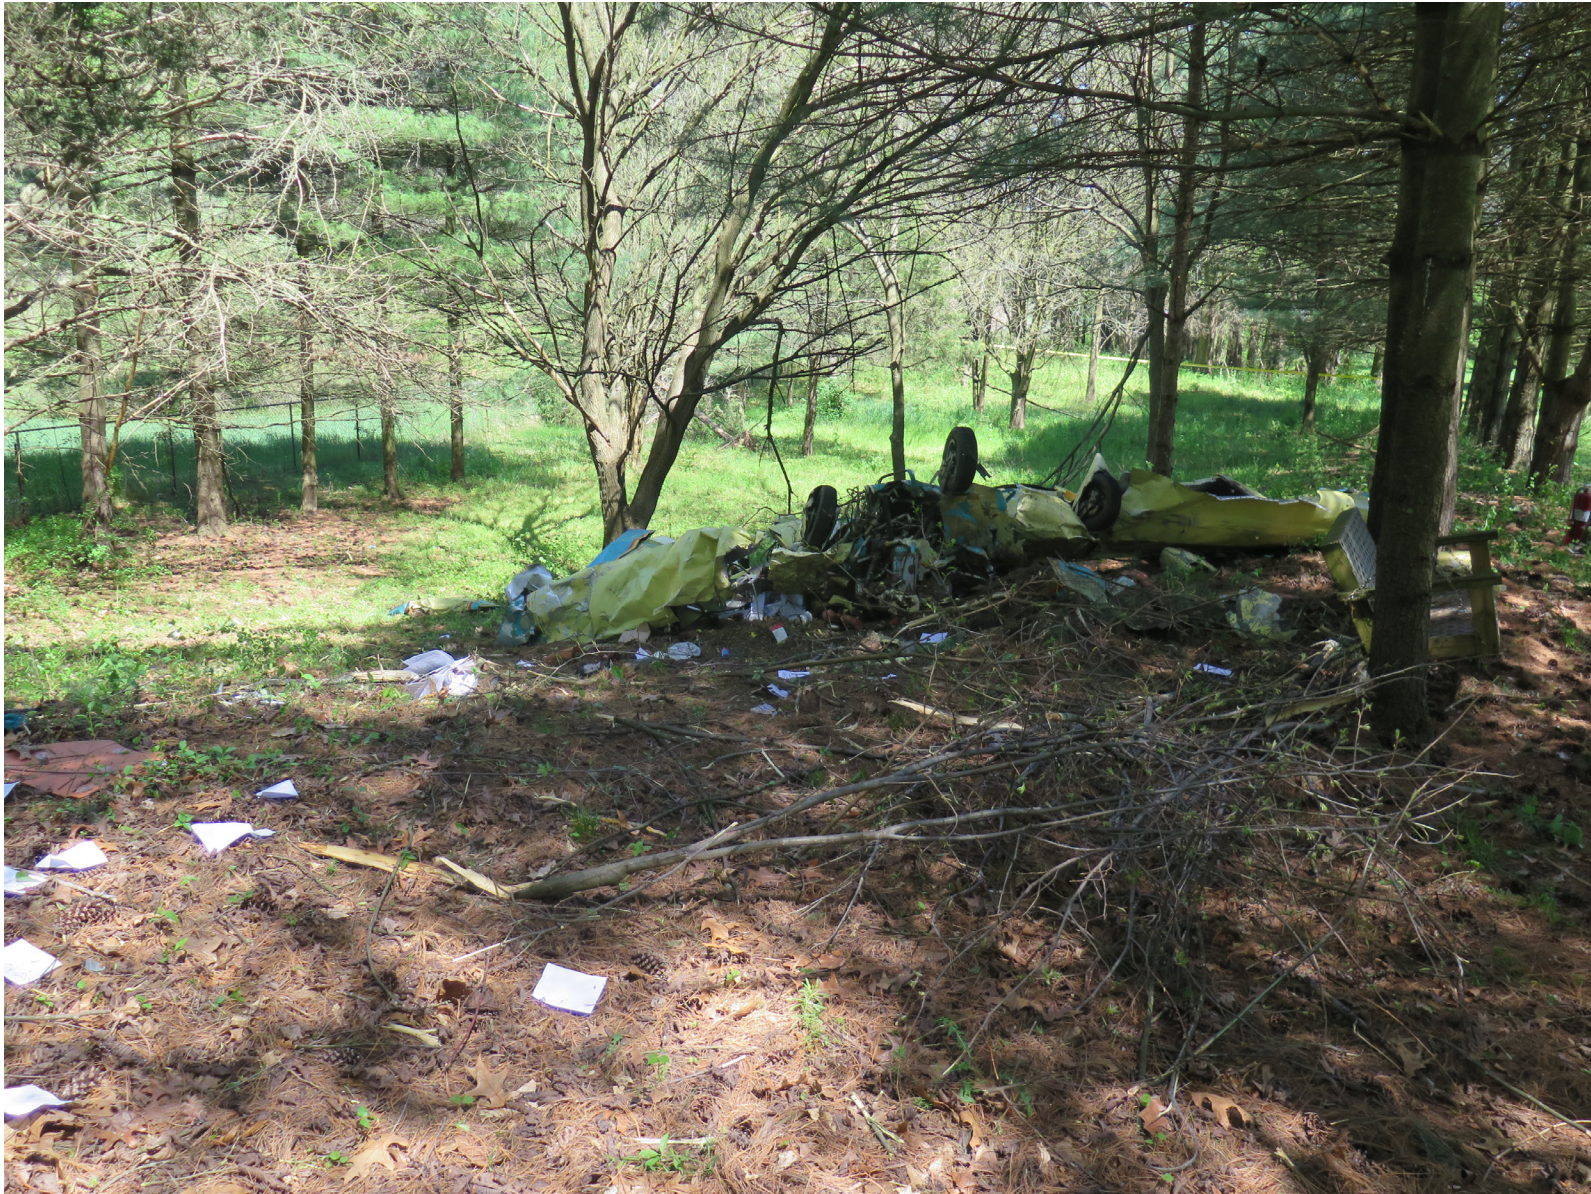
**Photograph 3 - Front of accident site, wreckage undisturbed (Courtesy of law enforcement)**

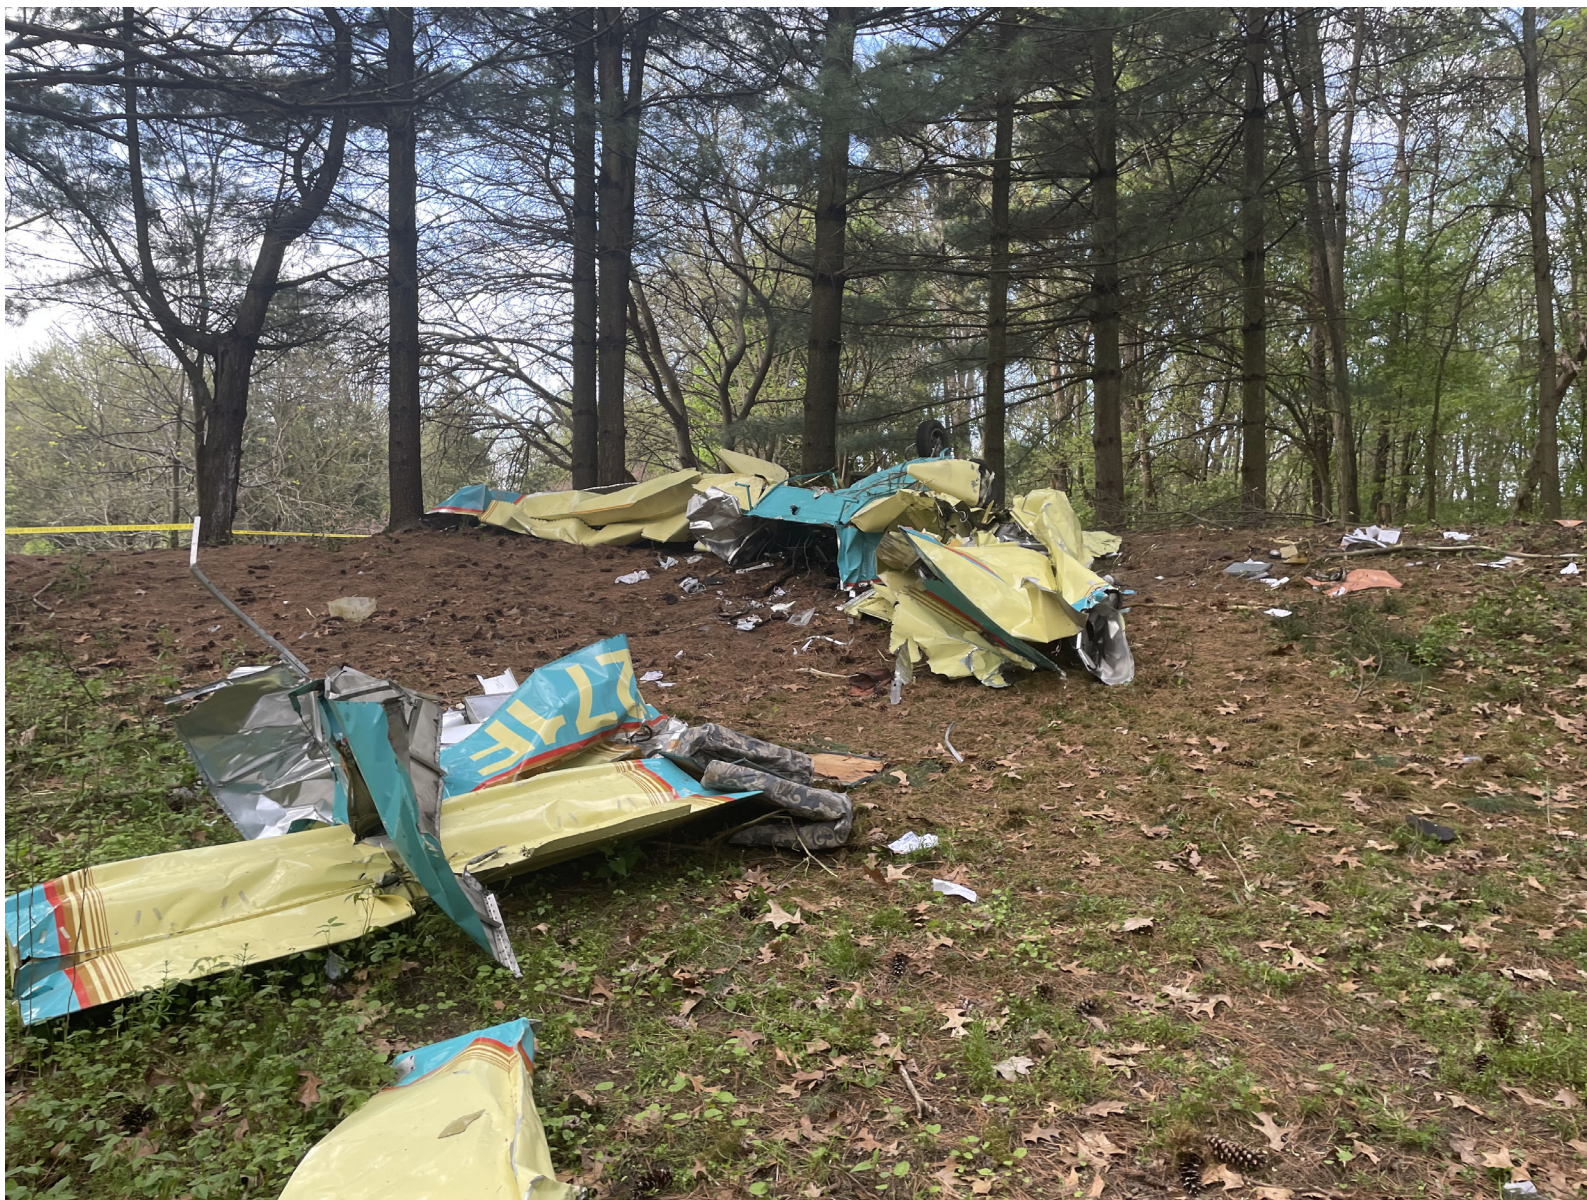
**Photograph 4 - Rear of accident site during NTSB examination (Courtesy of NTSB)**

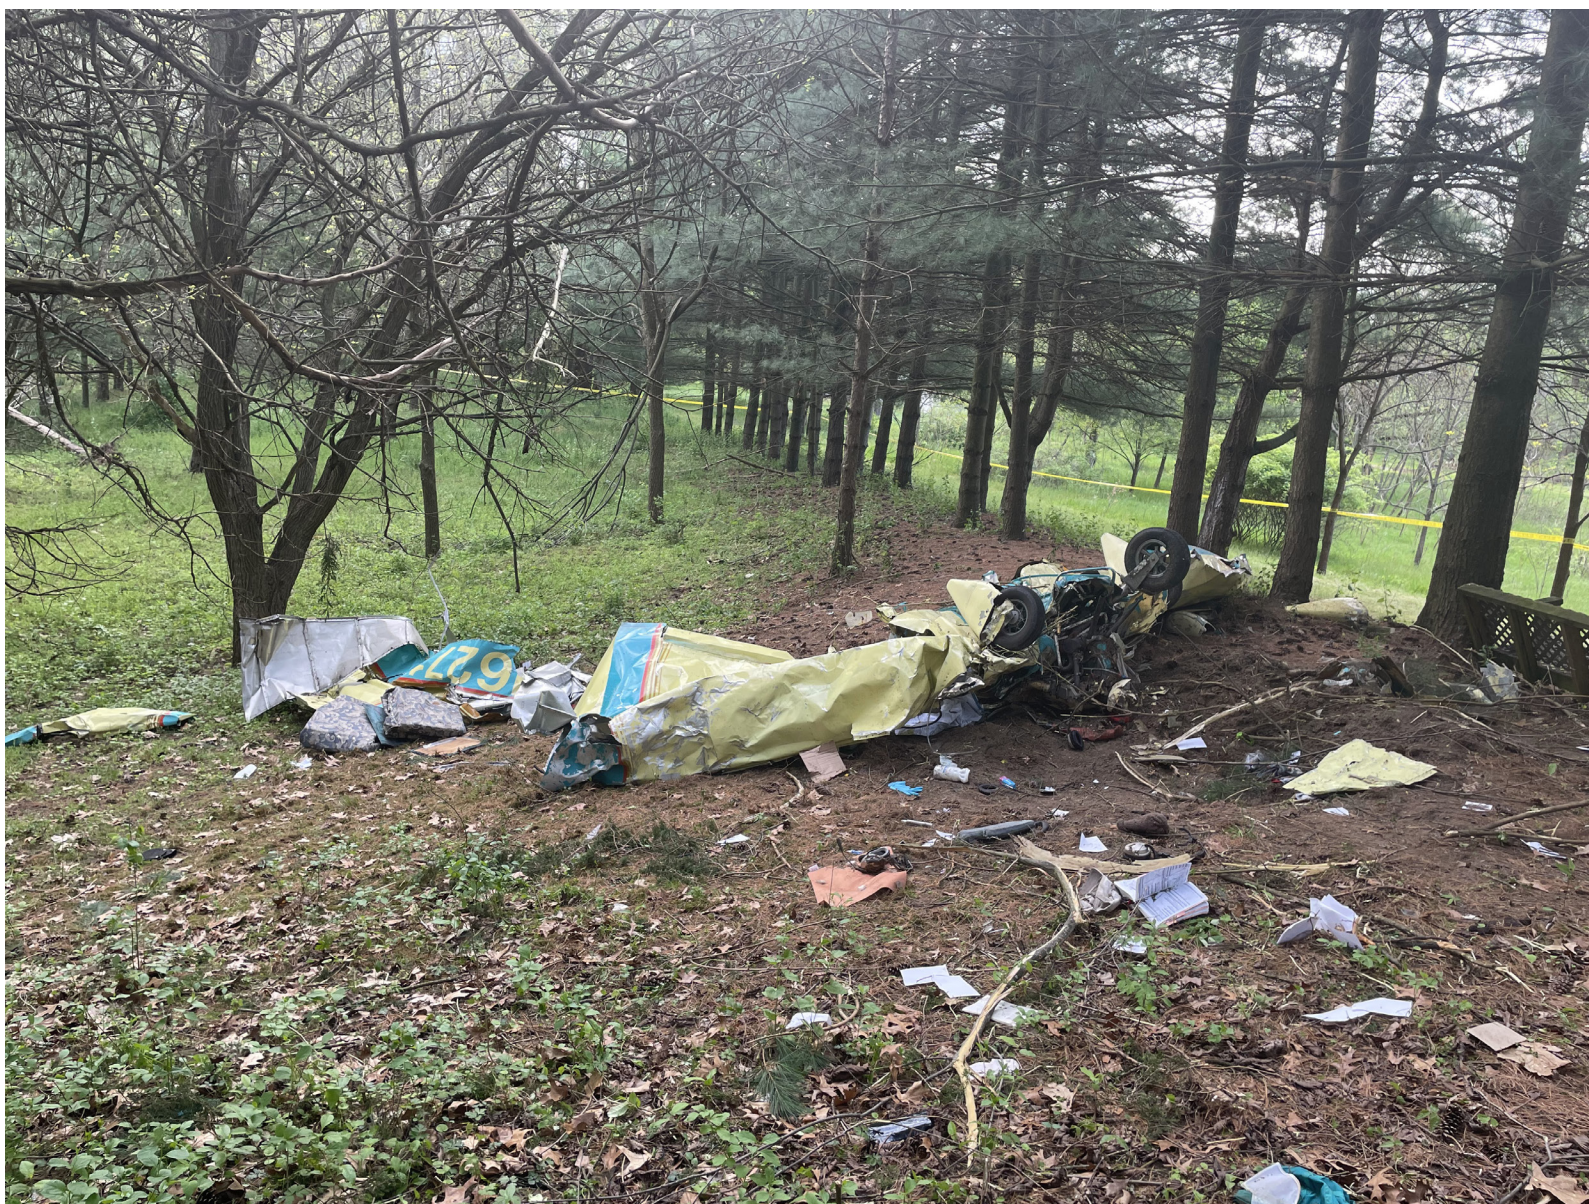
**Photograph 5 - Left side of accident site during NTSB examination (Courtesy of NTSB)**

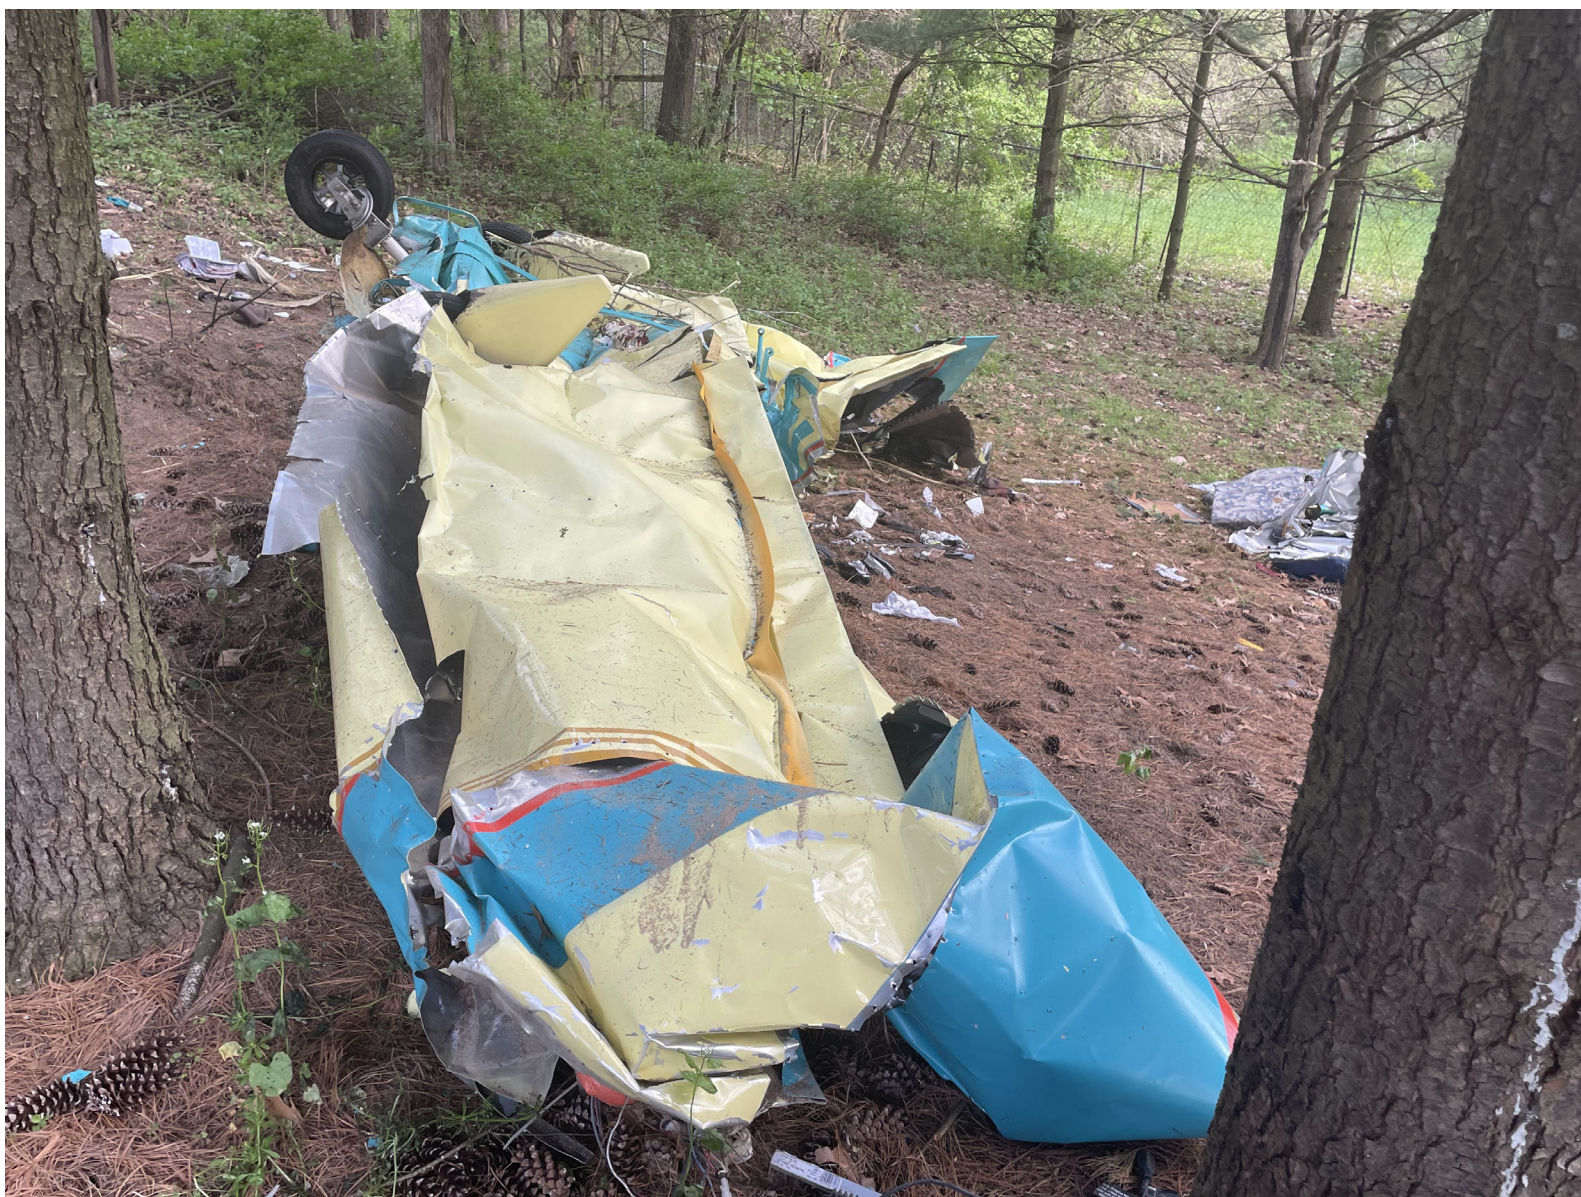
**Photograph 6 - Right wing during NTSB examination (Courtesy of NTSB)**

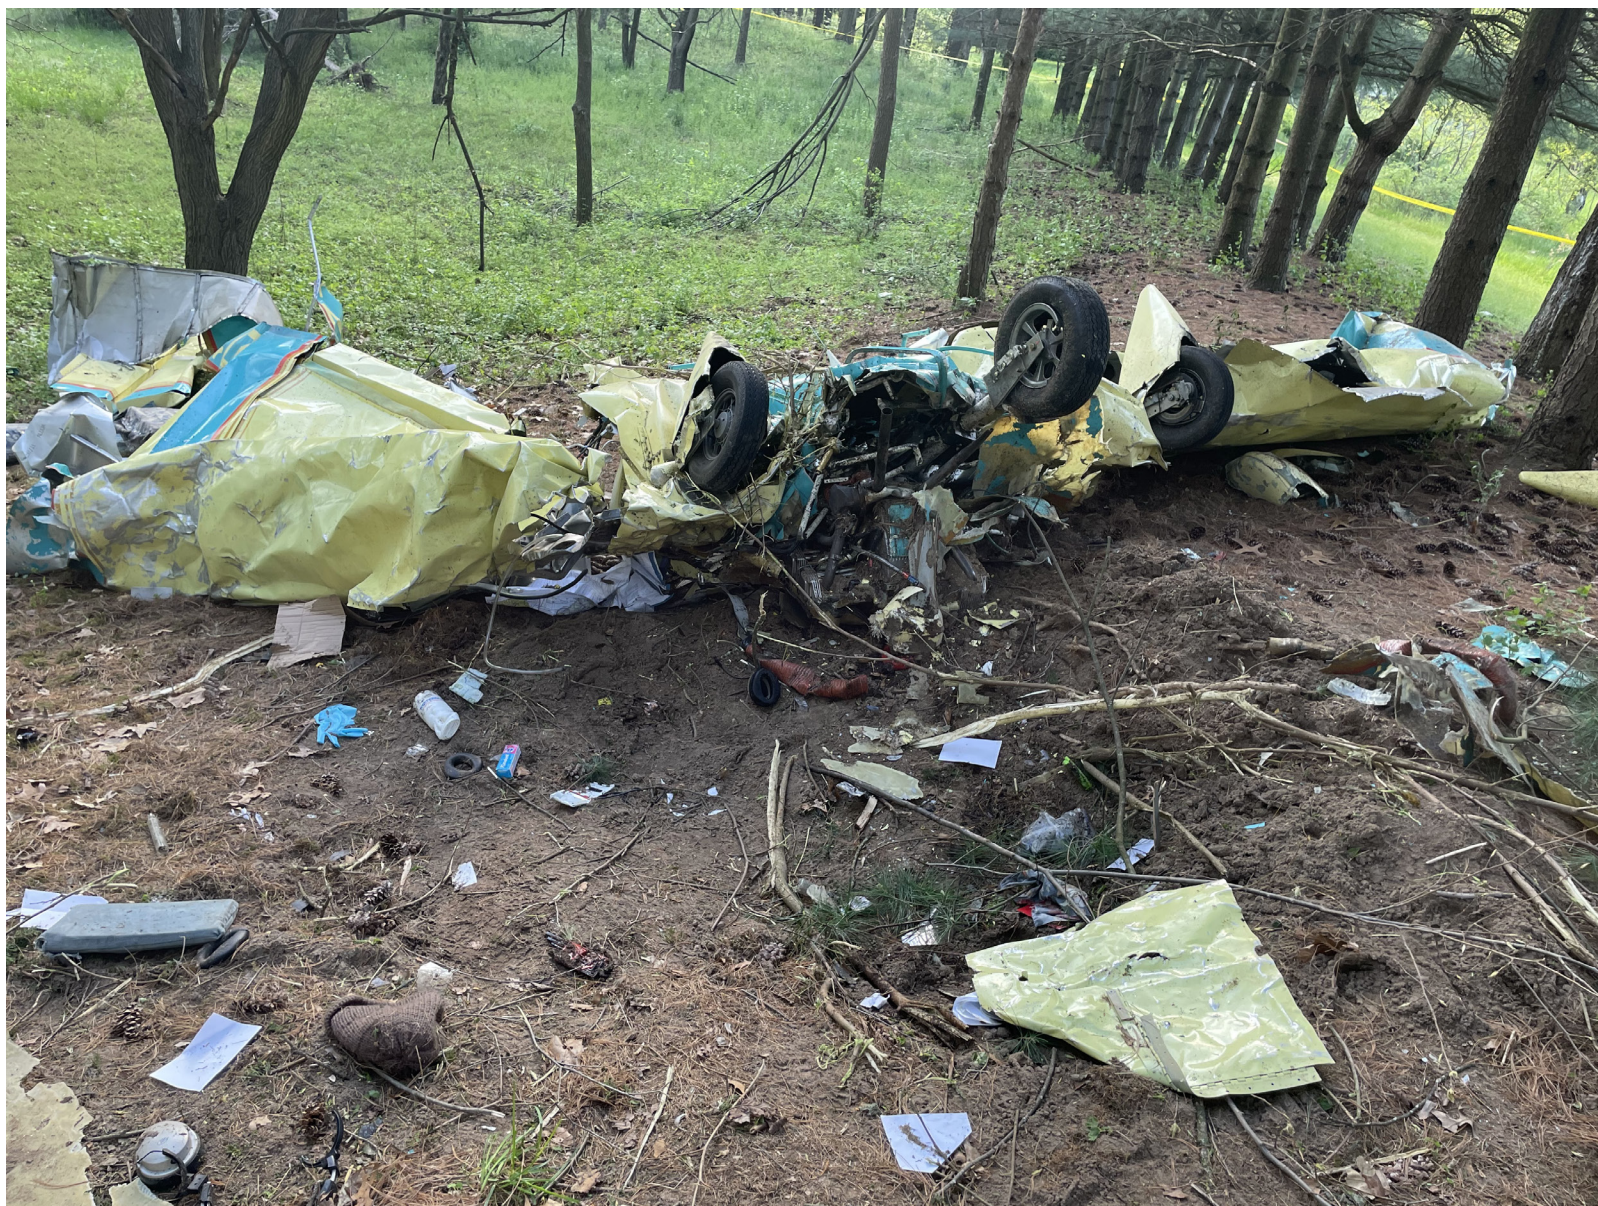
**Photograph 7 - Initial impact crater and main wreckage (Courtesy of NTSB)**

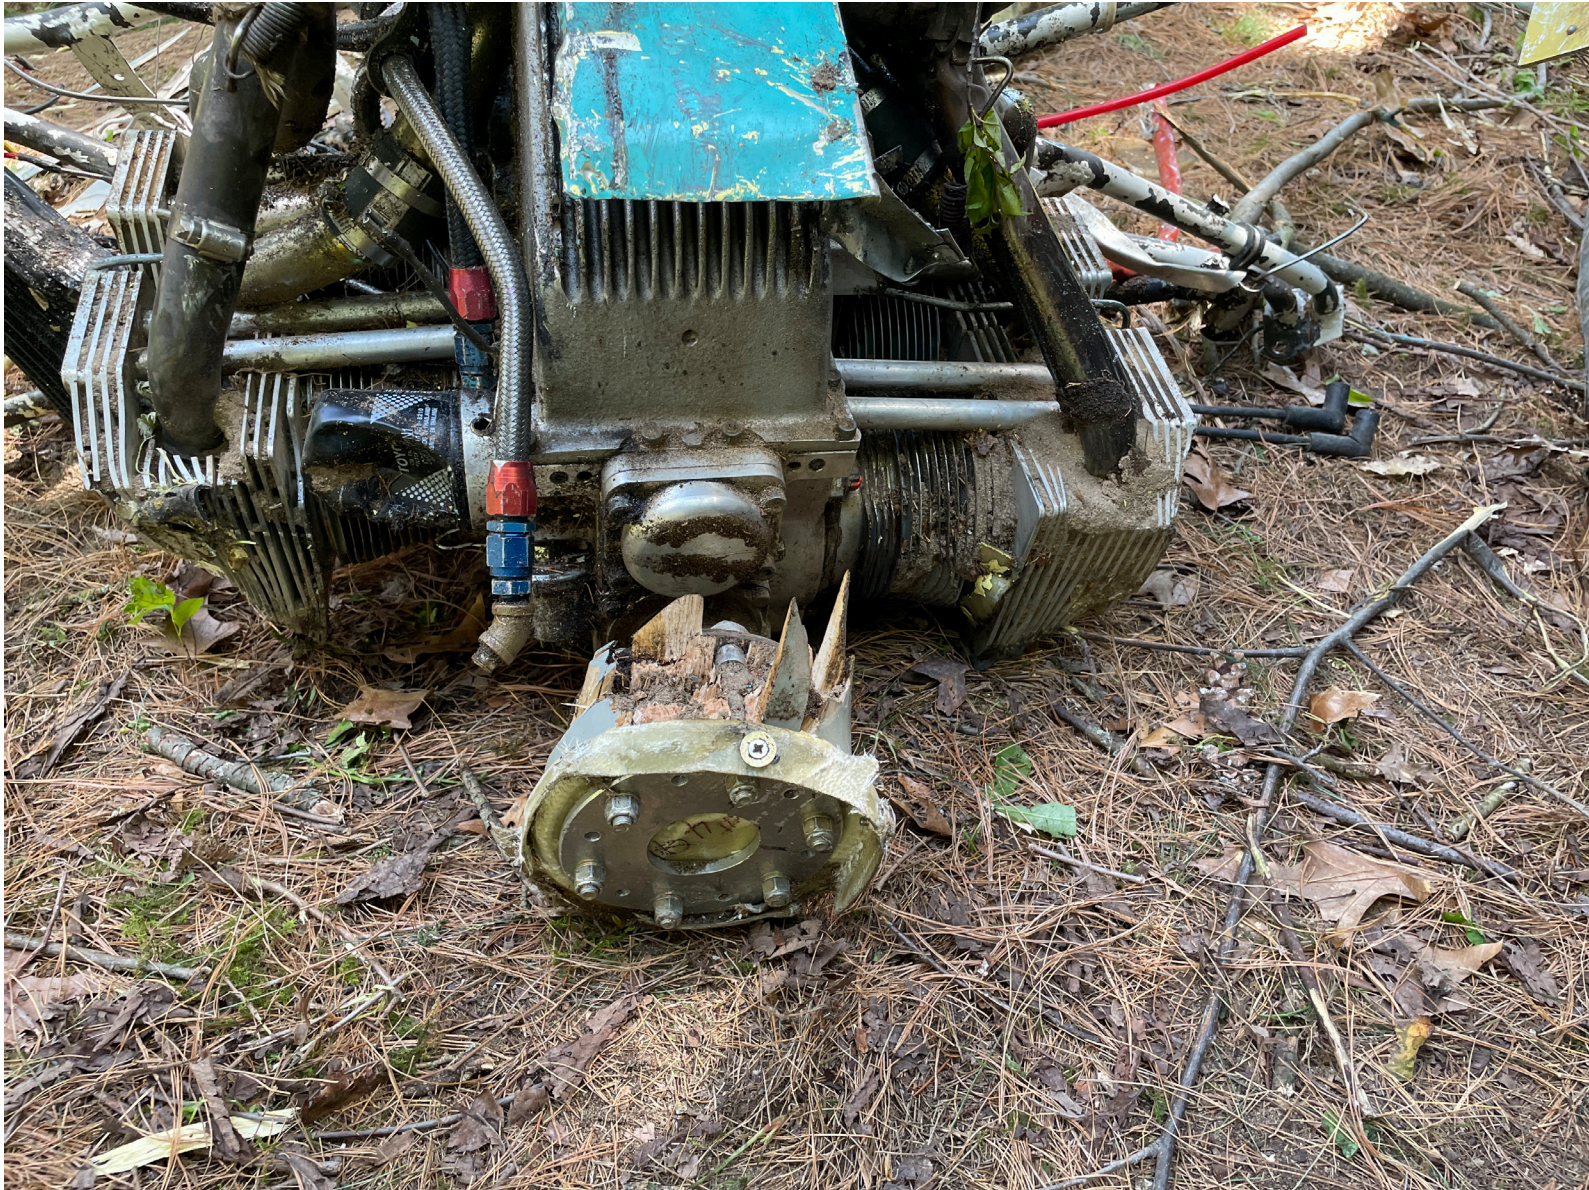
**Photograph 8 - Propeller flange (Courtesy of NTSB)**

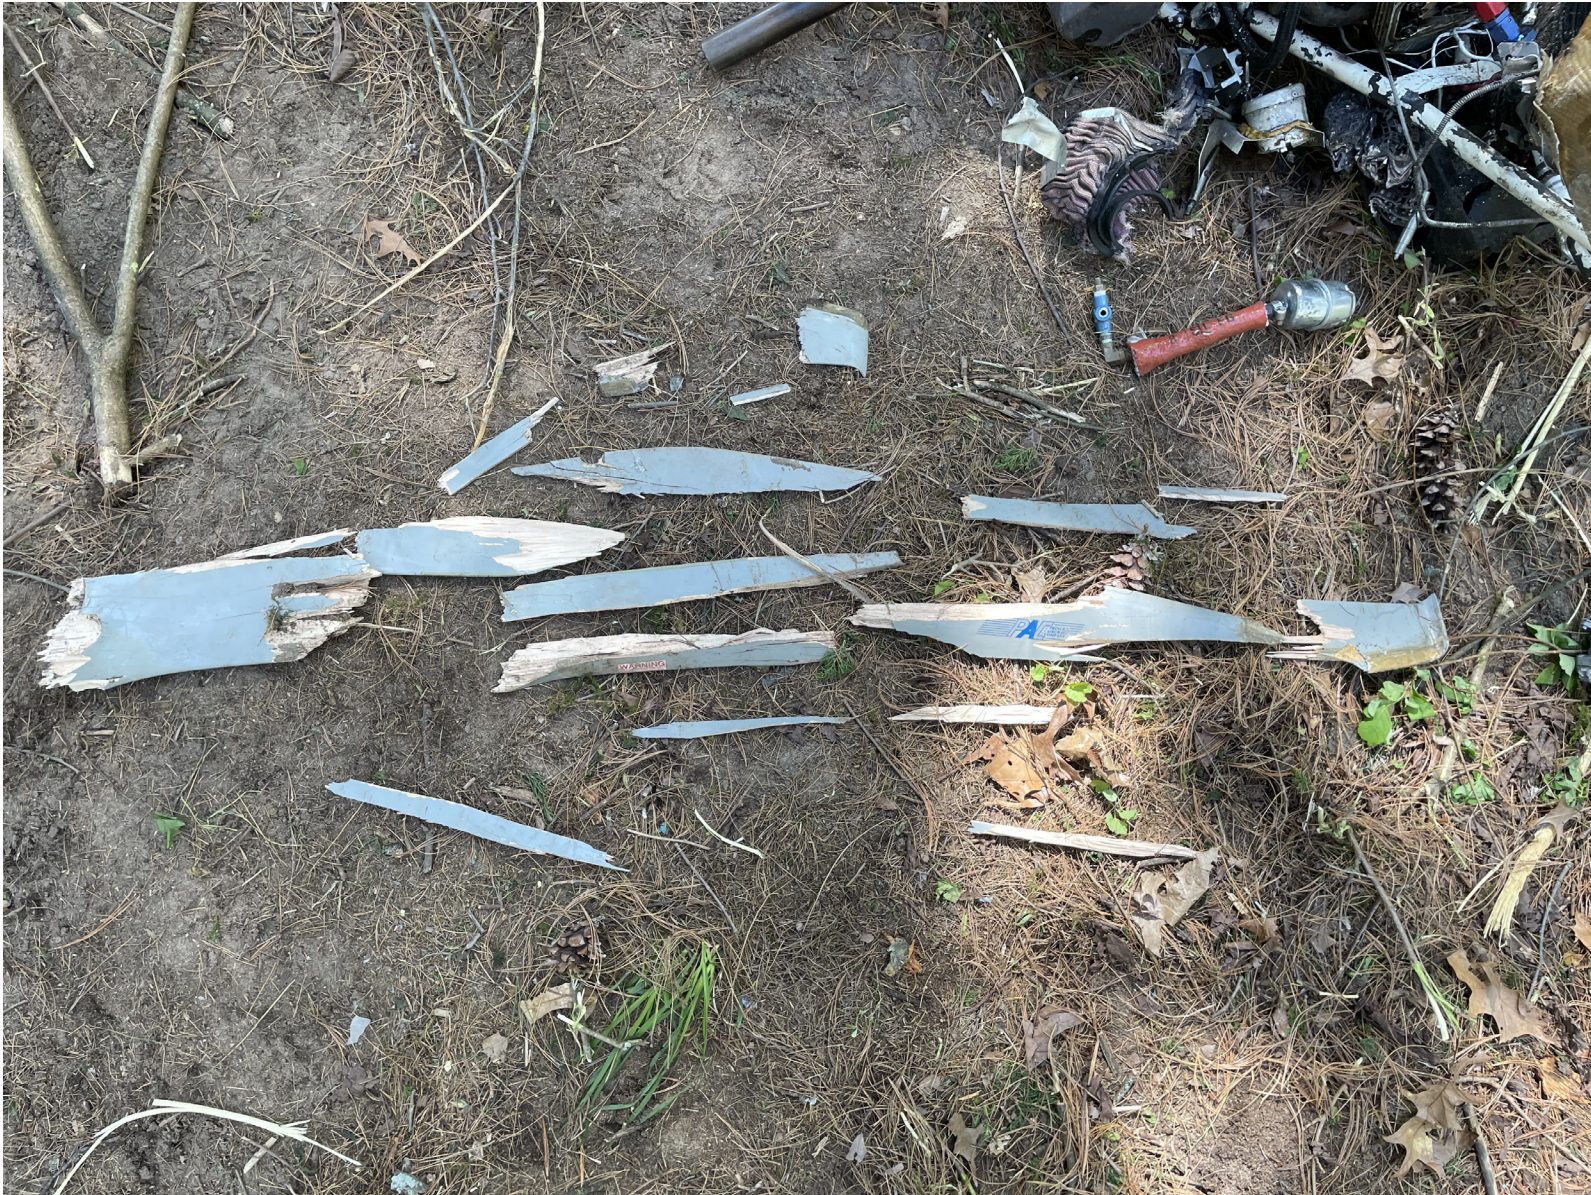
**Photograph 9 - Propeller blade pieces (Courtesy of NTSB)**
