# National Transportation Safety Board

CEN24FA170

## INVESTIGATION SUMMARY

Location: Bristol, Indiana  
Date: April 30, 2024  
Time: 1418 EDT  
Airplane: N6271F, Zodiac CH-601 HDS

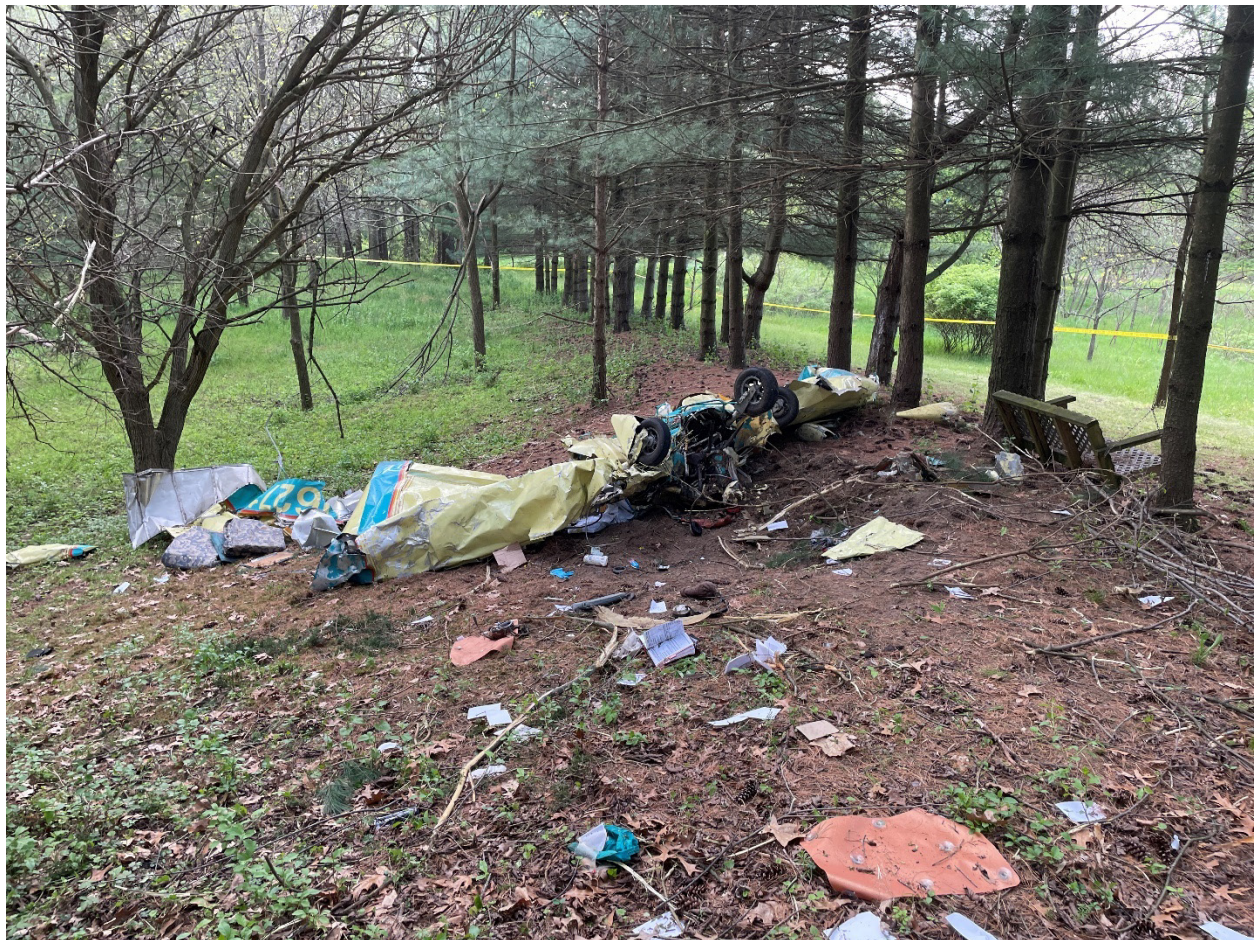
Figure 2. Accident site.

The accident site was located about 400 ft west of the final ADS-B point in a wooded area. The airplane impacted several tree tops and descended in a near vertical attitude into the ground, with the left wing impacting first. The impact crater was about 1-2 ft deep into the soft, sandy soil. The airplane and debris field were oriented east, back in the original direction of travel (as seen in the ADS-B flight track).

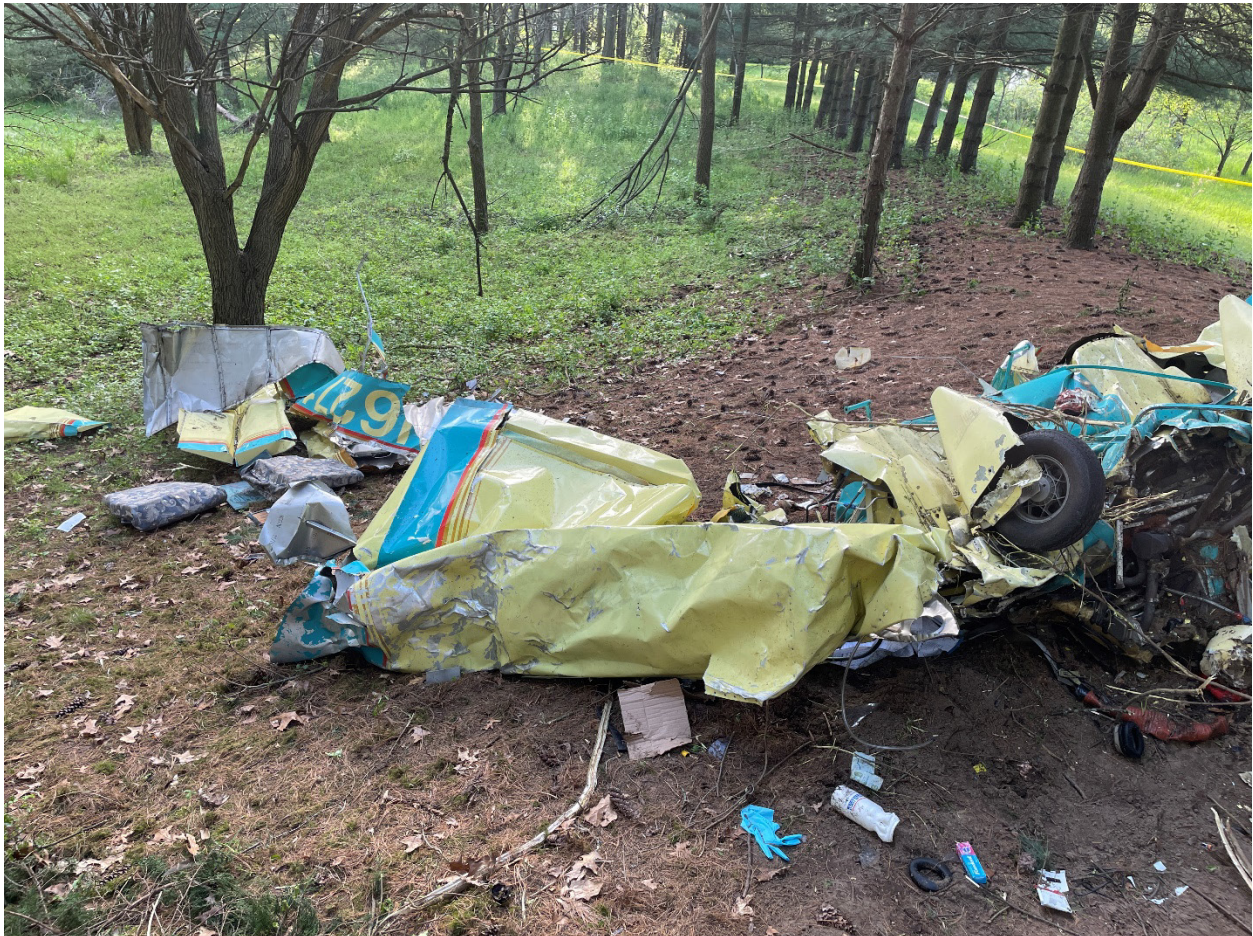
Figure 3. Left wing.

The left wing exhibited accordion crushing to the leading edge and the outboard half of the wing was bent aft.

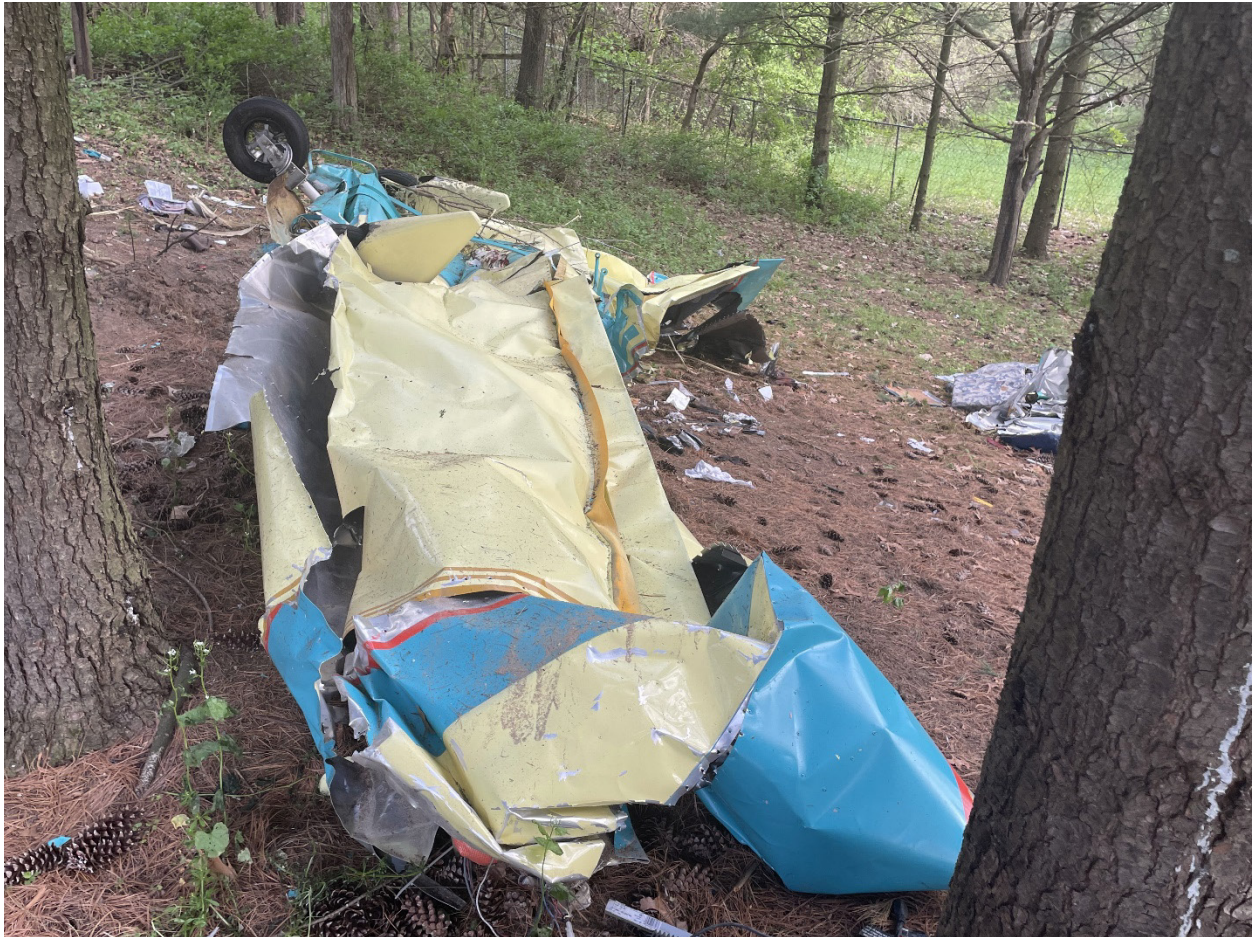
Figure 4. Right wing.

The right wing sustained impact damage and hydraulic deformation to the inboard leading edge near the fuel tank. The outboard ~2 ft of the wing sustained ground

impact damage and was bent aft. The bottom of the right wing was wrinkled and distorted.

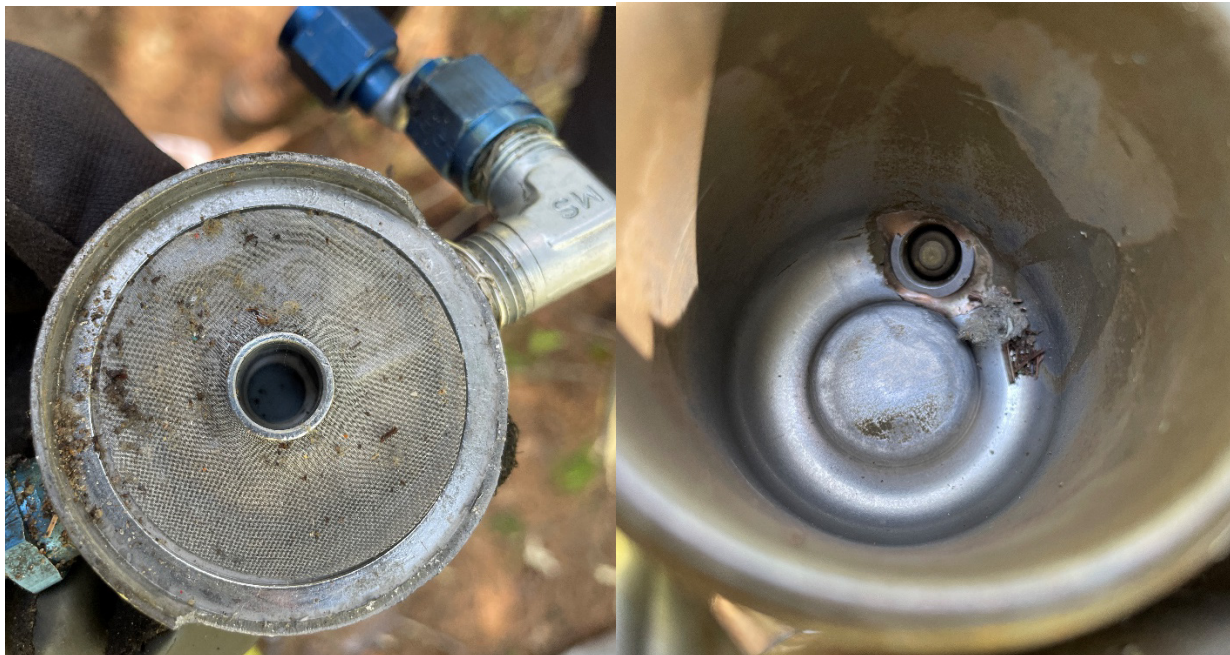
Figure 5/6. Firewall fuel strainer.

The right wing tank remained inside the wings and exhibited hydraulic deformation on the leading edge. The left wing tank was found separated from the wing and relatively intact with minimal impact damage except for the fuel line connection which was separated. The header tank remained next to the firewall and exhibited hydraulic deformation. All three fuel tanks were dry. The firewall fuel strainer remained installed at the firewall and sustained impact damage to the mount and fuel lines. The strainer bowl was slightly dislodged from the cap but the rubber gasket and filter element remained installed. The filter element and bowl contained a small amount of debris and was dry. The fuel lines were free of blockages or contamination.

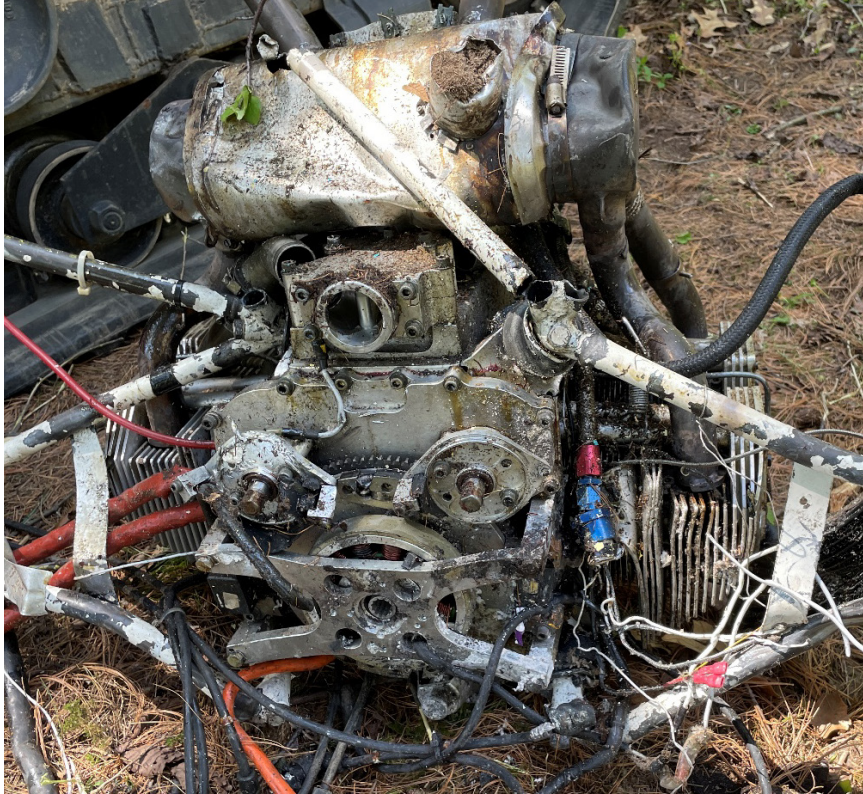
Figure 7. Engine.

Jabiru 2200. The engine sustained significant impact damage to the rear accessories but the case and cylinders remained intact. There were no holes in the case or signs of catastrophic failure.

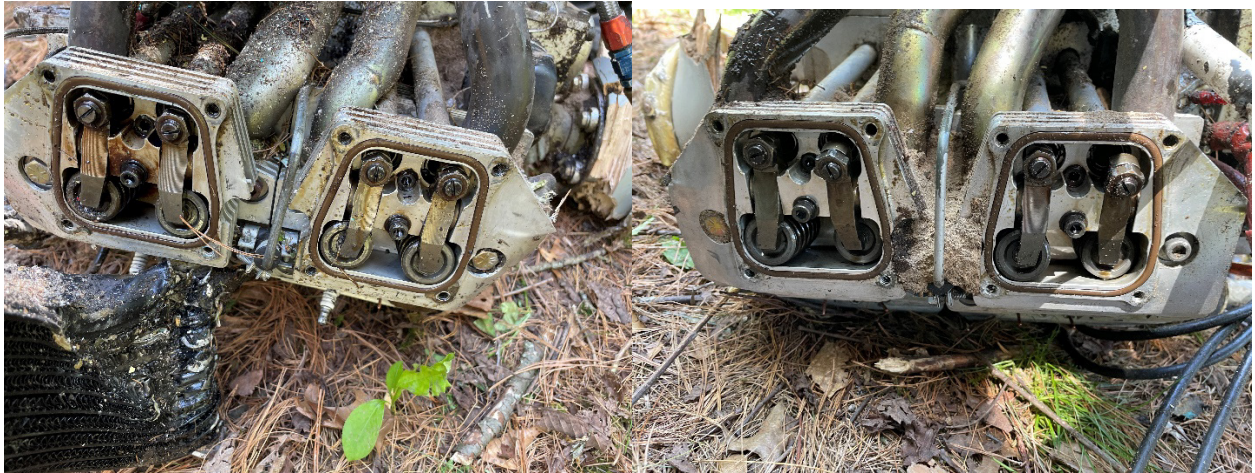
The valve rocker covers were removed and oil was found inside and coated all parts. The rockers all appeared in place with no anomalies noted. The push rods all appeared in place but were impact damaged and bent.

Figure 8/9. Right and left side of the engine with the valve covers removed.

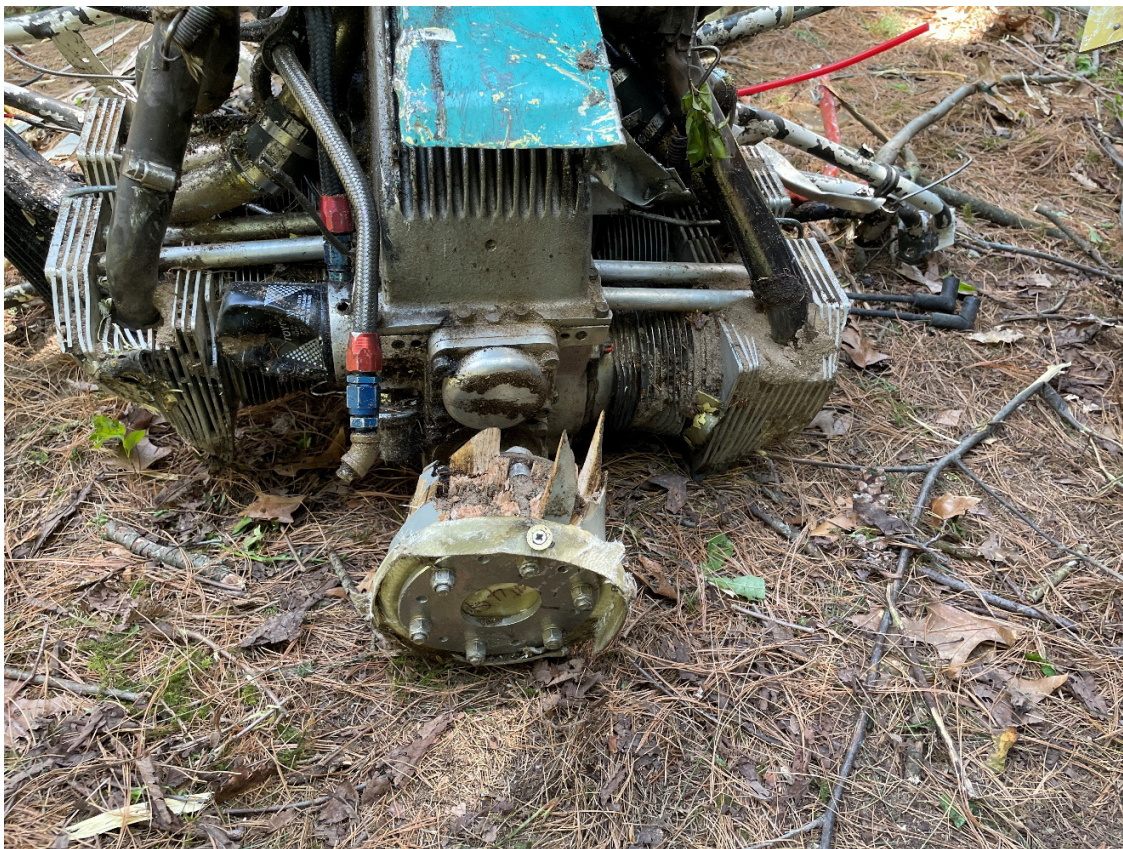
Figure 10. Propeller flange and engine.

The crankshaft was slightly bent at the propeller flange and was unable to rotate. Wooden propeller was shattered and scattered in and around the accident site. The farther piece of blade was found about 25 yards SE of the main wreckage. The propeller hub remained attached to the crankshaft flange and pieces of the propeller were still in the hub.
