# National Transportation Safety Board

CEN24FA179

## **STRUCTURES**

Group Chair's Factual Report

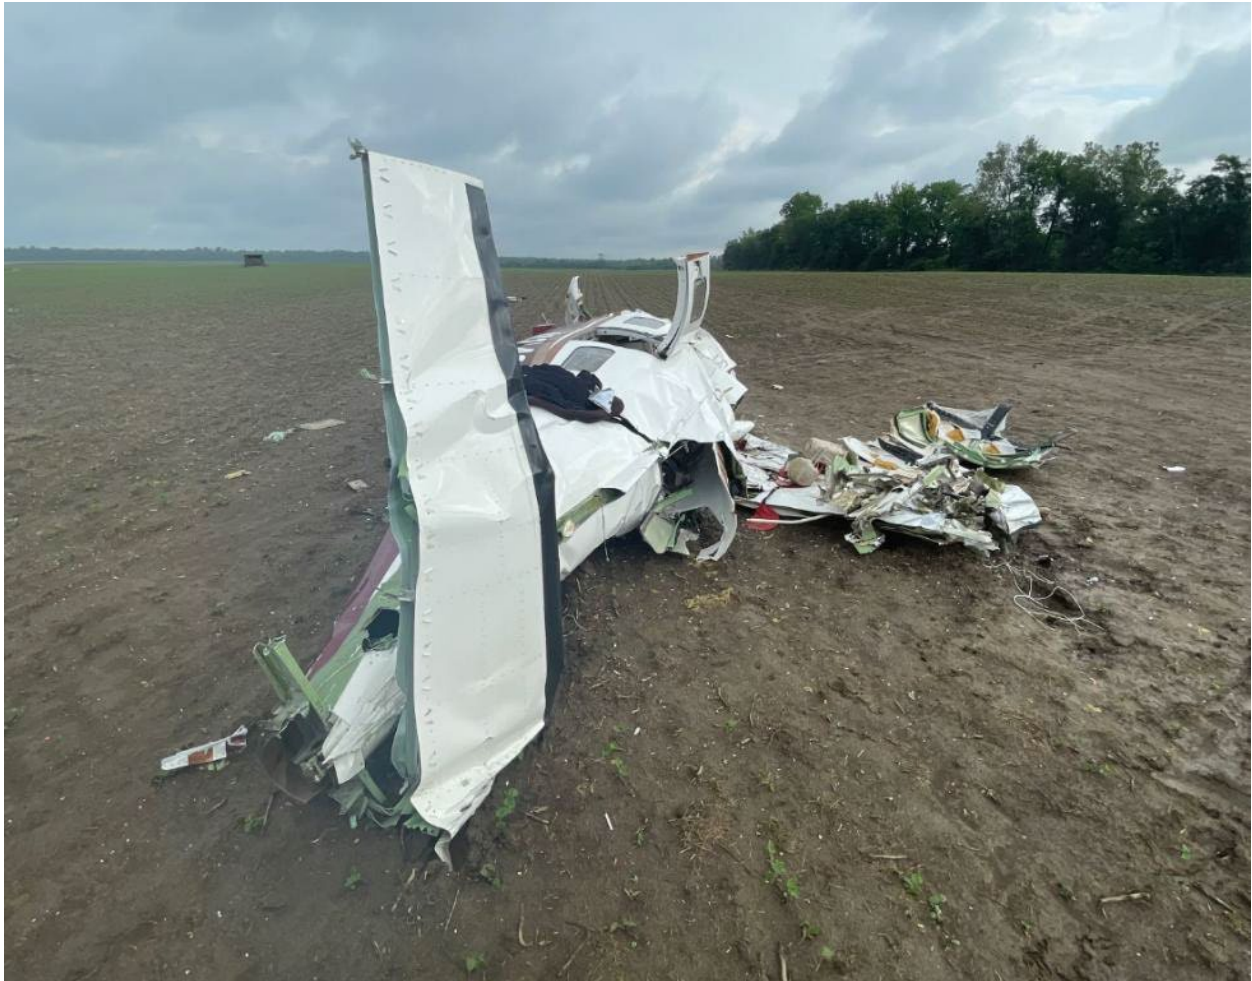
**Figure 5.** Wreckage on site (NTSB photo)

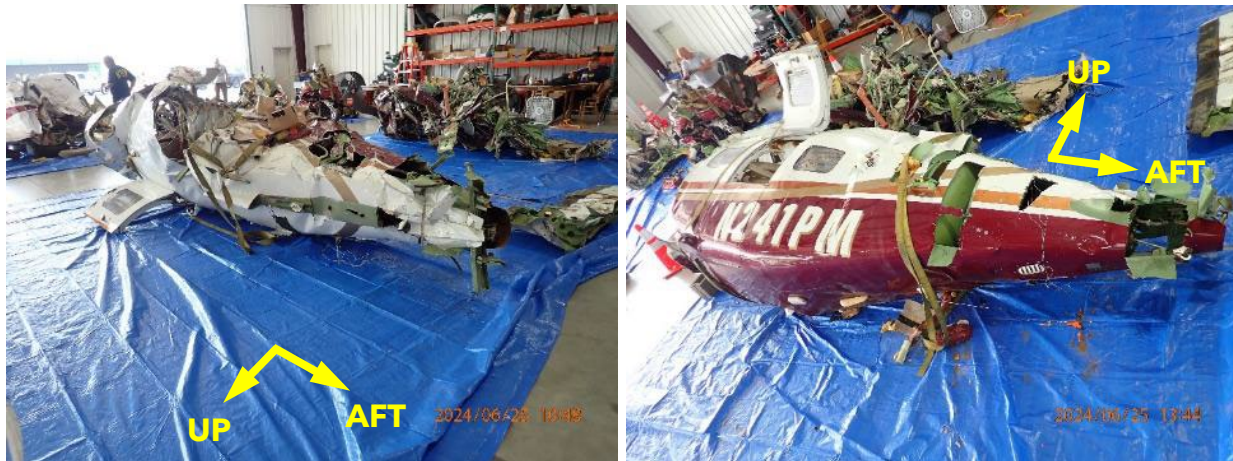
The fuselage had significantly more damage to the right side than the left consistent with the airplane landing on that side (figures 5 and 6). Cuts were made along the left side of the fuselage during recovery to separate it and were not related to the event.

**Figure 6.** Event airplane right side (left) and left side (right) (NTSB photos)

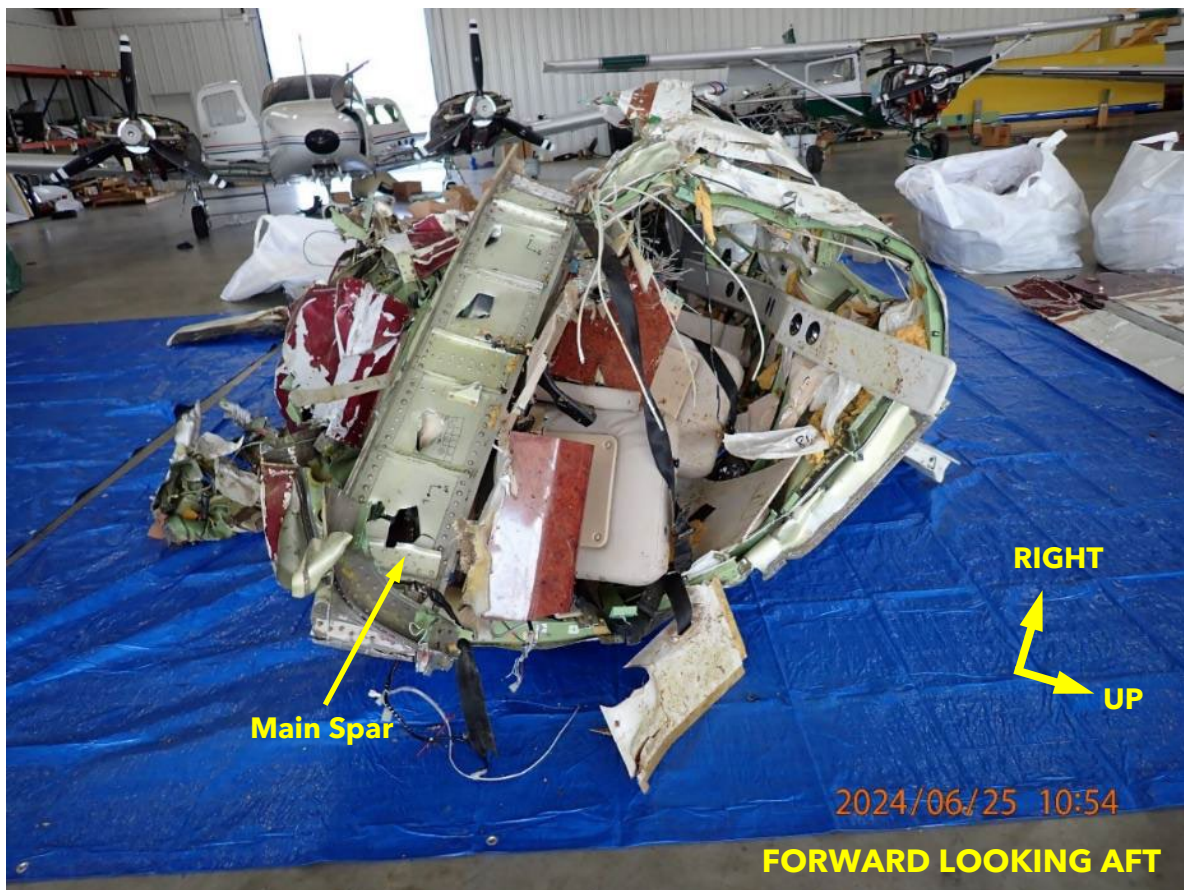
**Figure 7.** Fuselage (NTSB photo)

A portion, 55 inches long, of the main spar center section remained attached to the fuselage (figure 7). The spar was rotated aft on the right side bringing the left side forward. At both fractured ends, the main spar was deformed upward. The main spar also had 4 puncture holes through the web at least 4 inches each in diameter. The outboard holes were spaced about 9 inches from the inboard holes, and the two inboard holes were spaced about 16 inches from each other.

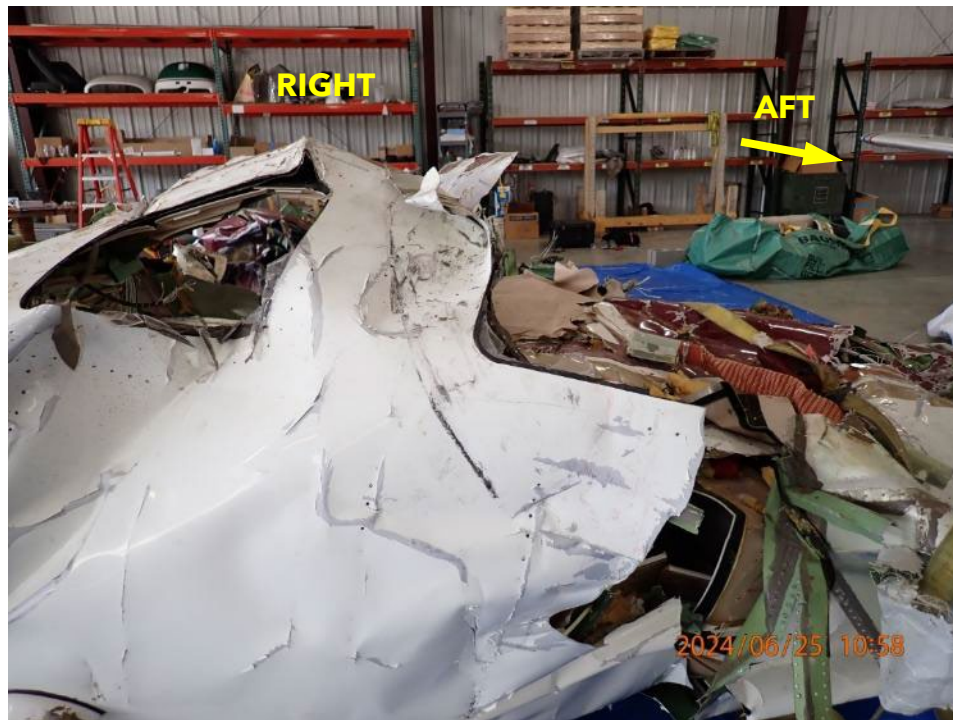
The right upper side of the fuselage had rubber transfer marks on the skin about 17 inches long with subsequent smaller marks towards the top and aft of the fuselage (figure 8).

**Figure 8.** Right side fuselage skin with rubber transfer mark (NTSB photo)

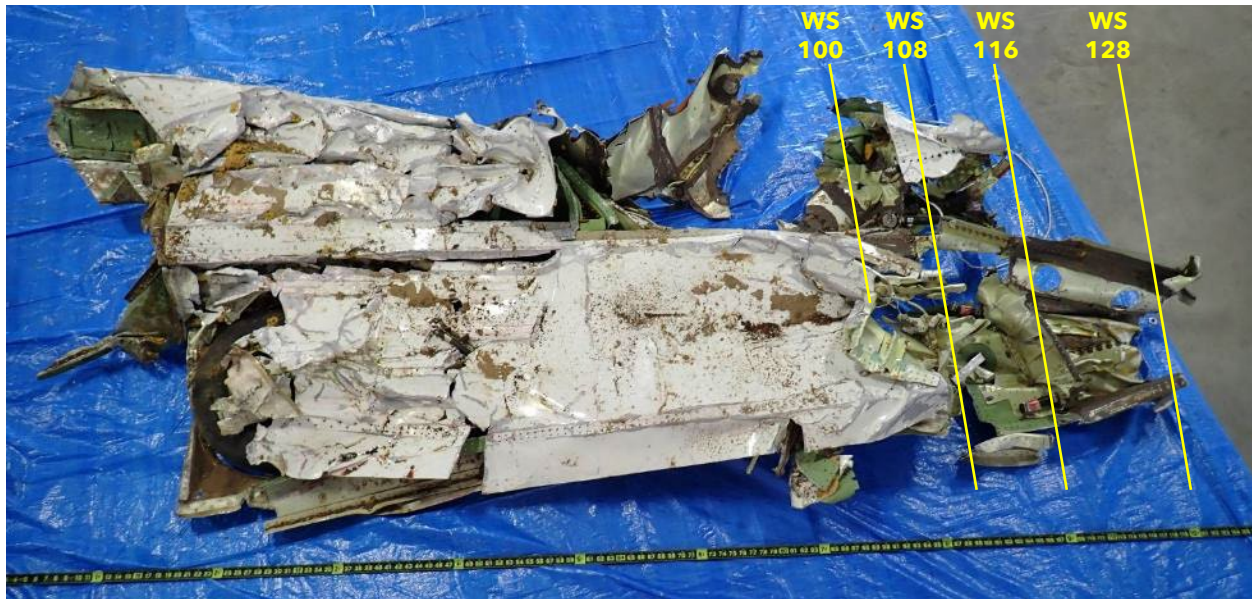
**Figure 9.** Right wing inboard section (NTSB photo)

The right wing inboard section separated from the airplane. It was resting partially under the airplane at the accident site and had significant impact damage and deformation (figure 9). The right wing inboard section was fractured into 3 major pieces. The largest piece fractured about WS 29, at the wing root, and extended to near WS 100 on the main spar and WS 108 on the aft spar. The second piece was about 8 inches of the aft spar that extended from WS 108 to WS 116. The third piece extended from about WS 100 to about WS 136 on the main spar and from about WS 116 to about WS 128 on the aft spar. There was a partial fracture of the main spar near WS 108. The overall deformation of the right wing inboard section was in an upward direction.

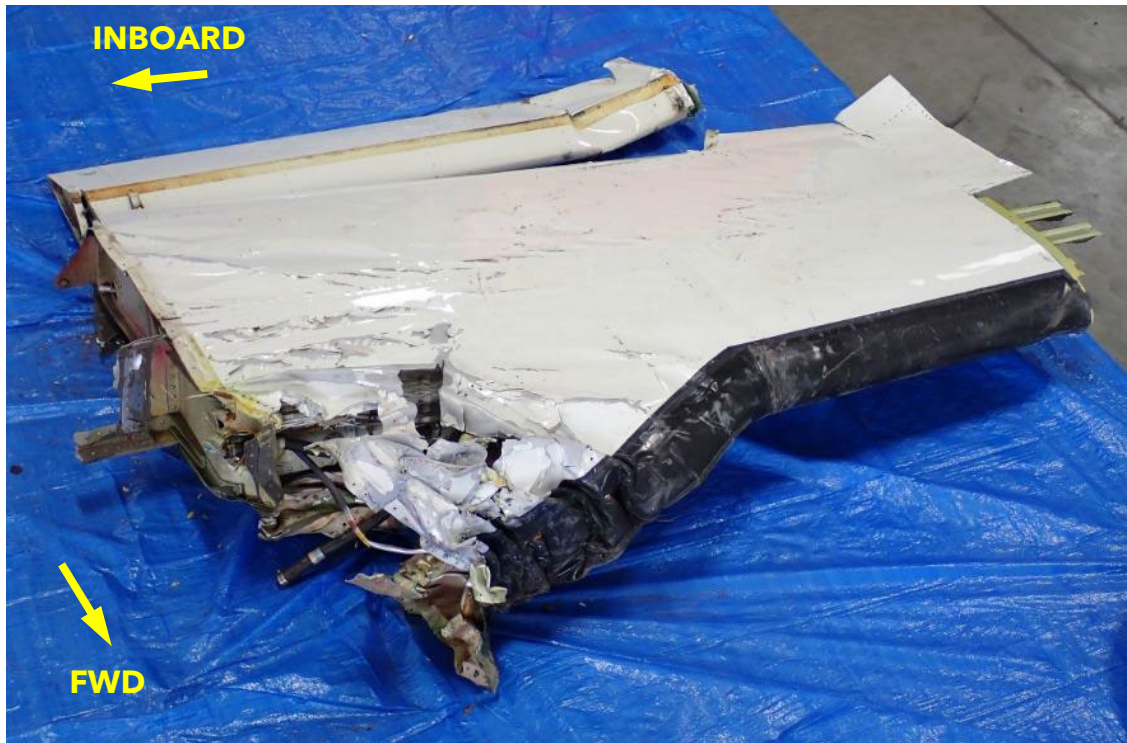
**Figure 10.** Left wing inboard section (NTSB photo)

The left wing inboard section separated from the airplane and was recovered near the main wreckage (figure 10). The left wing inboard section fractured near WS 29, at the wing root, and extended to about WS 108 at the main and aft spars. There was significant crushing damage to the inboard forward corner of the wing. The accordion-like crushed section extended from about WS 29 to about WS 58. The upper skin had buckling damage that extended to the end of the section.

At the WS 108 fracture, there was no obvious deformation of the forward spar but there was upward deformation of the aft spar and skin. The inboard half of the left flap remained attached to the inboard section of the wing. The flap section was deformed upwards and separated from the wing at the outboard flap track.

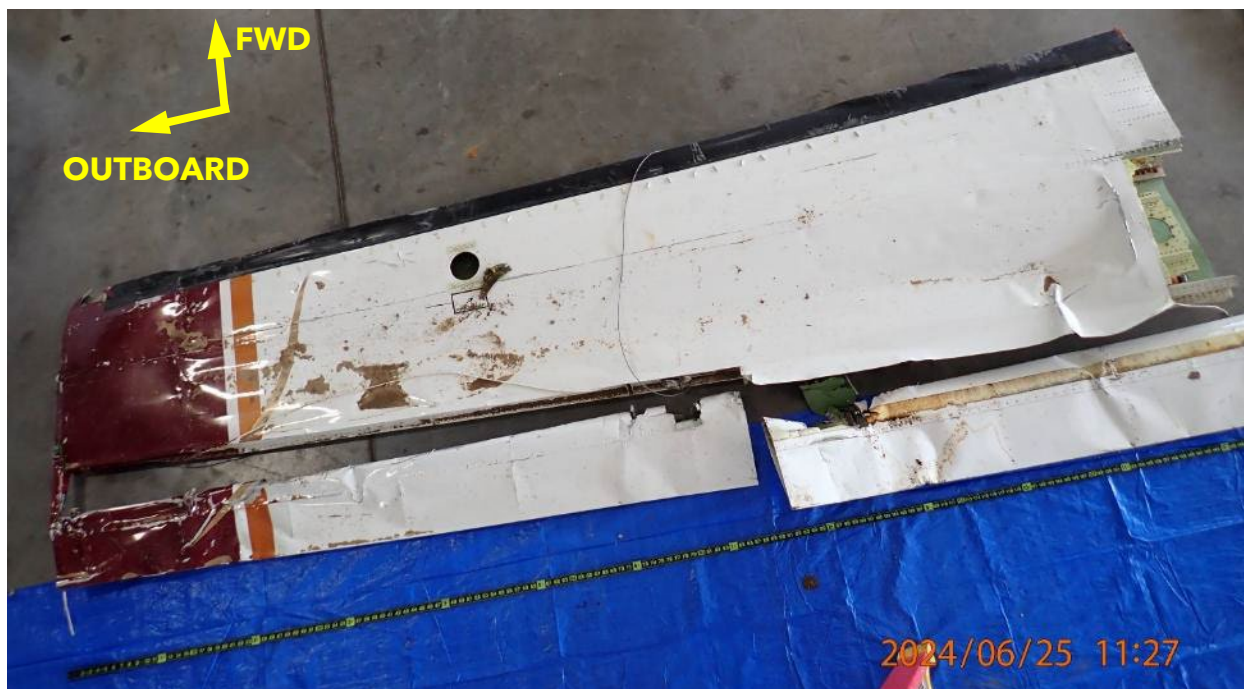
**Figure 11.** Left wing outboard section (NTSB photo)

The left outboard wing section separated from the airplane near WS 108 and was recovered (figure 11). The flap and aileron separated from the left wing and were recovered. The outboard wing was bent upward, and extended the full length of the section (figure 12).

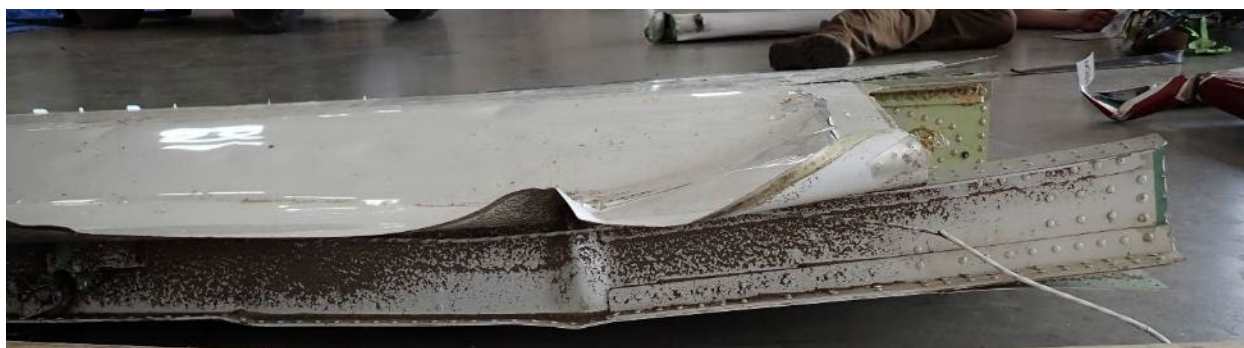
**Figure 12.** Left wing outboard section spar deformation (NTSB photo)

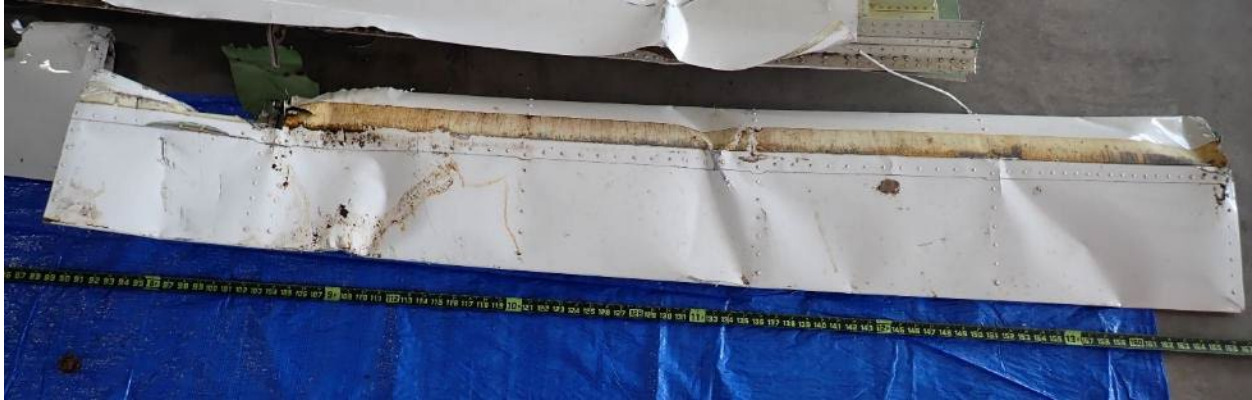
**Figure 13.** Left flap outboard section (NTSB photo)

The left outboard half of the left flap separated from the airplane and was recovered (figure 13). The flap was complete but separated in half, at about 77 inches from the outboard end. The outboard section buckled and fractured at the flap track attach points. The inboard half of the flap remained attached to the inboard section of the wing.

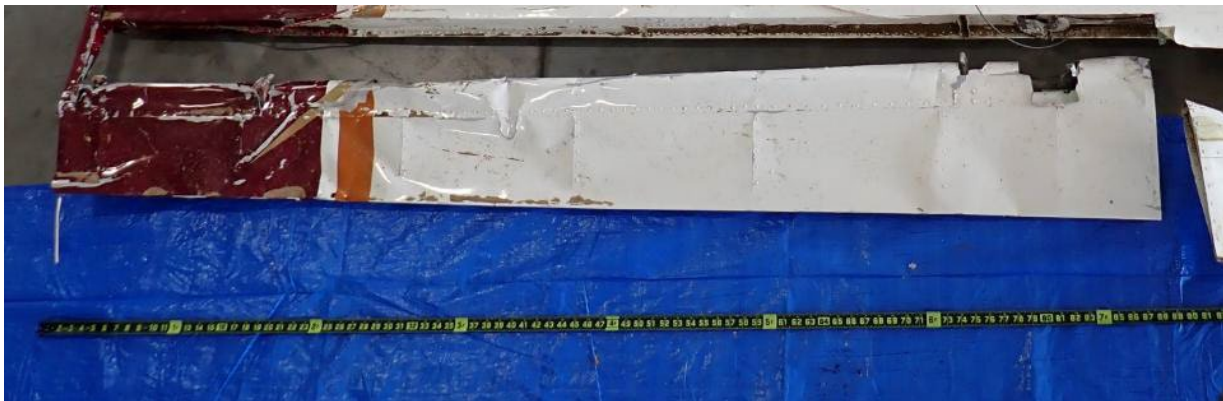
**Figure 14.** Left Aileron (NTSB photo)

The left aileron separated from the airplane and was recovered (figure 14). The aileron was mostly intact with some buckling and impact damage noted. The aileron hinges fractured from the wing structure. There was over travel impact damage at the aileron hinge locations.

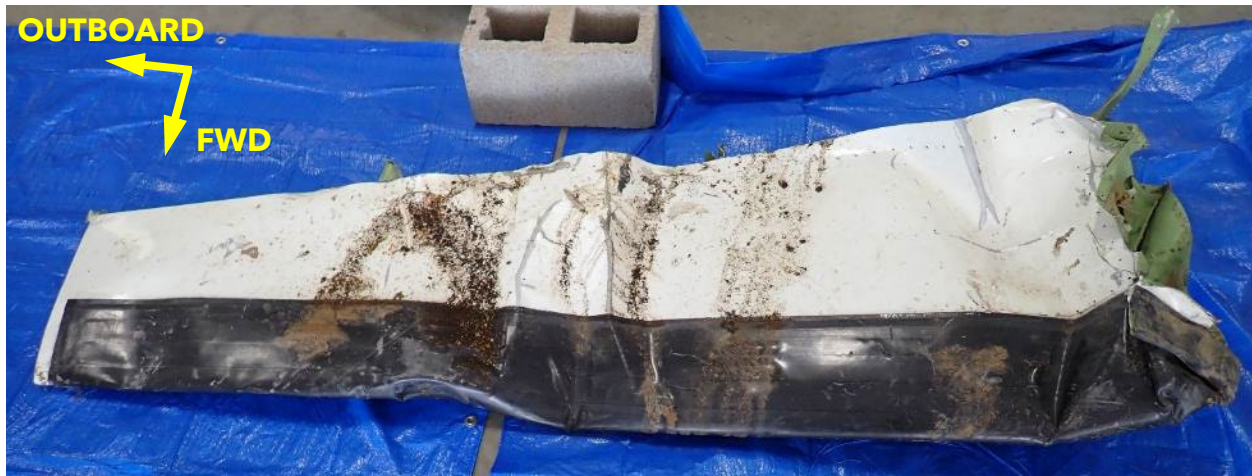
**Figure 15.** Right Horizontal Stabilizer (NTSB photo)

The right horizontal stabilizer remained partially attached to the fuselage on scene but was separated during recovery (figure 15). The stabilizer had buckling and impact damage. Both forward and aft spars were deformed upward at the fracture location and near the midspan location.

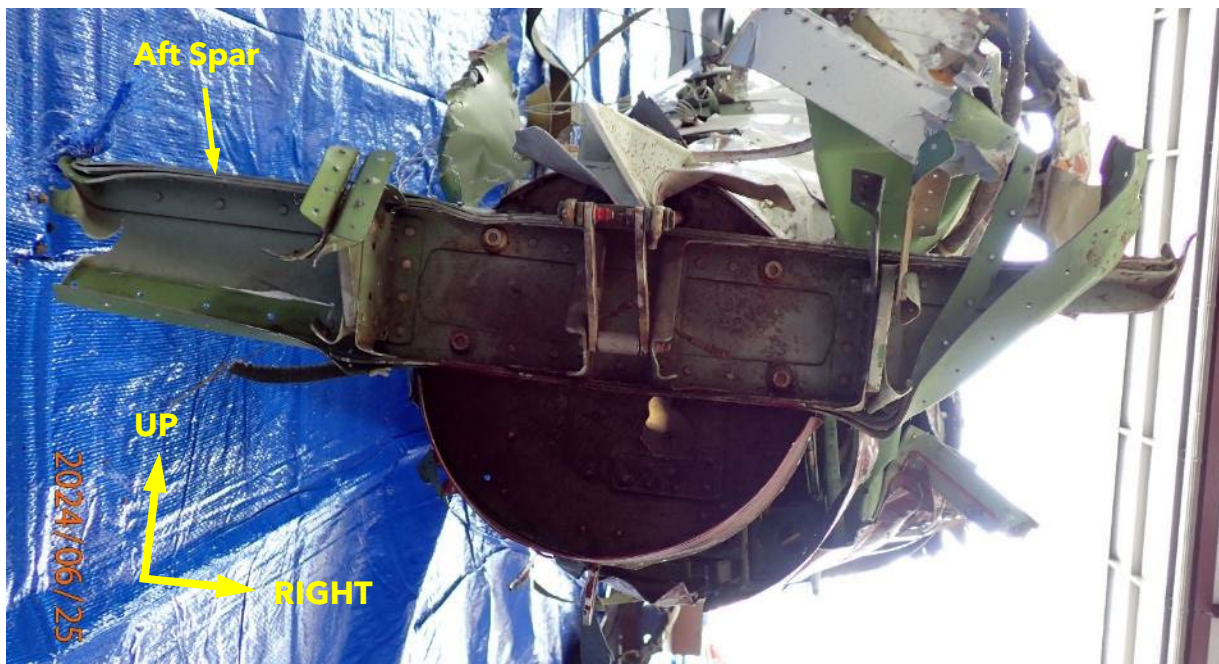
**Figure 16.** Horizontal stabilizer aft spar (NTSB photo)

A section of the horizontal stabilizer aft spar, about 30 inches long, remained attached to the fuselage (figure 16). The spar caps were deformed upwards at the fracture locations. The elevator trim actuator remained attached to the aft spar.

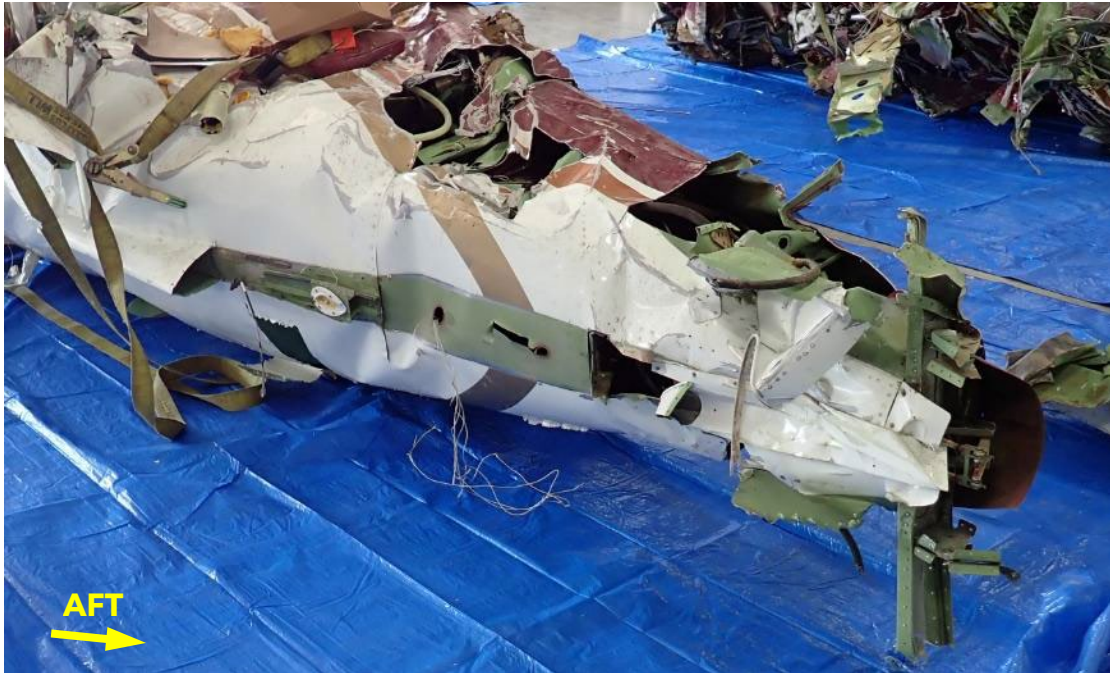
**Figure 17.** Vertical stabilizer attach locations (NTSB photo)

The vertical stabilizer separated from the fuselage. The forward attach point was pulled through and the aft spar was deformed aft (figure 17).
