# National Transportation Safety Board

CEN24FA179

## **FLIGHT PATH DATA STUDY**

Location: Marianna, Arkansas  
Date: May 12, 2024  
Time: 19:56 central daylight time (CDT)  
Airplane: Piper PA46-500TP, N241PM

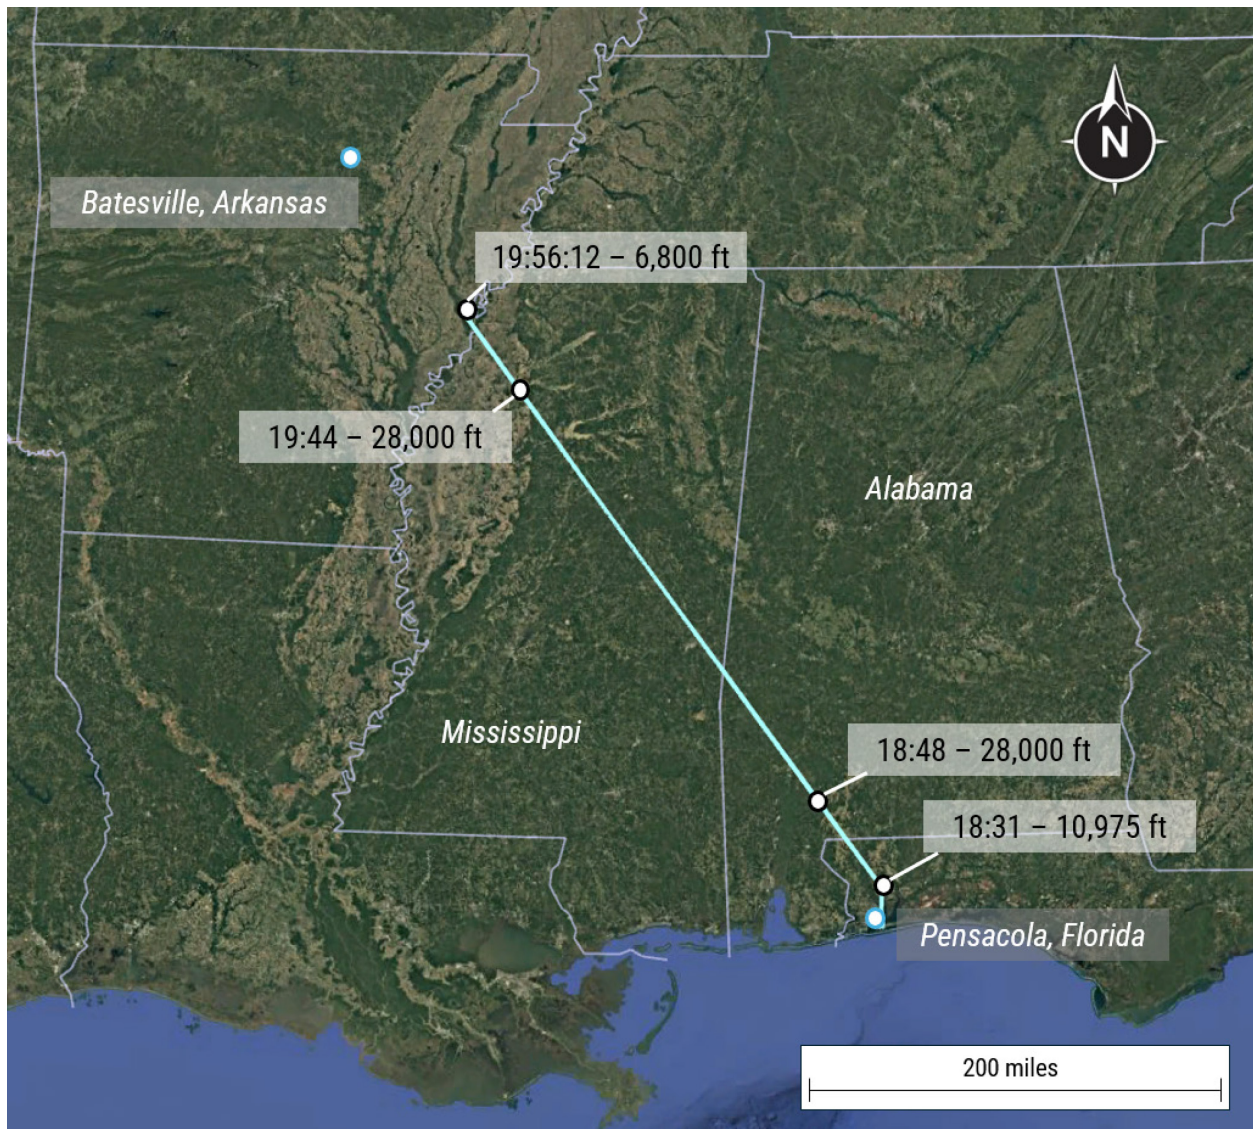
The airplane took off from Pensacola International Airport (PNS), Florida at 18:21CDT with the intended destination of Batesville, Arkansas (Figure 2). The airplane turned onto a northwesterly track towards Batesville by 18:31. The pilot requested flight level 280 (28,000 ft) at 18:33. The airplane climbed steadily (Figure 3) at a rate between 1,000 and 1,500 fpm and reached a cruising altitude of 28,000 ft pressure altitude (corrected geometric altitude was just over 29,000 ft) by 18:48 which it maintained until 19:44 when it began to descend. The calculated calibrated airspeed was consistently above 150 kts.

**Figure 2.** ADS-B flight path with selected times and pressures altitudes (uncorrected) shown.

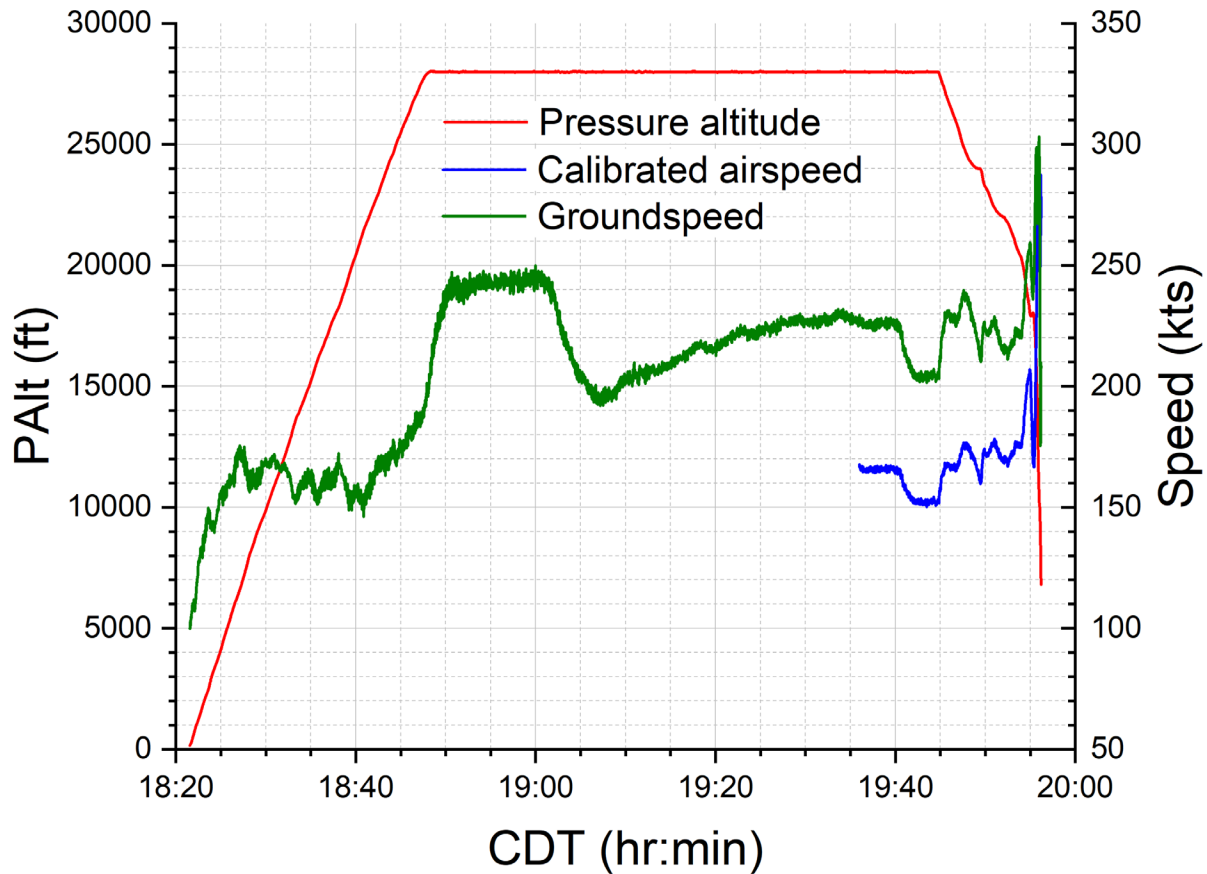
**Figure 3.** ADS-B pressure altitude (uncorrected for barometric setting), recorded groundspeed, and calculated airspeed. Airspeed is calculated using the HRRR sounding data and is more accurate as it approaches the end of flight.

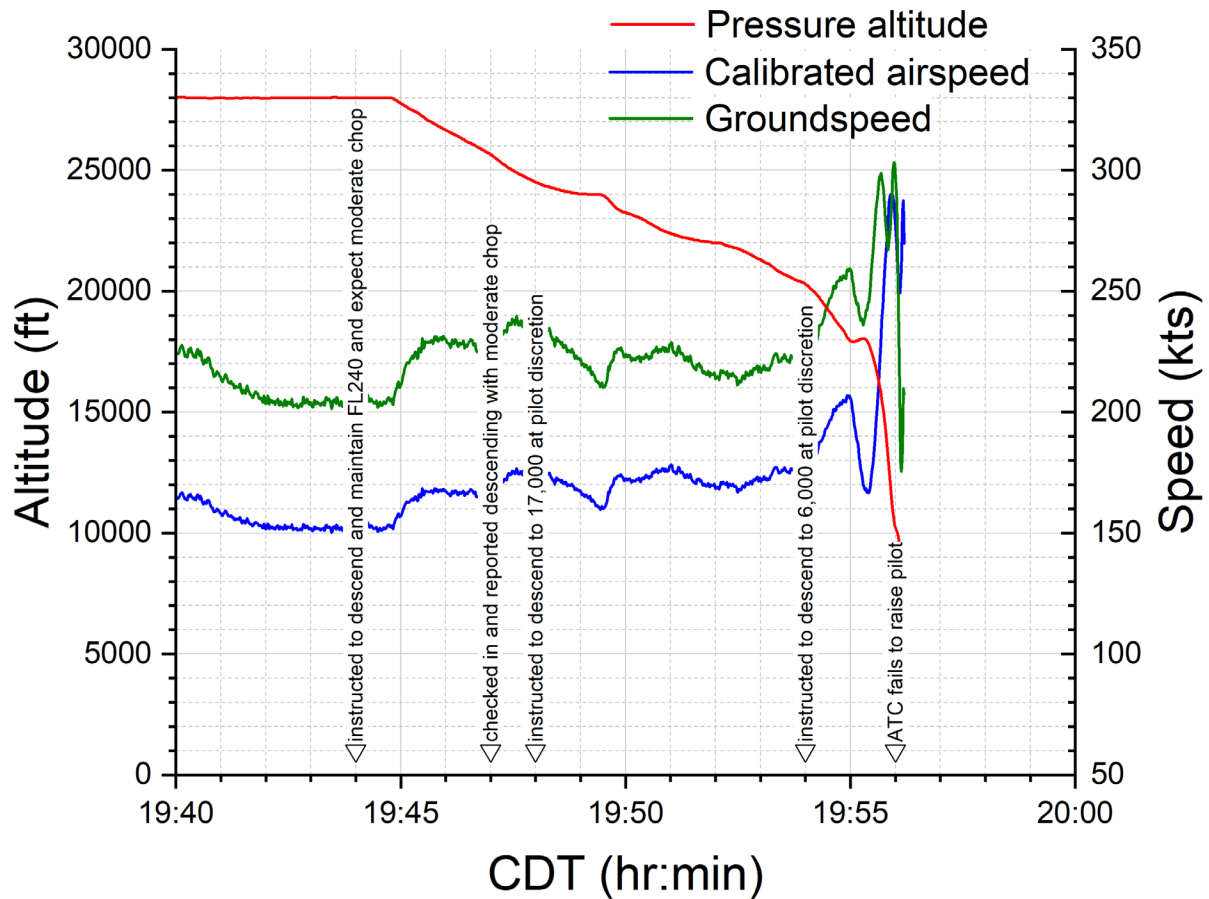
The pilot reported to ATC that his satellite weather radar was not functioning at 18:41 and later asked for assistance navigating through weather. At 19:08 he reported light chop over the prior 40 miles but that it was currently smooth. At 19:44, ATC instructed the pilot to descend to flight level 240 and to expect moderate chop. The airplane began to descend at a rate between 1,000 and 1,500 ft/min (Figure 5). At 19:47 the pilot checked in with a new ATC center on his route and reported descending with moderate chop. ATC responded by instructing the pilot to descend at his discretion to 17,000 ft. The airplane reached 24,000 ft (the previously instructed altitude) at 19:49 where it stayed for less than a minute before continuing its descent. The first portion of this descent was at a rate of -2,000 ft/min before slowing to near -1,000 ft/min.

**Figure 4.** ADS-B pressure altitude (uncorrected for barometric setting), recorded groundspeed, and calculated calibrated airspeed. Airspeed is calculated using the HRRR sounding data and is more accurate as it approaches the end of flight. Also included are select ATC communications.

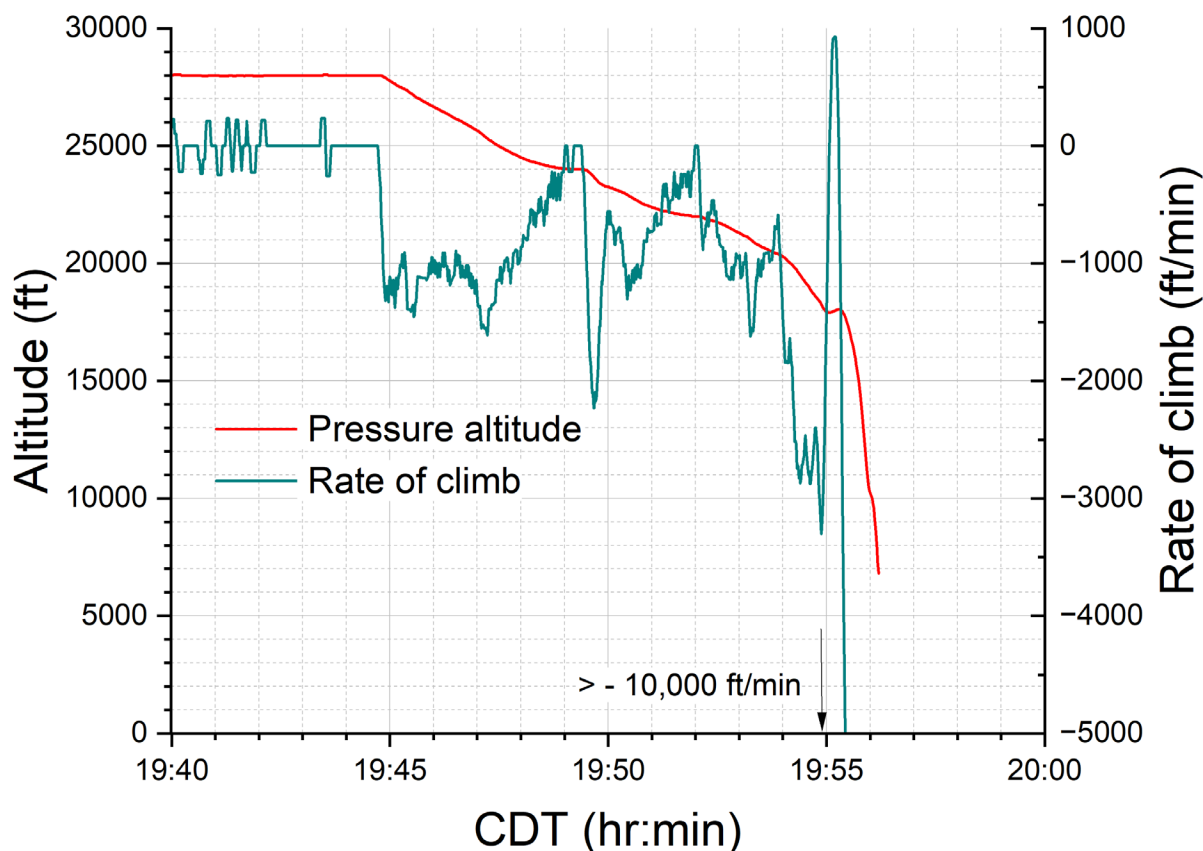
**Figure 5.** ADS-B pressure altitude (uncorrected for barometric setting) and calculated rate of climb for the end of flight.

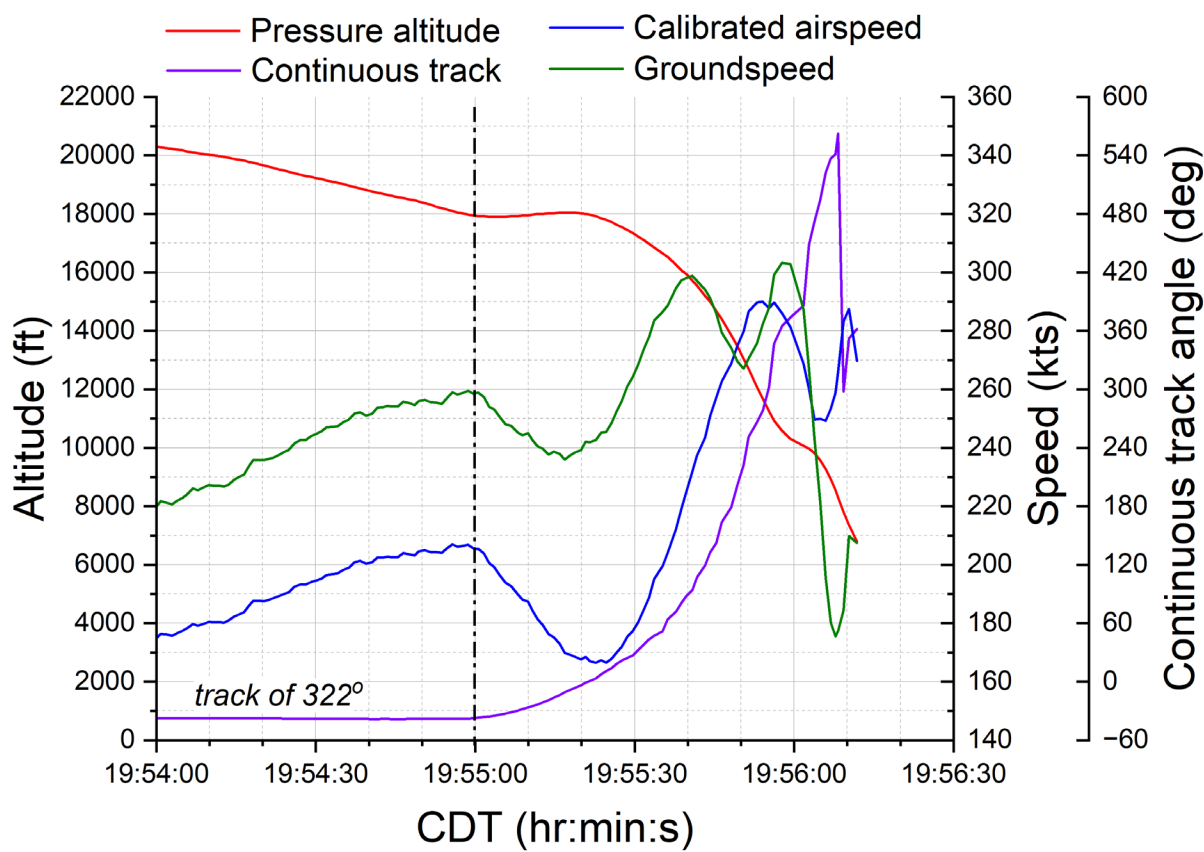
At 19:55, the airplane arrested its descent at 18,000 ft and began a small climb as it began to slow its airspeed. It also began an initially shallow right turn (Figure 6 and Figure 7). The airplane had been within 2° of the same northwesterly track for the previous 1 hour and 20 minutes. As noted earlier, the steady track, altitude and climb rates indicated that the autopilot was in use. At 19:55, the airplane's altitude passed through the ADS-B recorded selected altitude value of 18016, after which the airplane began a brief climb and the ground track began to deviate to the right, no longer consistent with autopilot control.

**Figure 6.** ADS-B pressure altitude (uncorrected for barometric setting), calibrated airspeed, groundspeed, and track angle as a continuous angle.

At 19:55:20, the airplane began rapidly descending and after 19:55:24, the airplane's speed rapidly increased from 160 kts to 290 kts while in a tightening right turn. The airplane experienced an in-flight breakup consistent with the increasing speed in a descending tight turn, which exceeded the airplane's structural limitations.

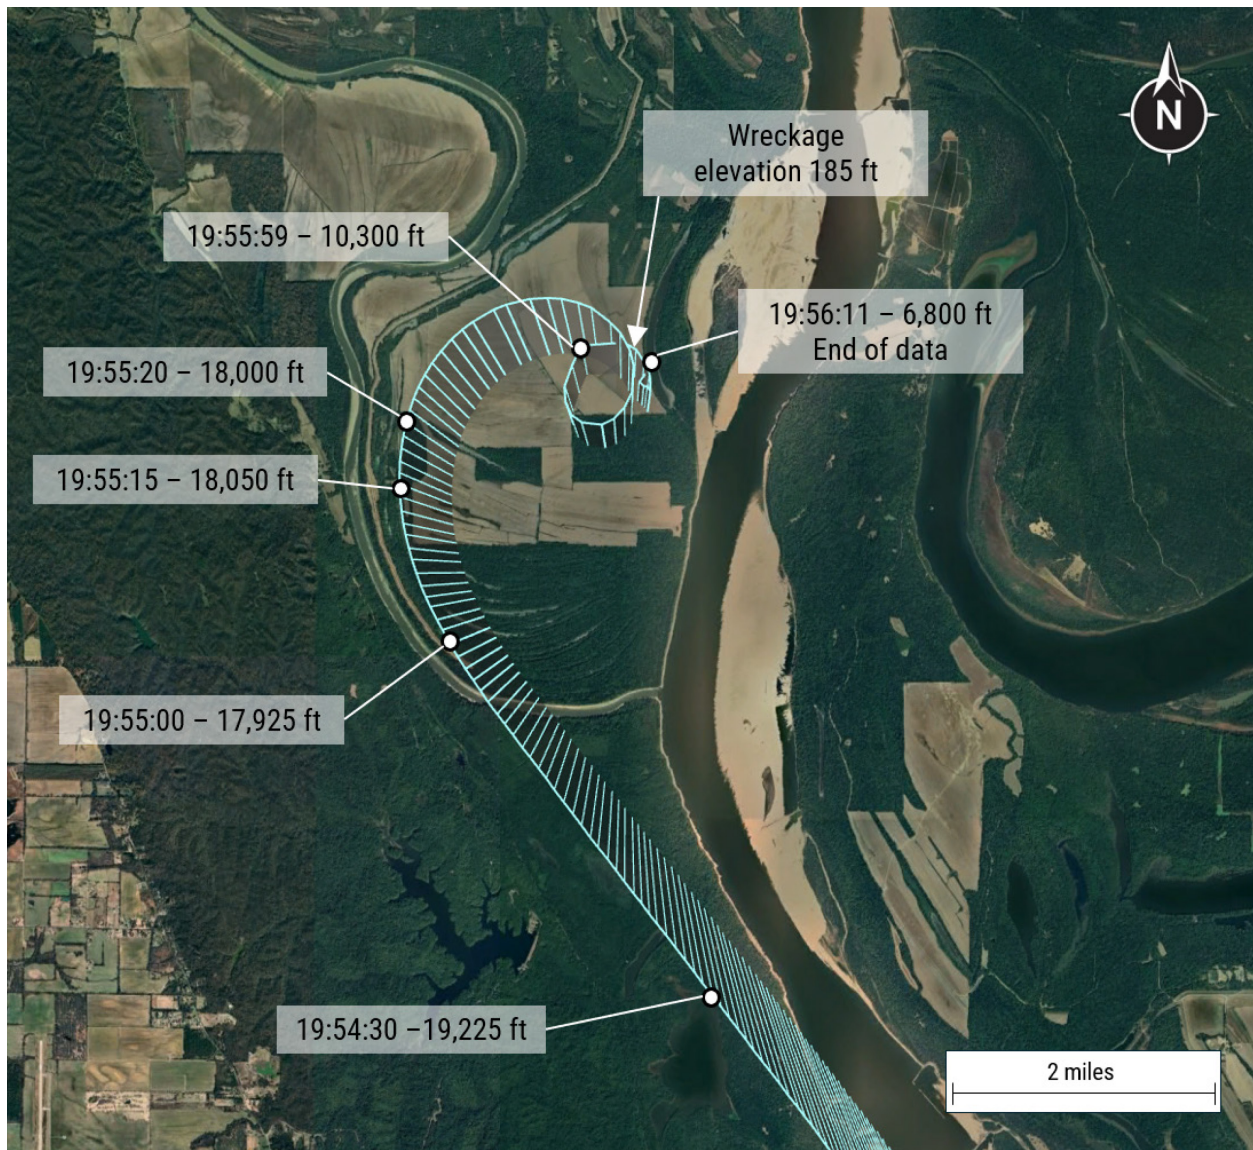
**Figure 7.** ADS-B flight path for the end of flight with selected times and pressure altitudes (uncorrected) annotated.
