# National Transportation Safety Board

CEN24FA179

## EXAMINATION SUMMARY

Location: Marianna, Arkansas  
Date: May 12, 2024  
Time: 1956 CDT  
Airplane: Piper PA46-500TP, N241PM

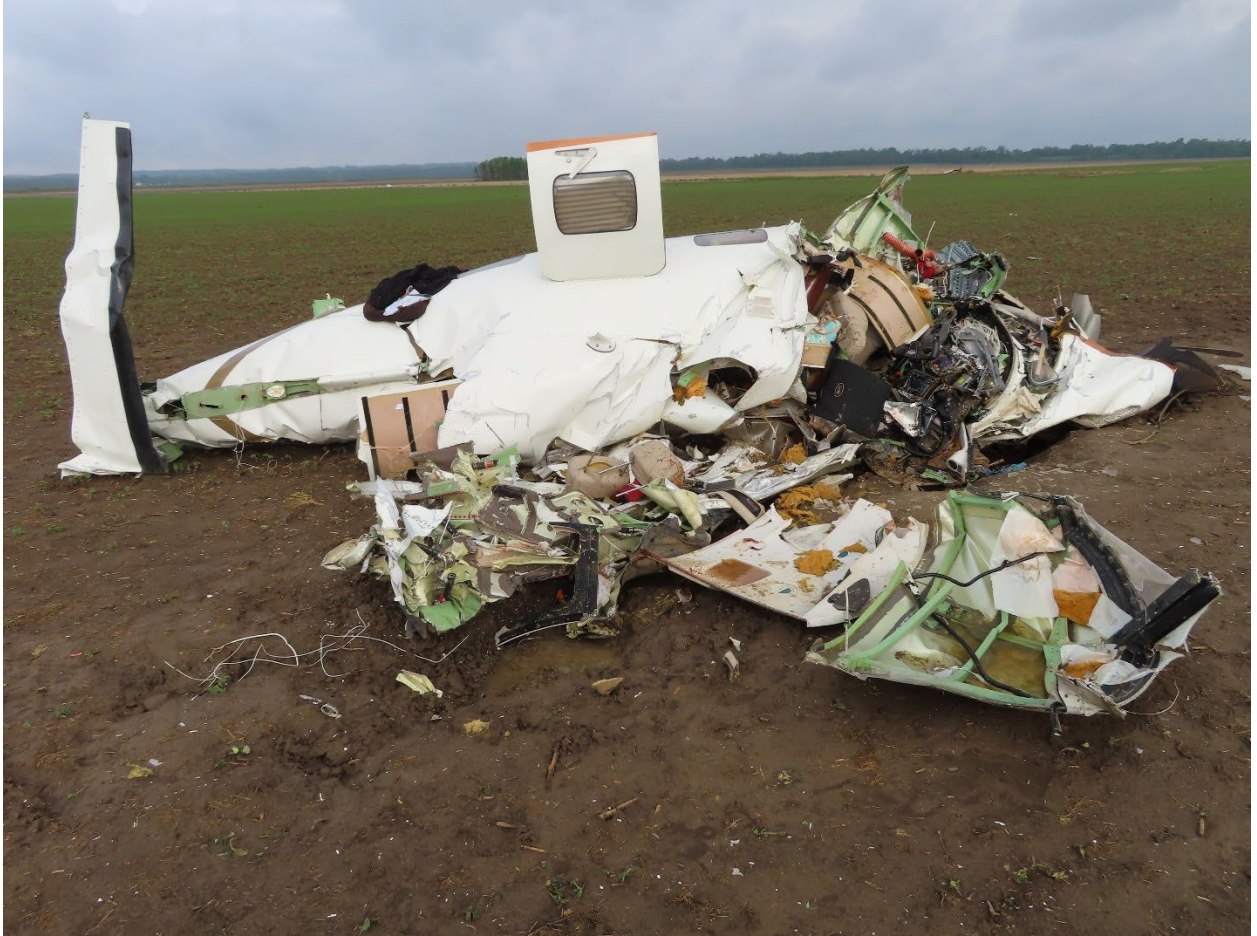
The main fuselage was located in an open, flat, agricultural soybean field, with a newly planted crop of approximately 4 inches tall. The main fuselage was located at 34.661442 and -090.596506. The outboard portion of the left wing was located at 34.66169 and -090.59654. The inboard portion of the left wing was located at 34.6651 and -090.59663. The fuselage was resting oriented toward 010 degrees true. The left wing was detached at the wing root. The left wing was in two pieces. The left inboard portion of the wing was found about 30 ft and 281° from the main wreckage, and the outboard portion of the left wing was found about 80 ft and 353° from the main wreckage. The inboard right wing was fractured at the wing root and found partially under the fuselage. The engine was attached to the engine mount and embedded in the ground. The propeller assembly was embedded in the ground and only two propeller blades were visible. An odor consistent with jet fuel was present.

Figure 1. Wreckage at accident site.

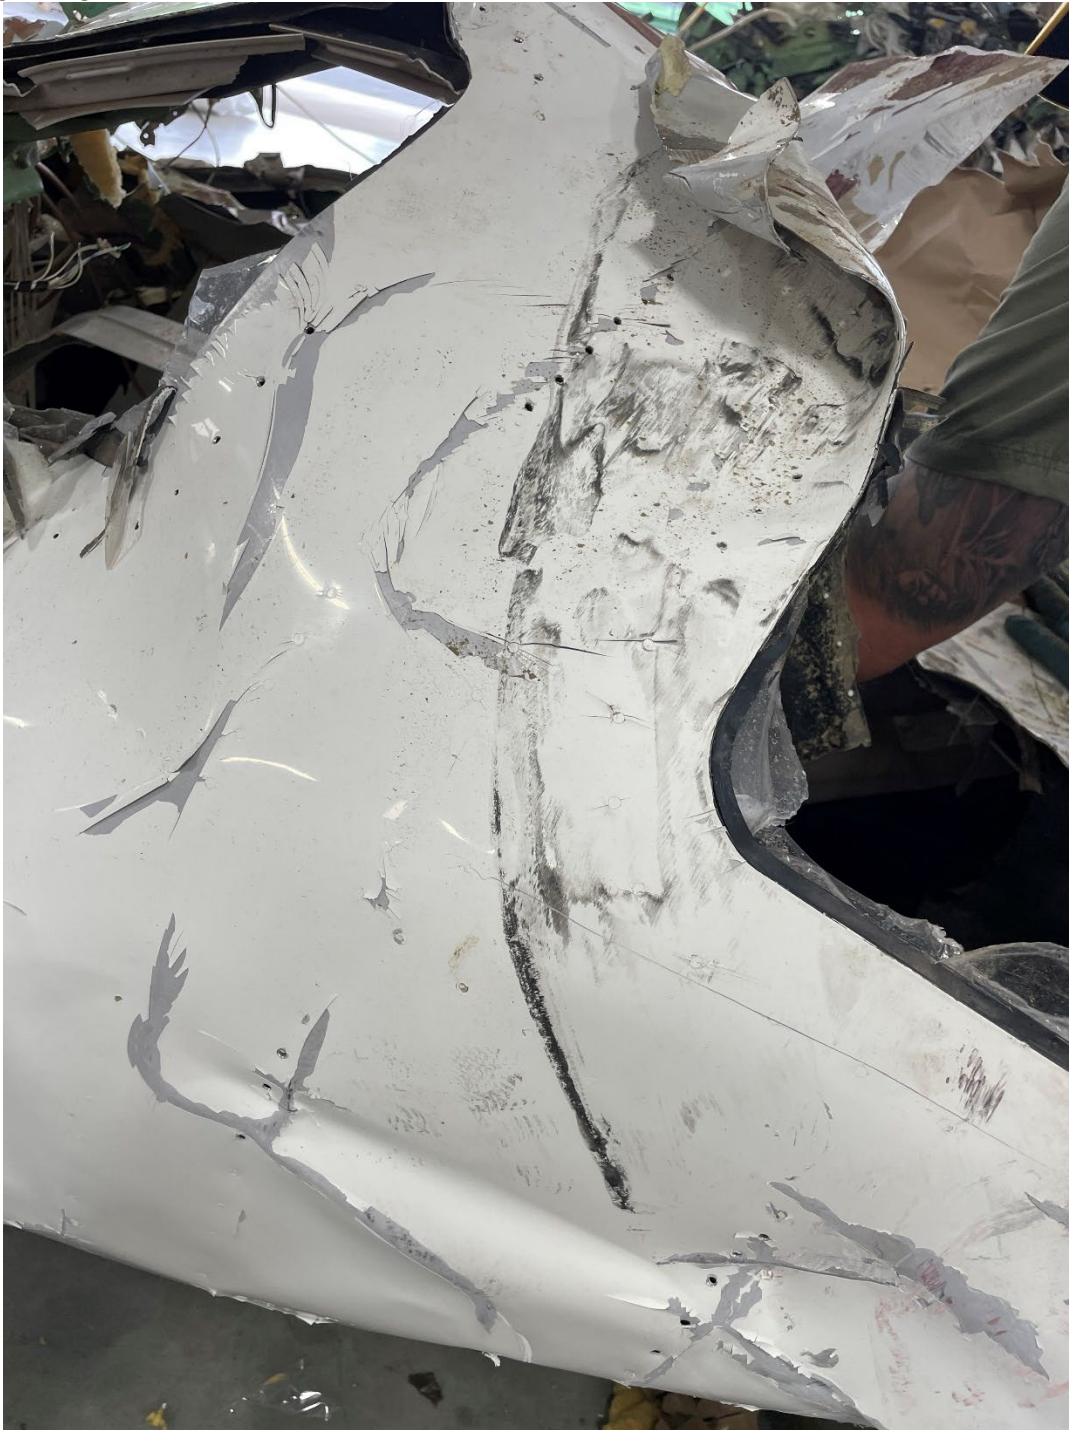
selector handle was broken from the instrument panel. The flap actuator displayed one thread exposed on the jackscrew, consistent with a flap retracted position. The fuel pump switch was found selected to auto. The propeller heat switch was found selected off and the pitot heat switch was found selected on. Black witness marks consistent with leading edge wing de-ice boots were found on the right side of the aft fuselage (Figure 2).

Figure 2. Right side aft Fuselage

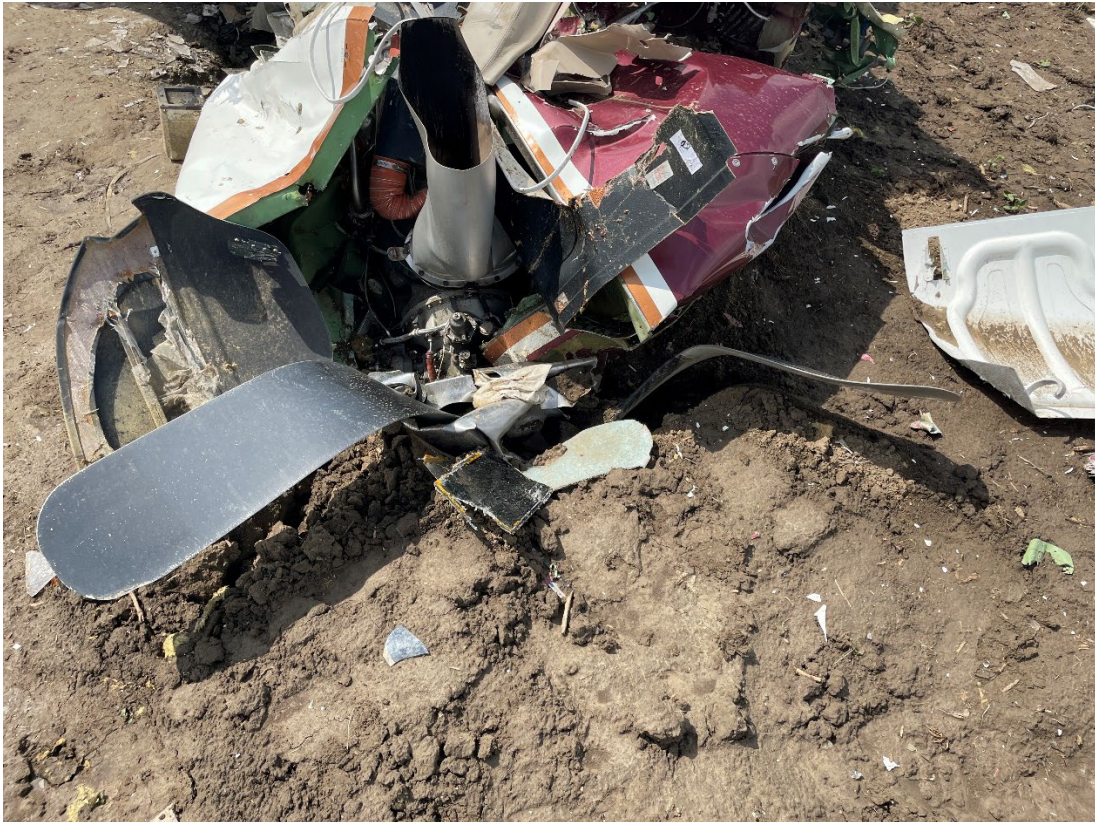
The engine was a Pratt and Whitney PT6A-42A, serial number PCE-RM0161. The engine was found embedded in soft mud and remained attached to the engine mount. The exhaust duct exhibited torsional buckling consistent with torque production. The engine was retained for further examination.

Figure 3. Engine and propeller as found at the accident site.
