# National Transportation Safety Board

CEN24FA188

## **FLIGHT TRACK DATA SUMMARY**

Date: May 15, 2024  
Time: 2039 central daylight time (0139 UTC)  
Location: Godley, Texas  
Airplane: Cessna 150L  
Registration: N1701Q

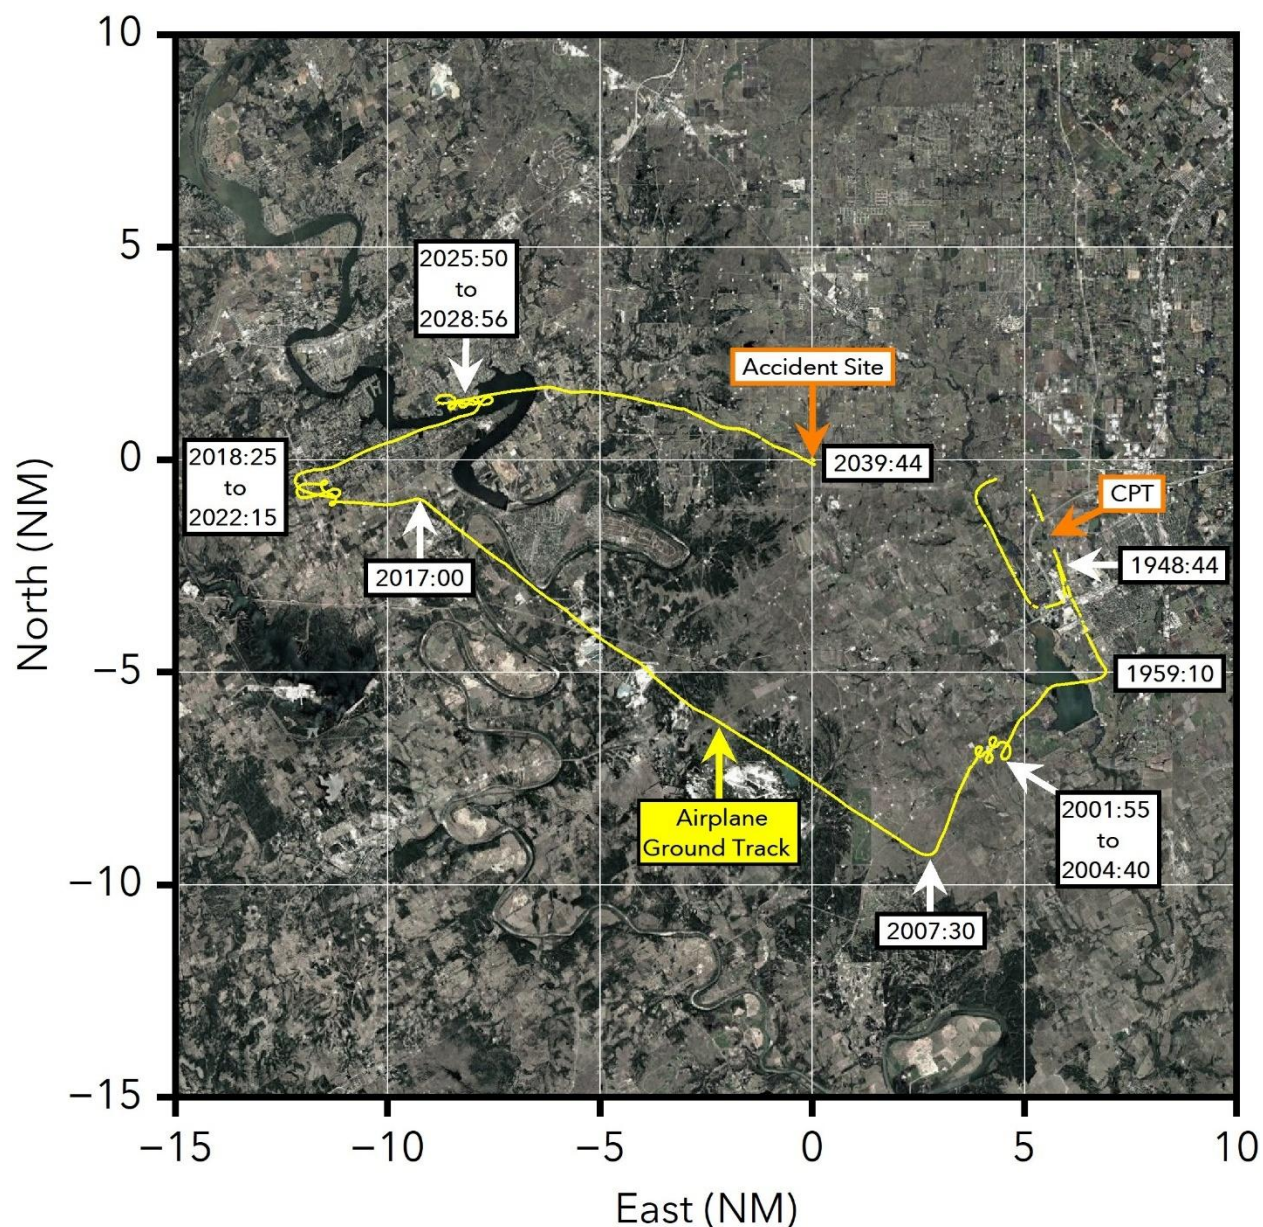
According to available ADS-B track data, at 1948:44, the airplane was in a climb after takeoff from runway 15 at Cleburne Regional Airport (CPT), Cleburne, Texas. The airplane entered a right traffic pattern for runway 15, completed one landing, and then flew south-southeast of CPT, as shown in figure 1.

**Figure 1.** Plot of airplane flight track data.

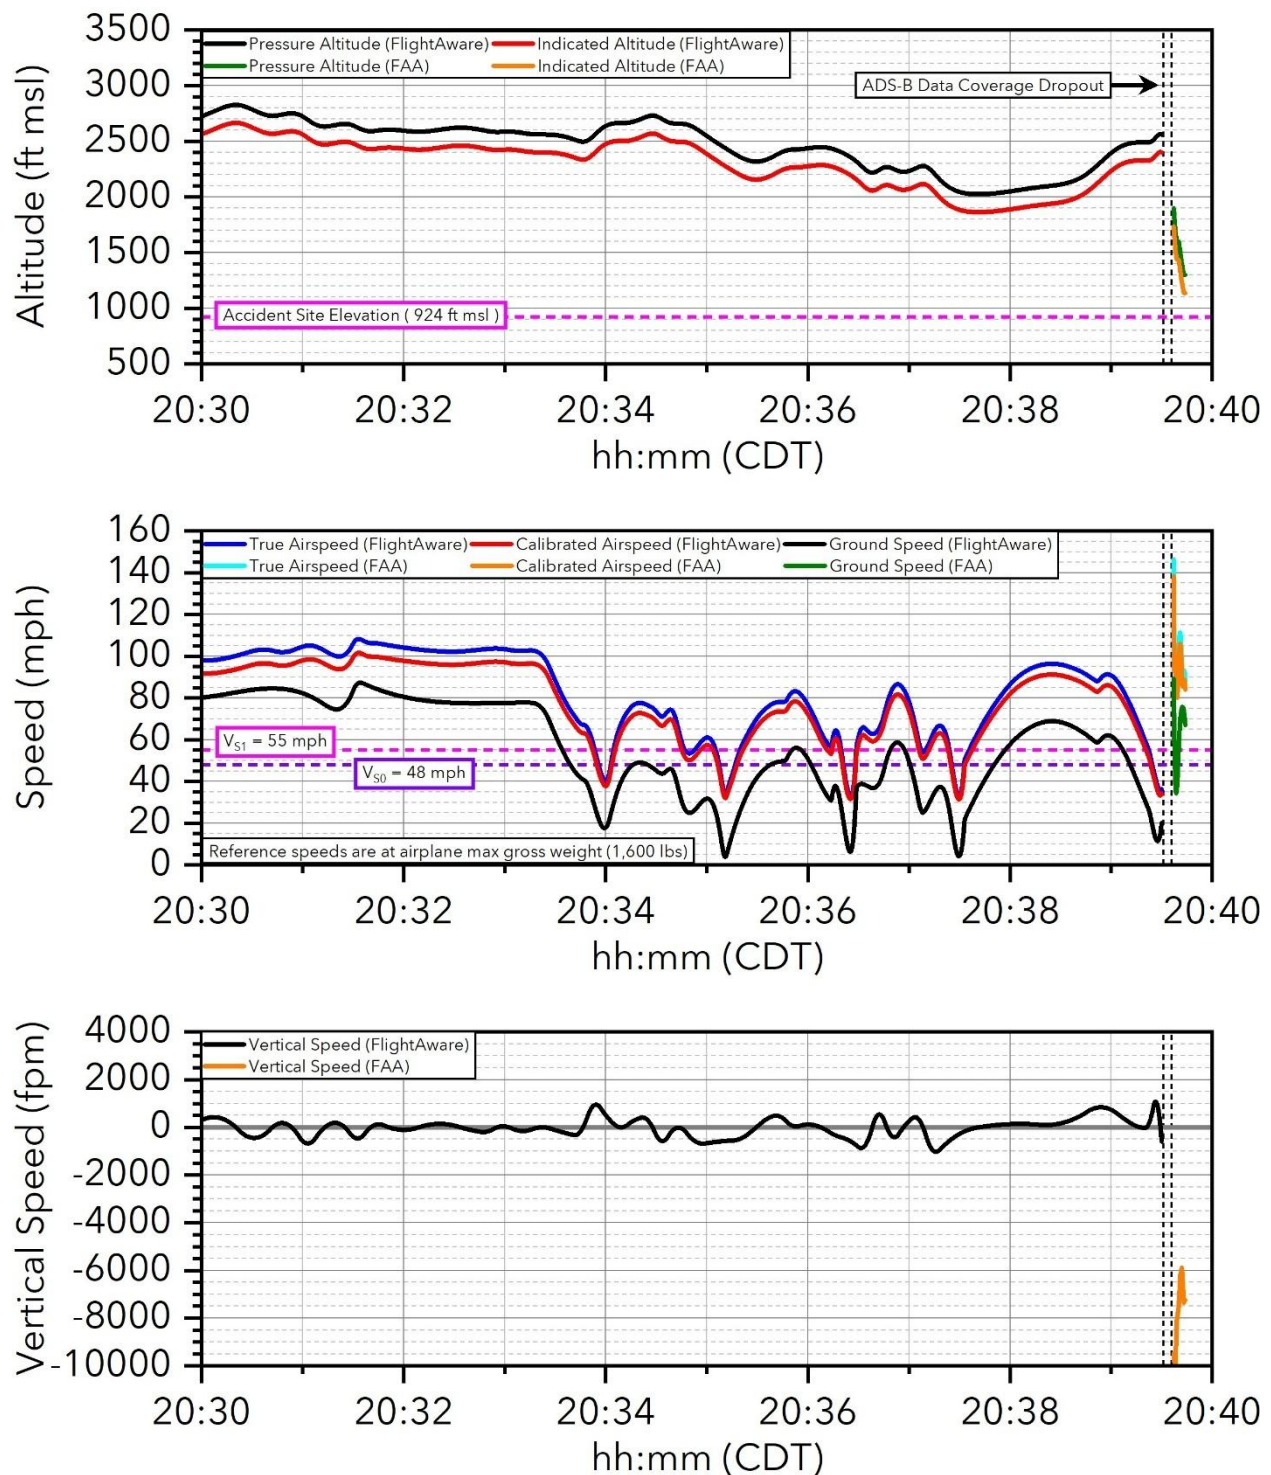
Airplane performance calculations, based on the available track data and an atmospheric model, revealed that between 2033:15 and 2038:00 the airplane completed four large deceleration-and-acceleration cycles, as shown in figure 2. During each of these four cycles, the airplane's calibrated airspeed (CAS) decreased below the airplane's aerodynamic stall speed before it increased again. The airspeed and altitude profiles during these maneuvers were consistent with the pilot practicing aerodynamic stalls.

At 2037:30, during the fourth deceleration-and-acceleration cycle, the airplane decelerated to about 31 mph CAS before it began accelerating. Over the next 10 seconds, the airplane briefly leveled off at 1,865 ft msl before it entered a climb. At 2038:25, the airplane had accelerated to 91 mph CAS and was climbing through 1,940 ft msl at a vertical speed about 100 fpm.

**Figure 2.** Plots of airplane pressure altitude, indicated altitude, ground speed, true airspeed, calibrated airspeed, and vertical speed.
