# National Transportation Safety Board

CEN24FA188

## **WRECKAGE EXAMINATION SUMMARY**

Date: May 15, 2024  
Time: 2039 central daylight time (0139 UTC)  
Location: Godley, Texas  
Airplane: Cessna 150L  
Registration: N1701Q

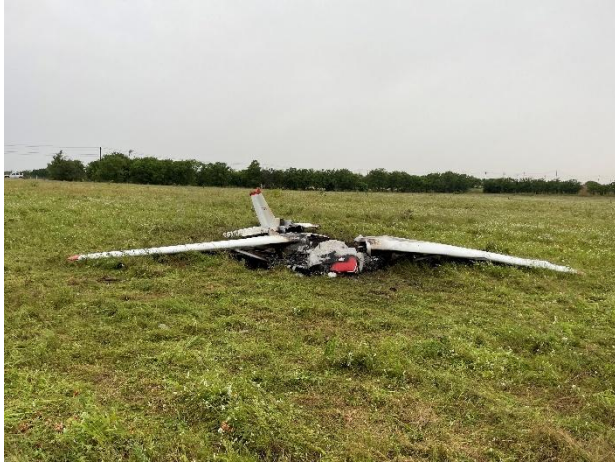
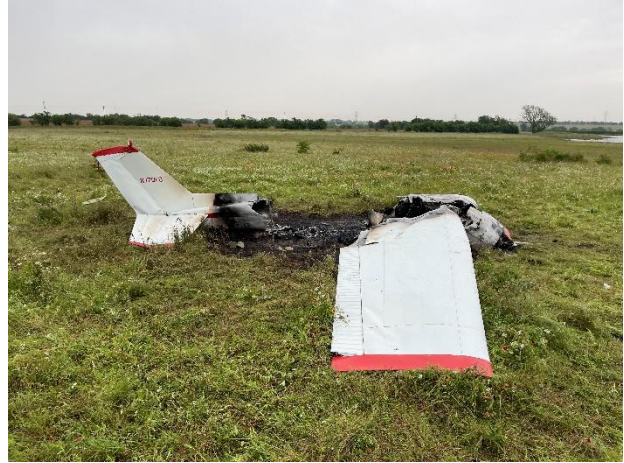
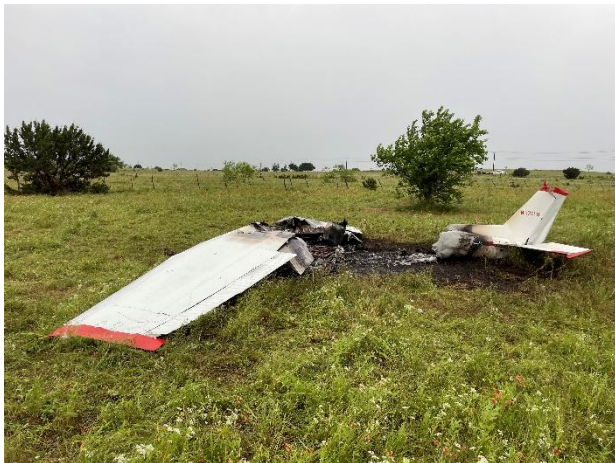
The airplane came to rest upright and wings level on a south-southeast (125° true) heading, as shown in figures 2-4. There was evidence of a significant postimpact fire that destroyed the entire cabin and cockpit. The cockpit and instrument panel, including all avionic devices, were destroyed during the fire, as shown in figure 5. There were no non-volatile memory components recovered. All flight control surfaces were located at the accident site. The fixed nose landing gear remained attached to the engine mount. The engine was canted down and to the right, as shown in figure 6.

**Figure 2.** Main wreckage, Front

**Figure 3.** Main wreckage, Right

**Figure 4.** Main wreckage, Left

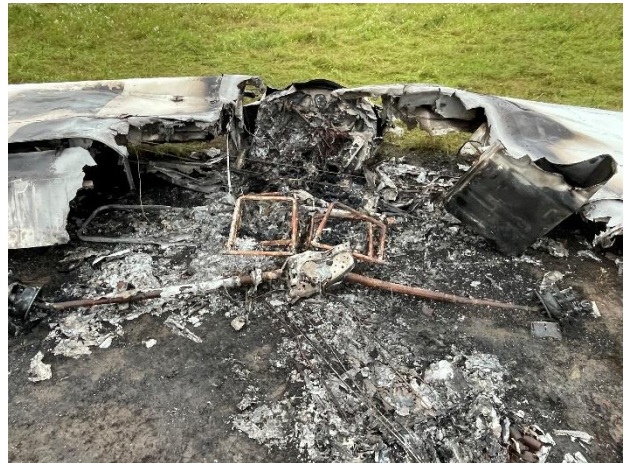
**Figure 5.** Cabin and Cockpit

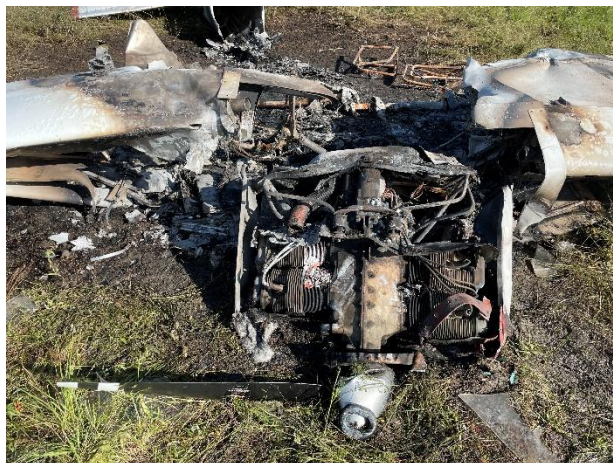
**Figure 6.** Engine

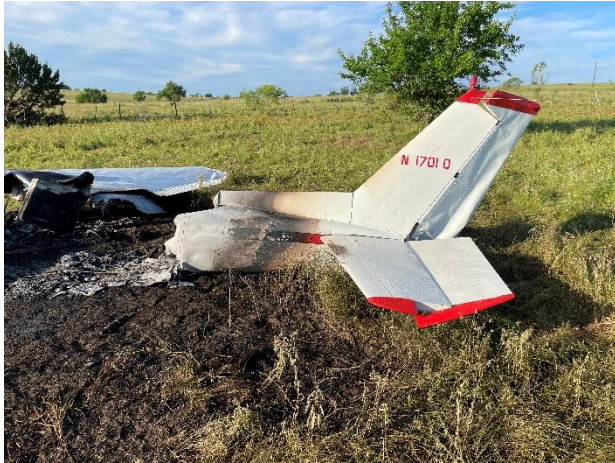
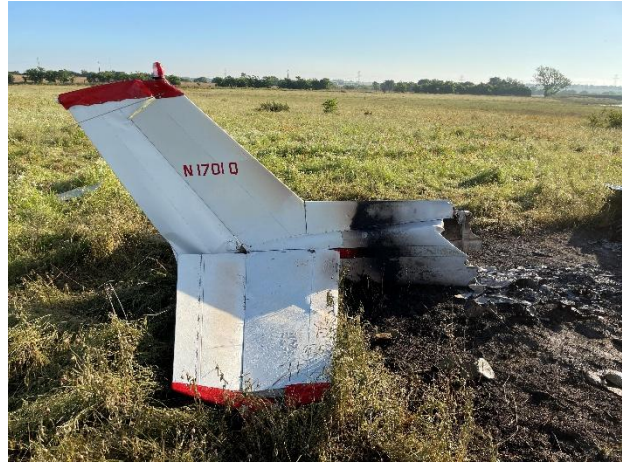
The empennage was thermally separated from the aft fuselage but, otherwise, remained relatively intact and displayed minor impact-related damage, as shown in figures 7-8. The empennage was displaced to the right. The vertical stabilizer with attached rudder and the left and right horizontal stabilizers with attached elevators remained attached to their respective attachment points.

**Figure 7.** Empennage, Left

**Figure 8.** Empennage, Right

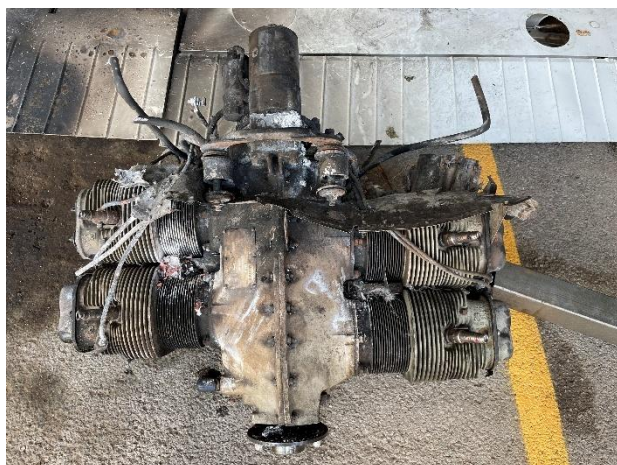
The engine was separated from the mounts during wreckage recovery, as shown in figure 9. The top spark plugs were removed and exhibited features consistent with normal engine operation, as shown in figure 10. The engine crankshaft rotated by hand through the propeller. Internal engine and valve train continuity were confirmed as the crankshaft was rotated through the crankshaft flange. Compression and suction were noted on cylinder nos. 2, 3, and 4 in conjunction with crankshaft rotation. No compression was noted on the no. 1 cylinder. The no. 1 cylinder exhaust valve did not move in conjunction with crankshaft/camshaft rotation. A borescope inspection of each cylinder did not reveal any anomalies with the cylinders, pistons, valves, valve seats, or bottom spark plugs. The spin-on type oil filter was found separated and thermally damaged. The oil filter was not disassembled during the examination.

**Figure 9.** Engine

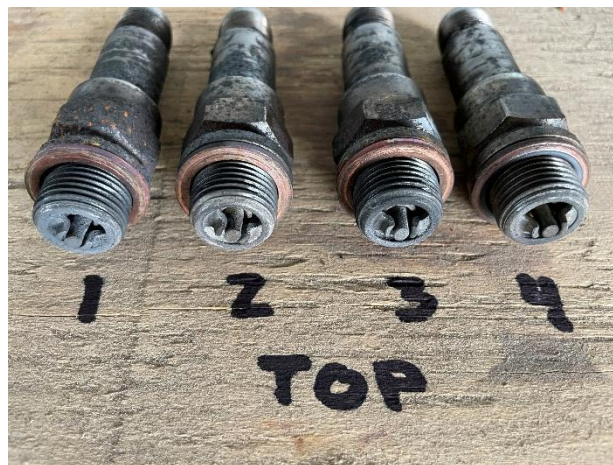
**Figure 10.** Spark plugs, Top

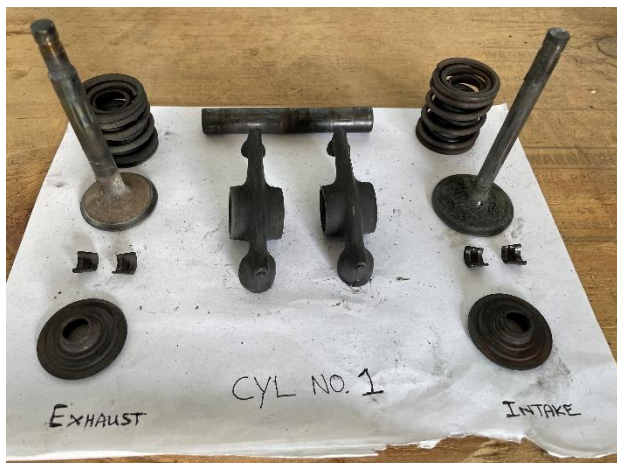
The no. 1 cylinder was separated from the engine crankcase to remove the intake and exhaust valves and their associated spring assemblies, as shown in figure 11. The three exhaust valve springs were about 0.25 inch shorter than the intake valve springs, as shown in figure 12. The height difference was consistent with the exhaust springs being compressed at impact and taking a new set when they cooled after the postimpact fire. The shorter exhaust valve springs did not allow the exhaust valve to seat, which resulted in the lack of cylinder compression when tested.

**Figure 11.** Valves, No. 1 Cylinder

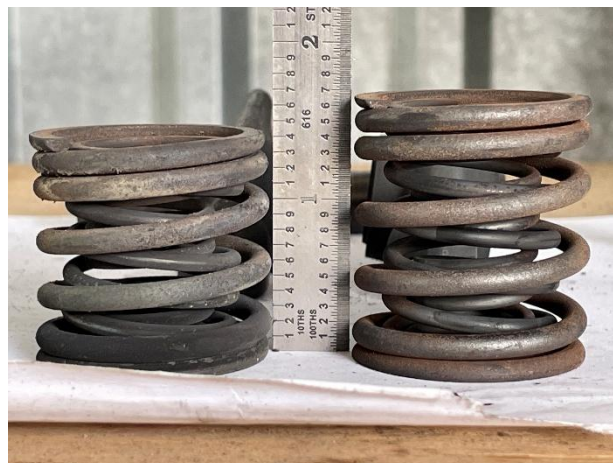
**Figure 12.** Valve Springs, No. 1 Cylinder

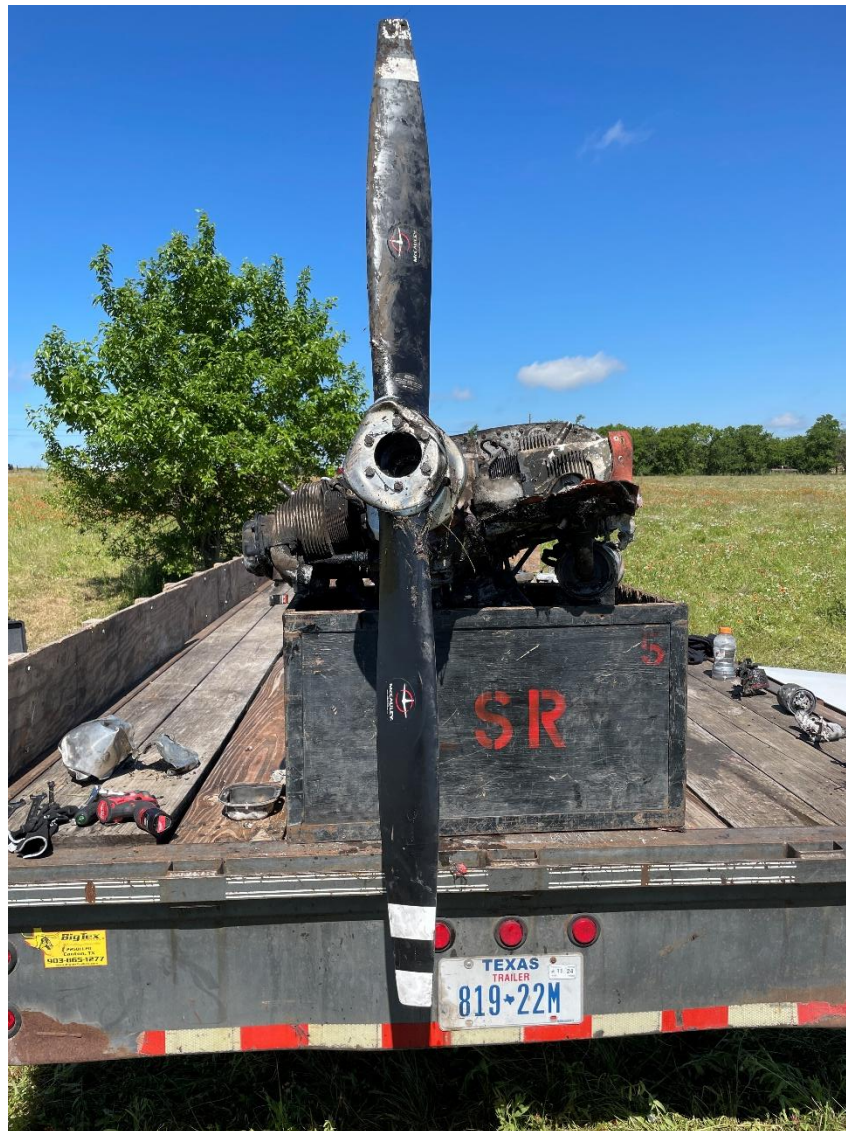
The fixed 2-blade propeller blade remained attached to the engine crankshaft propeller flange and spacer, as shown in figure 13. Propeller blade "A", shown in figure 14, exhibited a slight bend/twist about 10 inches from the blade tip, a leading-edge gouge, shown in figure 15, and minor chordwise scratches. Propeller blade "B", shown in figure 16, was relatively undamaged and did not exhibit any bends, twists, leading edge damage, or chordwise scratches.

**Figure 13.** Propeller

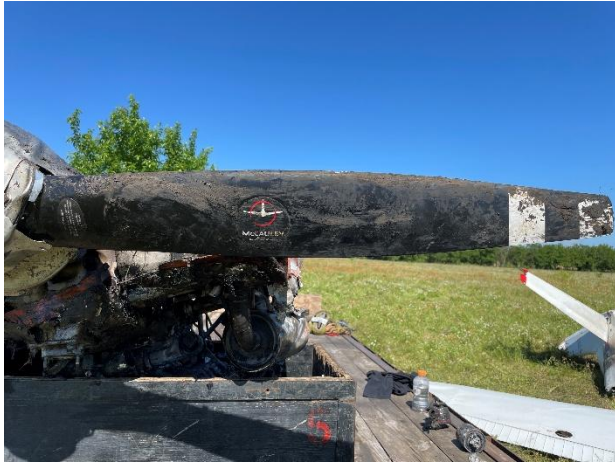
**Figure 14.** Propeller Blade "A"

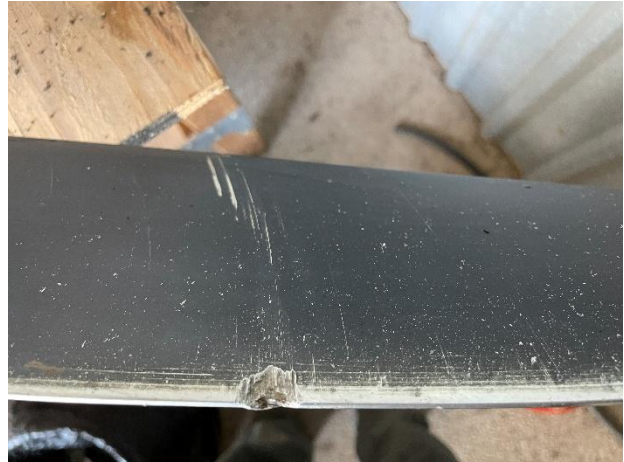
**Figure 15.** Blade "A" gouge and scrapes

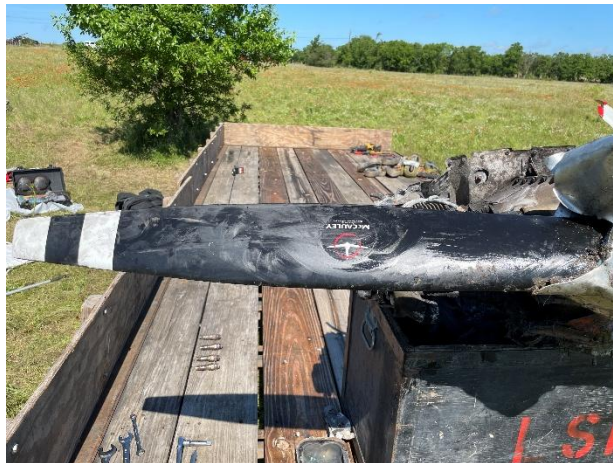
**Figure 16.** Propeller Blade "B"
