Bradley Miller  
Aviation Accident Investigator  
AS-CEN

**Subject:** CEN24FA212 - Maintenance Review Summary

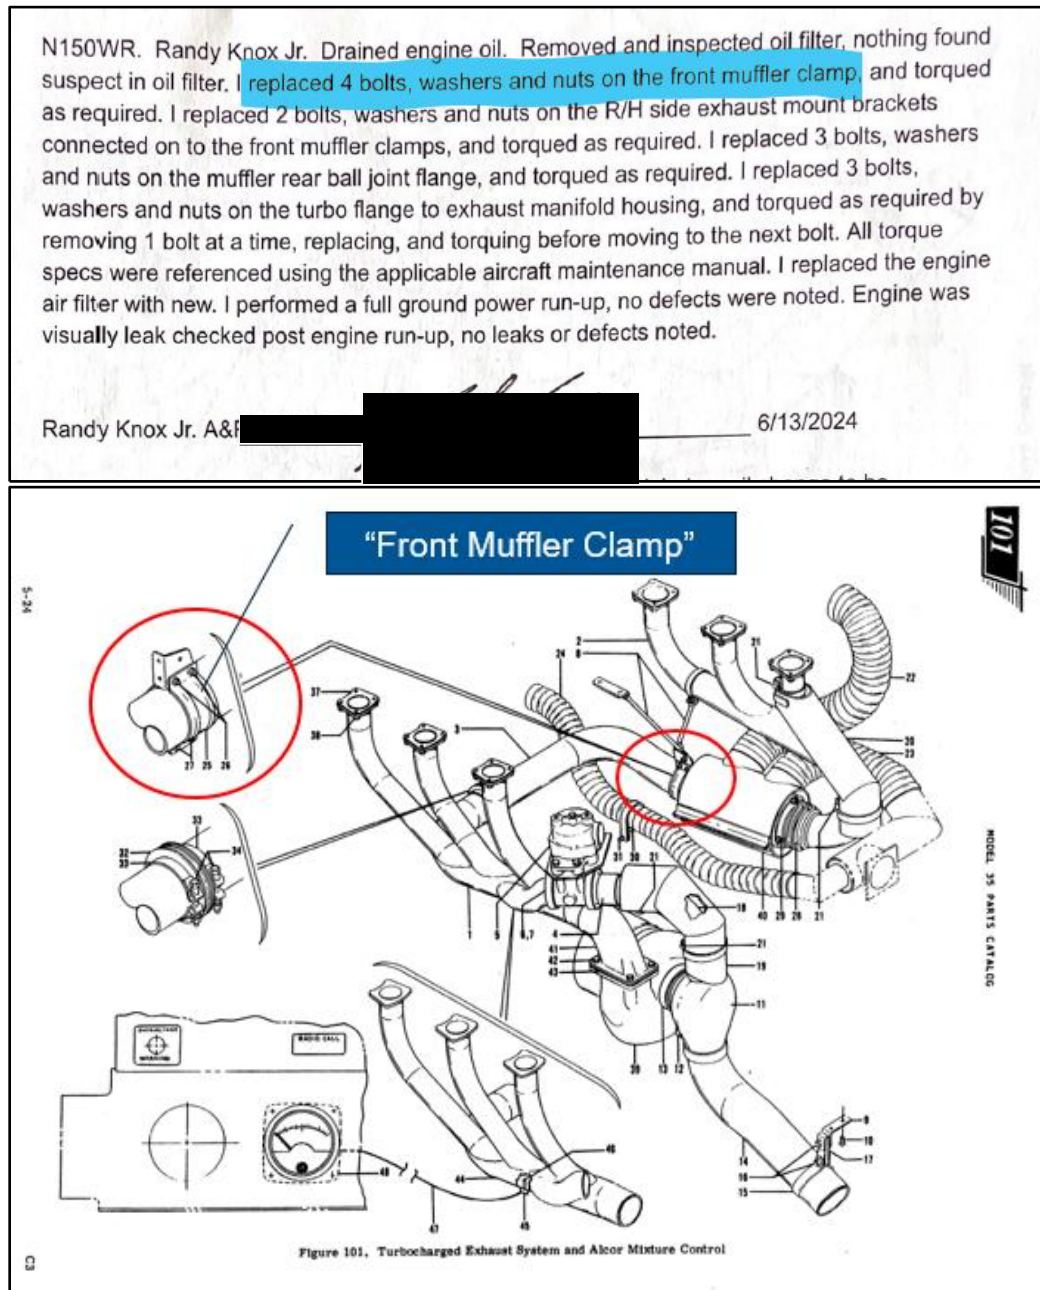
Figure 2. Front muffler clamp hardware.

N150WR. Randy Knox Jr. Drained engine oil. Removed and inspected oil filter, nothing found suspect in oil filter. I replaced 4 bolts, washers and nuts on the front muffler clamp, and torqued as required. I replaced 2 bolts, washers and nuts on the R/H side exhaust mount brackets connected on to the front muffler clamps, and torqued as required. I replaced 3 bolts, washers and nuts on the muffler rear ball joint flange, and torqued as required. I replaced 3 bolts, washers and nuts on the turbo flange to exhaust manifold housing, and torqued as required by removing 1 bolt at a time, replacing, and torquing before moving to the next bolt. All torque specs were referenced using the applicable aircraft maintenance manual. I replaced the engine air filter with new. I performed a full ground power run-up, no defects were noted. Engine was visually leak checked post engine run-up, no leaks or defects noted.

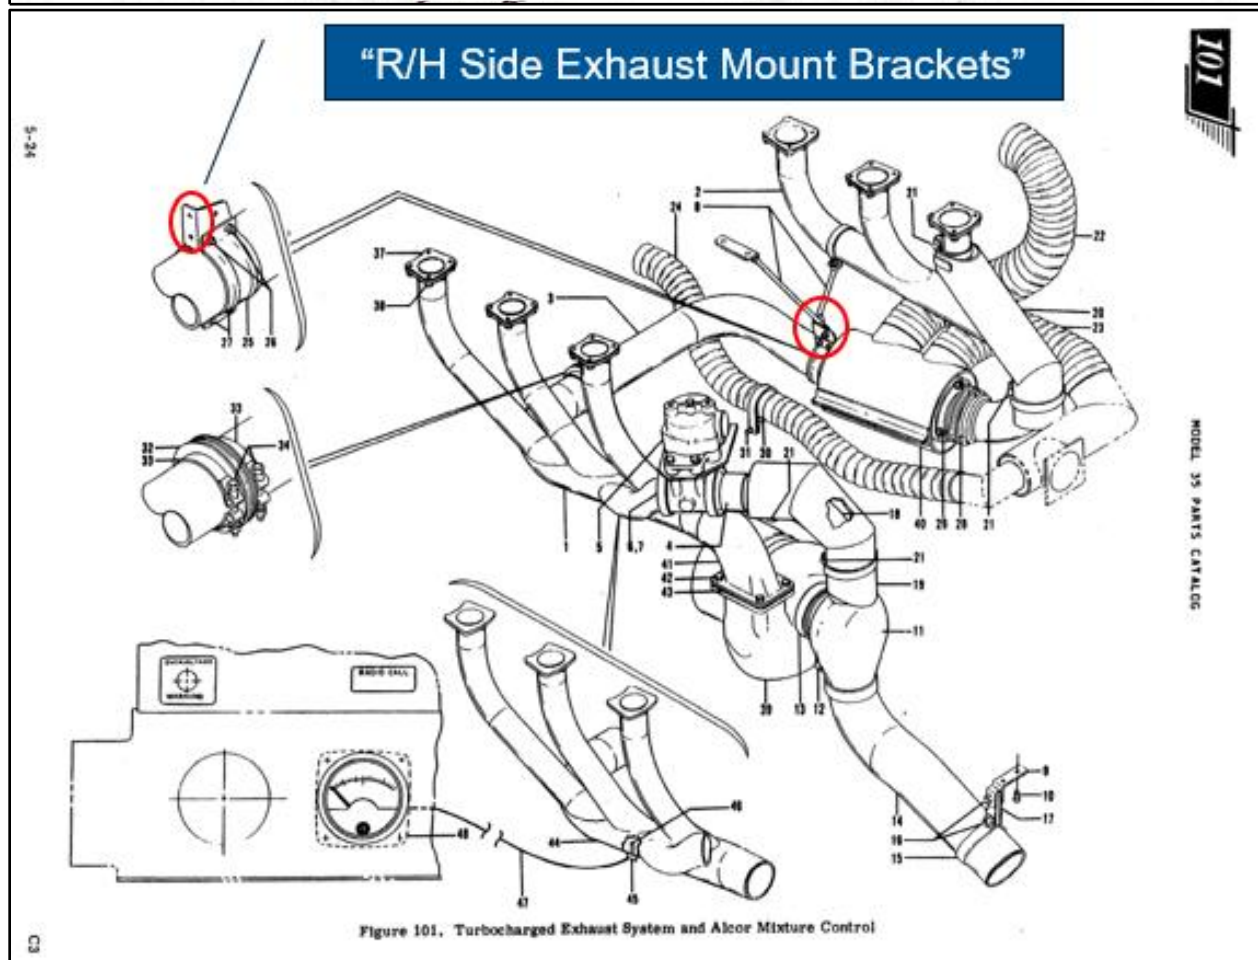
Figure 3. Exhaust mount brackets hardware.

N150WR. Randy Knox Jr. Drained engine oil. Removed and inspected oil filter, nothing found suspect in oil filter. I replaced 4 bolts, washers and nuts on the front muffler clamp, and torqued as required. I replaced 2 bolts, washers and nuts on the R/H side exhaust mount brackets connected on to the front muffler clamps, and torqued as required. I replaced 3 bolts, washers and nuts on the muffler rear ball joint flange, and torqued as required. I replaced 3 bolts, washers and nuts on the turbo flange to exhaust manifold housing, and torqued as required by removing 1 bolt at a time, replacing, and torquing before moving to the next bolt. All torque specs were referenced using the applicable aircraft maintenance manual. I replaced the engine air filter with new. I performed a full ground power run-up, no defects were noted. Engine was visually leak checked post engine run-up, no leaks or defects noted.

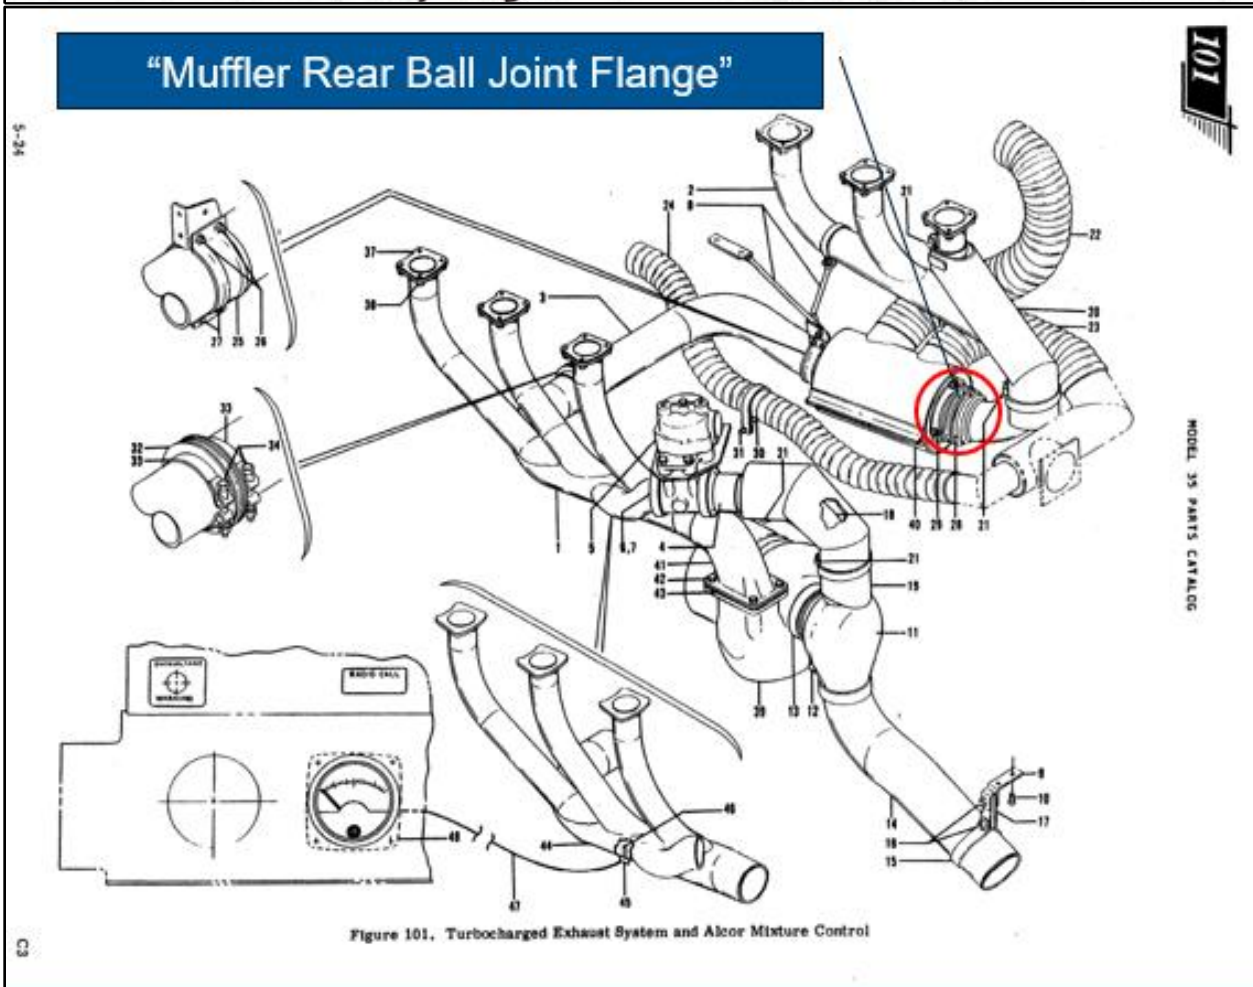
Figure 4. Muffler rear ball joint flange hardware.

N150WR. Randy Knox Jr. Drained engine oil. Removed and inspected oil filter, nothing found suspect in oil filter. I replaced 4 bolts, washers and nuts on the front muffler clamp, and torqued as required. I replaced 2 bolts, washers and nuts on the R/H side exhaust mount brackets connected on to the front muffler clamps, and torqued as required. I replaced 3 bolts, washers and nuts on the muffler rear ball joint flange, and torqued as required. I replaced 3 bolts, washers and nuts on the turbo flange to exhaust manifold housing, and torqued as required by removing 1 bolt at a time, replacing, and torquing before moving to the next bolt. All torque specs were referenced using the applicable aircraft maintenance manual. I replaced the engine air filter with new. I performed a full ground power run-up, no defects were noted. Engine was visually leak checked post engine run-up, no leaks or defects noted.

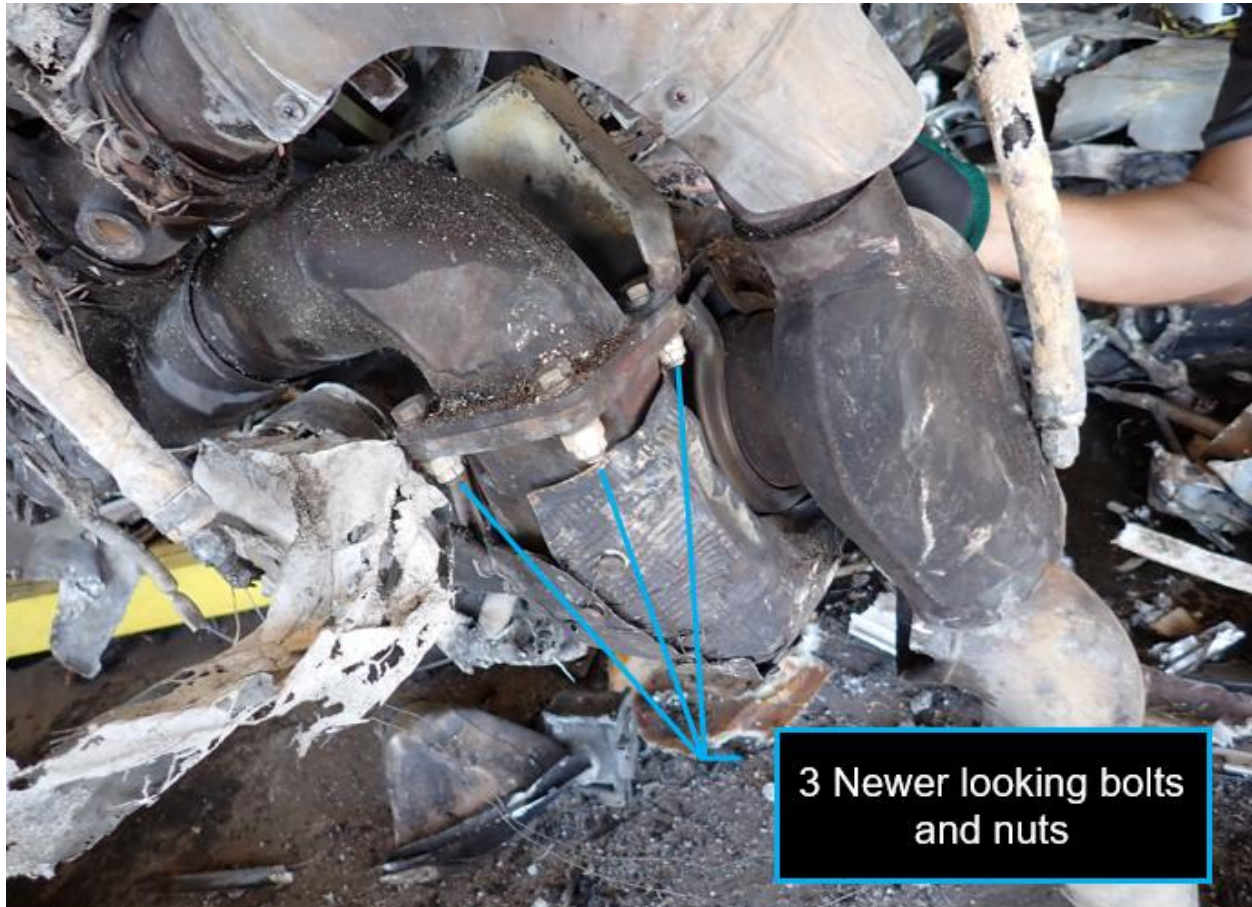
Figure 6. New bolts found during wreckage examination.

During the wreckage layout examination, prior to talking to the technicians, three newer bolts were noted on the turbocharger exhaust flange that match the location described by the technicians. See Figure 6.
