CEN24FA212

## INVESTIGATION PHOTOGRAPHS

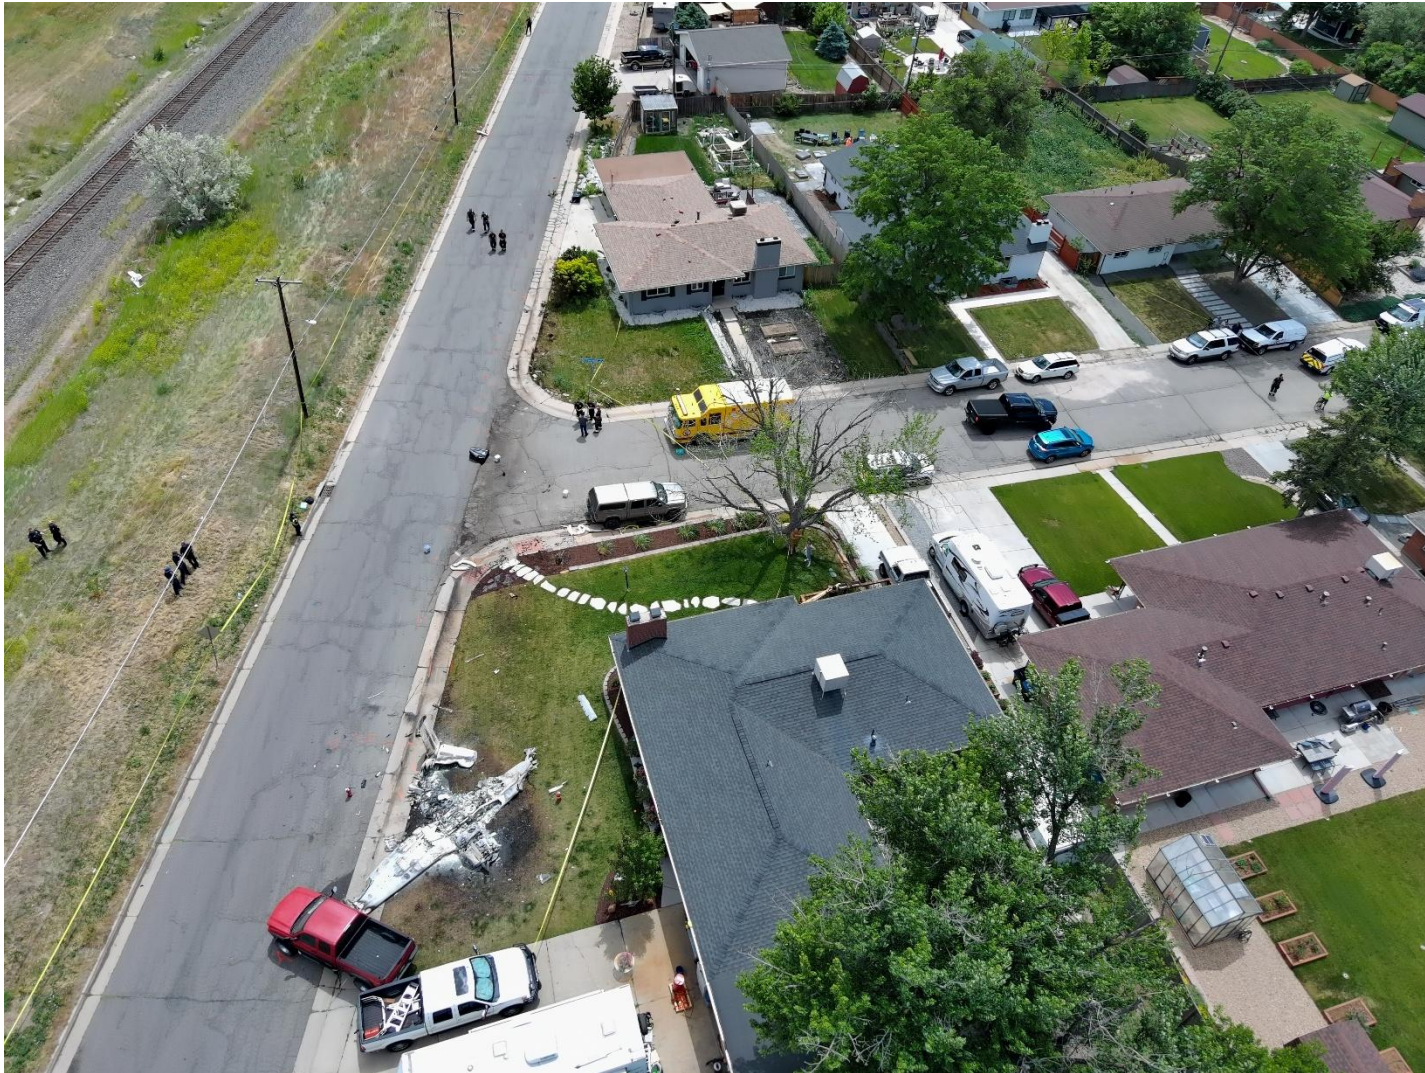
**Photograph 1 - Accident site (courtesy of local law enforcement)**

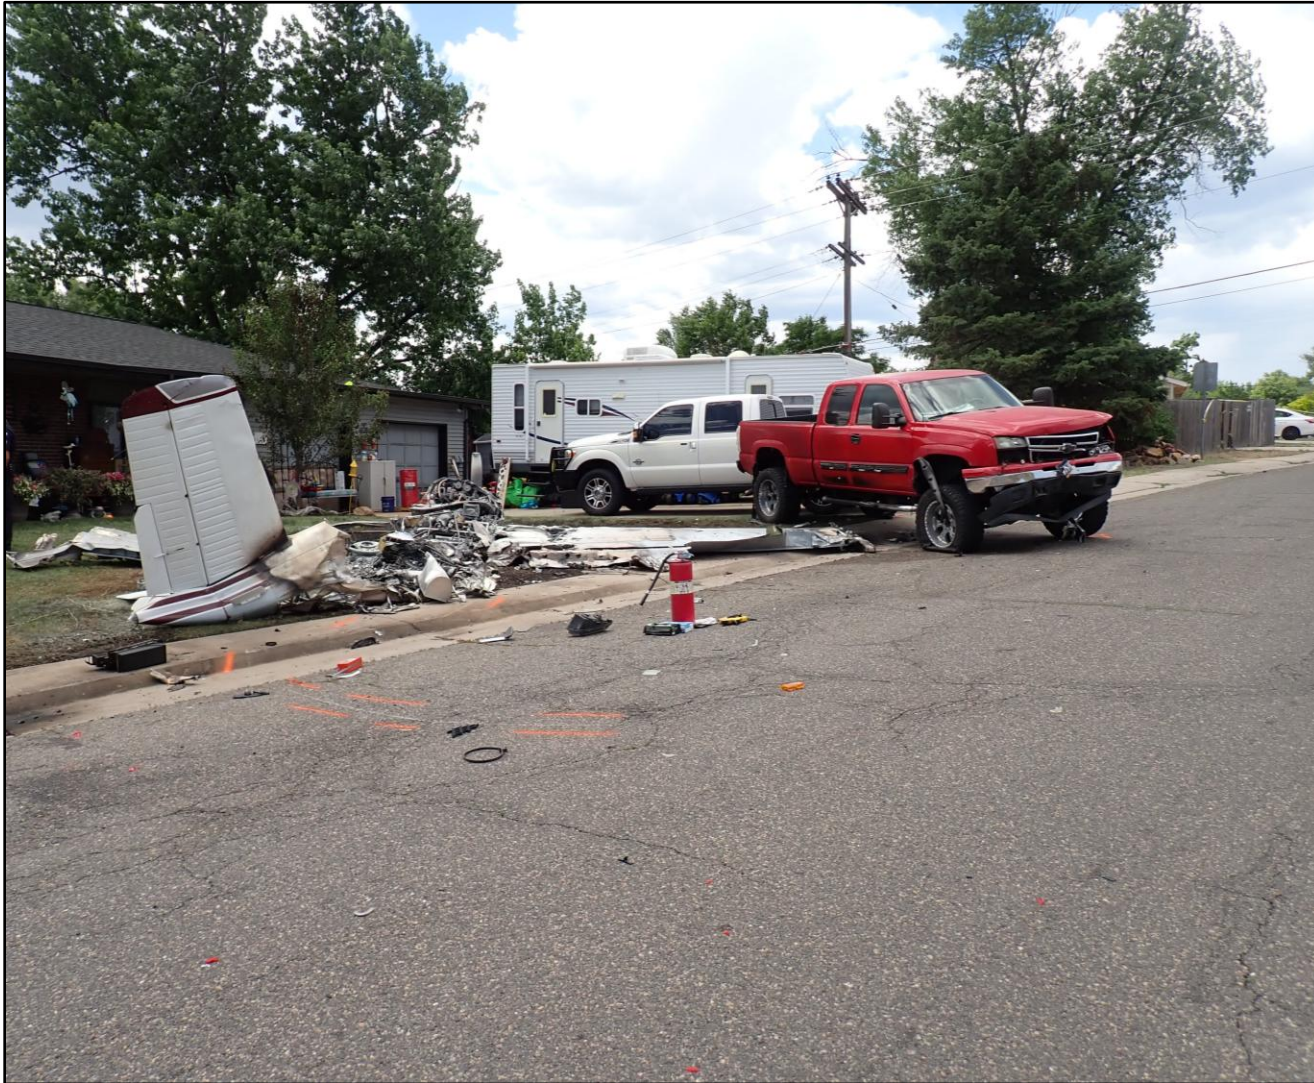
**Photograph 2 - Accident site**

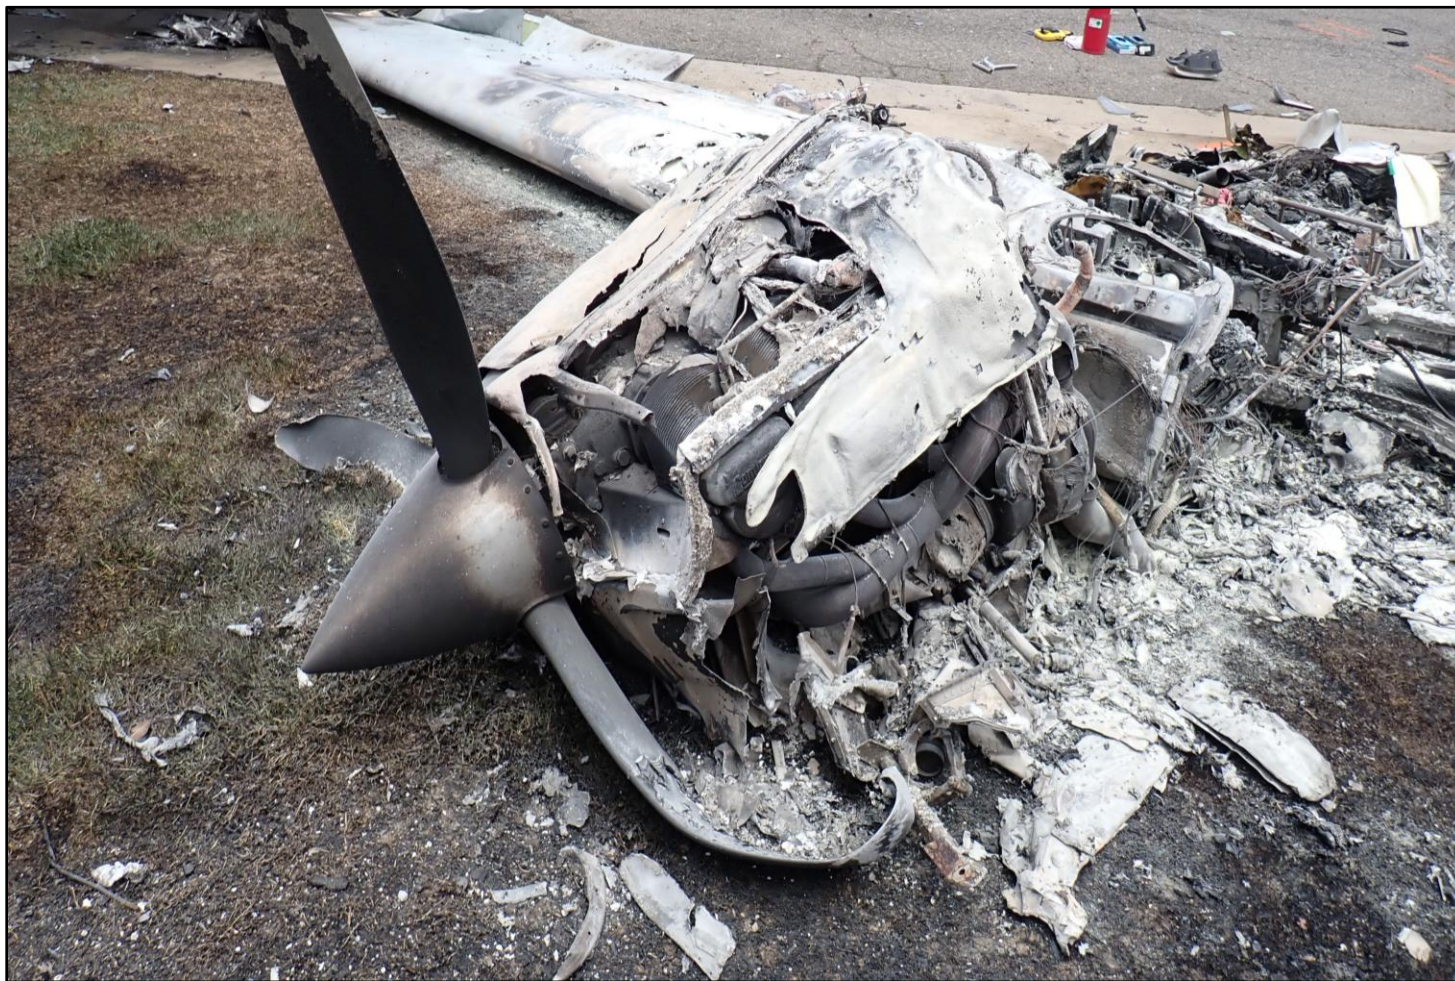
**Photograph 3 - Engine and propeller**

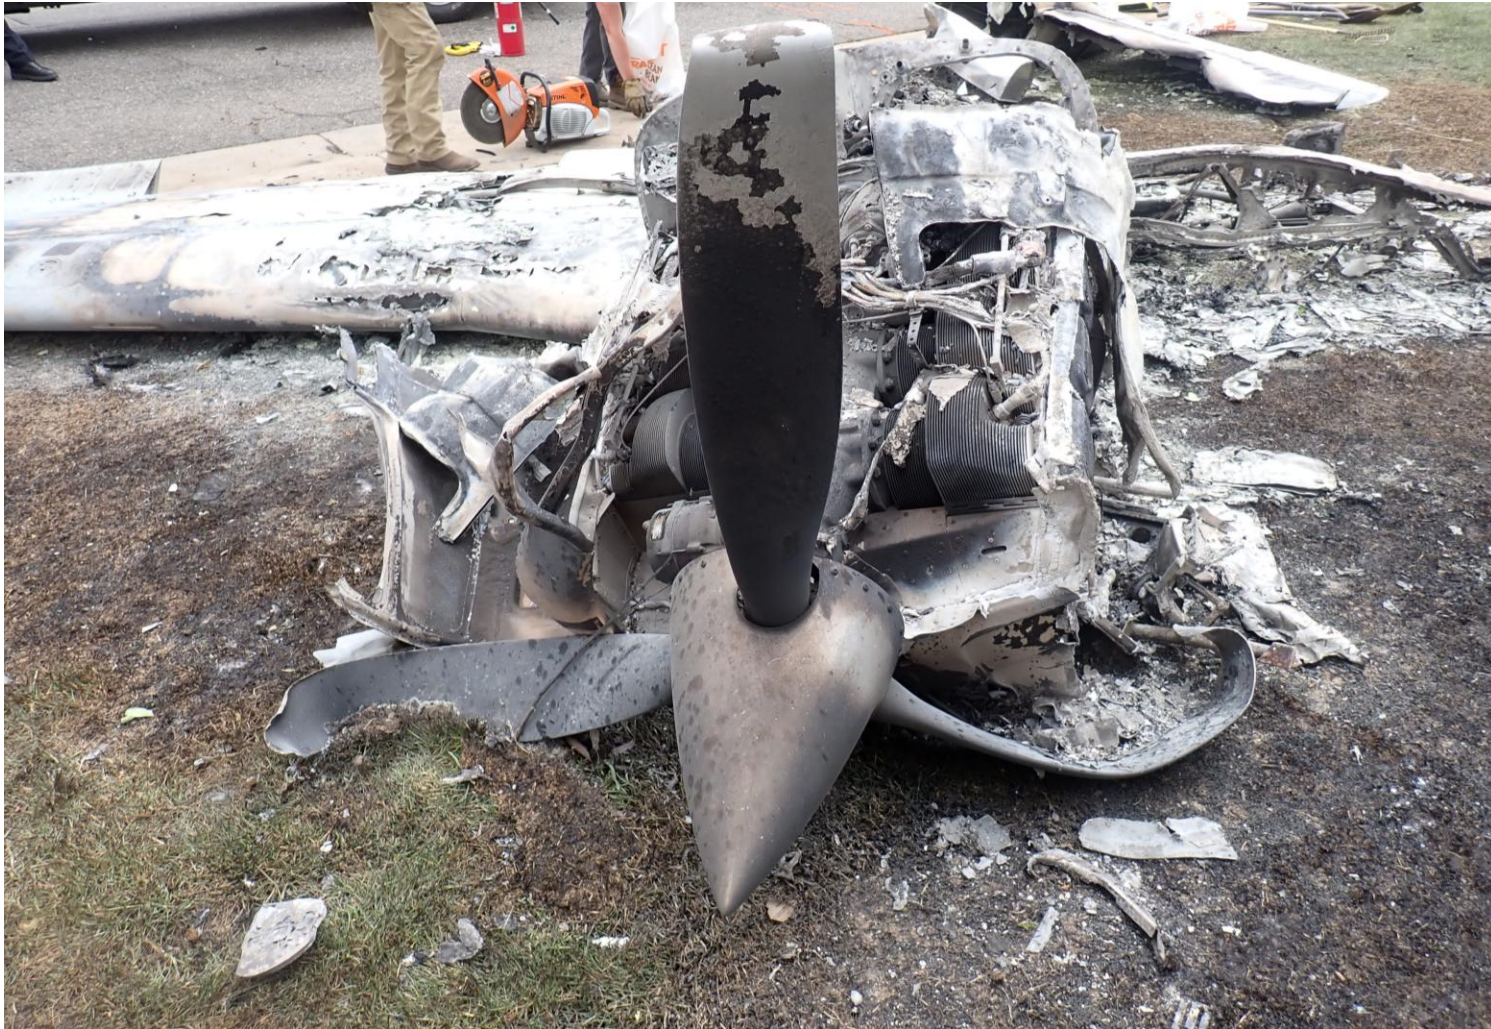
**Photograph 4 - Propeller**

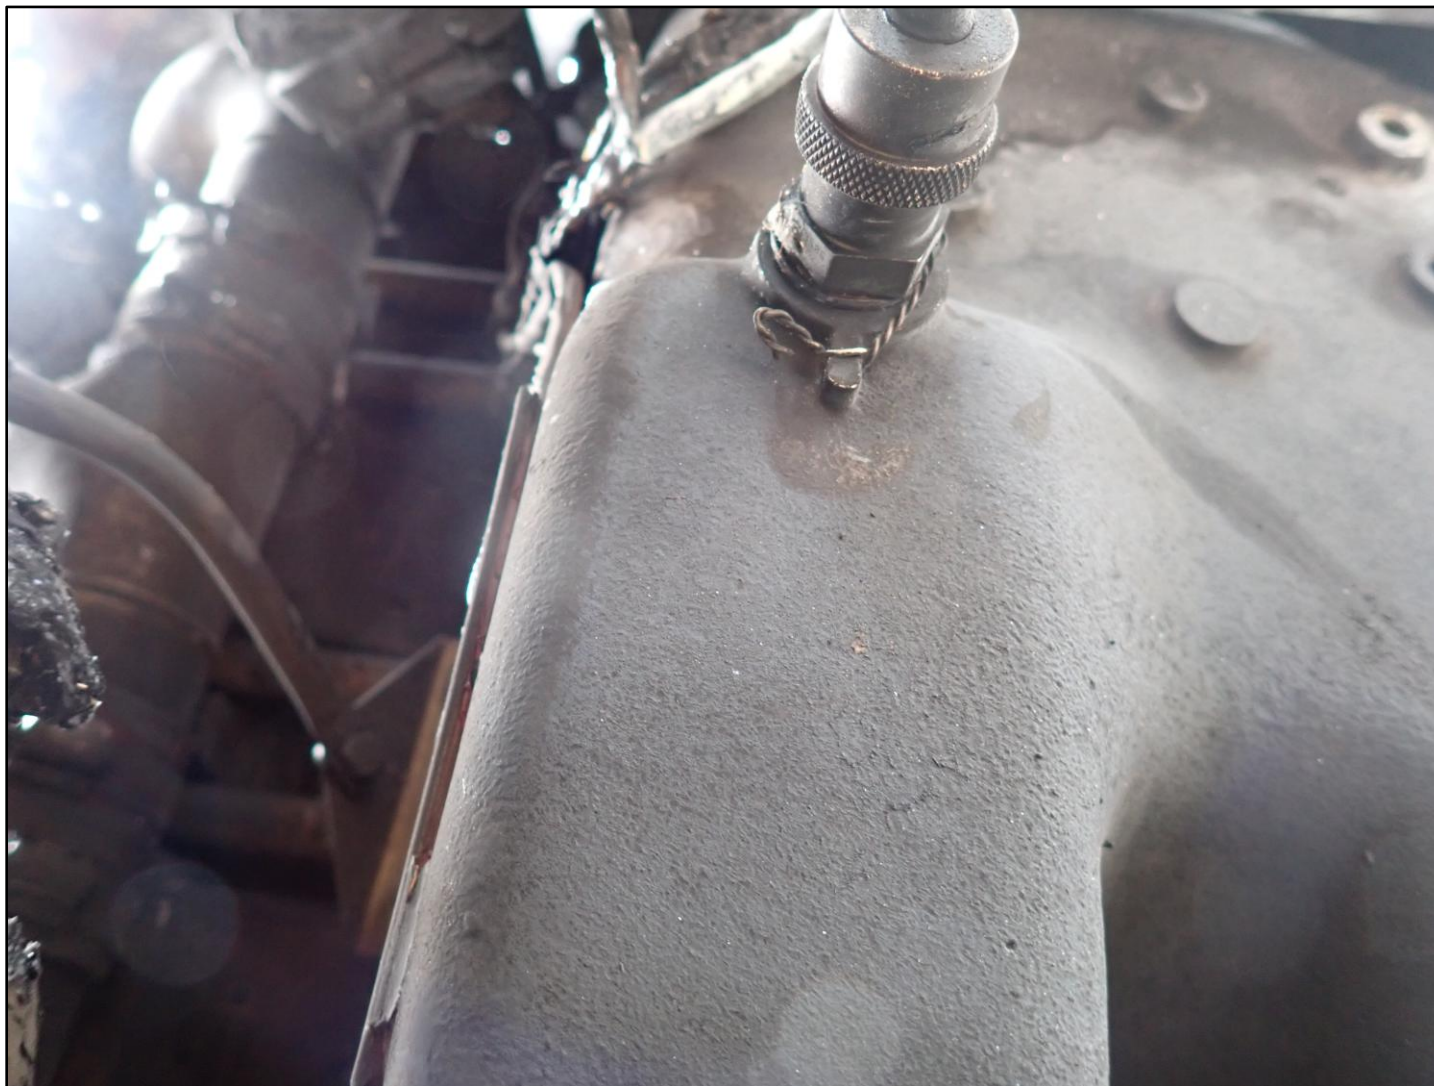
**Photograph 5 - Oil quick drain as found at accident site**

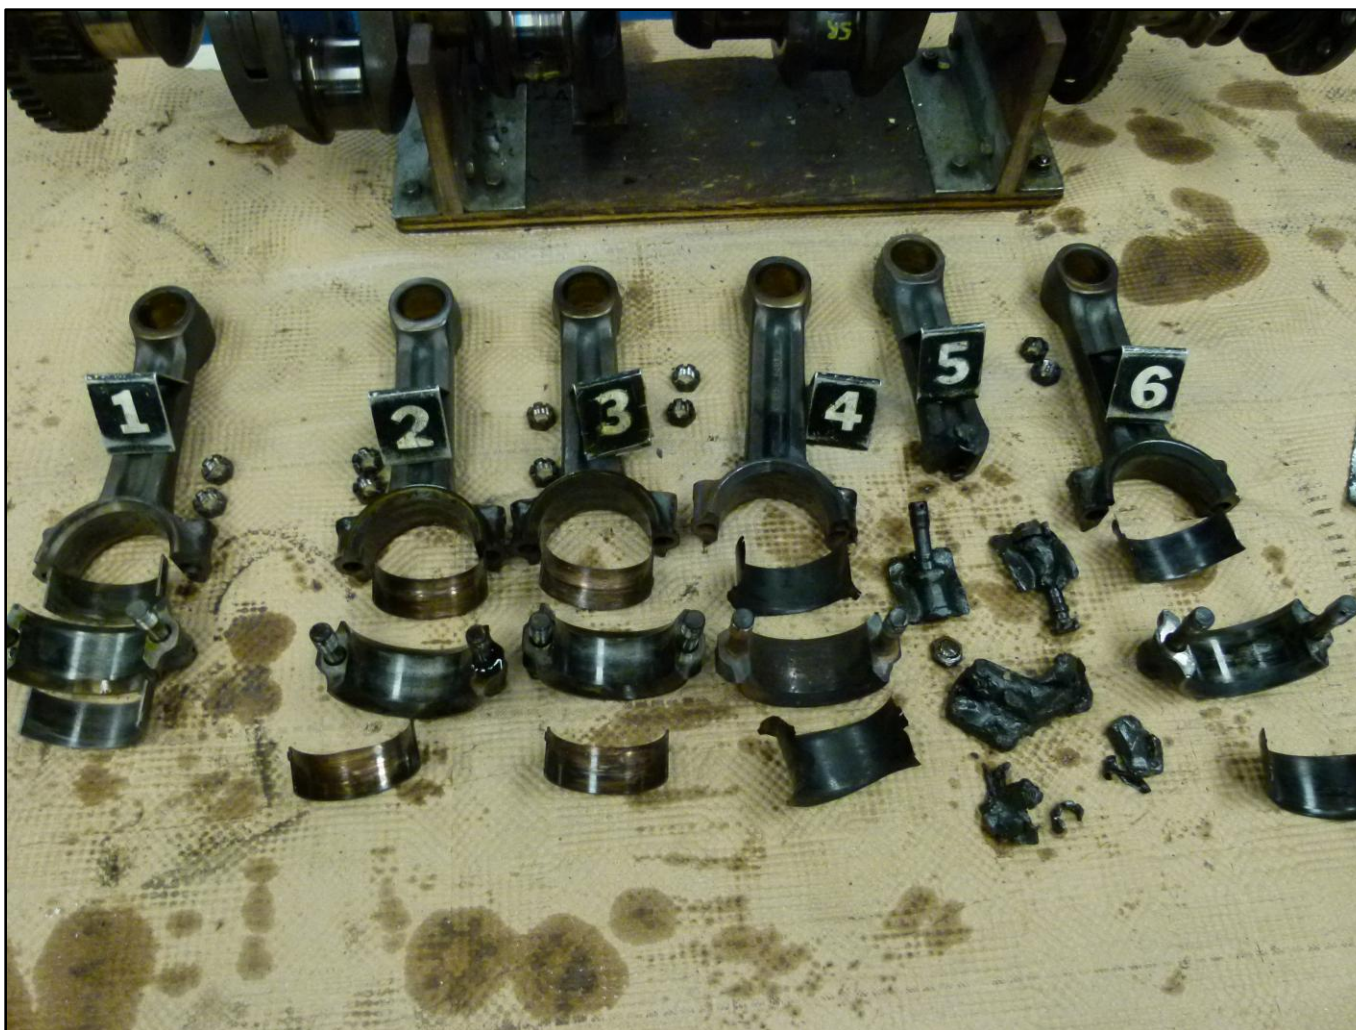
**Photograph 6 - Engine examination - connecting rods and bearings  
(Courtesy of Continental Aerospace Technologies)**

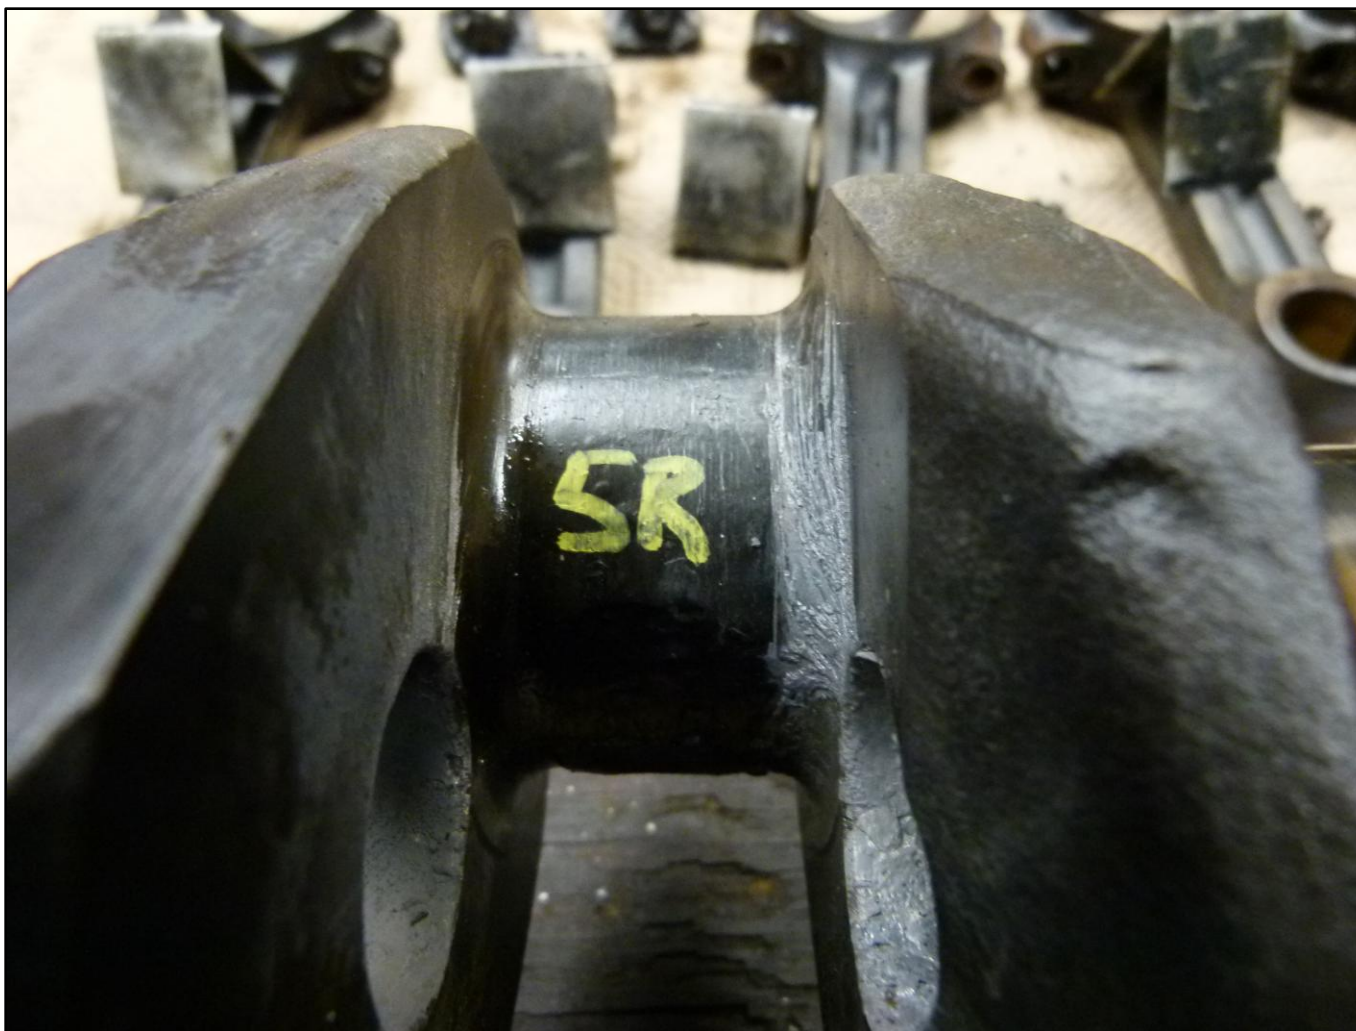
**Photograph 7 - Engine examination - No. 5 connecting rod journal  
(Courtesy of Continental Aerospace Technologies)**
