# National Transportation Safety Board

CEN24FA212

## **WRECKAGE EXAMINATION**

Location: Arvada, Colorado  
Date: June 7, 2024  
Time: 0930 Mountain Daylight Time  
1530 Universal Coordinated Time (UTC)  
Airplane: Beech V35A Airplane, N150WR

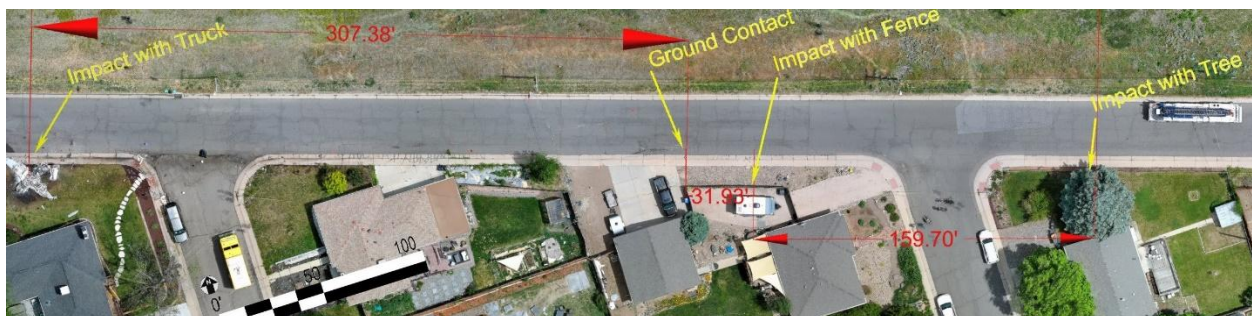
Figure 1. Accident Site Diagram (courtesy of Denver Police Department)

Examination of the accident site showed that the airplane's left wingtip impacted a 30-ft tall tree adjacent to the roadway. Parts of the left wingtip were found in the roadway near the tree. Evidence at the accident site showed that the airplane contacted the roadway, gear up, and slid down the road until it collided with a parked vehicle and came to rest upright in the front yard of a private residence. Ground scars on the roadway were consistent with contact and scraping from the bottom of the fuselage. The distance traveled from the initial impact with the tree to the final resting place was about 400 ft. See Figure 1.

Initial point of impact was a tree.

159 feet from initial point of impact on the left side of the road, impact damage was noted on a fence.

191 feet from the initial point of impact, markings on the road indicated ground contact had been made by the accident airplane.

499 feet from the initial point of impact, the airplane impacted a parked pickup truck and came to rest in the front yard of a residence.

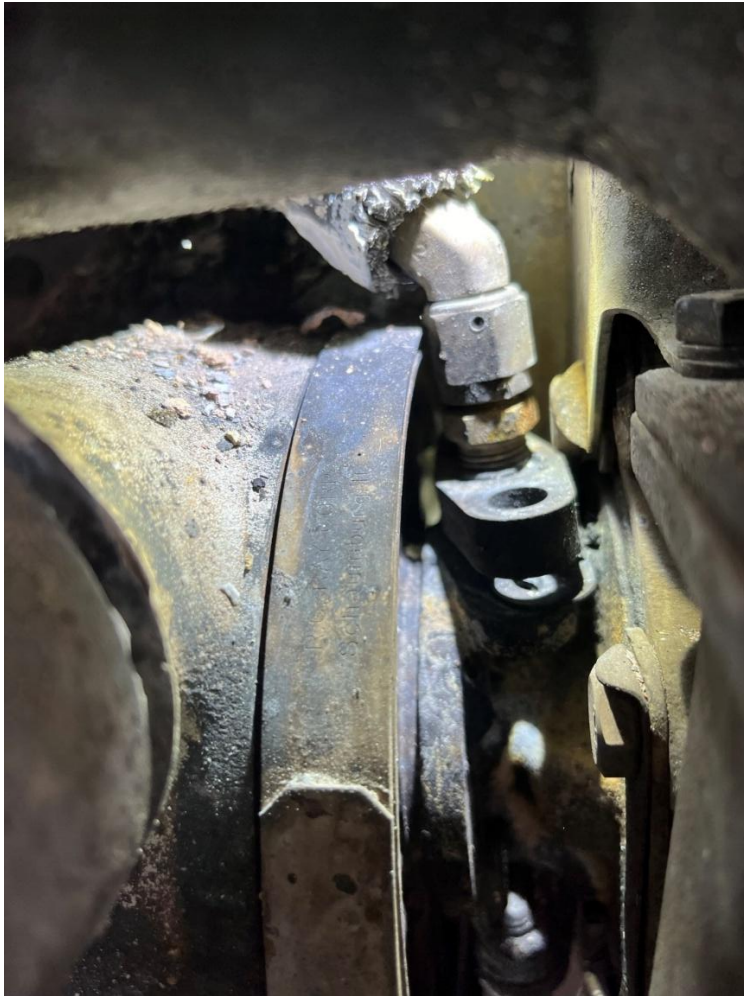
Figure 2. Missing bolt.

The turbocharger oil supply (pressure side) line fitting that connected the oil line to the top of the turbocharger assembly was missing one attachment bolt. The other attachment bolt was found loose. The bolts for the attach fitting for the turbocharger oil return line that exited the bottom of the turbocharger assembly were found loose. Components of the turbocharger were removed to expose the exhaust end of the turbocharger assembly. The outboard trailing edge of the hot section turbine blades were damaged, and some material was missing on the corner of several turbine blades. The turbine wheel rotated with significant resistance when rotated by hand.

The turbocharger oil supply (pressure) line fitting that connects the oil line to the top of the turbocharger assembly was missing one attach bolt and the other was loose. See Figure 2. The bolts for the attach fitting for the turbocharger oil return line exiting the bottom of the turbocharger assembly were also loose.

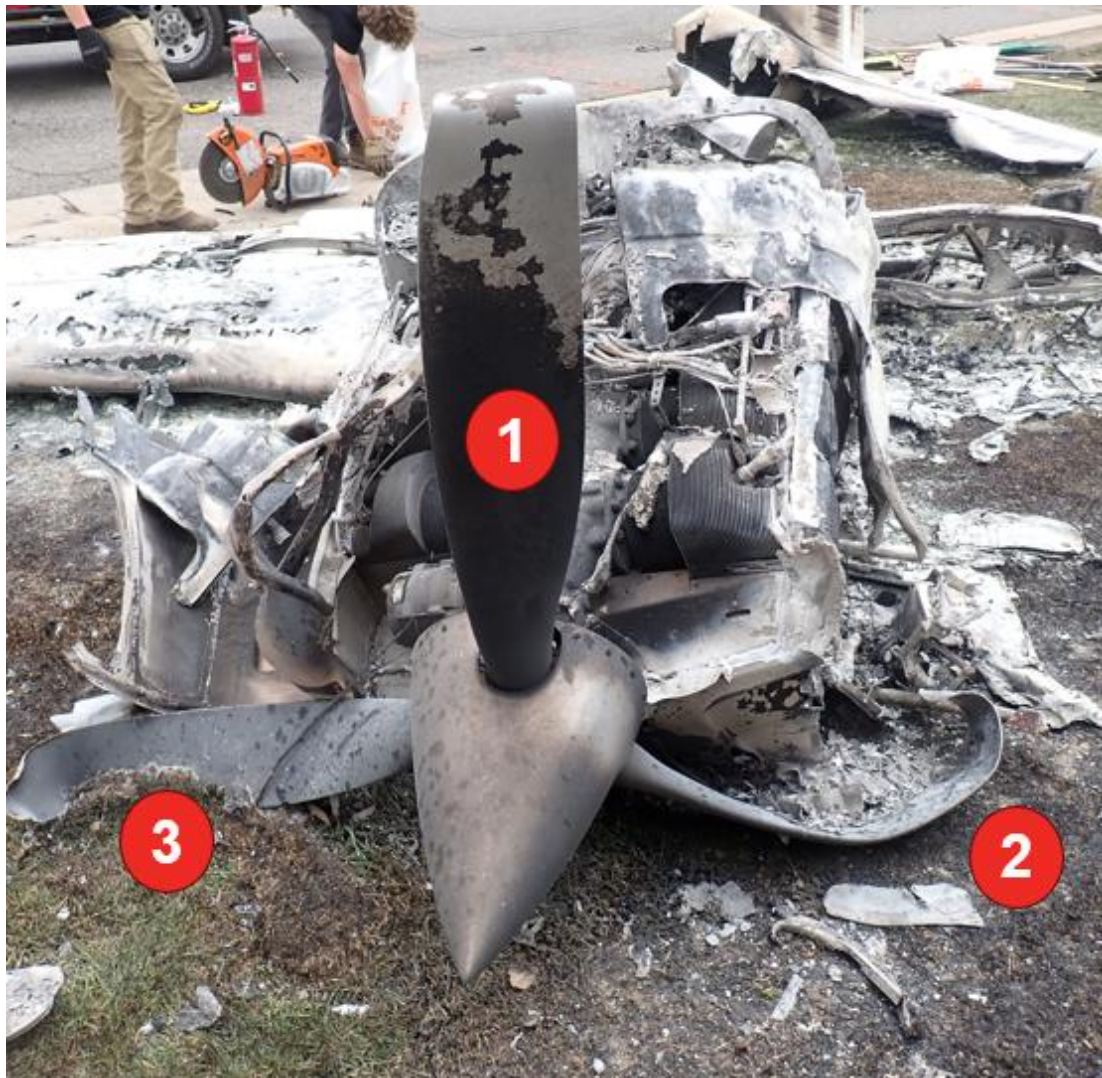
Figure 3. Propeller.

The propeller remained attached to the engine. The spinner was intact and covered with soot. Blade 1 was bent aft mid-span and had paint missing from its outboard end. Blade 2 was bent aft mid-span; the tip was curled aft; was likely rotated past its pitch stops, and the forward side of the blade tip had deep scratches in the chord wise direction and at a 45° angle. Blade 3 was rotated past its pitch stops; bent aft at the outboard end of the blade; the tip was curled aft; and the trailing edge of the blade was heavily ground down with leading edge gouging opposite the damage. See Figures 3-6.
