# National Transportation Safety Board

CEN24FA215

## EXAM SUMMARY

Location: Clinton, MI  
Date: June 10, 2026  
Time: 13:11  
Airplane: N1039X 1975 PA-28-140, S/N: 28-7525265

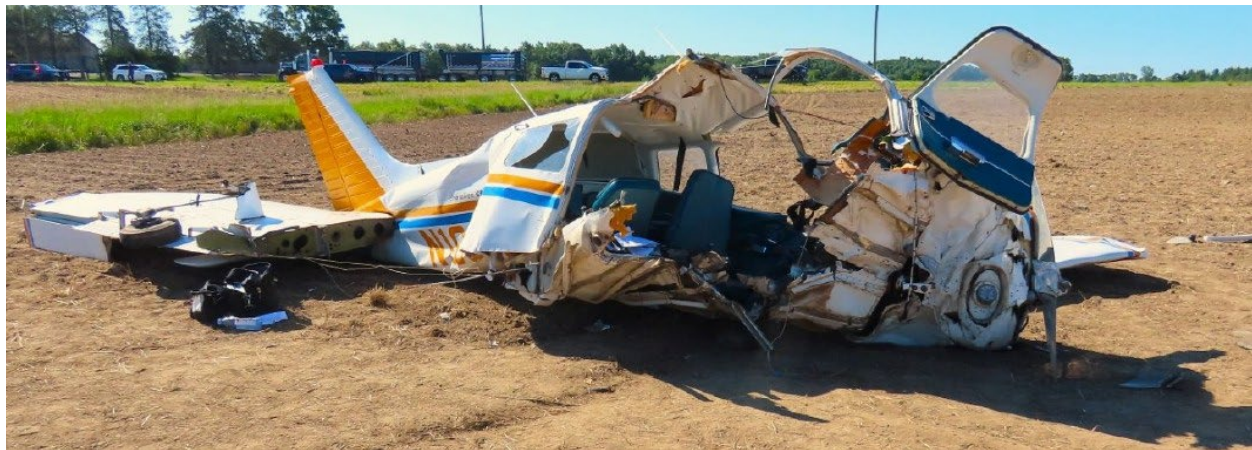
Figure 1 Accident Airplane

The airplane initially impacted terrain with the right wing tip and then the nose. Pieces of the right wing tip were located in a shallow ground scar near the first identified point of impact. The main wreckage came to rest south of the initial impact point. There was no fire, and all major structural components were present at the accident location. Rescue operations further damaged the forward cabin area.
