# National Transportation Safety Board

## **MATERIALS LABORATORY**

Factual Report 25-038

Location: Broseley, Missouri  
Date: June 14, 2024  
Vehicle: Air Tractor Inc. AT-602, N115AA  
Investigator: Timothy Sorensen, AS-CEN

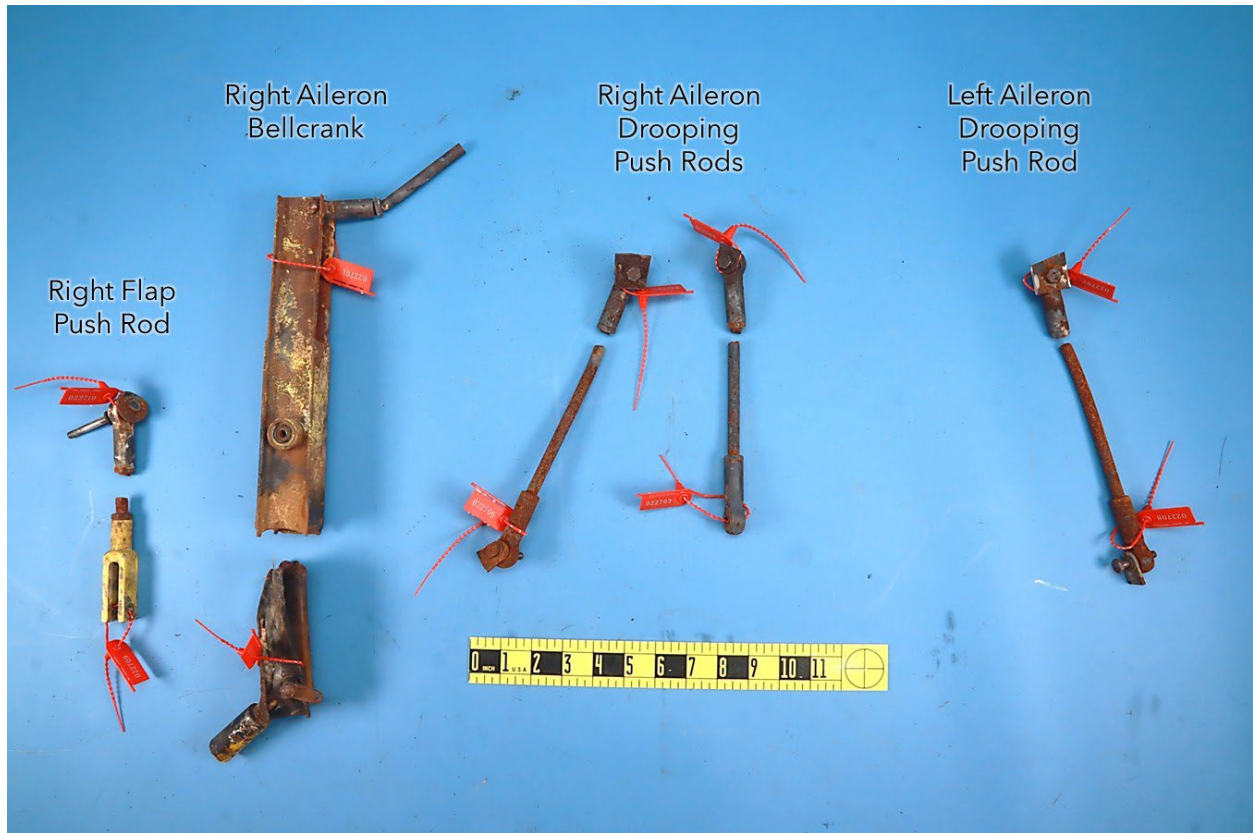
Portions of the aileron and flap control systems from the accident aircraft were disassembled and/or cut from the wreckage prior to being submitted to the NTSB materials laboratory for examination. Figure 1 shows a view of the components as received.

**Figure 1.** Photograph of the fractured components as received.

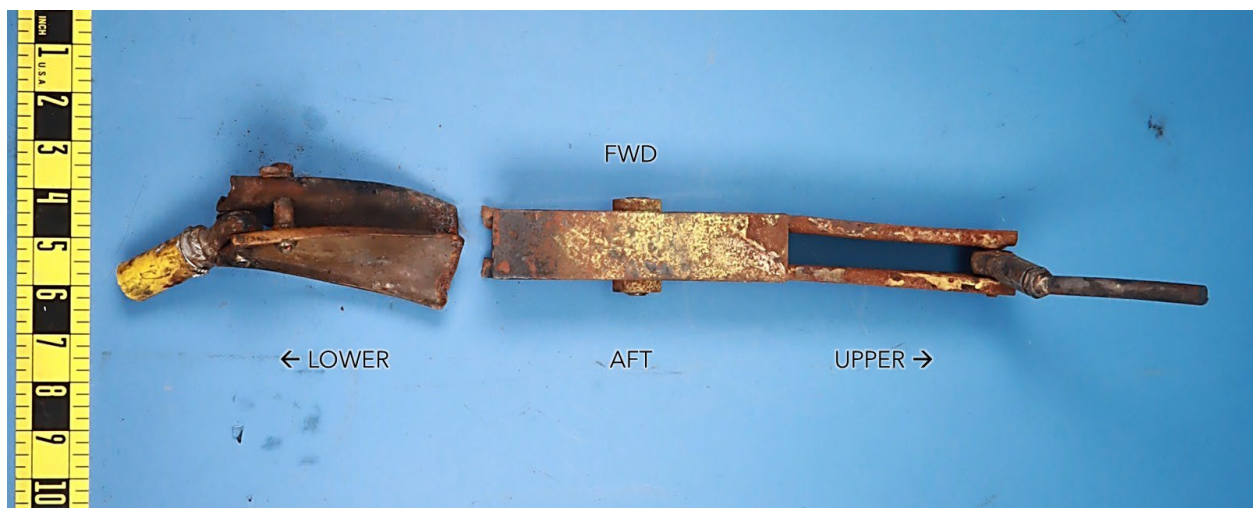
The free ends of the c-shaped beams, above and below the welded plates were deformed/twisted aft as shown in figure 2 from the perspective of looking outboard. The deformation patterns were consistent with side loads or torsional loads imparted by the attached pushrods.

**Figure 2.** Photograph of the fractured right aileron bellcrank viewed looking outboard.

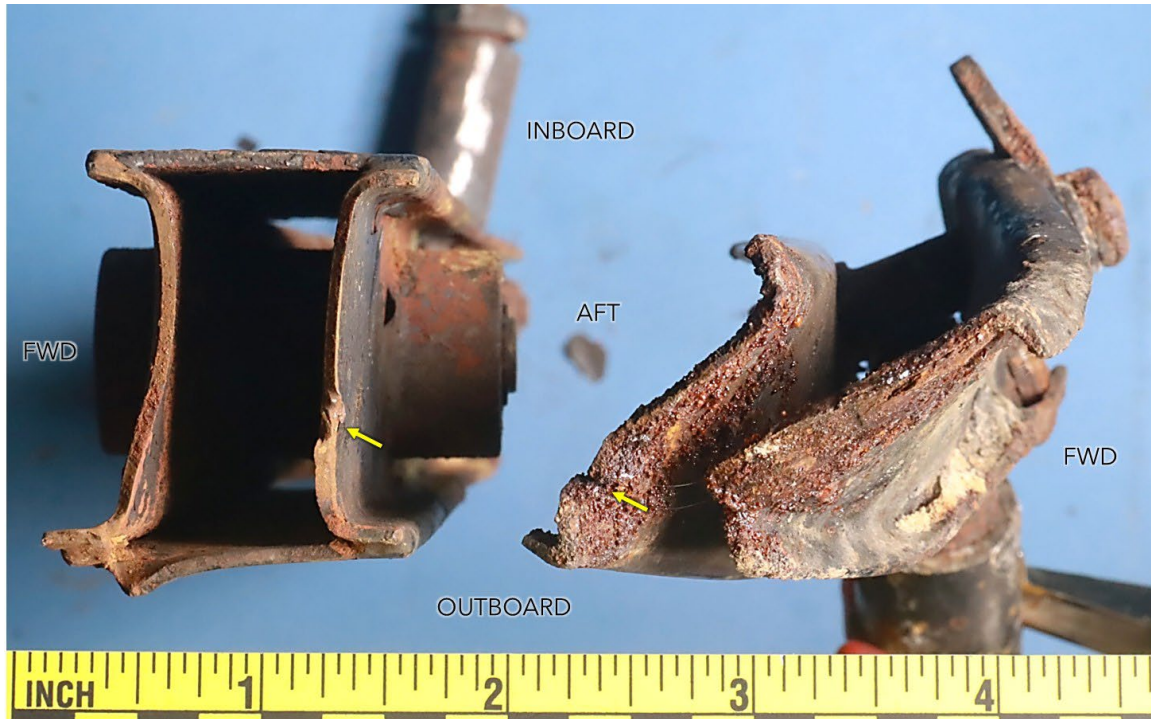
The bellcrank fractured along both c-shaped beams just below the welded plates. Figures 3 and 4 show normal and oblique views, respectively, of mating sides of the bellcrank fracture surface with the upper portion on the left and the lower

portion on the right. The bellcrank fractures were examined more closely using a 4x - 80x stereomicroscope. The fracture surfaces were covered with reddish-brown rust and were oriented along a slanted plane relative to the axes of the beams, consistent with shear lip features as a result of overstress separation. A reversal in the fracture surface orientation was observed along the aft c-shaped beam as indicated by yellow arrows, consistent with a sudden change in the load path. The degree of deformation observed was greater on the lower portion of the bellcrank outside of the regions attached to the welded plates.

**Figure 3.** Photograph of mating sides of the fractured right aileron bellcrank with the upper portion on the left and the lower portion on the right. A shift in the fracture surface orientation is indicated by yellow arrows.

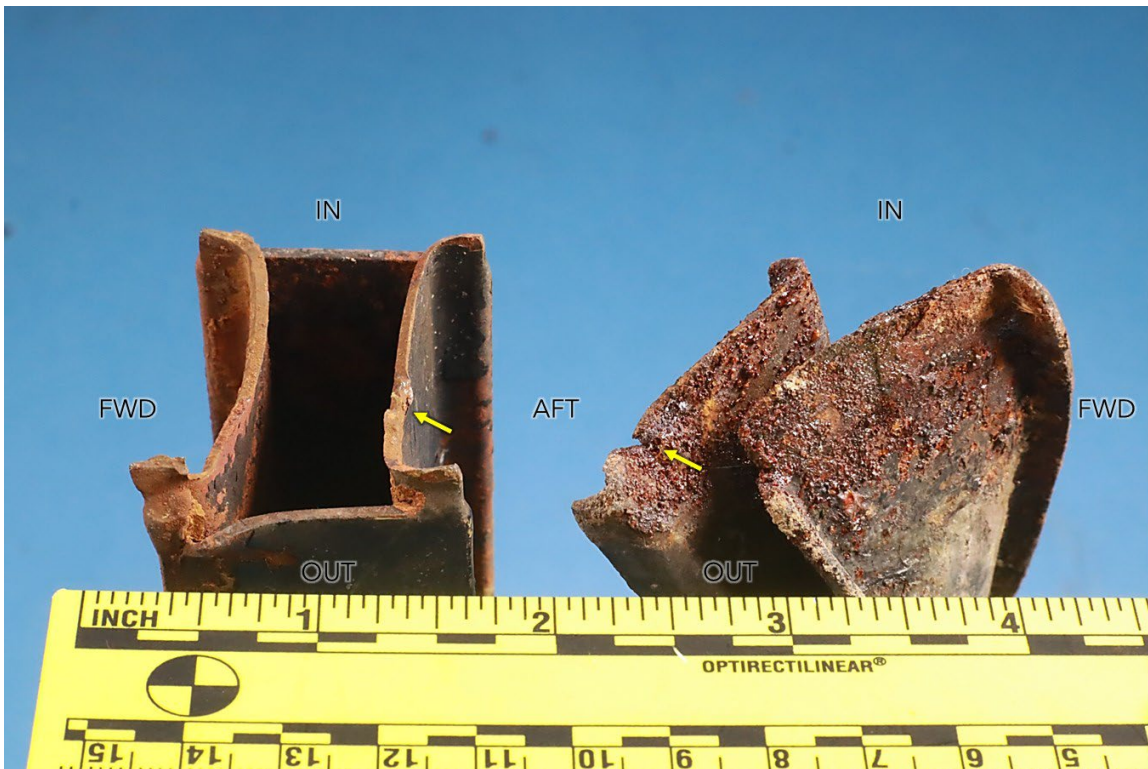
**Figure 4.** Similar photograph as figure 3 taken from a more oblique angle. A shift in the fracture surface orientation is indicated by yellow arrows.

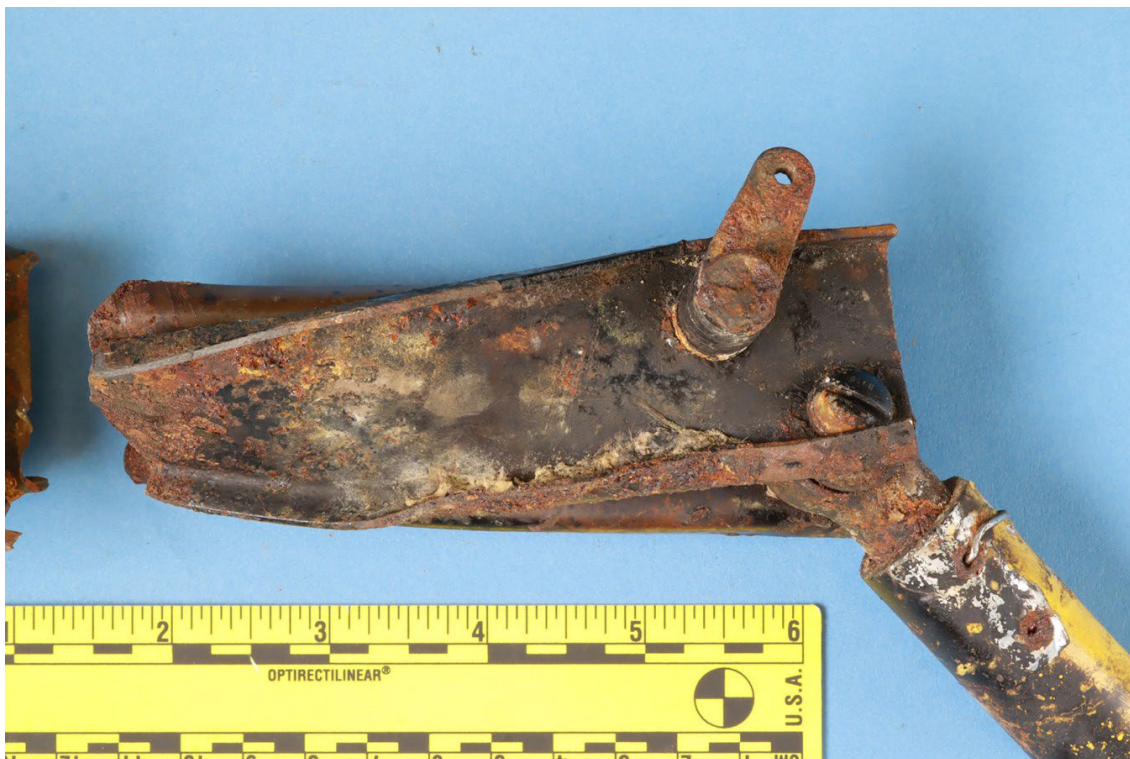
Figure 5 shows a closer view of the forward c-shaped beam from the lower portion of the fractured bellcrank. The outboard flange was bent forward toward the base of the c-shaped beam for approximately 3 inches from the lower end of the bellcrank and the cavity formed was impacted with debris consistent with soil. The forward side of the section of the main aileron pushrod near the rod end exhibited chipped paint, gouges, smeared metal, and flattened/smeared regions on the safety wire as shown more closely in figure 6.

**Figure 5.** Photograph of the forward side of the lower portion of the fractured right aileron bellcrank showing the bent outboard flange at the lower end.

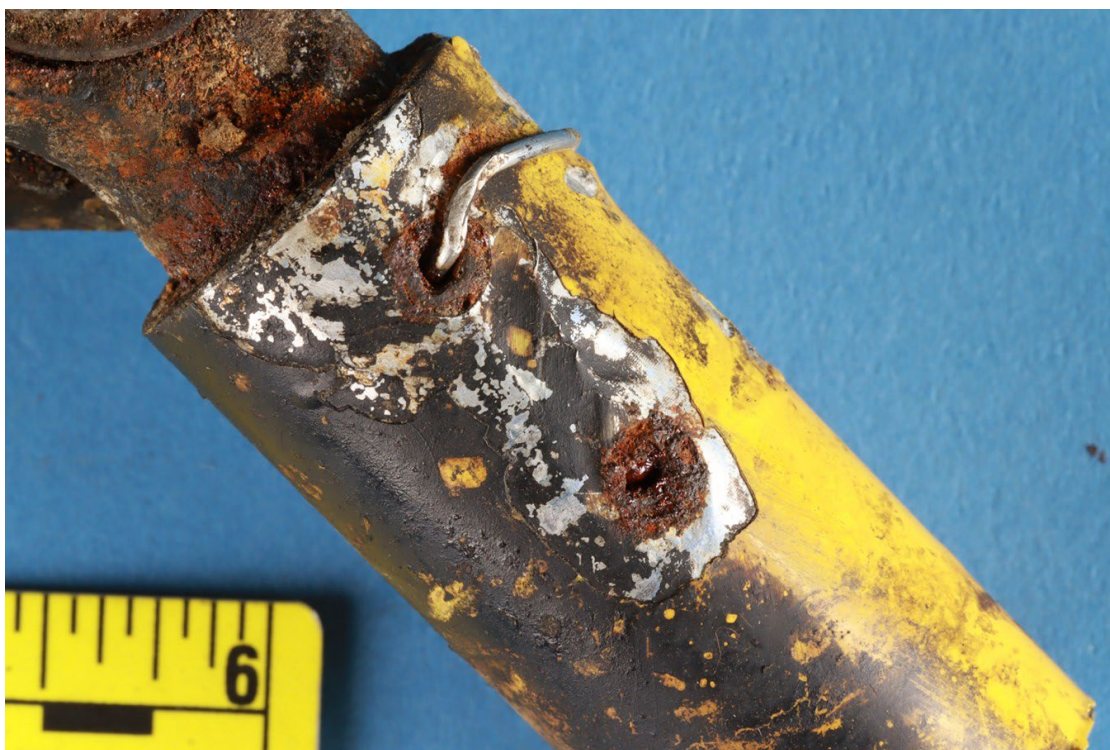
**Figure 6.** Closer photograph of the forward side of the section of main aileron pushrod retained by the lower portion of the fractured bellcrank showing chipped paint, gouges, and smeared metal.

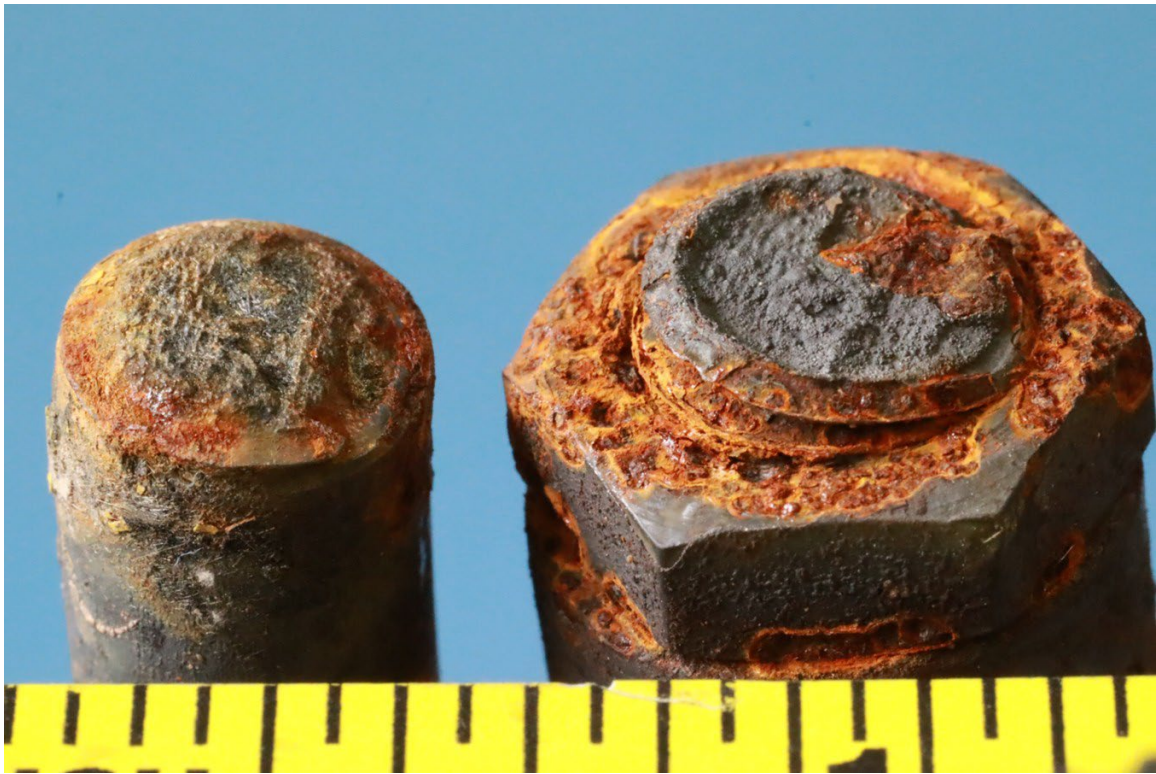
The two right and one left aileron drooping push rod fractures were examined more closely using a 4x - 80x stereomicroscope and are shown in figures 7 - 9. Rust and smearing damage was observed, but all fractures exhibited a relatively rough fracture morphology and a cup-and-cone type appearance. The rods all fractured near the aft rod end in the threaded region within approximately two or three threads from the end of the jam nut. Bending deformation of the rods was observed at the fracture locations. The aileron push rods fractured in a manner consistent with tensile/bending overstress.

**Figure 7.** Photograph of the fractured right aileron drooping push rod (longer rod).

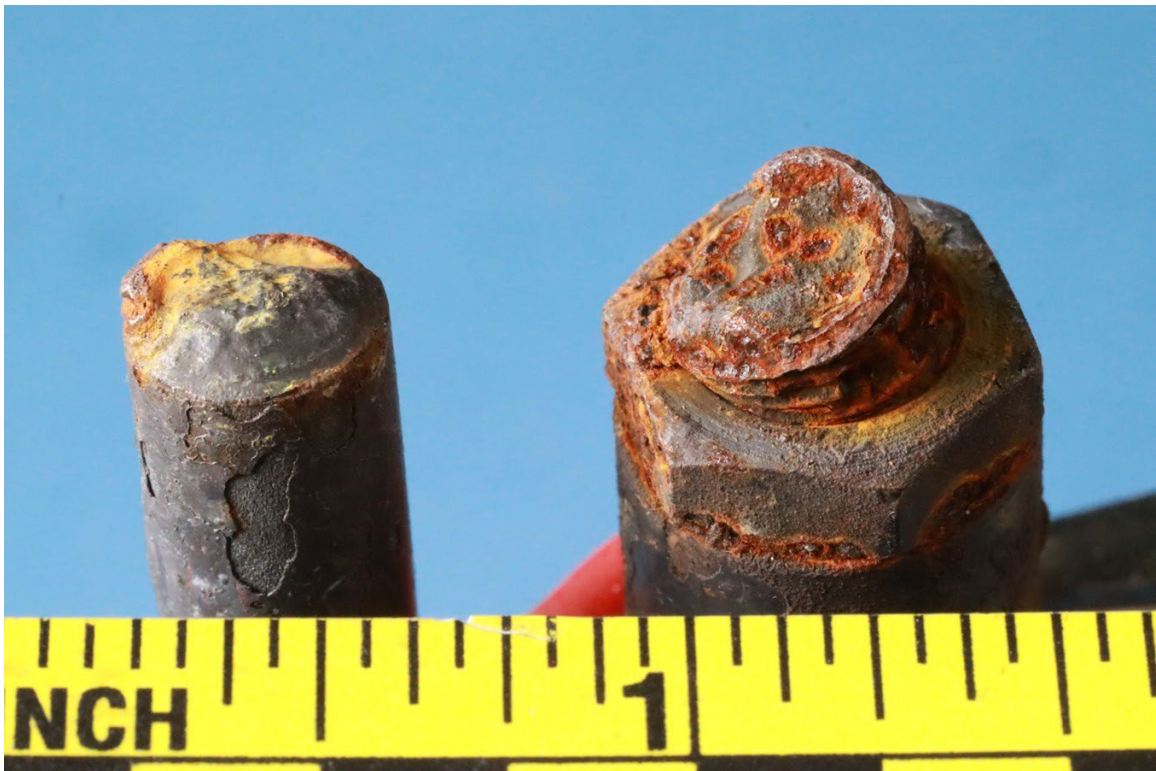
**Figure 8.** Photograph of the fractured right aileron drooping push rod (shorter rod).

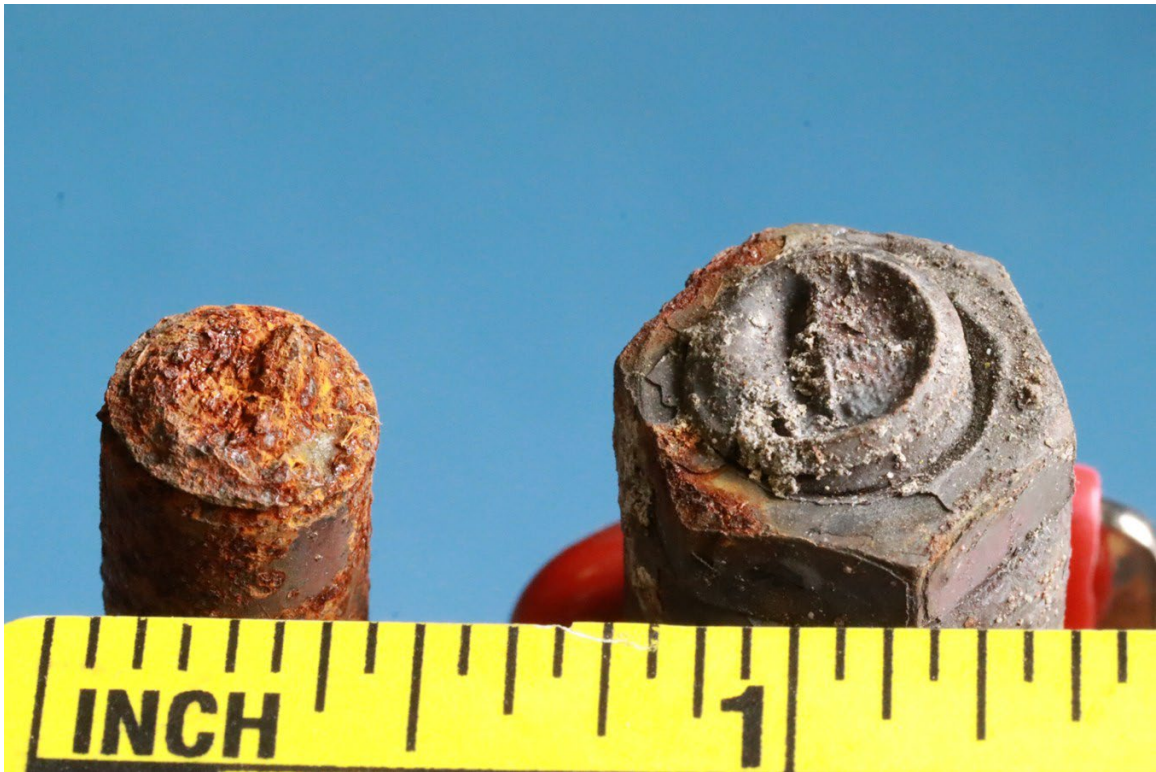
**Figure 9.** Photograph of the fractured left aileron drooping push rod.

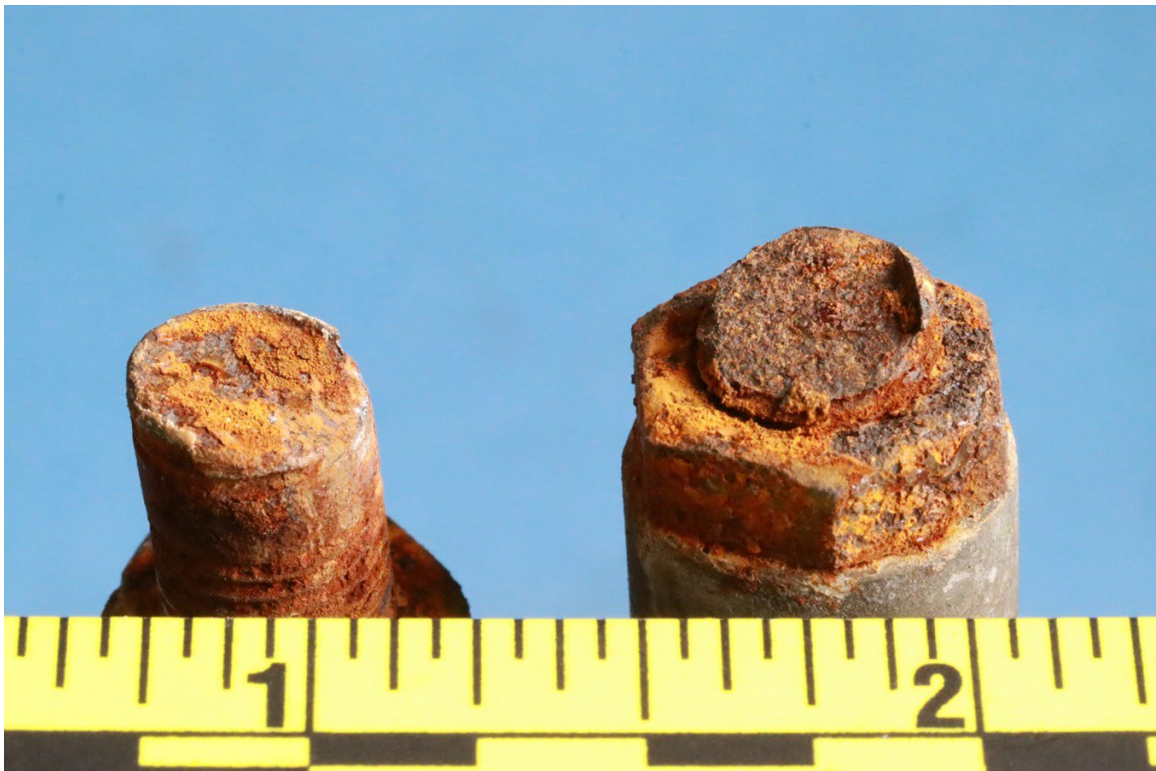
The right flap push rod was examined more closely using a 4x - 80x stereomicroscope and is shown in figure 10. Rust was observed covering the fracture surface, but the fracture surface exhibited a slanted orientation relative to the axis of the rod. The fracture surface was cleaned using a diluted solution of water and Evapo-Rust® and reexamined. Upon cleaning, parallel smear lines were observed along the slanted plane that were consistent with shear overstress separation.

**Figure 10.** Photograph of the fractured right flap push rod.
