# National Transportation Safety Board

CEN24FA221

## FIELD NOTES

Location: Morton, Texas  
Date: June 14, 2024  
Time: 0840 CDT  
1340 UTC  
Airplane 1: AT-502B, N2030K  
Airplane 2: AT-502B, N8525V

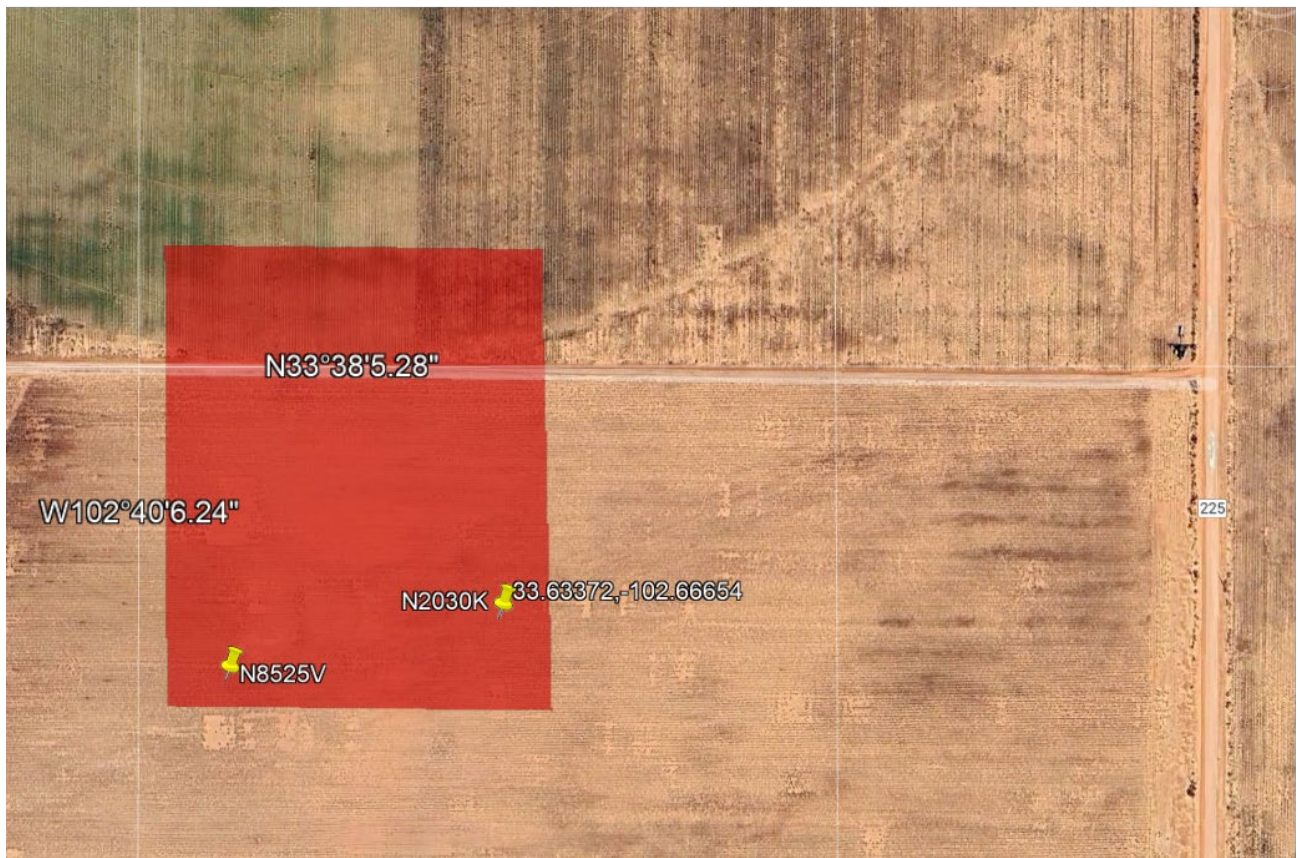
Debris from both aircraft were scattered across about a 700 ft by 400ft area on about a 160° heading that covered the cotton field the pilots were conducting spray operations on, as well as an adjacent cotton field to the south.

Power lines were found along the eastern edge of the field and a center pivot irrigation system was in the field to the north of the main wreckage. A center pivot irrigation system was located in the field containing the main wreckage of both N8525V and N2032K. There were no signs of damage to surrounding obstacles.

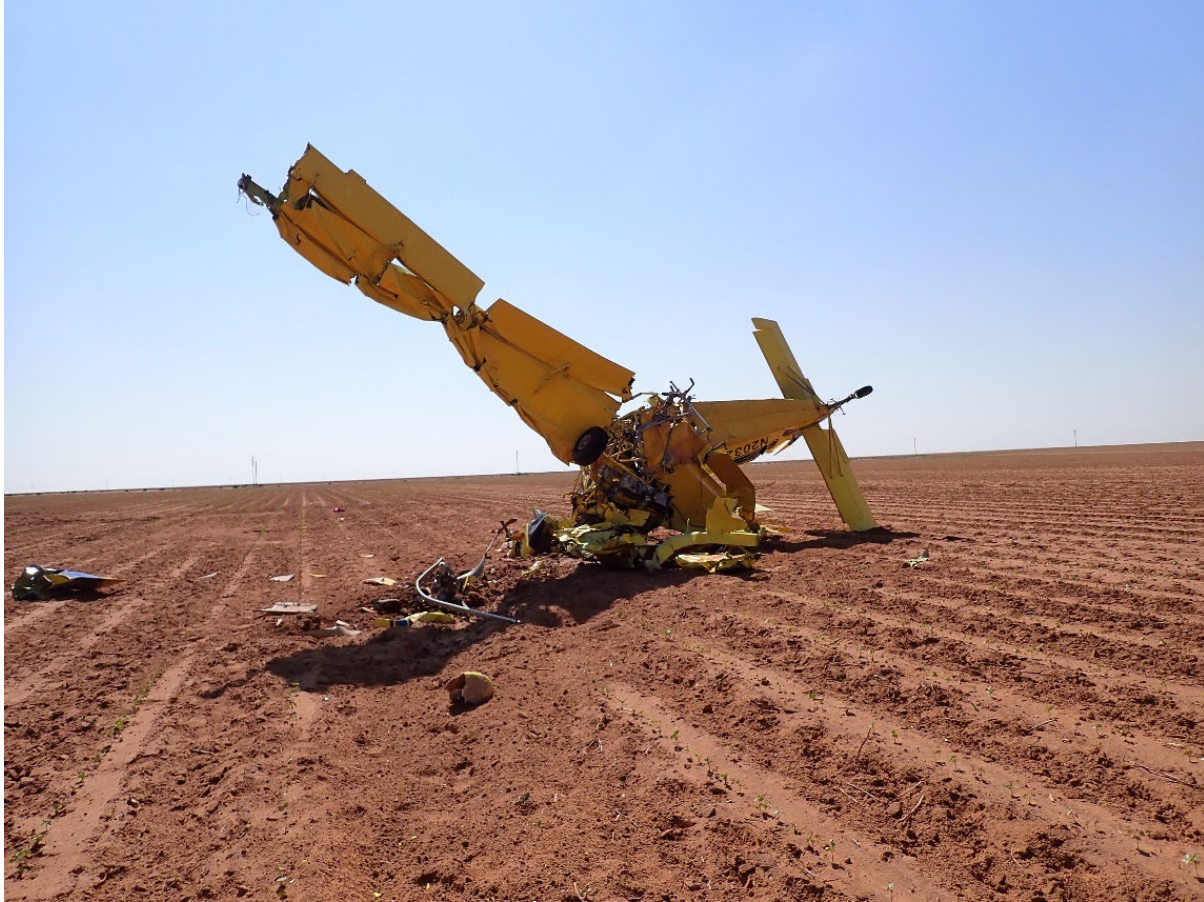
Air Tractor AT-502B, Serial Number 502B-2749, Manufactured: 2011  
33°38'1.39"N 102°39'59.54"W MAGNETIC HEADING: 036°

A ground scar that contained wing tip fragments and pieces of navigation light glass was found about 42 ft northwest of the main wreckage

The left wing tip and outboard aileron tip were impact separated. Outboard portion of the left wing was found beneath the left wing and exhibited accordion crushing along the leading edge. The left composite wing tip and nav light were also found near the main wreckage. The left flap was damaged but intact. The leading edge of the wing exhibited accordion crushing across the full span.

The right wing exhibited impact damage and was bent aft and upward. The right wing was separated midspan and the aileron was not attached. The separated portion of the right wing was not located at the main wreckage site but found northwest of the wreckage. The right flap was found attached to the right wing.

The aft fuselage was intact and bent upward , and showed crushing damage. The empennage was intact, and all control surfaces remained intact. The wire deflector remained attached. The right horizontal stabilizer leading edged displayed impact deformation.

The engine compartment was destroyed. The engine was bent in a U shape at the combustion chamber. Two compressor hubs were liberated from the engine and found near the main wreckage with some blades still attached. The remaining blades displayed spanwise bending and chordwise breaks consistent with engine power at the time of impact. The engine case displayed torsional twisting along its axis.

The propeller was found separated from the flange about 15 feet from the main wreckage. Two blades remained attached to the hub and exhibited "S" bending. The third blade was separated from the hub at the root and exhibited "S" bending.

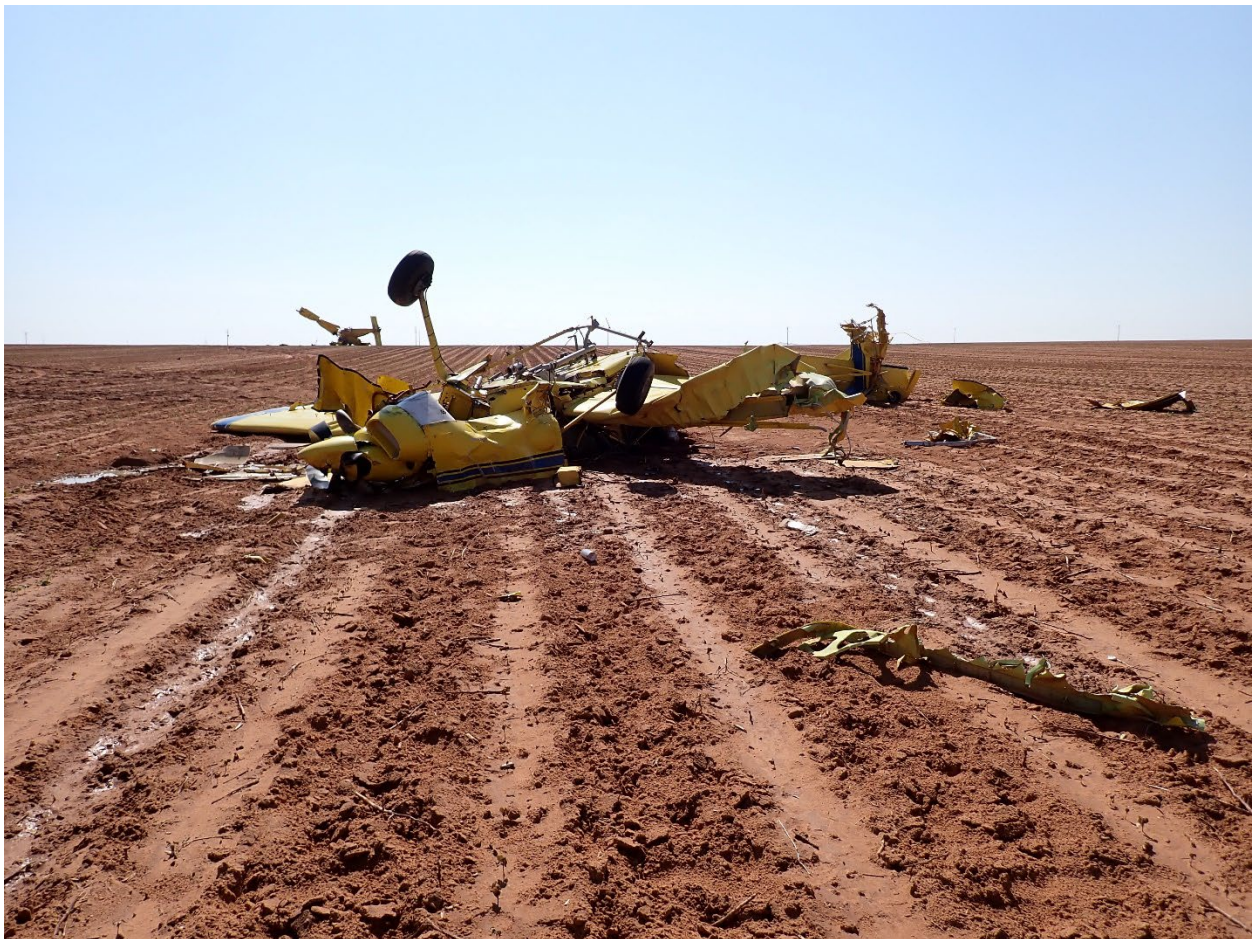
33°38'0.42"N 102°40'4.62"W MAGNETIC HEADING: 310°

The left wing was mostly intact with minor skin deformation. The wing exhibited crushing damage on the leading edge mid span near the stall vane, the stall vane was not present. A portion of the composite left wing tip trailing edge was impact separated.

The right wing was partially intact and exhibited impact crushing on the leading edge. The wing was separated near flap and aileron hinge connection. The lower wing skin was bent downward and showed impact crushing. The right flap was connected to the wing with a portion of the outboard trailing edge of the flap torn away. The right aileron was impact separated and not located at the main wreckage.

The fuselage was crushed, and impact separated. The aft fuselage and empennage were located about 30 feet south of the main wreckage. Portions of the fuselage skin were separated and found near the main wreckage site.

The horizontal and vertical stabilizers were intact. The right horizontal stabilizer exhibited impact crushing and was bent up and rearward. The rudder was pushed past the right limit and the right trailing edge of the elevator penetrated through the rudder. The top portion of the vertical stabilizer containing the wire deflector was impact separated and found attached to the main wreckage.

The engine compartment was impact crushed with portions of the cowling cracked and separated. The skin under the air intake exhibited black transfer signatures. The engine case displayed torsional twisting along its axis consistent with power during impact.

The propeller hub showed deformation and cracking near the propeller roots. Portions of the propeller blades were impact separated and found in the initial impact crater. Two blades remained attached to the hub, and the third was separated from the root and was found about 20 feet from the wreckage. All three propeller blades exhibited span wise twisting.
