# National Transportation Safety Board

CEN24FA228

## **ON-SCENE EXAMINATION**

Location: Steamboat Springs, Colorado  
Date: June 17, 2024  
Time: 1623 MDT  
2223 UTC  
Airplane: Cessna 412C

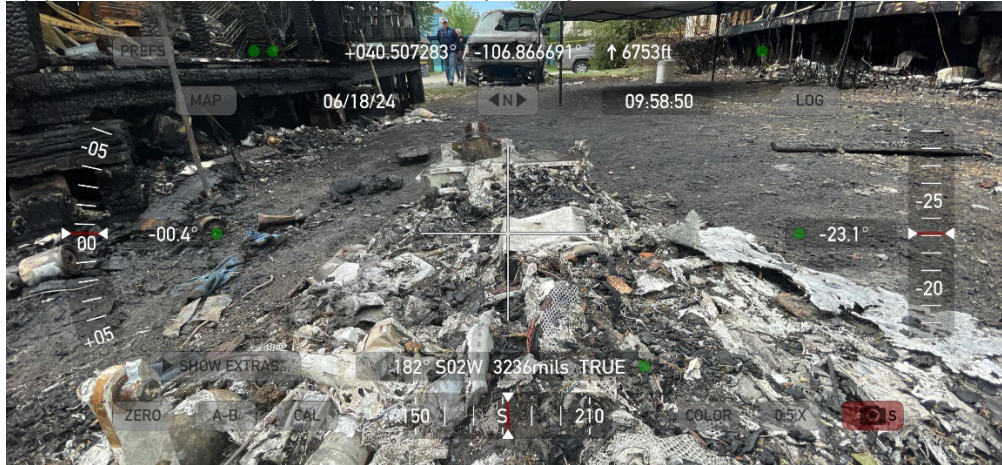
**Figure 1 Nose Alignment Reference**

The airplane came to rest between two mobile homes in the West Acres Trailer Park. A post impact fire ensued which destroyed the airplane. Impact signatures were consistent with a low energy impact with the airplane in a relatively level (flat) attitude. The nose of the airplane was facing about 180° magnetic heading. The airplane appeared to have impacted completely intact and there was no debris field.

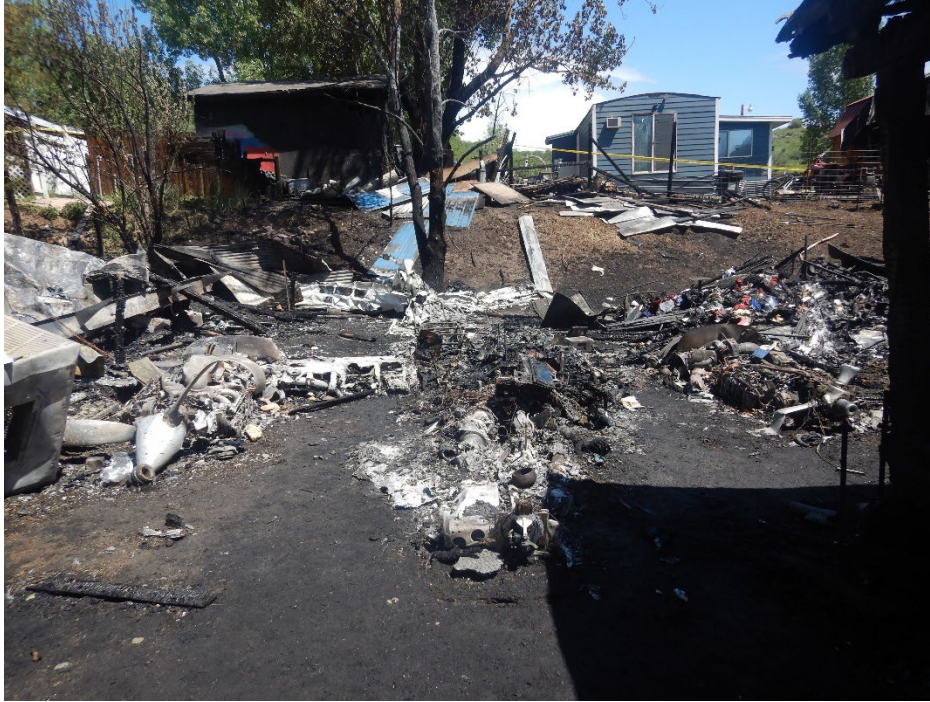
**Figure 2 Wreckage Overview (photo from Textron Aviation)**

Severe fire damaged consumed major portions of the wings, fuselage, and empennage.

Primary flight control continuity was confirmed from the cockpit area to the ailerons, rudder, and elevators. The right aileron cable was fractured with signatures consistent with overload. The remaining cable from the fracture to the bellcrank was located near the fractured cable. Aileron trim was set to 8° tab up. Pitch trim was relatively neutral. Rudder trim was set to 2° tab left.

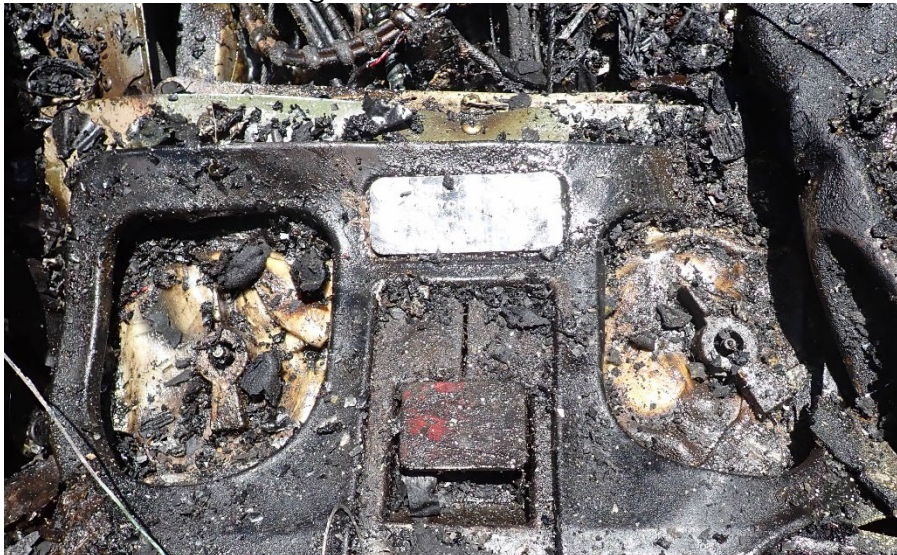
**Figure 3 Fuel Selectors**

The fuel system components sustained heavy fire damage. The left selector handle was in a mid-position between Left and Right and the right selector handle was in the Left (crossfeed) position. The left and right main fuel tanks were completely thermally destroyed. The left- and right-wing locker auxiliary tanks were thermally damaged. The left and right auxiliary fuel pumps were both thermally damaged. Neither the left nor right fuel filters were observed.

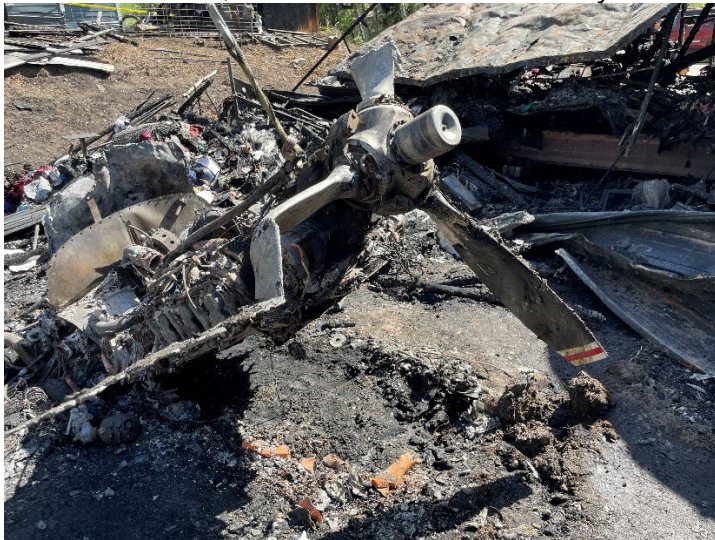
**Figure 4 Left Propeller**

The left propeller assembly remained attached to the engine. The blades appeared to all be in the feathered position. The number one blade was pointing horizontal to the ground and about one foot from the hub it melted and fell to the ground. The number two blade was pointed nearly vertical and eight inches from the hub it completely melted. The number three blade was submerged into the soil and when retrieved, was found to be relatively undamaged.

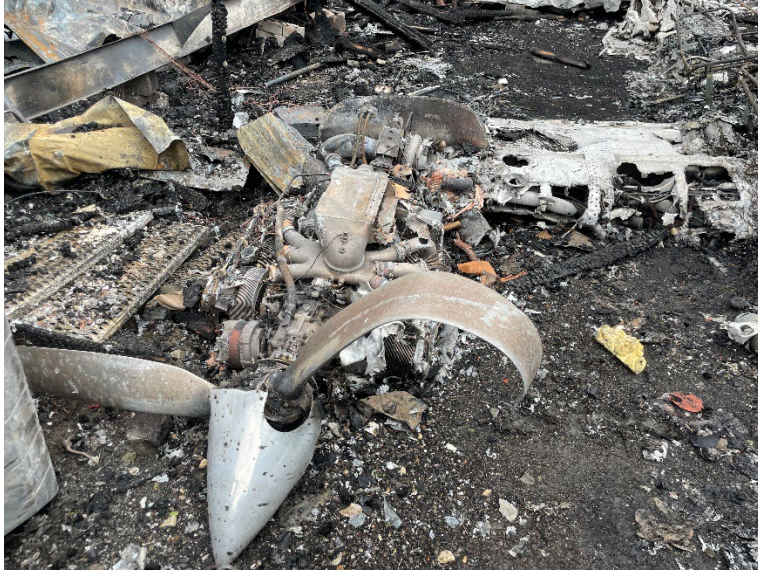
**Figure 5 Right Propeller**

The right propeller assembly remained attached to the engine. Blade angles were not consistent. The number one blade was free to rotate in the hub with some force. At mid span there was chordwise scuff marks and the blade curled out to the tip toward the non-camber side. There were three gouges in the LE several inches from the tip. The number two blade and about eight inches of the hub adjacent to it fracture separated from the propeller assembly. The blade was buried in the ground about 3 feet. It was slightly bent in the direction opposite of rotation at ground level. The blade exhibited chordwise scratch marks on the non-camber side. Several gouges were present several inches from the tip. The number three blade was straight except for the last 6 inches where it had come into contact with a concrete block. A one-inch section was bent up at about 90 degrees the tip was thermally damaged.
