# National Transportation Safety Board

CEN24FA228

## **ENGINE TEARDOWN**

Location: Steamboat Springs, CO  
Date: June 17, 2024  
Time: 1623 Local  
2223 UTC  
Airplane: Cessna 421, N245T

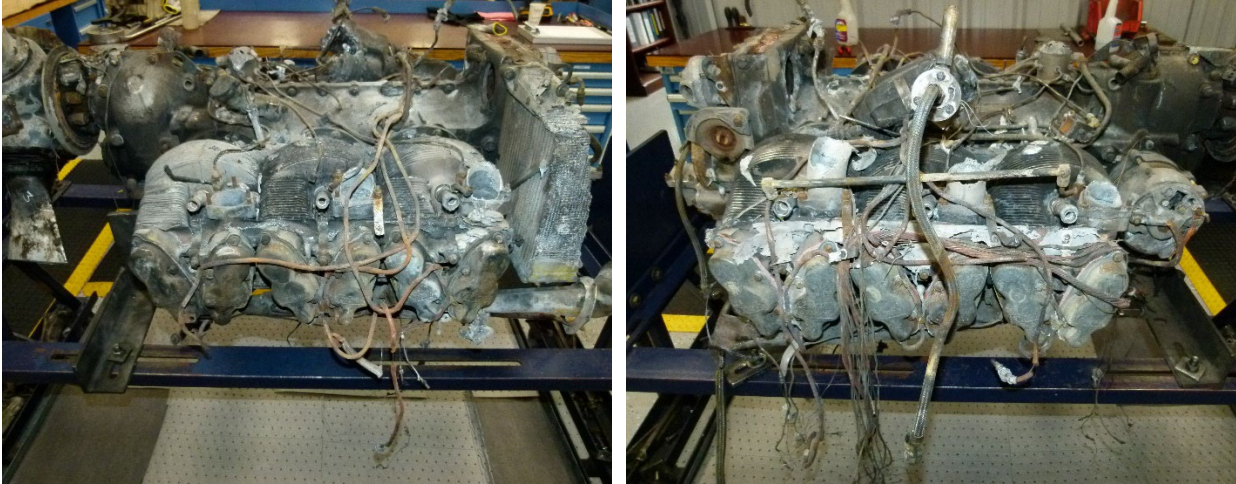
**Figure 1 Left Engine on Stand (Continental Photos)**

The left engine was removed from its secured shipping container and placed on an engine stand for disassembly and examination. The engine could not be rotated by hand. The engine's intake system was largely destroyed by fire and the remnants melted and settled into the engine cylinders.

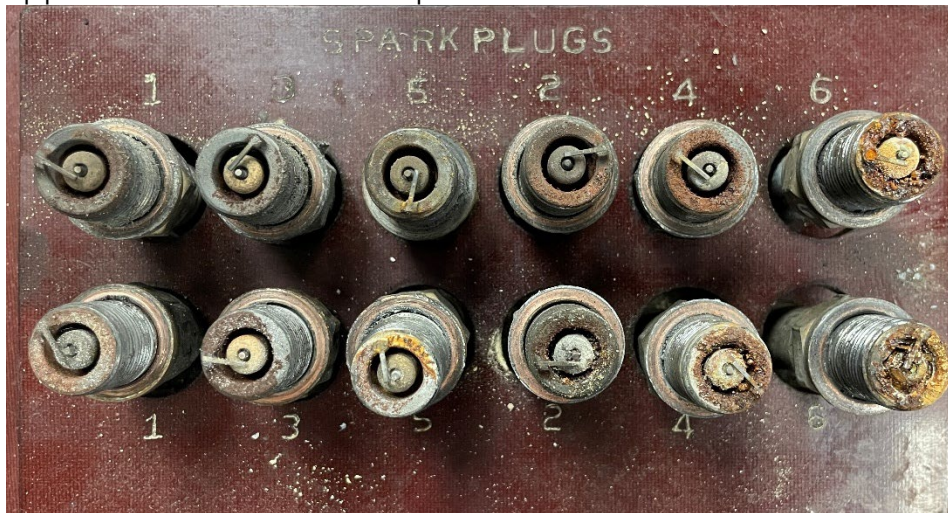
**Figure 2 Spark Plugs**

The spark plugs were removed and photo documented. All spark plugs appeared to be serviceable prior to the accident.

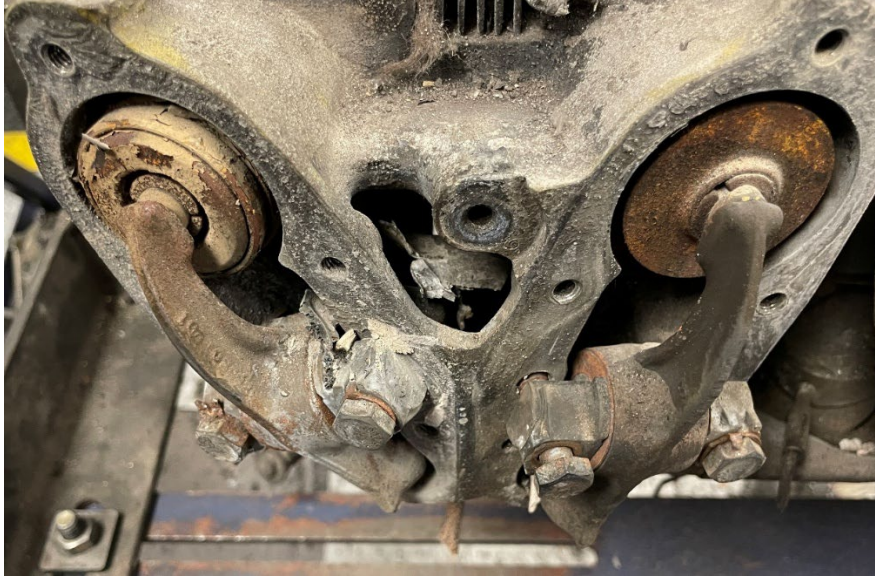
**Figure 3 No. 6 Cylinder Rocker Arms**

The rocker boxes were removed, and the rocker arms were disassembled from the engine along with the push rods. The No. 6 cylinder's intake rocker arm's securing hardware: the left side did not contain the proper hardware, and the right side had the securing fins turned outwards but appeared to be secured (see figure 3).

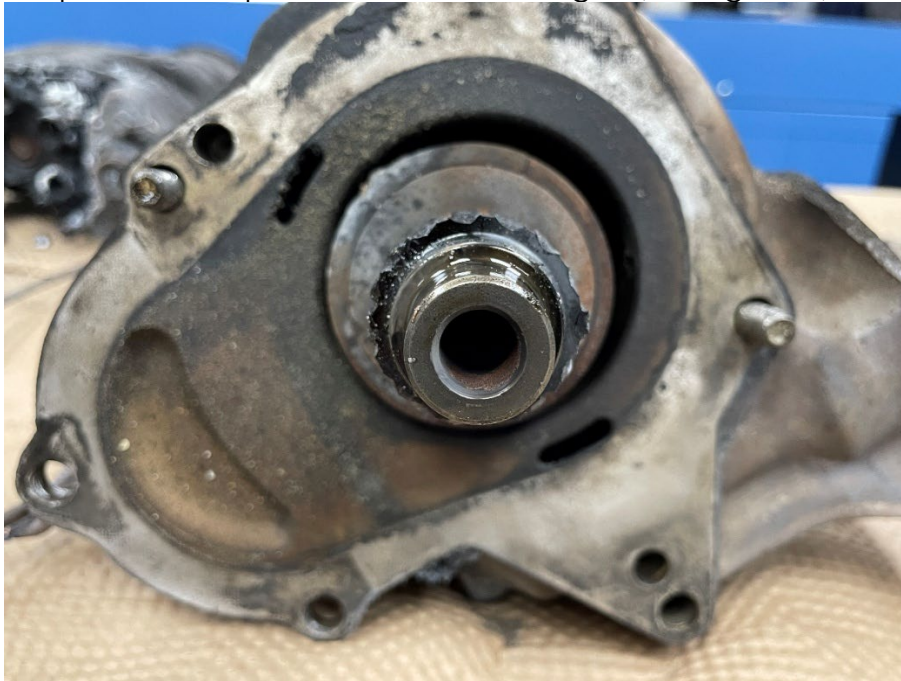
**Figure 4 Engine Starter Adapter**

The engine accessories were removed and documented. The engine starter adapter's drive spline teeth were damaged (see figure 4).

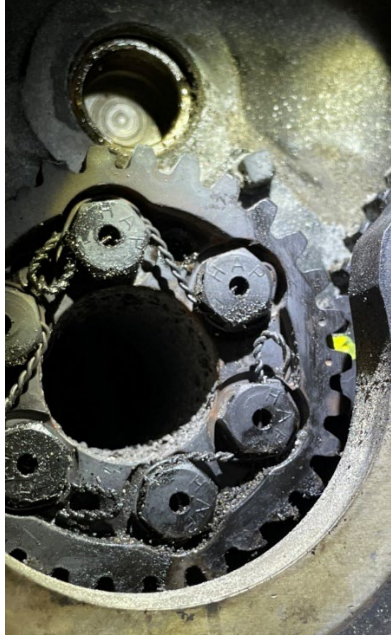
**Figure 5 Timing Marks with Paint Added**

Further disassembly of the engine found that the accessory drive sprocket from the crankshaft gear had broken and missing teeth. Yellow paint was placed on the alignment mark on the camshaft cluster gear. Rotating the engine, the camshaft and camshaft cluster gears were found to be properly aligned (see figure 5).

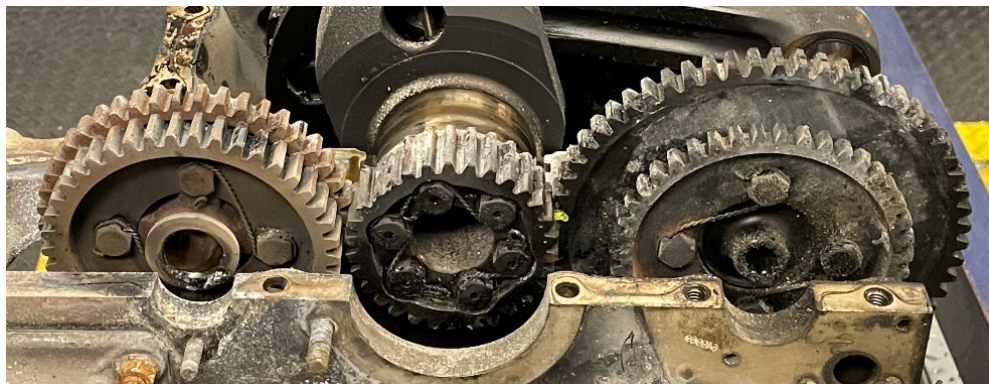
**Figure 6 Gears**

There are no timing marks on the idler gear. It could not be determined if the idler gear which drove the magnetos may have shifted which would change the magneto timing (see figure 6). In figure 5, the idler gear is the left most gear.

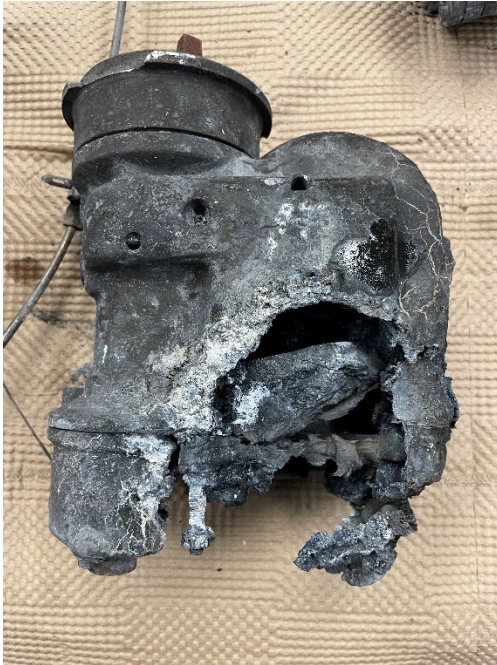
**Figure 7 Left Magneto**

The left magneto was partially consumed by the postimpact fire and could not be tested (see figure 7).

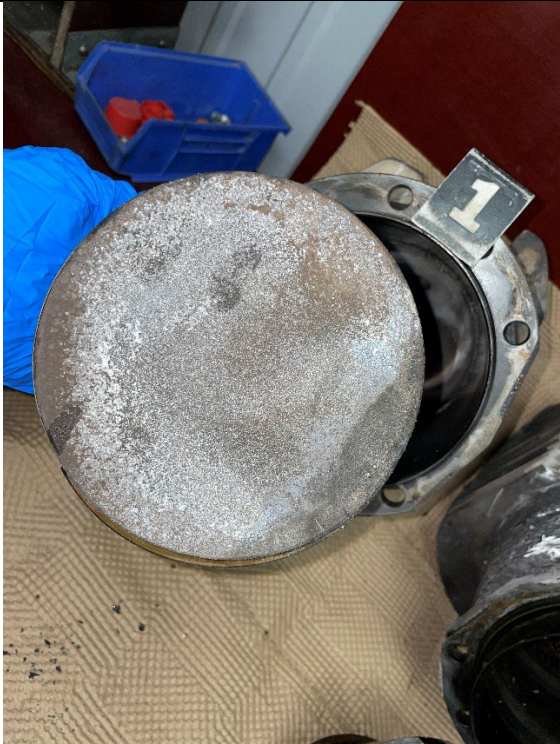
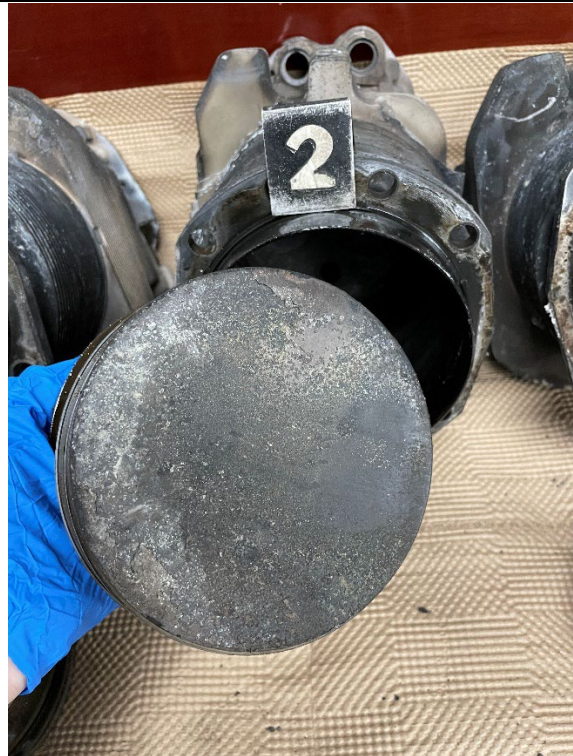
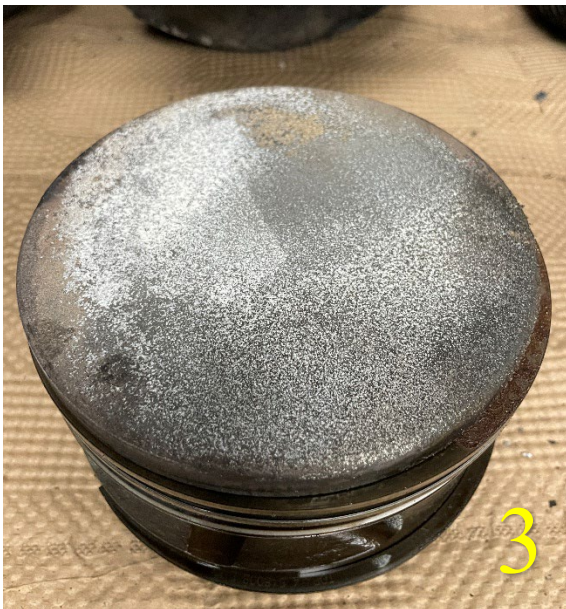
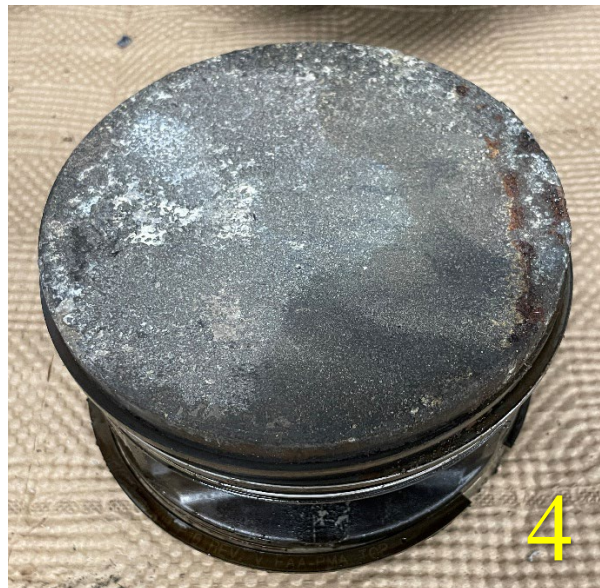
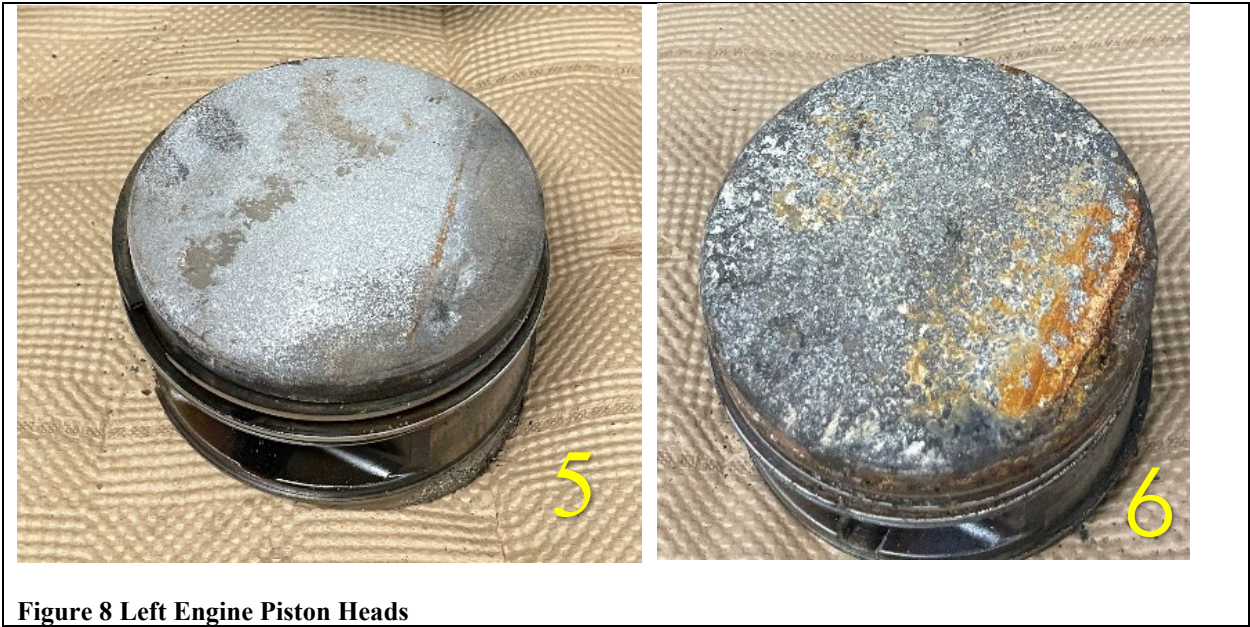
**Figure 8 Left Engine Piston Heads**

No other anomalies were detected with the engine. No evidence of internal thermal distress from oil starvation was found.

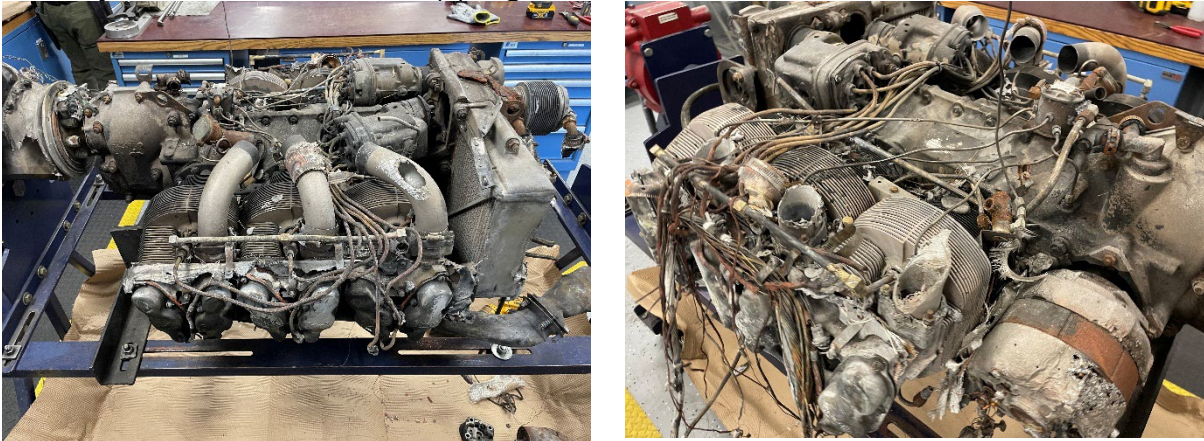
**Figure 9 Right Engine on Stand**

The right engine was removed from its secured shipping container and placed on an engine stand for disassembly and examination. The engine could not be rotated by hand. A portion of the induction system had been removed during recovery and was not in the shipping container.

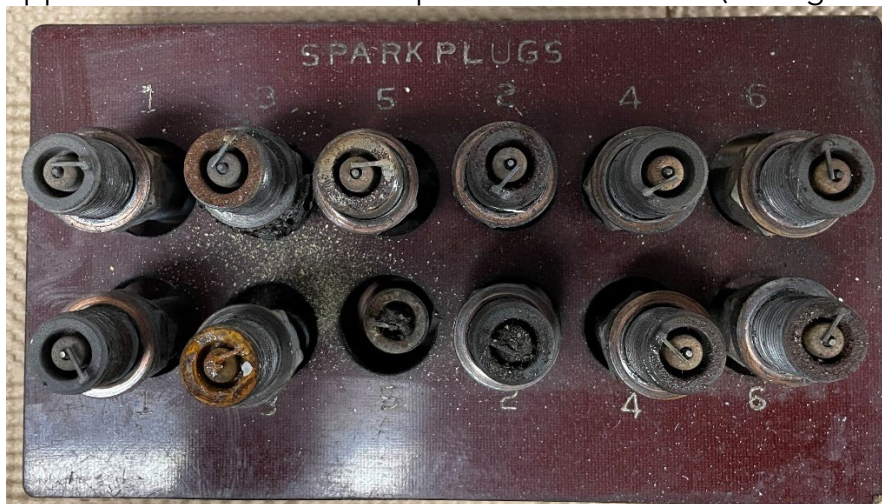
**Figure 10 Right Engine Spark Plugs**

The spark plugs were removed and photo documented. All spark plugs appeared to be serviceable prior to the accident (see figure 10).
