# National Transportation Safety Board

CEN24FA243

## EXAMINATION SUMMARY

Location: Selden, Kansas  
Date: June 30, 2024  
Time: 1748 CDT  
2248 UTC  
Airplane: N14137 - 1934 Waco YKS-6, S/N 4223

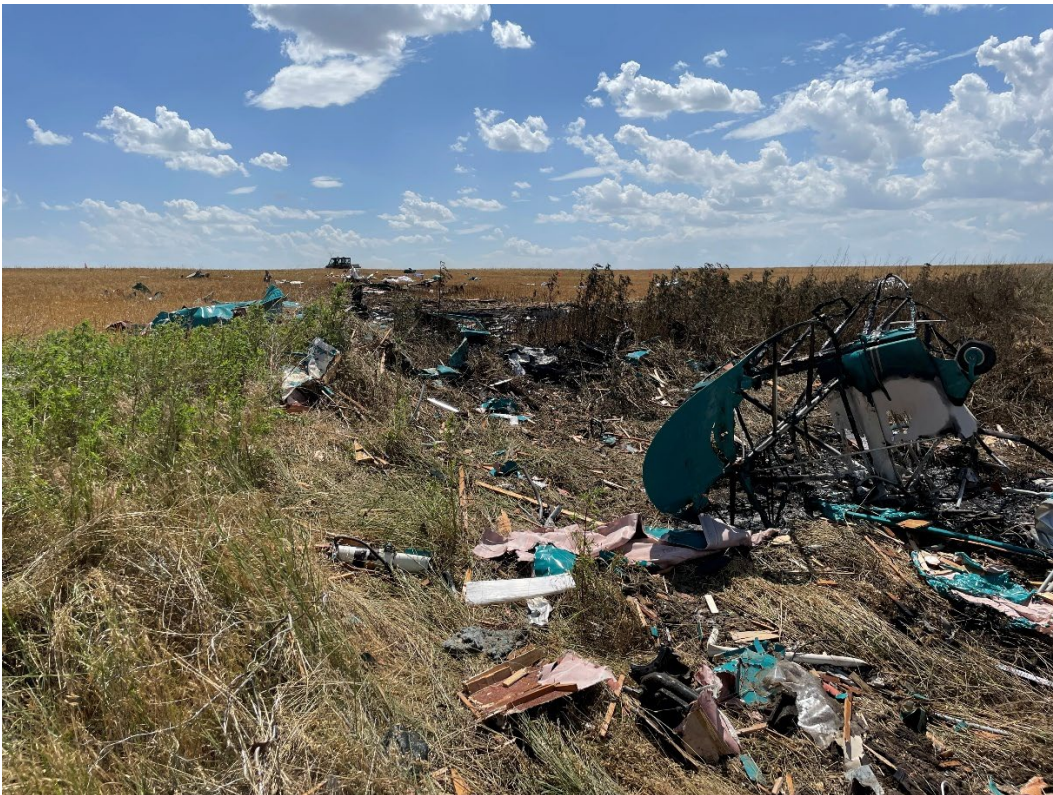
Figure 1. Accident Site Overview

- Location is +039°29'38.88" / -100°27'39.95"
- Airplane debris field is on about a 228° MH.
- Altitude is about 2749 ft MSL
- Airplane debris field is in a trough extending up into a flat agricultural field.
- Accident site is surrounded by, in the local area, by similar rolling terrain.
- Post impact vegetation fire was observed in and around the airplane debris field.

The airplane came to rest in the field fragmented. A post-crash fire thermally damaged the separated rear fuselage and empennage. The fire also damaged the remaining wing structure and forward fuselage. The rest of the airplane was scattered across the rest of the field with various states of thermal and impact damage.

The debris path measured about 526 ft in length and 67 ft in width on a heading of about 228°. An initial ground scar of both right wings started 19 ft prior to the main debris field on a heading of about 183°. The initial signature consisted of two scars about 5 ft in separation with a propeller strike about halfway along the 19 ft length. The right scar, facing direction of travel, contained a wing tip bow vertically buried in the ground at the start of the path. Next to the wing tip bow was the right navigational light. The left scar contained a wing tip box vertically buried in the ground at the start of the path. Wing compression struts were found within the scar path consistent with collapsing right-wing structure in the longitudinal axis along the leading edge of both wings.

A large section of the engine and propeller with the lower forward fuselage were found buried in the ground at about a 40° nose down attitude in a crater. Debris extended out from the buried fuselage to the edge berm of the tough. The separated rear fuselage and empennage were between the crater and the edge berm of the tough 60 ft from the initial impact point.

The debris extended beyond the berm out along a flat agricultural field. Numerous wing structure and forward and upper fuselage fragments were found within this area extending out to 526 ft from the initial impact point.

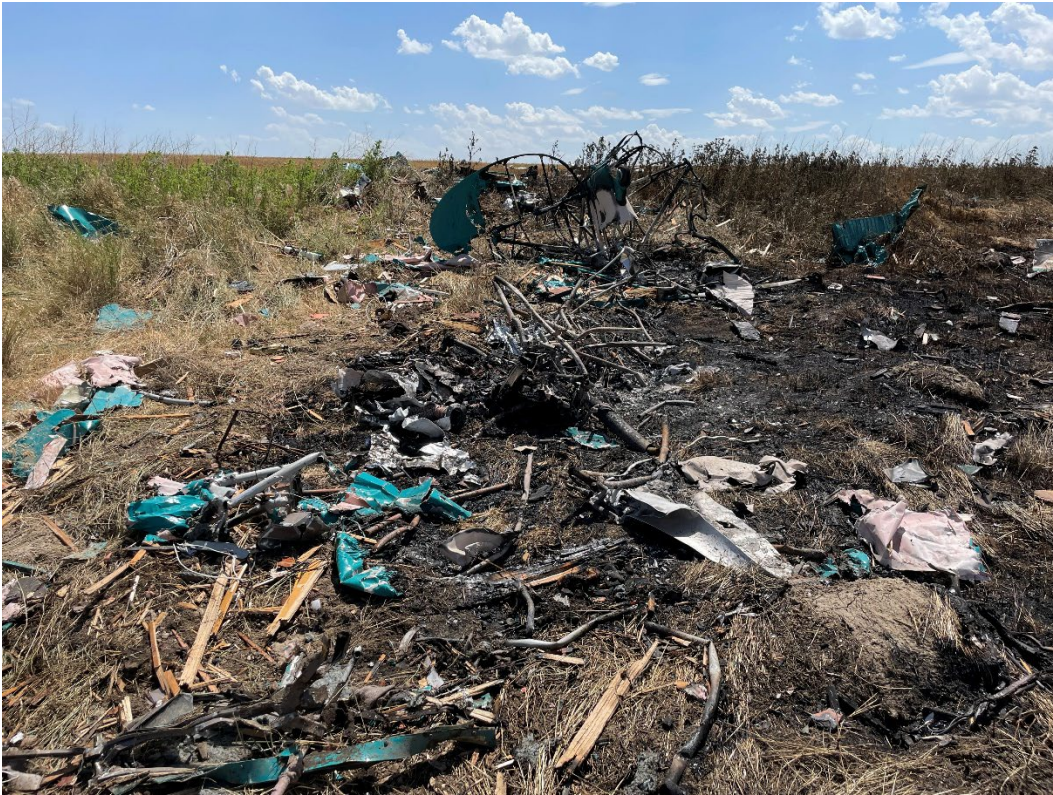
Figure 2. Fuselage Debris

The lower section of the forward fuselage containing the rudder pedals was found buried in an impact crater 19 ft from the initial impact point. This section of fuselage was unable to be examined due to biological remains and was recovered by the medical examiner before investigator arrival. The rear half of the lower fuselage was found separated, in the direction of travel, with thermal and impact damage. The rest of the forward and upper fuselage was found separated and fragmented, in the direction of travel, with thermal and impact damage in the agricultural field.

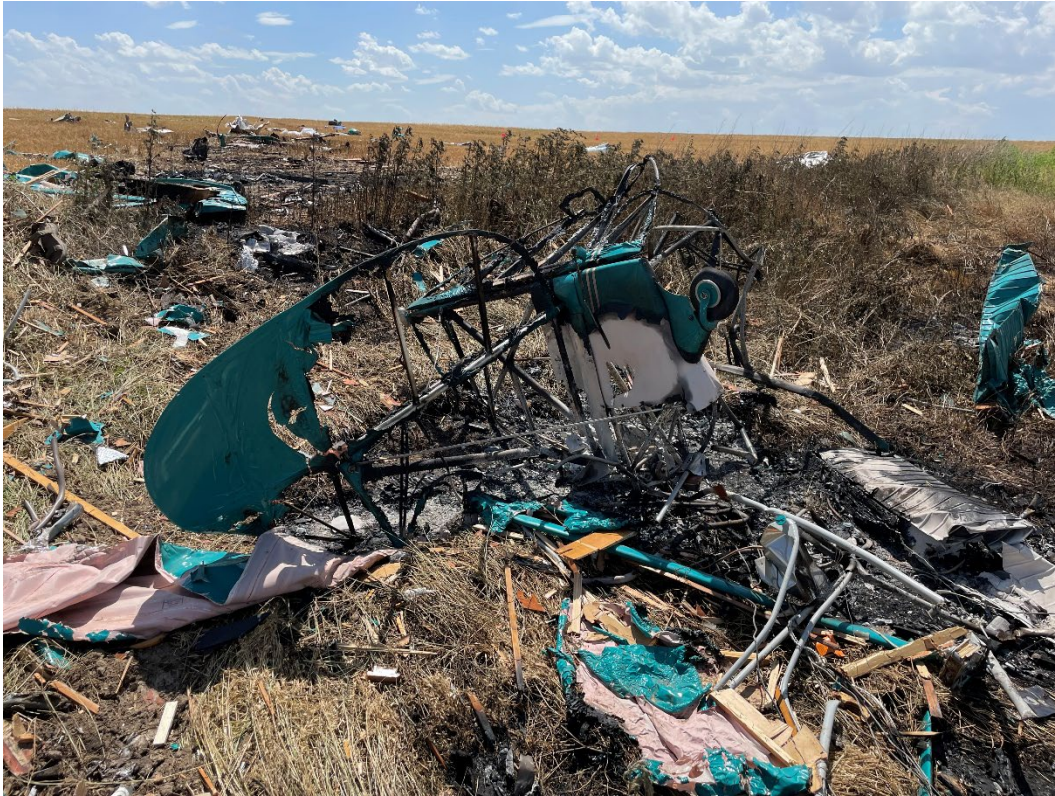
Figure 3. Empennage Debris

The empennage was separated from the upper fuselage with post-impact fire damage. The right horizontal stabilizer and elevator had inward deformation of the tube structure with post-impact fire damage to the fabric skin and structural tubes. The left horizontal and vertical stabilizer, left elevator, and rudder had no observed structural damage. However, these components had post-impact fire damage to the skin and structural tubes. The rudder trim tab setting was unable to be determined due to fire damage. Flight control continuity was established from the elevator and rudder control surfaces to the cockpit controls. The elevator trim control was established from the elevator to the phenolic block. The cable from the block to the trim control handle was separated with fracture consistent with overload failure.

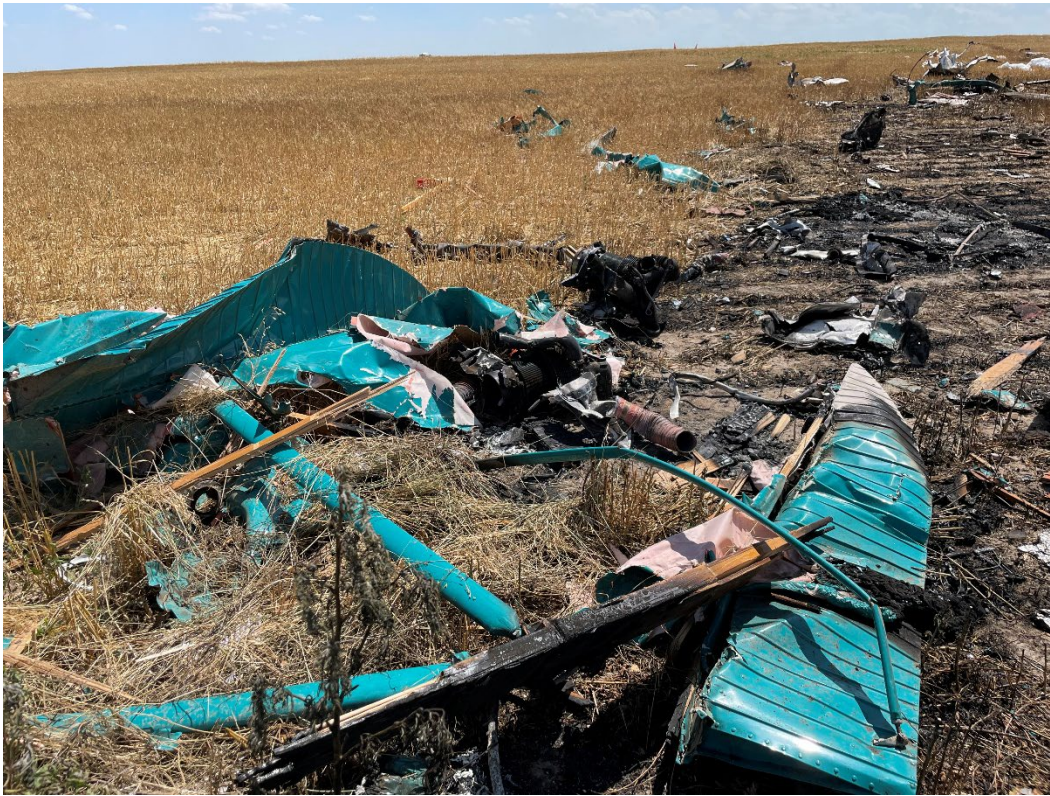
Figure 4. Left Outboard Upper & Lower Wing

All four wing structures were found fragmented throughout the debris field. The left-wing ailerons were 69 ft from the initial impact point with crush damage. The right-wing ailerons were among the debris field with crush damage and fire damage. The lower right-wing aileron was still attached to separated lower wing structure and struts. Both sets of lower ailerons still had the slave tube attached with the upper ailerons having impact separation of the tube consistent with overload failure at the fracture. Flight control continuity beyond the slave chain drive at the dual station Y yoke mount was not established due to impact damage of the fuselage and wings. Both aileron control cables were not located in the debris field.

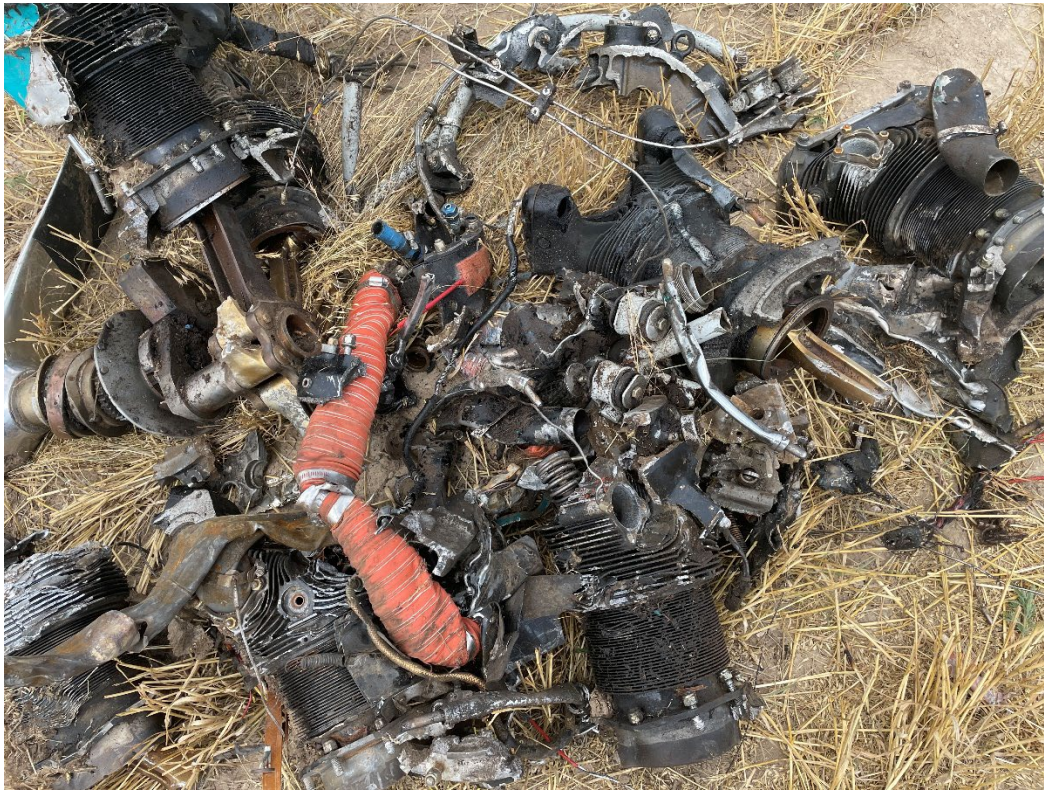
Figure 5. Recovered Engine Components

The airplane was equipped with a modified Jacobs R-755B2. The modification was for a Radial Engines, Ltd. Fuel Injection STC No. SE01288W1.

The engine was fragmented throughout the debris field. The largest section containing the forward half of the crankshaft, two connection rods and pistons heads, two cylinders, and propeller were found buried in a crater 19 ft from the first impact point. The rest of the engine components were fragmented through out the debris field. All components had impact related damage and unable to be tested or examined. Both magnetos were found in the debris field with impact damage and unable to be functionally tested. Ignition harness was found with impact damage and unable to be functionally tested. All spark plugs were found separated in the cylinders from impact related damage. The ADC engine oil filter was found and had still contained engine oil. Induction system was unable to be located.

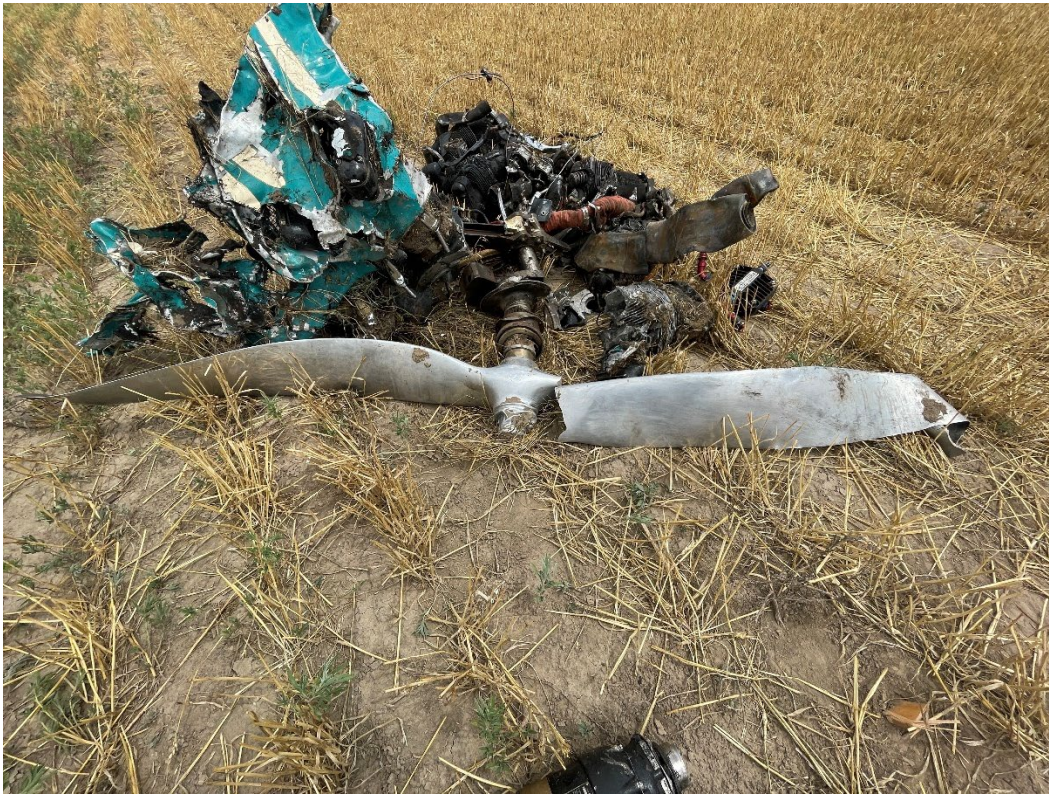
Figure 6. Propeller

The propeller was found still attached to the forward section of the crankshaft. The #1 Blade was still attached to the hub and had aft and rotational bending of the blade. #1 Blade also had rotational scaring on the face and back side consistent with ground impact. #2 Blade was found separated from the hub with the blade root buried in the ground. The #2 blade had s bending with aft lengthwise curling of the blade tip. The #2 blade leading edge had numerous gouges and scraping consistent with ground impact. The #2 blade face had numerous witness marks and rotational scraping consistent with ground and engine impacts.
