# National Transportation Safety Board

CEN24FA248

## EXAMINATION SUMMARY

Location: Andale, Kansas  
Date: July 5, 2024  
Time: 0801 CDT  
1301 UTC  
Helicopter: Faber Vincent L, Scorpion 133, S/N: F883417

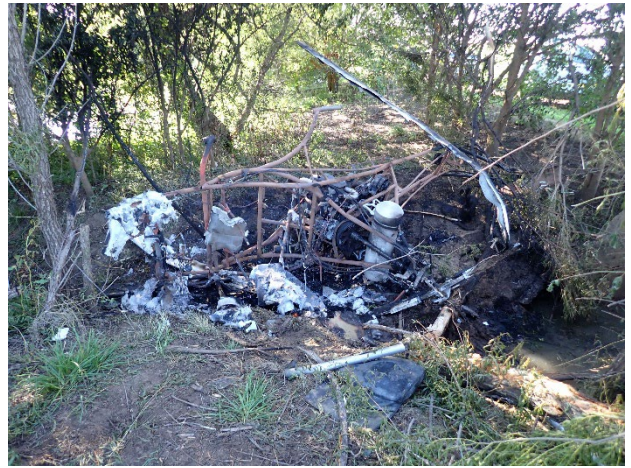
The helicopter impacted a ravine adjacent to a cultivated field on a northeasterly heading and came to rest inverted on northerly heading. The postimpact fire damaged several trees near the main wreckage. The accident site was

Photograph of main wreckage.

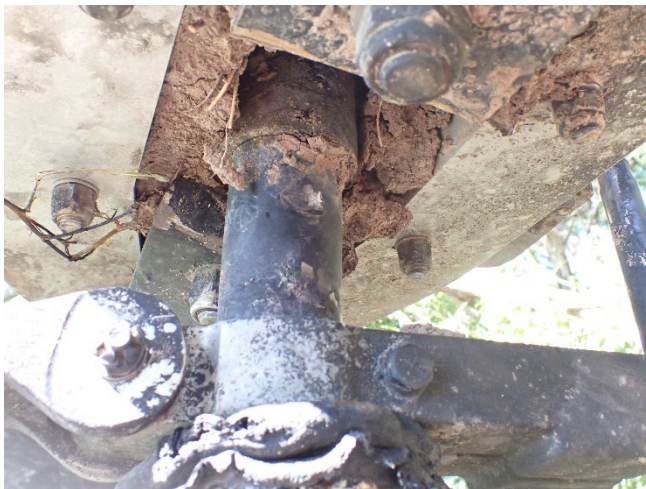
main rotor blades remained attached and exhibited downward droop. An impact mark was observed on the main rotor mast beneath blade **W**. Blade **S** displayed thermal discoloration, and a mid-chord skin separation was present about 2 ft inboard of the tip.

Photograph of main rotor mast impact under blade **W**.

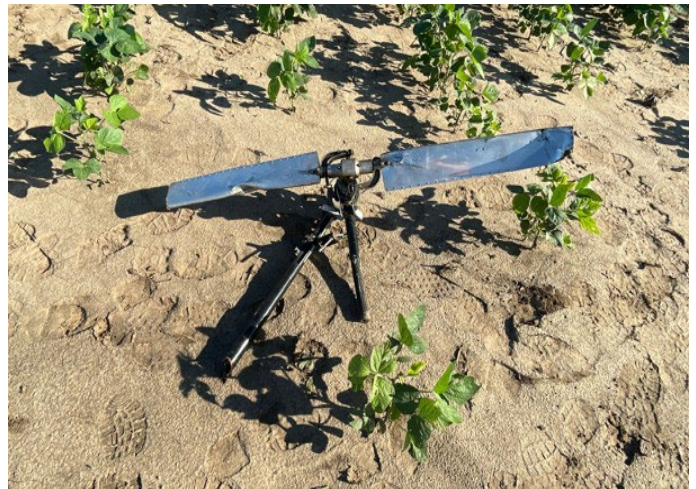
The tail rotor assembly and about 3 ft of the tail boom's tubular structure were separated from the helicopter. The remaining structure exhibited leftward deformation at the separation area. The tail rotor drive belts were fractured and separated from their respective pulleys. Deformation was observed on the tail rotor drive pulley and its supporting structure. The tailrotor control cable rod end remained attached, and the cable housing was impact separated at its tail rotor attachment point. Both tail rotor blades and pitch change links remained attached to their mounts. One blade exhibited deformation at the tip. The other blade displayed a semicircular impression on the leading-edge near mid-span, with black transfer marks consistent with the paint from the tail boom's tubular structure. White transfer marks were present on the tail rotor drive belt pulley. The tail rotor drive pulleys rotated freely when facilitated by hand.

Photograph of separated tailboom section.

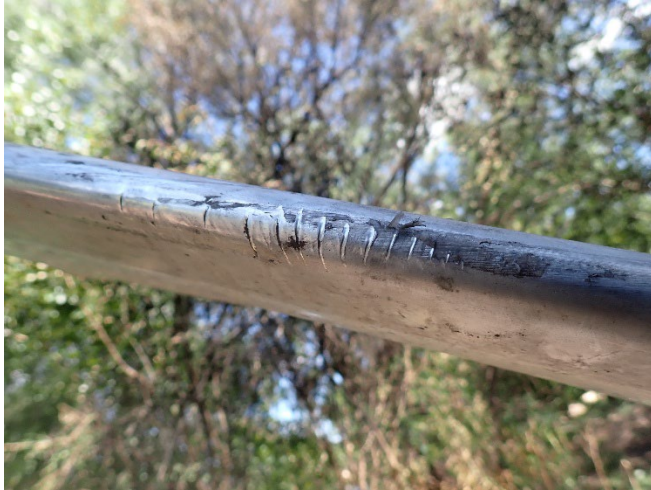
Blade **W** exhibited aft bending about 3 ft from the tip, and a mid-chord upper-skin separation was noted approximately 4 in from the tip. Gouging and an impression consistent to that of impact with a threaded fastener were noted to the outboard leading-edge area of the blade. A leading-edge impression consistent with contact from a steel ballast weight was identified on the blade. The ballast weight showed deformation and material transfer consistent with impact from a main rotor blade. Leading-edge abrasions consistent with contact from the tail rotor control cable were noted approximately 8 in from the blade tip.

Photograph of tailrotor control cable abrasion noted to leading-edge of blade **W**.

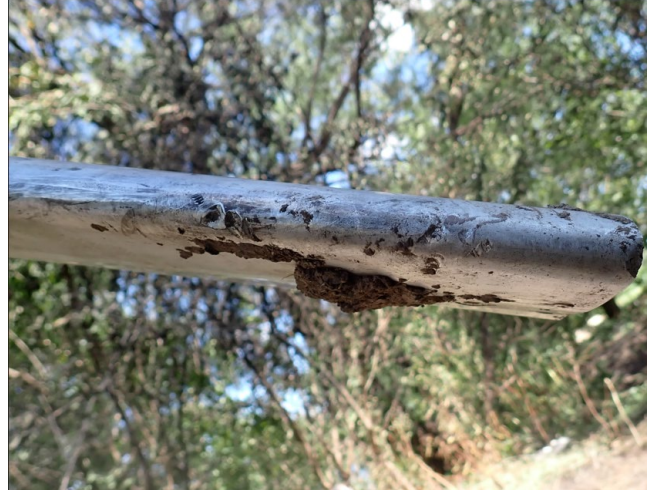
Photograph of threaded fastener impression noted to leading-edge of blade **W**.

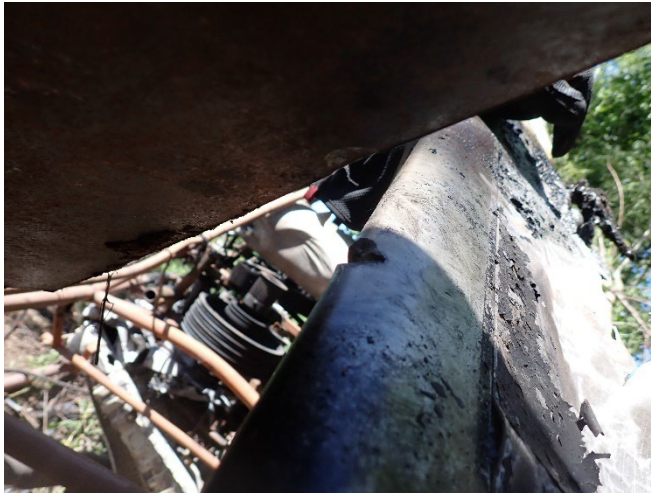
Photograph of ballast weight impact with blade **W**.

The recovered ballast weights consisted of a steel plate, dumbbell, and barbell plate which totaled about 65 pounds. The ballast was not secured in the helicopter and their location in the helicopter was unknown.

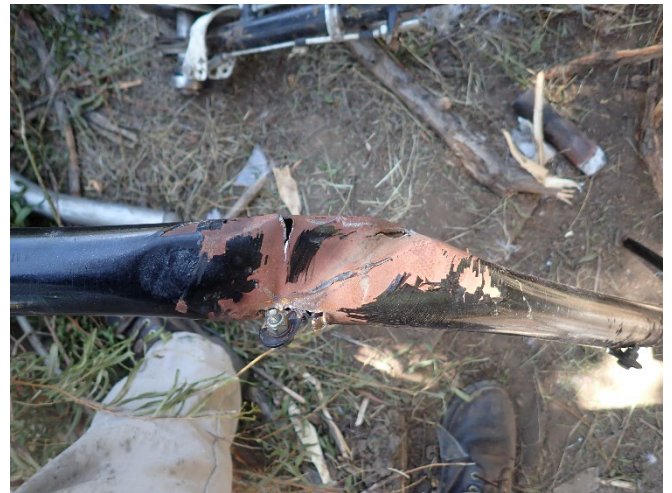
Photograph of separated tailboom structure threaded fastener and blade **W** impact impression.

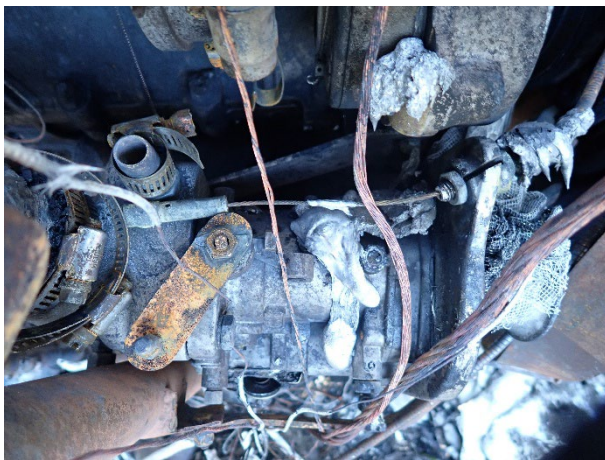
The fuel tank and fuel lines were mostly destroyed by fire. The fuel valve was in the "on" position and continuity was established during a field test with low-pressure air. The carburetor remained attached to its mount and exhibited thermal damage. It was observed in the idle position, and the fuel inlet port was unobstructed. The air filter and induction tubes were destroyed. The carburetor control cable was thermally separated from the collective control and the snap out ball joint was separated from the carburetor. The ball joint's safety sleeve was out of position and firmly attached to the barrel.

Photograph of snap out ball joint separated from the carburetor.

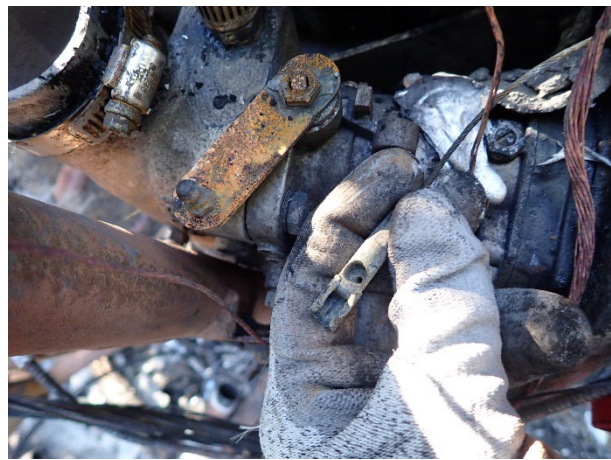
Photograph of ball joint safety not in position.
