CEN24FA260

## INVESTIGATION PHOTOGRAPHS

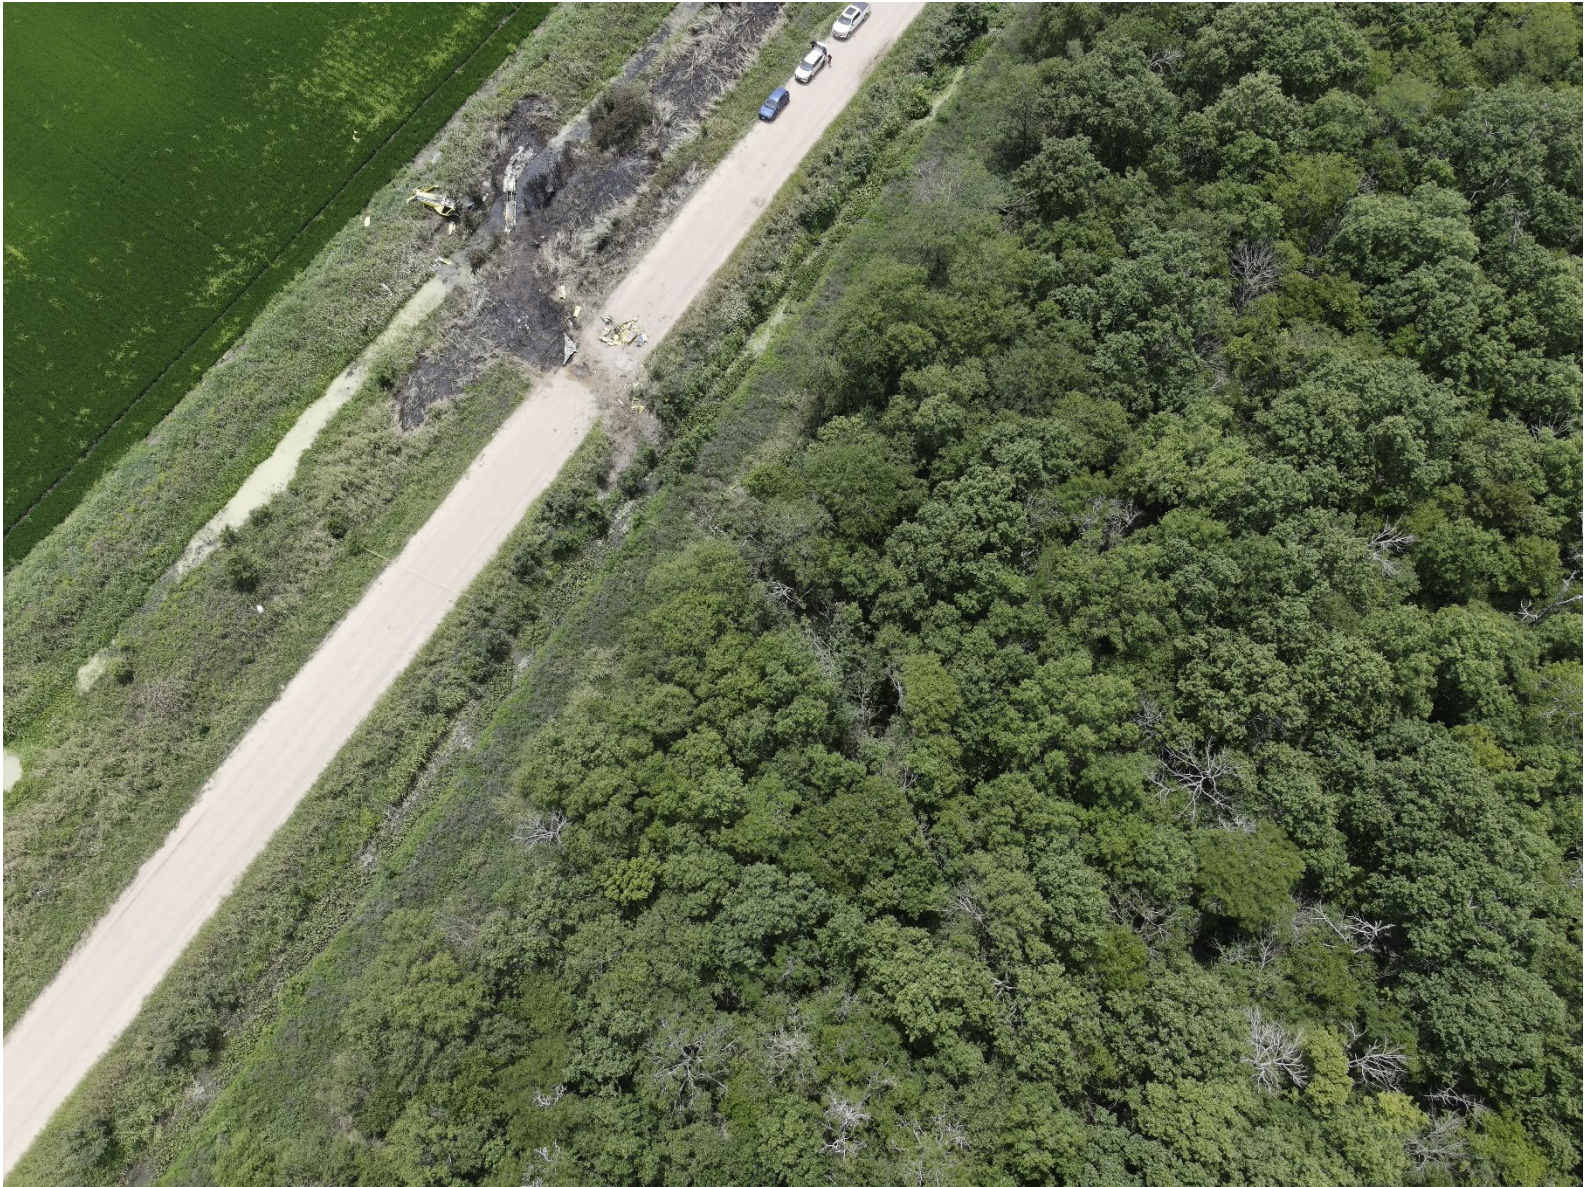
**Photograph 1 - Aerial view of accident site location**

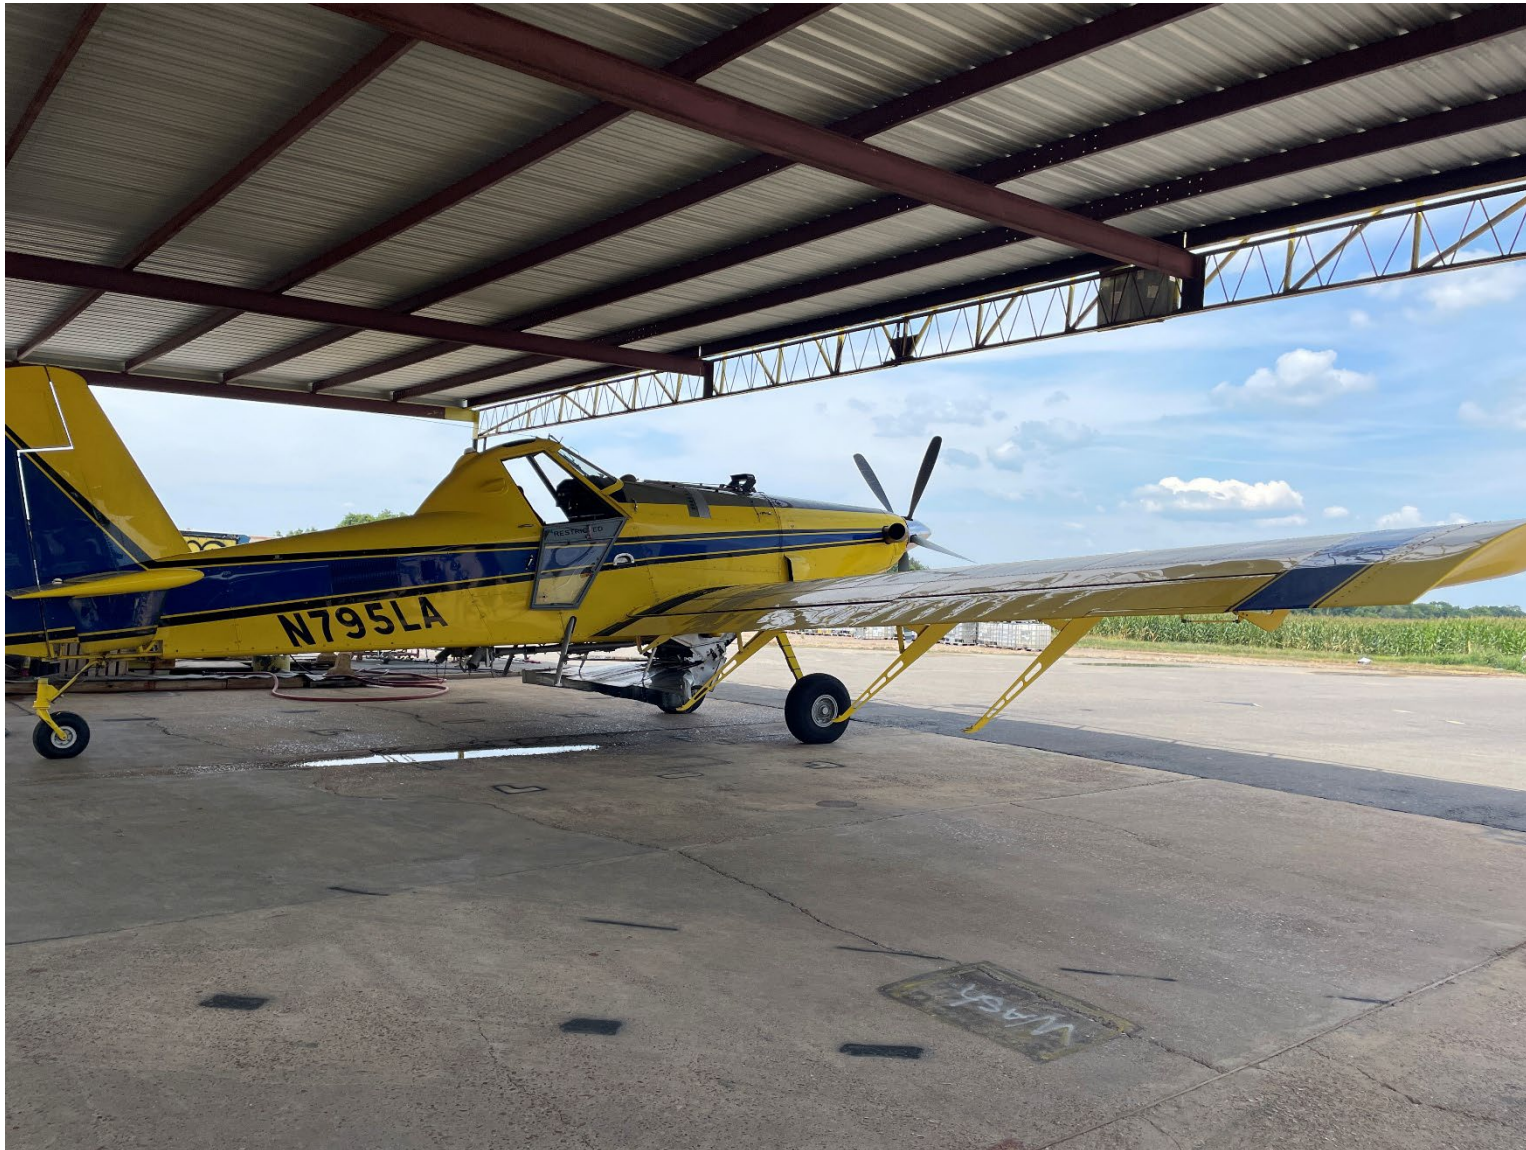
**Photograph 2 - N795LA Accident Airplane**

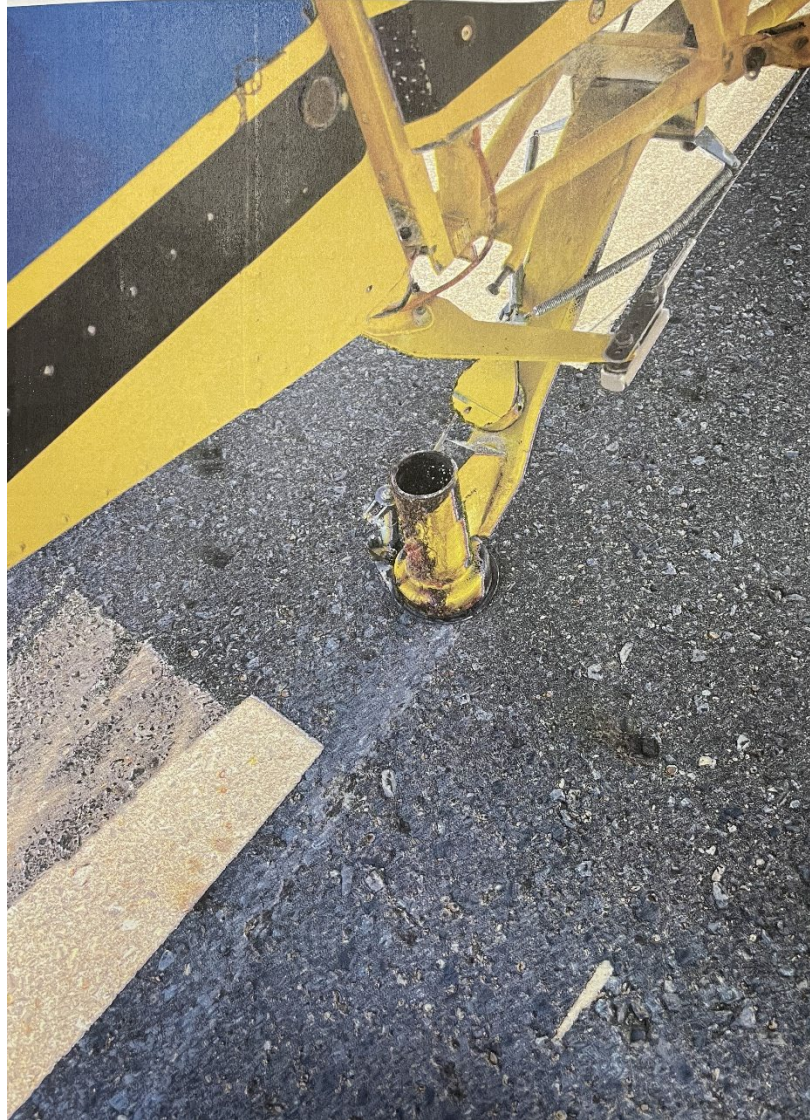
**Photograph 3 - N795LA Missing Tail Wheel Assembly (Source: Operator)**

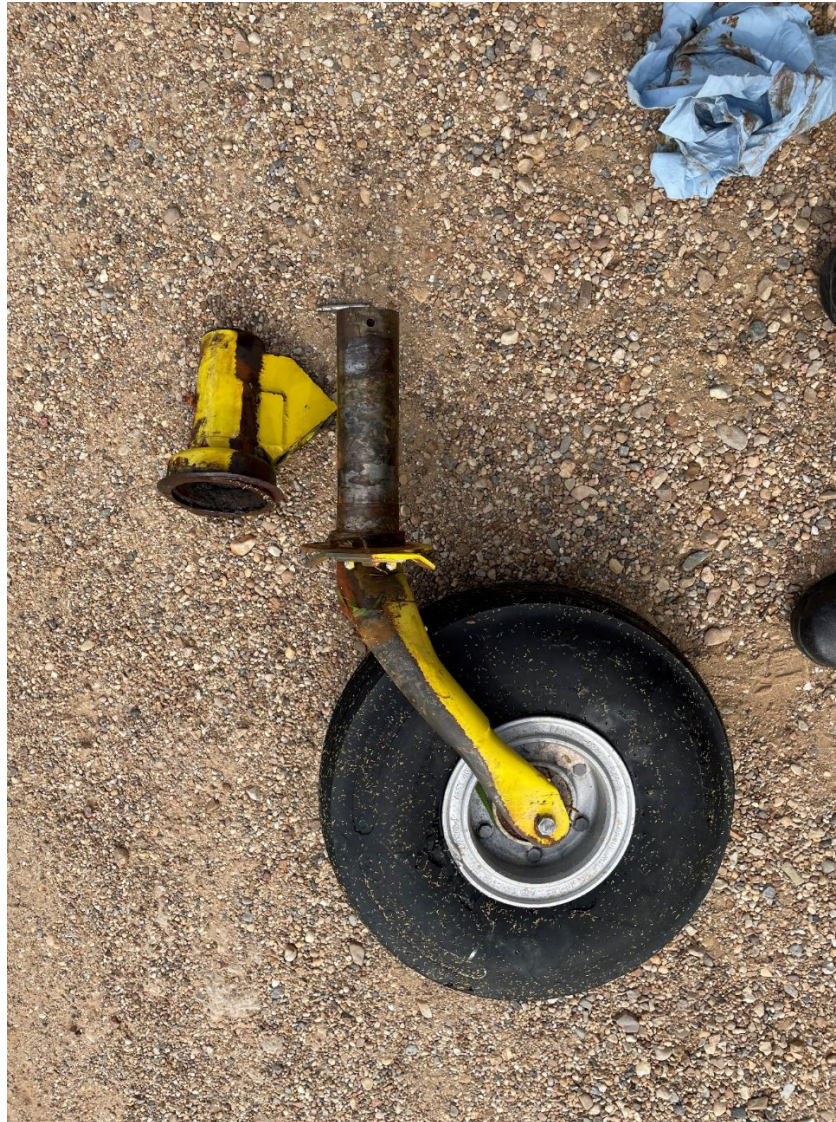
**Photograph 4 - N795LA Tail wheel assembly after recovery**

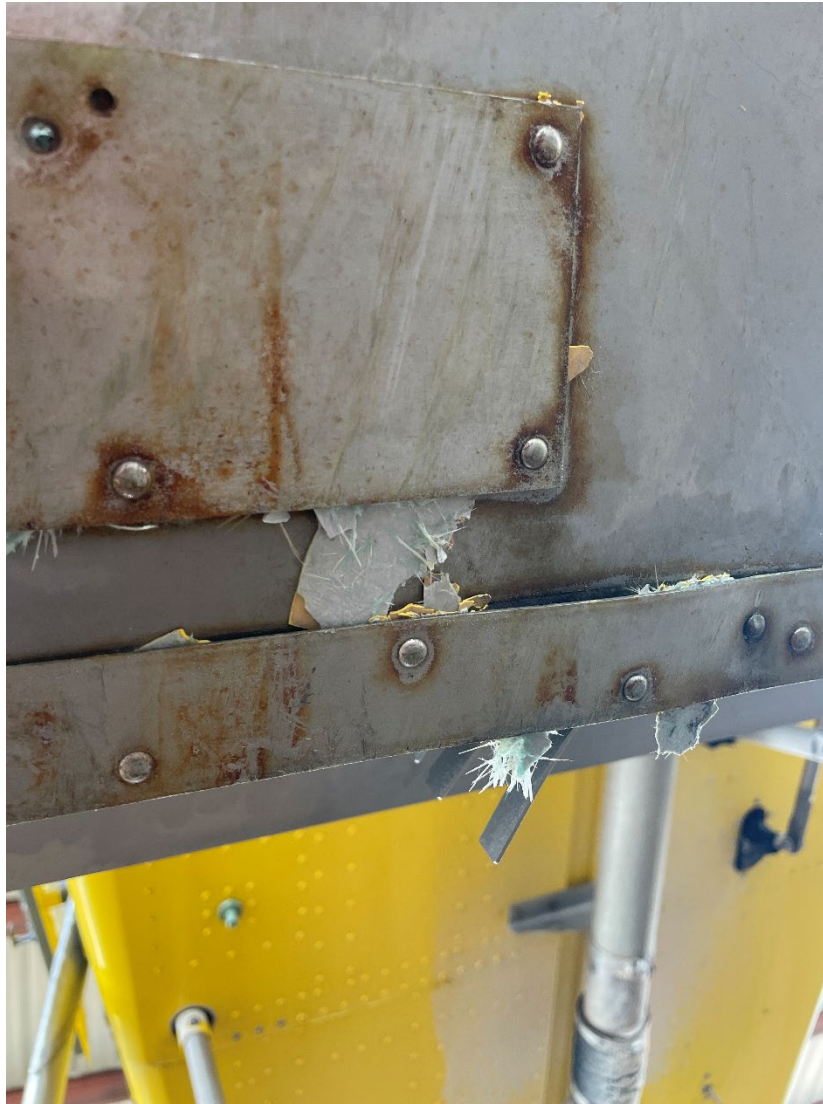
**Photograph 5 - N795LA Paint and fiberglass debris**

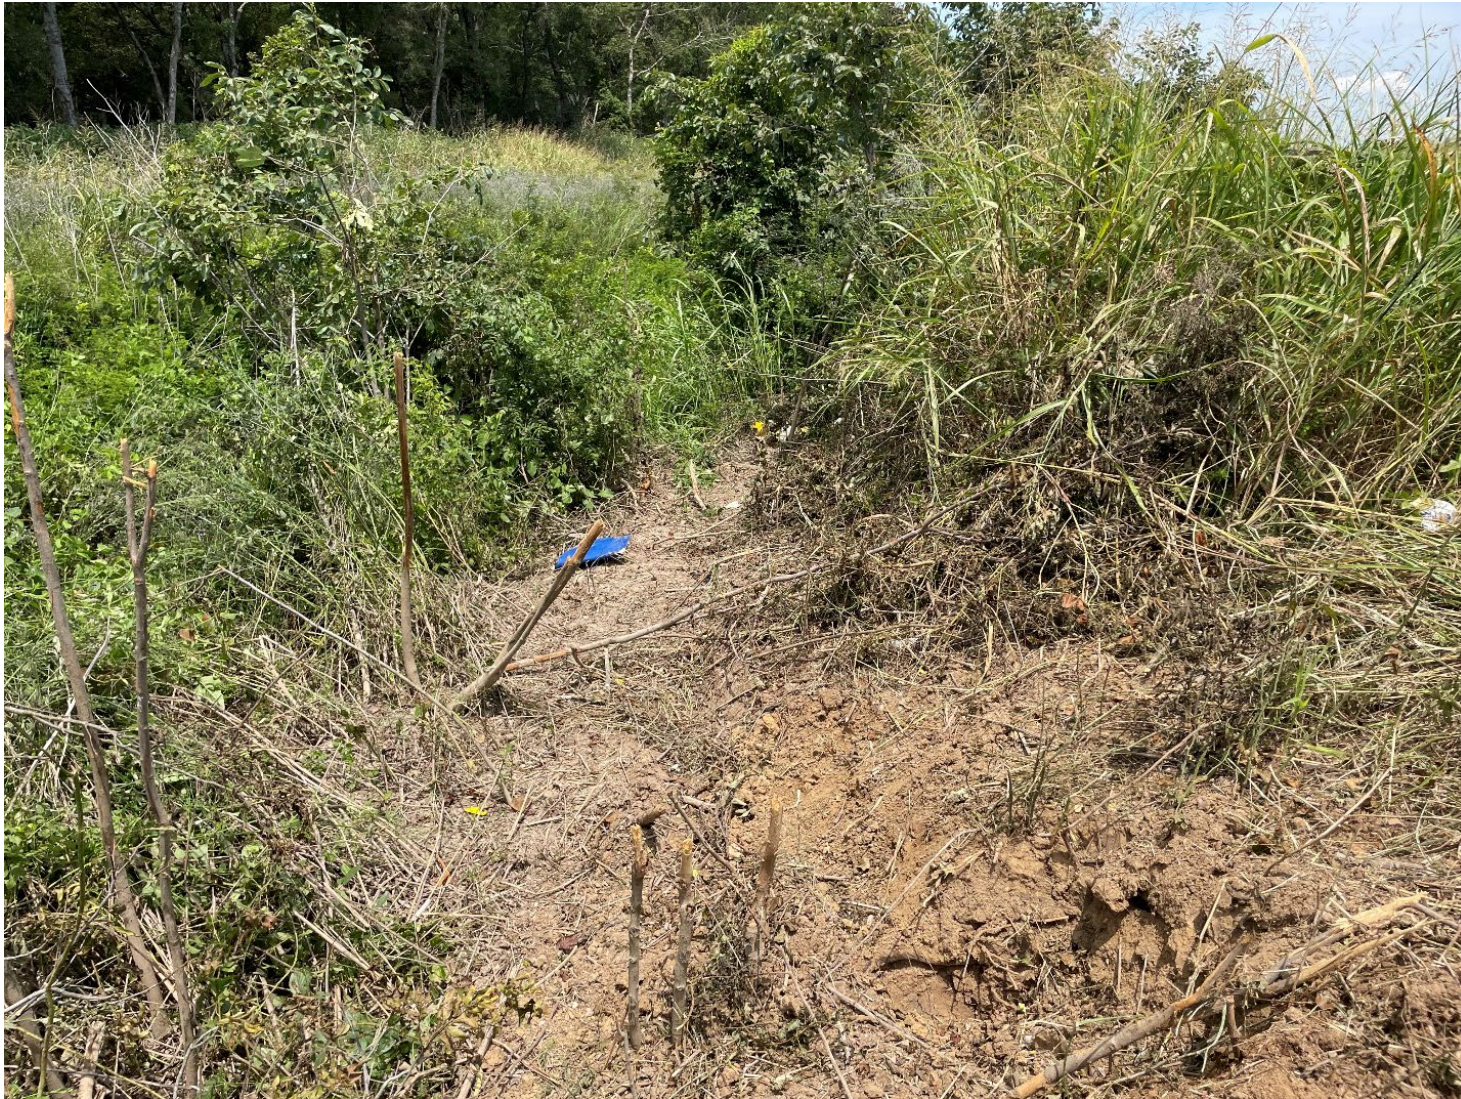
**Photograph 6 - N6177J Initial ground impact**

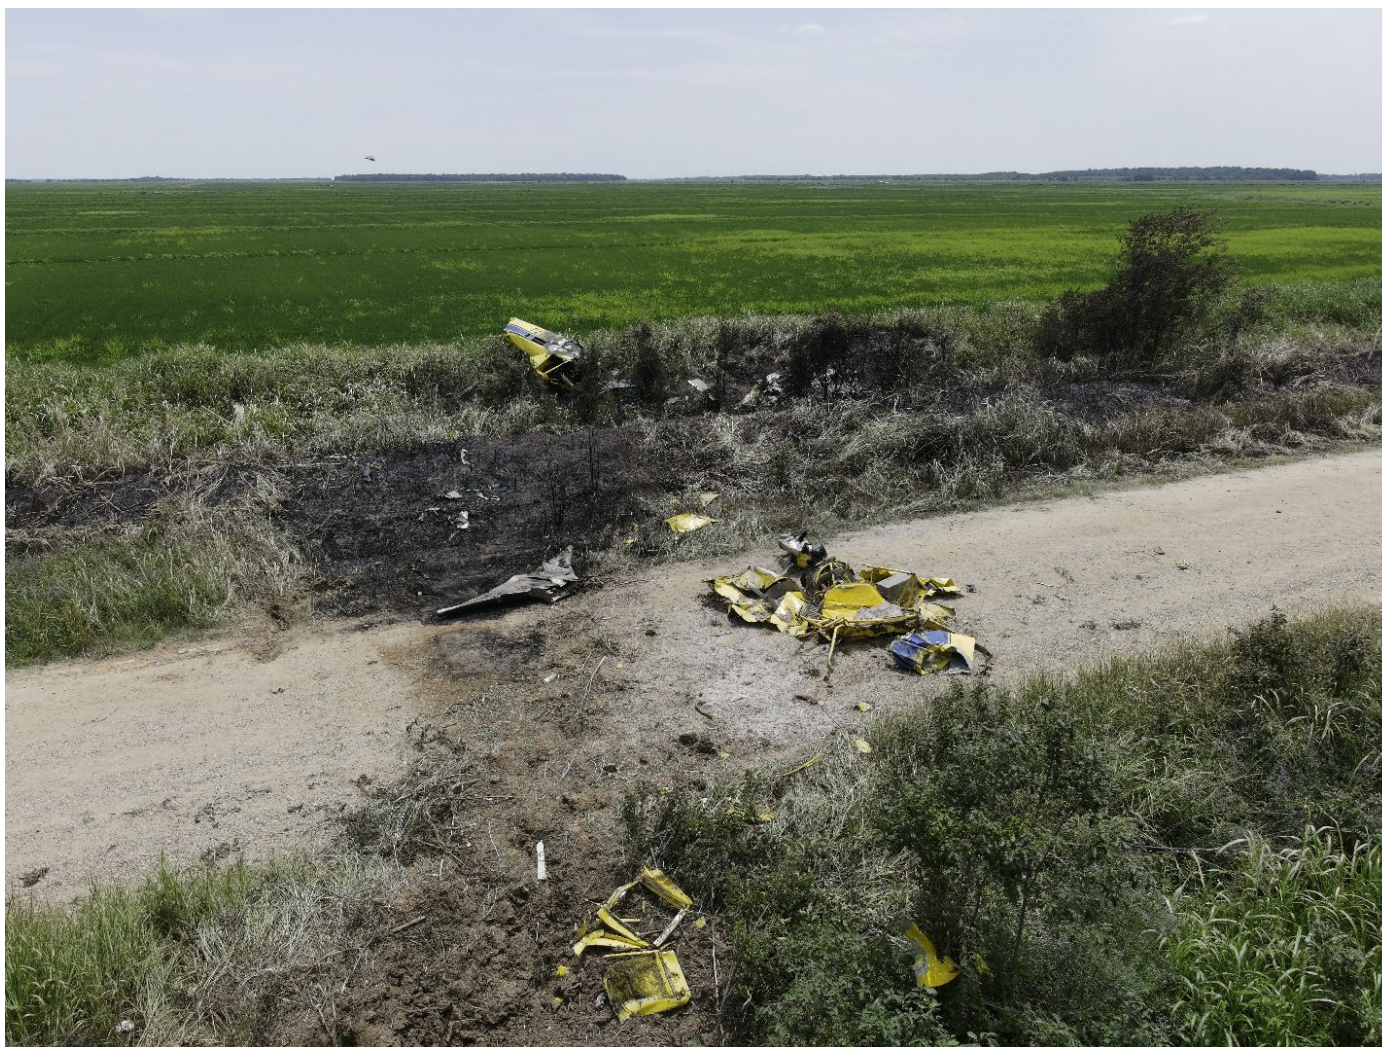
**Photograph 7. N6177J Debris field**

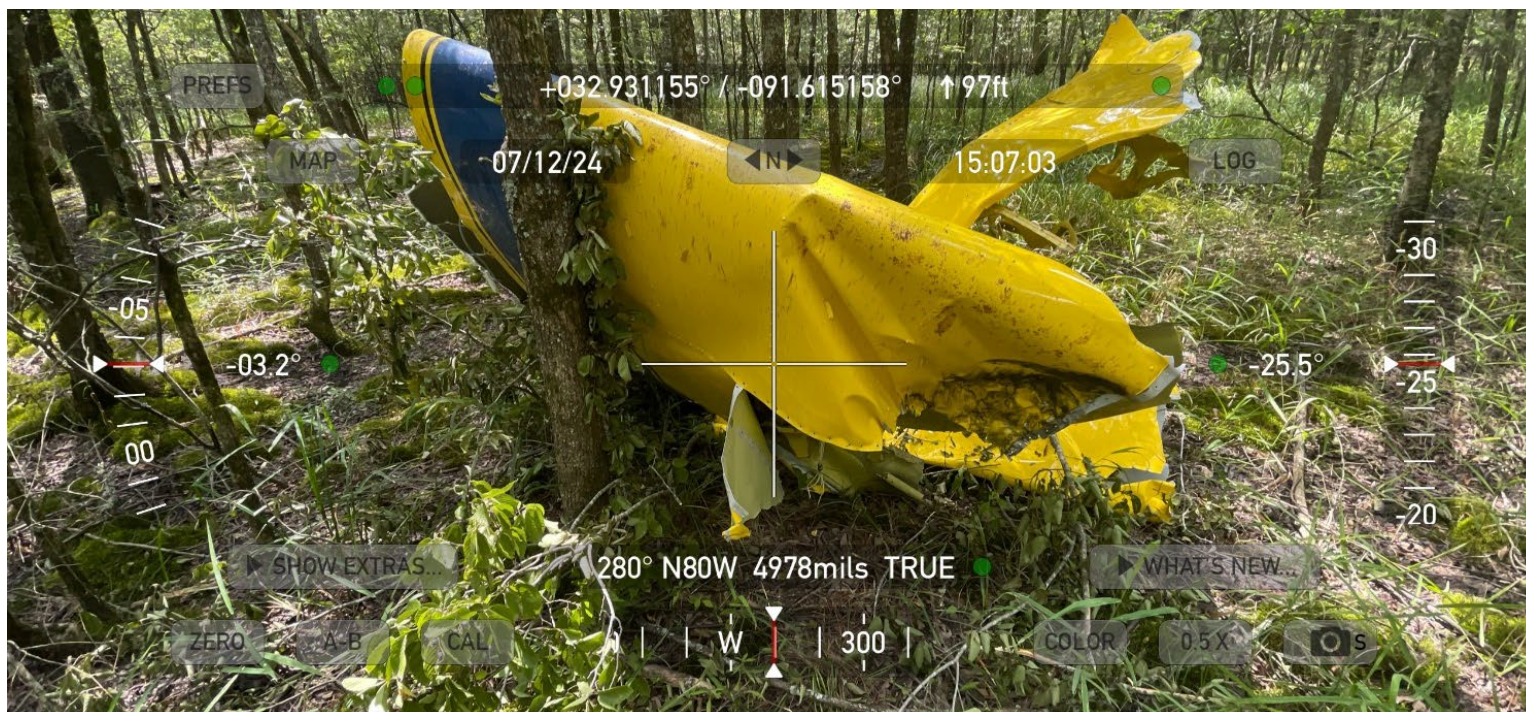
**Photograph 8. N6177J Separated outboard left wing (Source: FAA)**

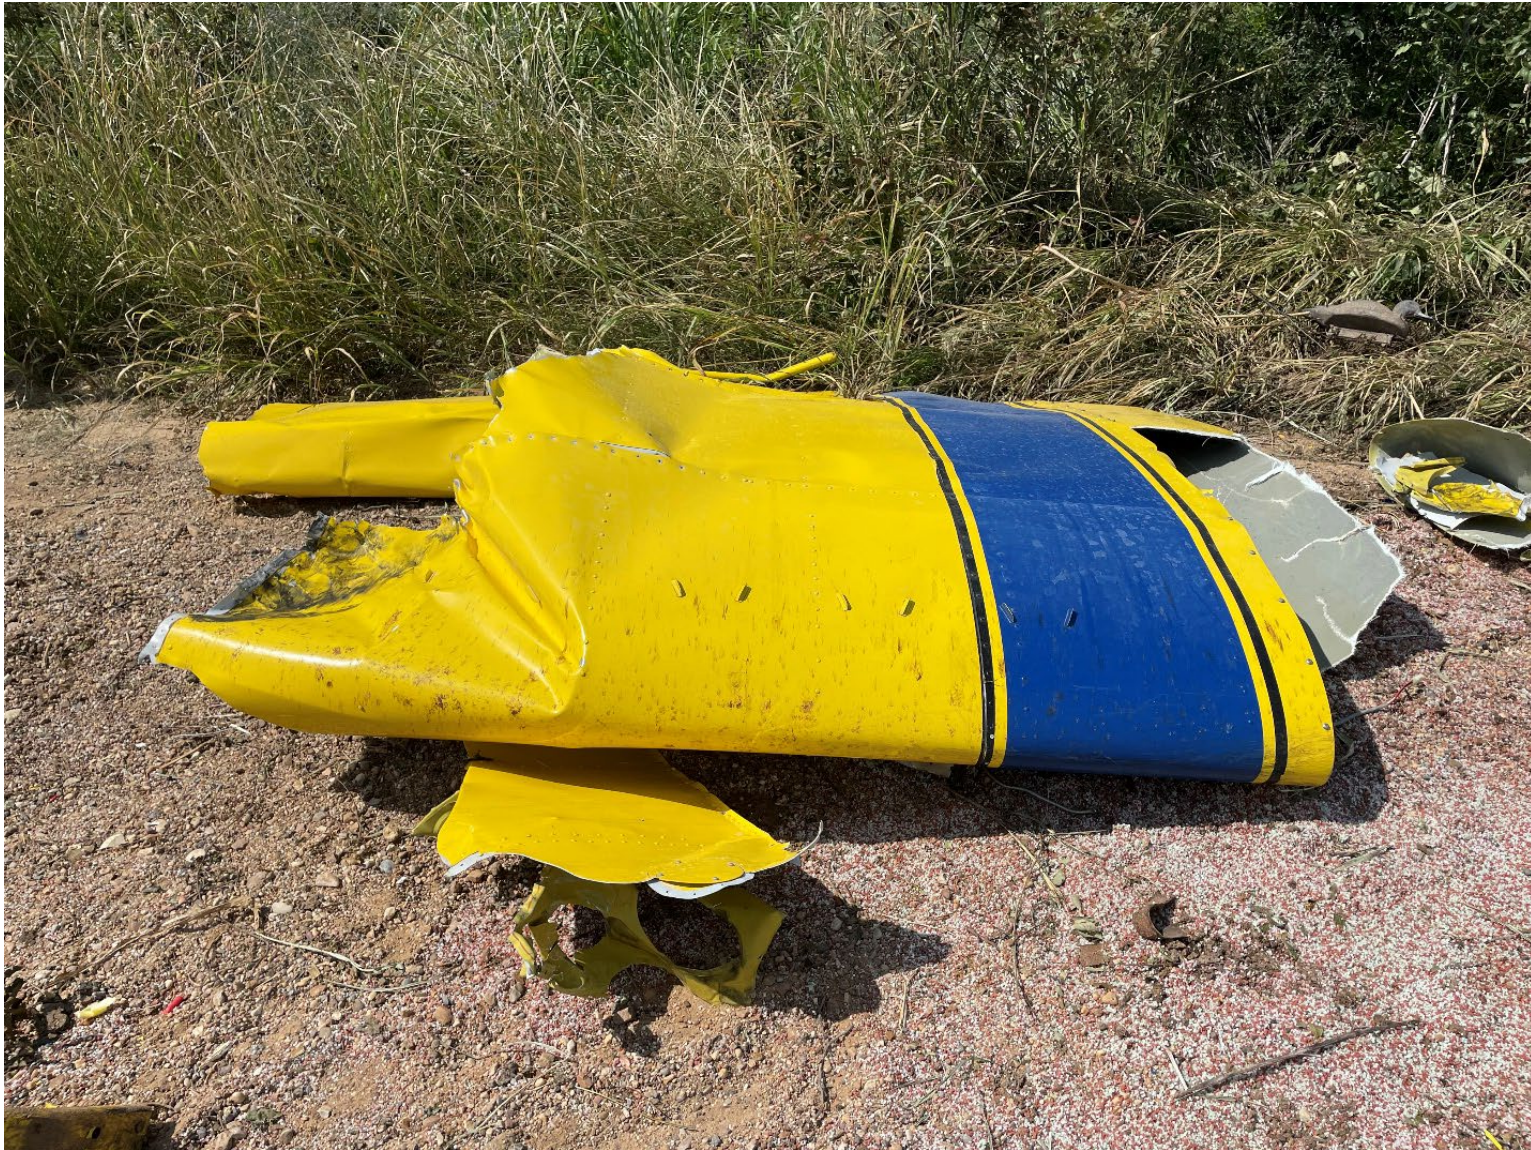
**Photograph 9. N6177J Separated outboard left wing**

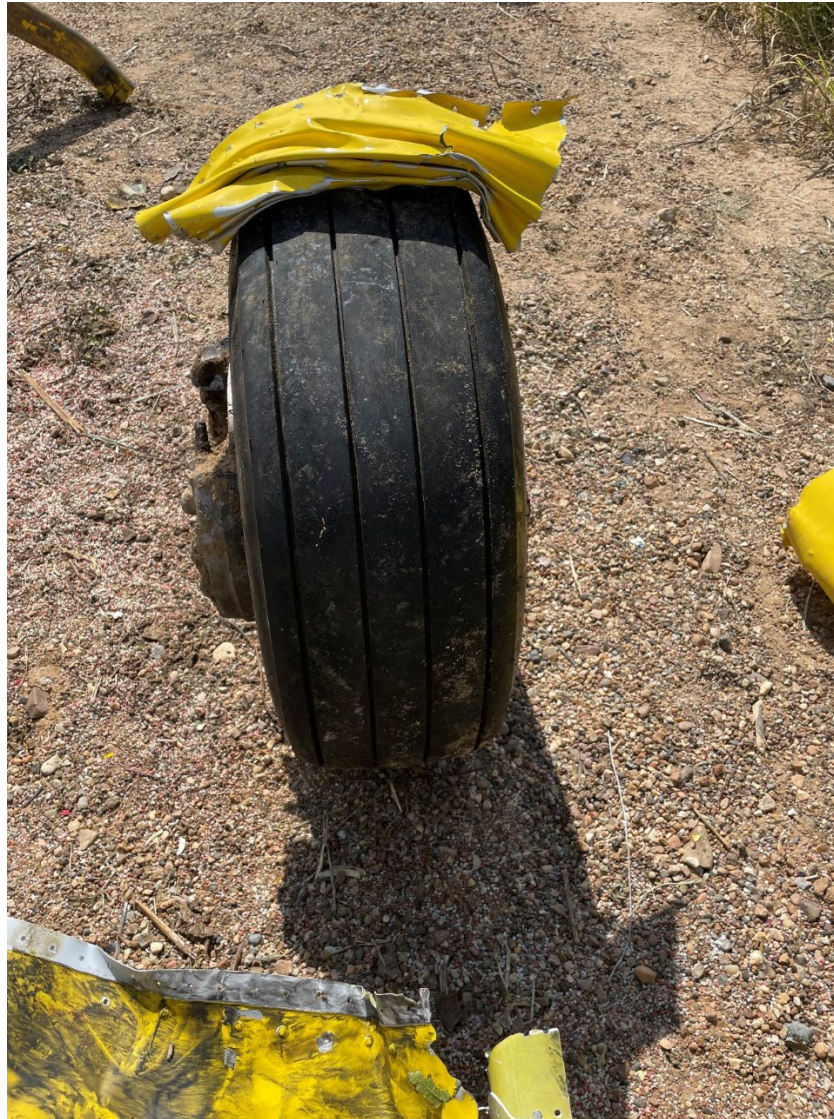
**Photograph 10. N6177J Separated left wing structure with exemplar wheel assembly**

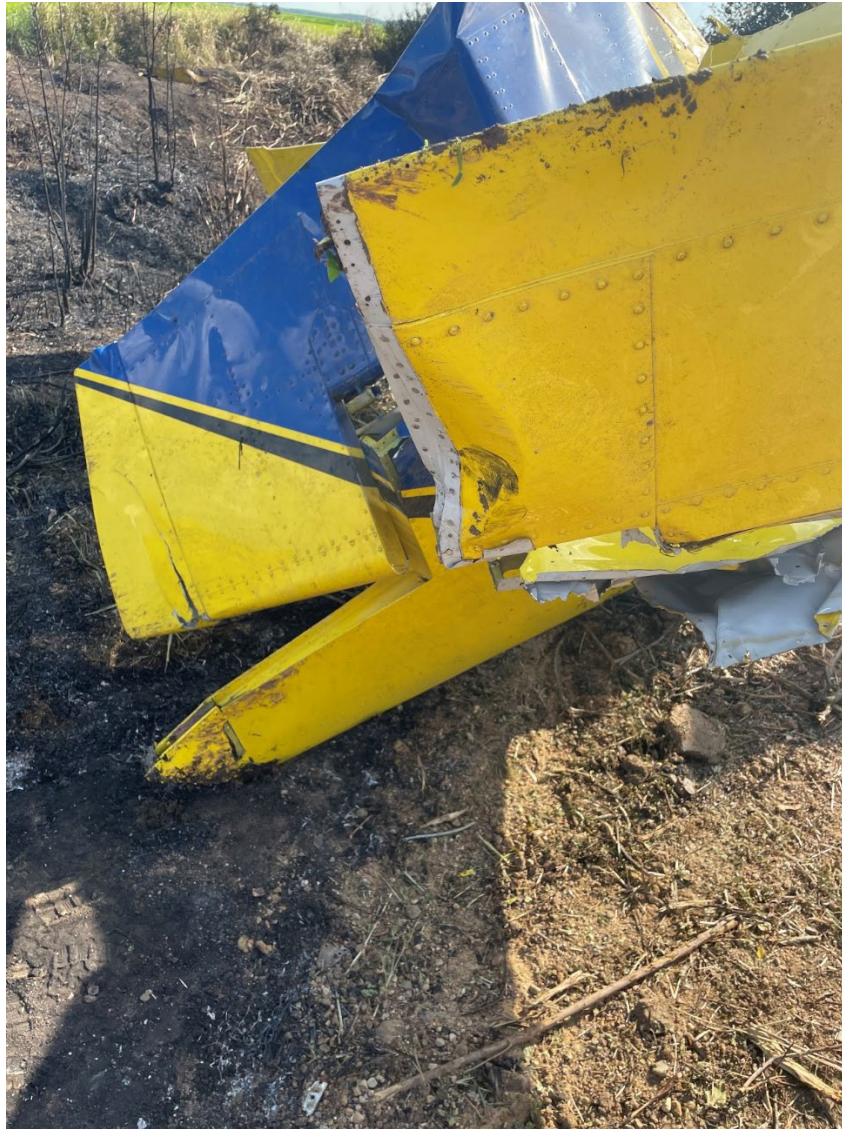
**Photograph 11. N6177J Left horizontal stabilizer**
