# National Transportation Safety Board

CEN24FA260

## **ACCIDENT SCENE AND AIRCRAFT SUMMARY**

Location: Bonita, LA  
Date: 07/11/2024  
Time: 1407 CDT  
Aircraft: Air Tractor AT-502B; N6177J / Air Tractor AT-802A; N795LA

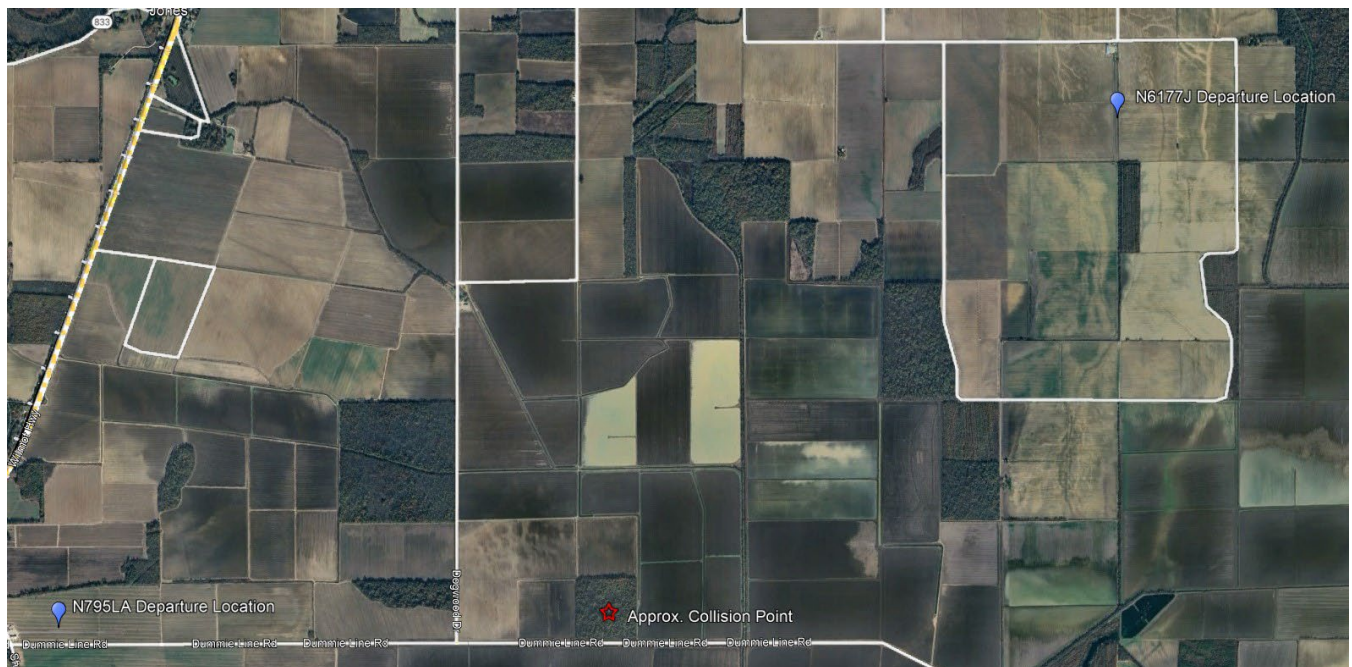
According to the N795LA pilot, he departed the private airstrip and was traveling east about 200 ft above ground level. About 2 miles after departure, the pilot suddenly observed N6177J about 100 ft to his left at the same altitude (See figure 1). The pilot pulled back on the control stick to avoid N6177J. The pilot felt and heard a bang, and he controlled the airplane after the collision. The pilot circled the area and noticed N6177J had impacted the terrain and observed a small ground fire. The pilot eventually returned to the airstrip, and the airplane landed with the tail wheel landing gear missing from the airplane. During the collision, the airplane sustained minor damage to the tail wheel and fertilizer spreader.

Figure 1. Overview of departure locations and collision point.

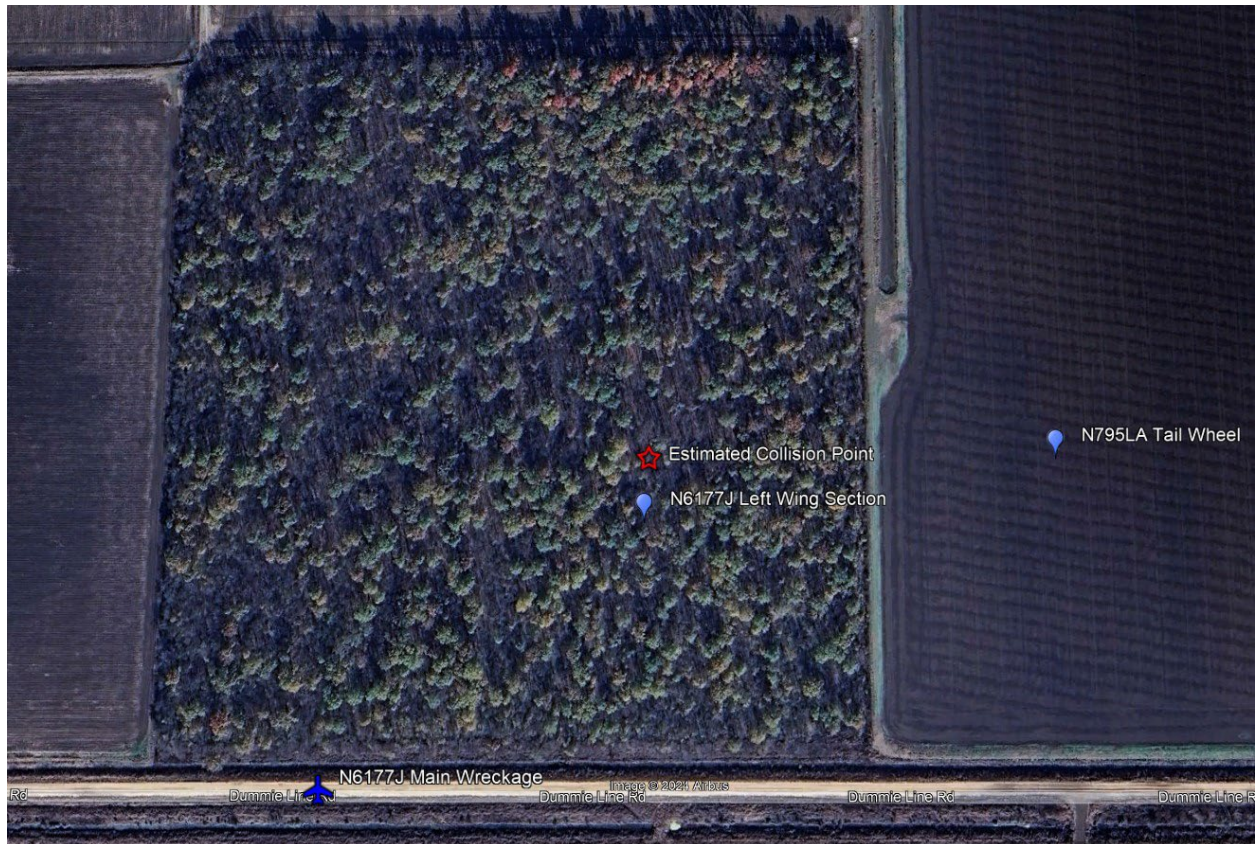
Figure 2. Accident site with debris and main wreckage annotated.

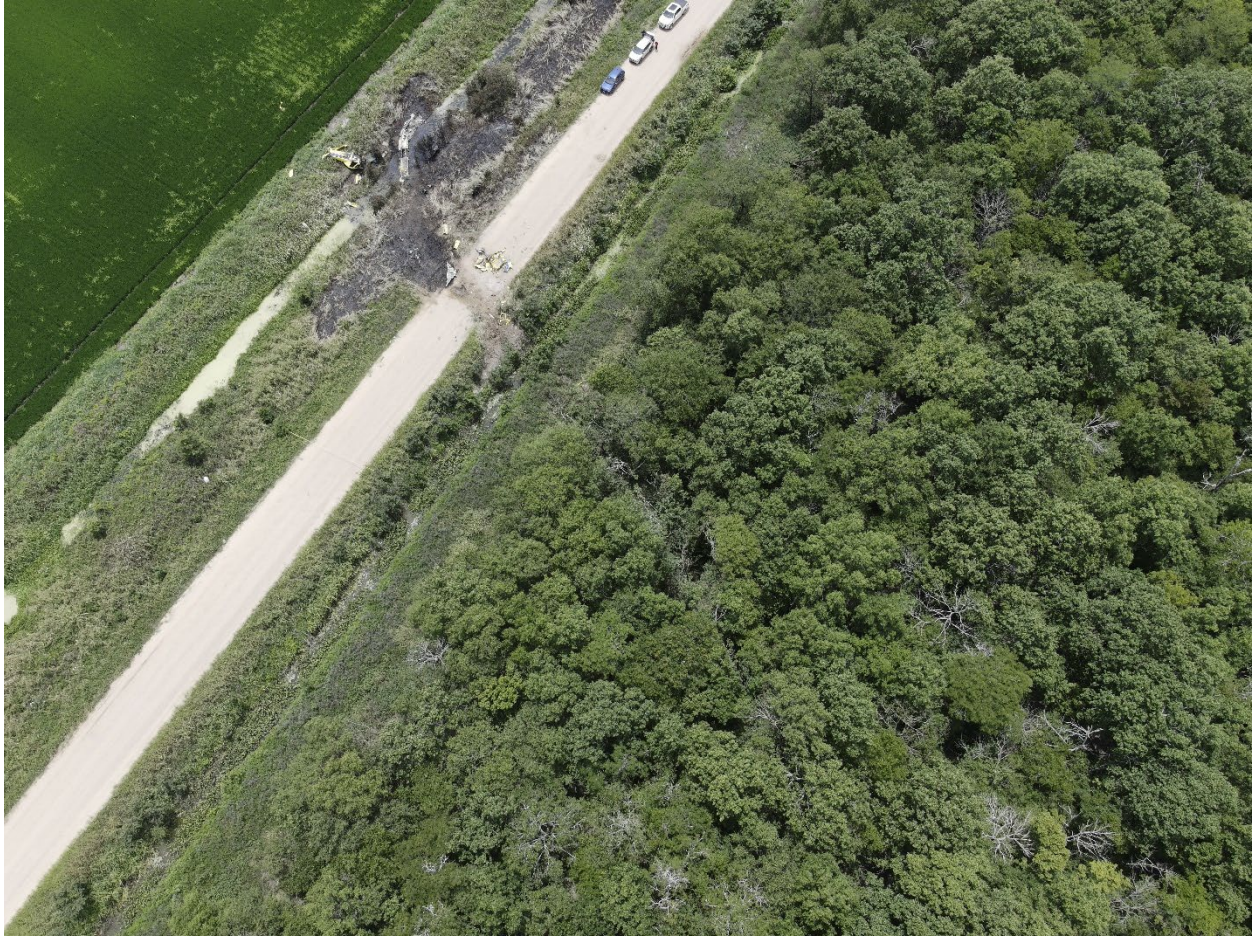
Figure 3. Aerial view of N6177J accident site.

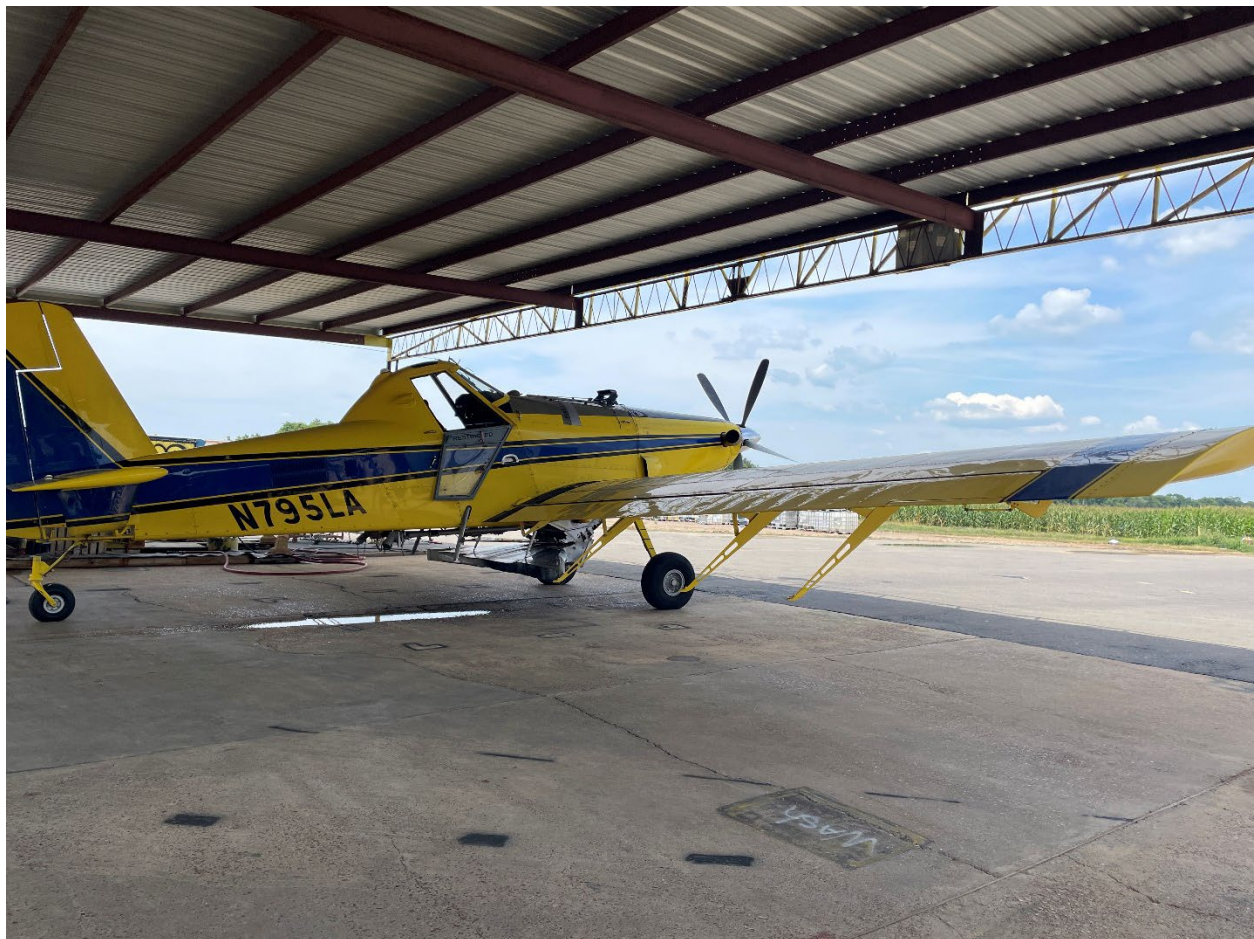
Initial postaccident examination of N795LA revealed the operator had completed repairs to the tail wheel assembly to continue their agricultural operations prior to the investigators' arrival to the airplane's location. The operator provided photographs of the airplane after it landed following the collision and details of what was repaired. The tail wheel and tail wheel fork were separated during the collision and located in a rice field to the east of the accident site location. Yellow paint chips and fiberglass shards were located on the underside of the spreader unit, consistent with the left wing tip from N6177J. Two additional areas of transfer marks were located; however, inconclusive on whether they were related to the collision: paint transfer on the right main landing gear tire (side walls), black transfer marks on the

Figure 4. N795LA in the operator's hangar facility (tail wheel assembly repaired).

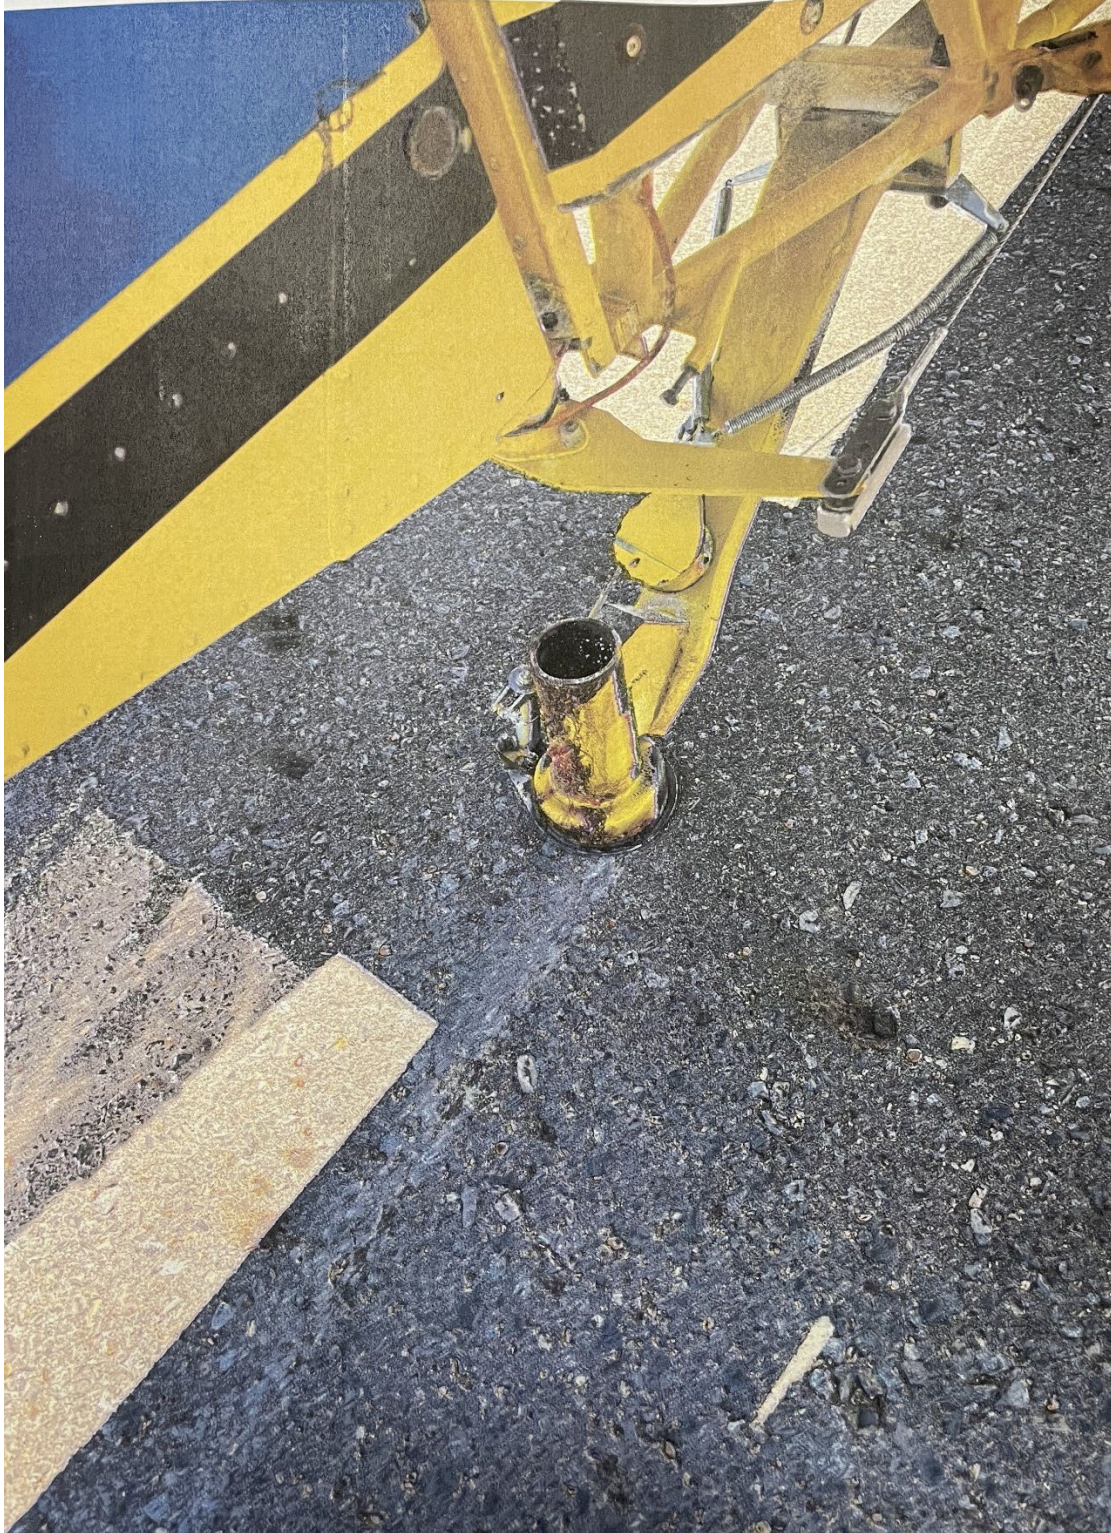
Figure 5. Missing tail wheel assembly following landing after the collision (Source: Arkla Flyers, Inc.)

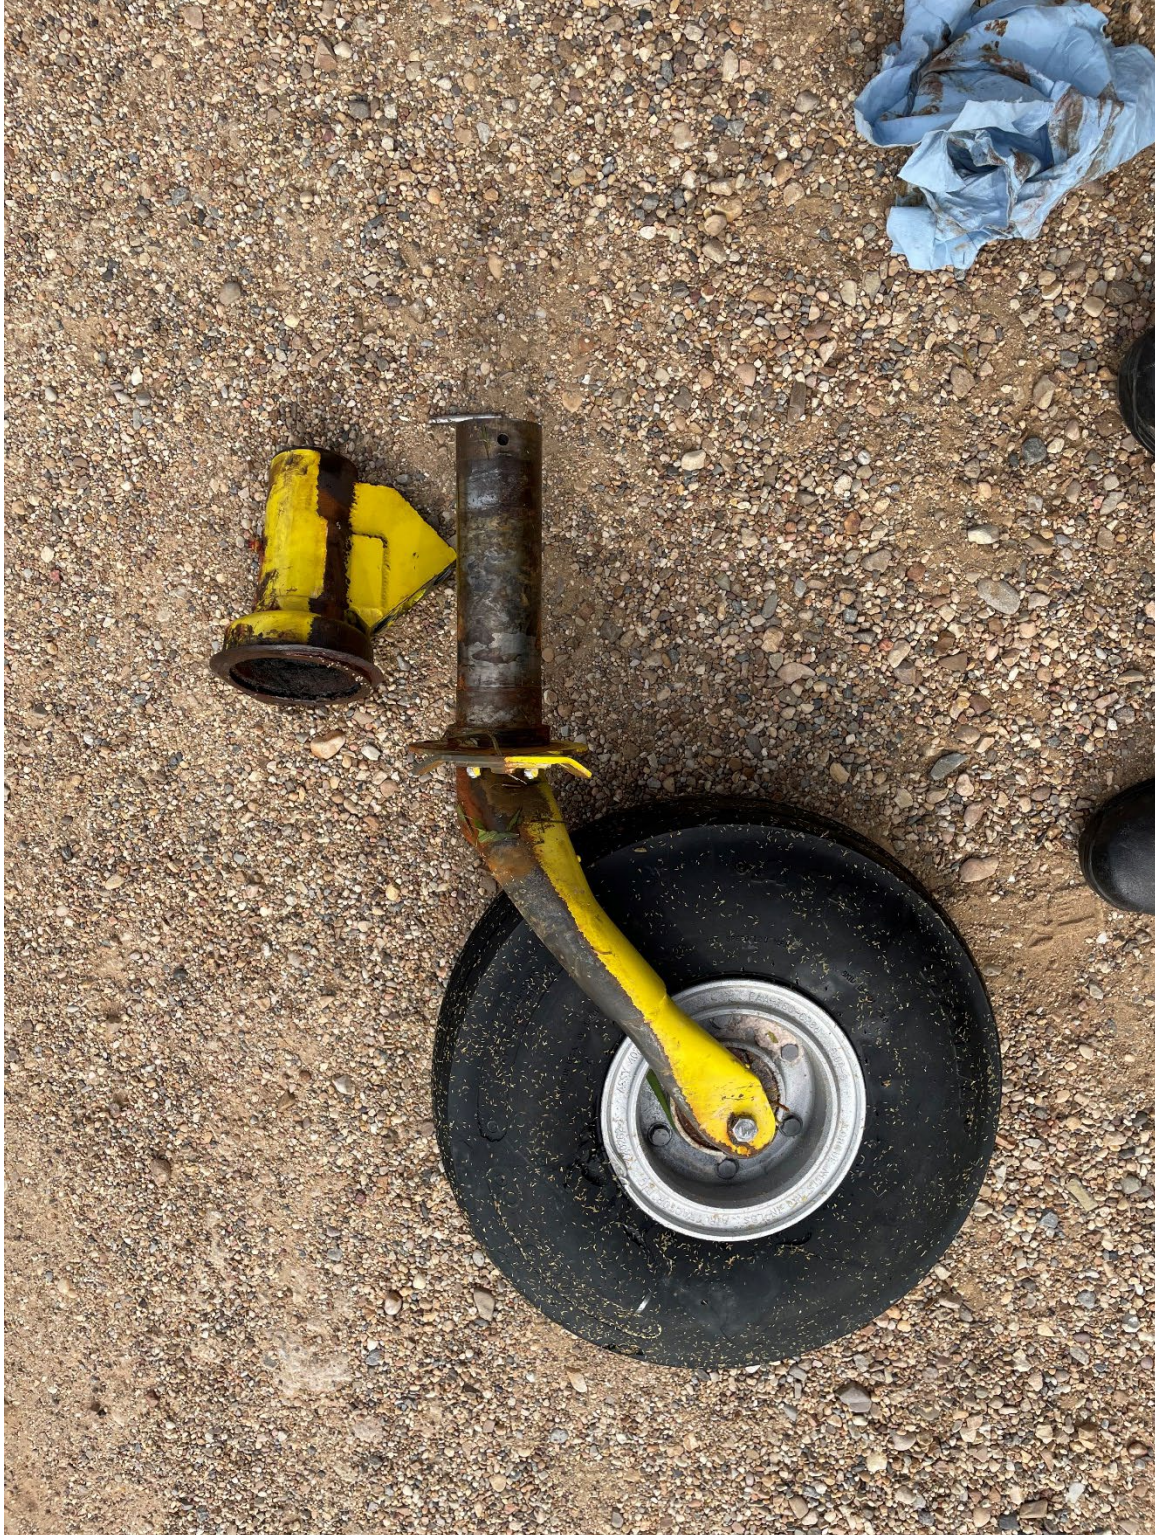
Figure 6. Accident tail wheel assembly after recovery from the rice field.

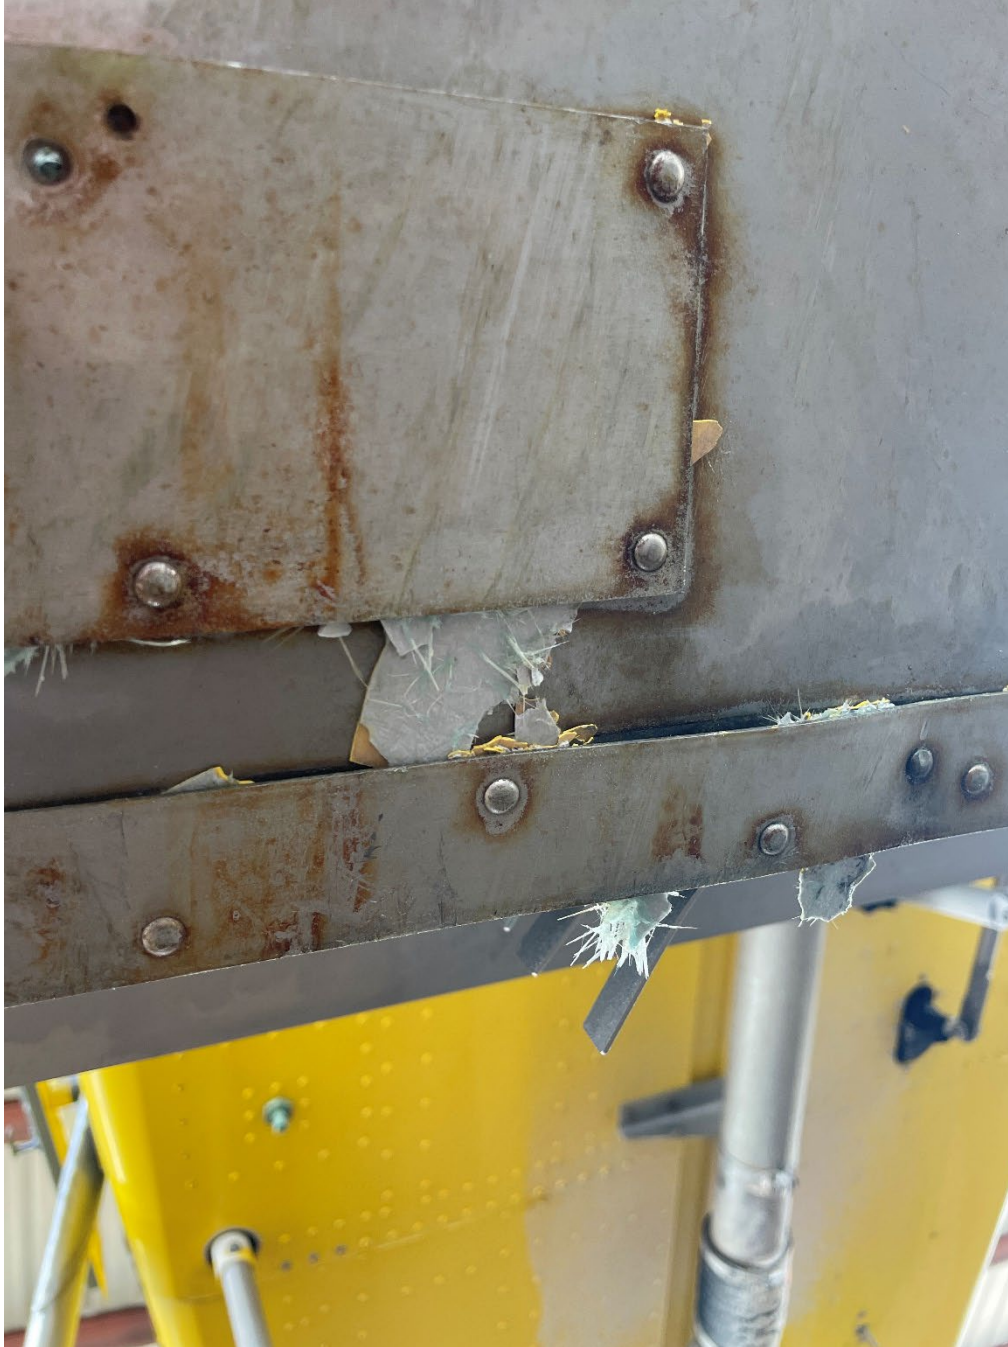
right forward leading edge of the spreader consistent with the wire deflector cable. The airplane sustained minor damage during the midair collision.

Figure 7. Paint and fiberglass debris located on the underside of N795LA's spreader.

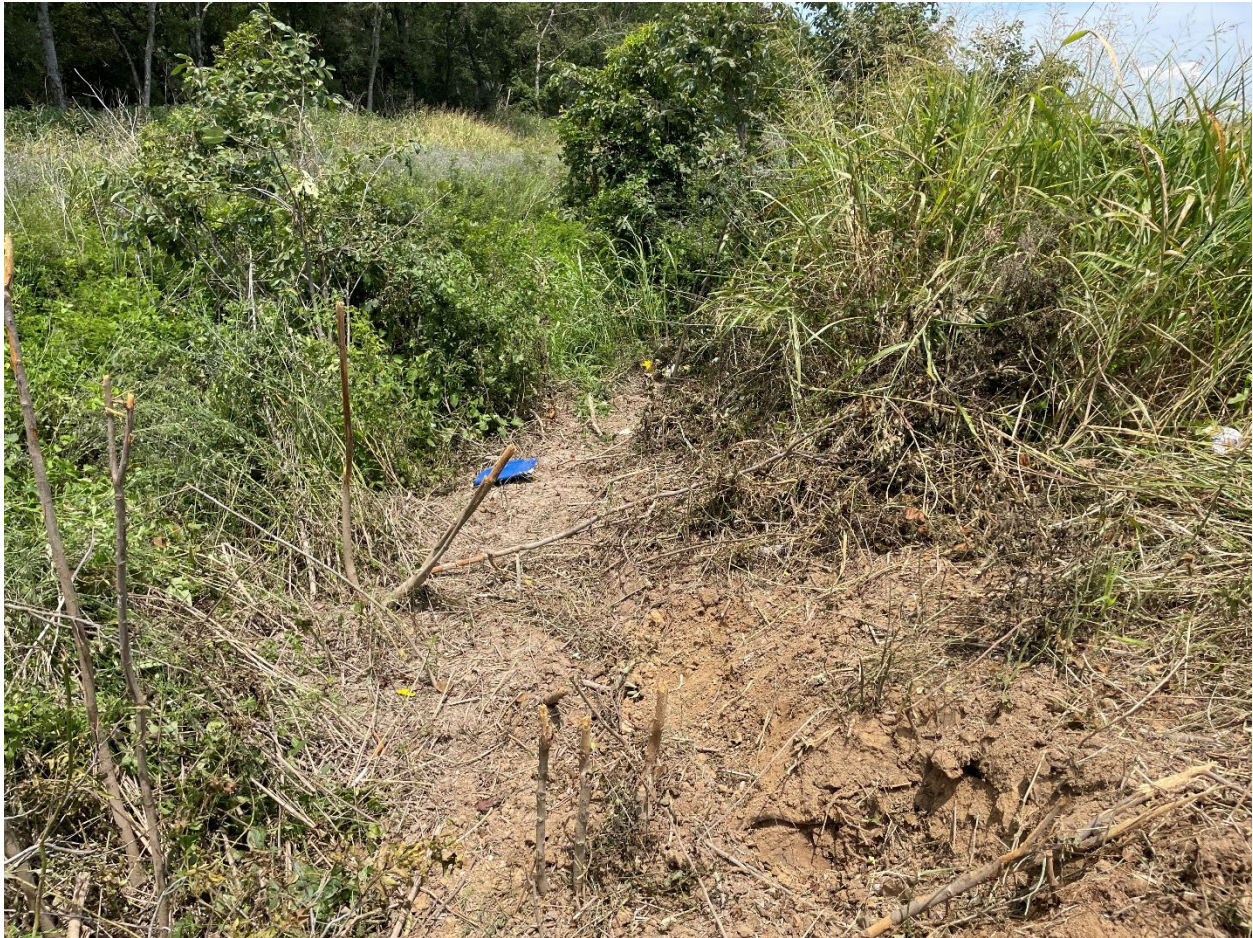
Postaccident examination of N6177J revealed the airplane impacted wooded terrain, and the initial ground impact was located on the north side ditch of Dummie Line Road. The initial ground impact was consistent with the right wing and forward

Figure 8. N6177J initial ground impact with right wing tip structure.

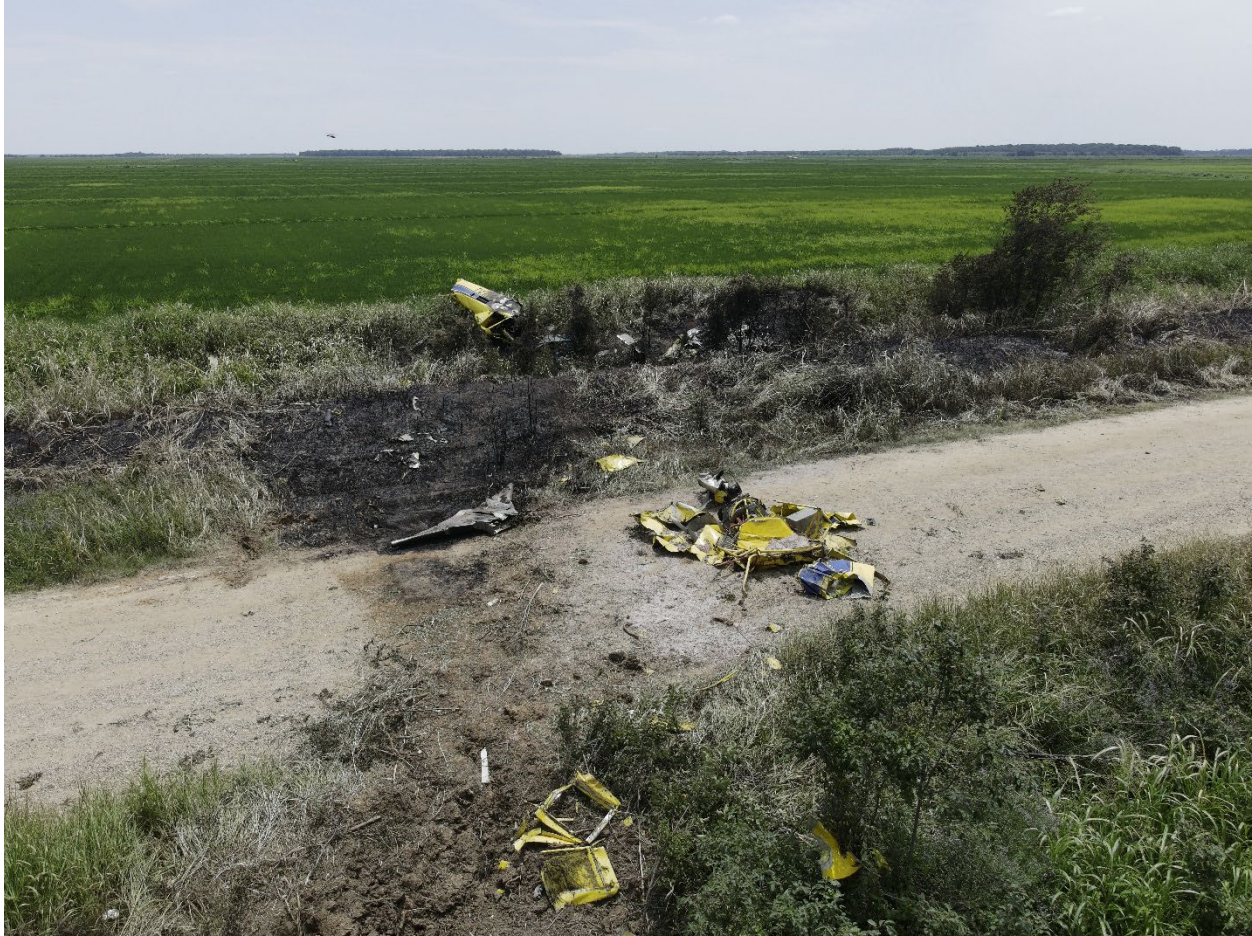
fuselage. Green navigation lens was found at the end of a long ground scar on the left side of the initial ground impact, consistent with the airplane impacting the terrain in an inverted position. Separated sections of the forward fuselage, main landing gear, engine, 3-blade propeller assembly, spreader, and right wing tip were located on the Dummie Line Road surface. The left and right wing structure and miscellaneous debris were separated from the fuselage and located in the south ditch (full of water) of Dummie Line Road. The cockpit, rear fuselage, and empennage were located on the top of a levee to the south of the ditch. A postaccident fire ensued and partially consumed the wing structure, miscellaneous debris, and vegetation in the south ditch.

Figure 9. N6177J debris field.

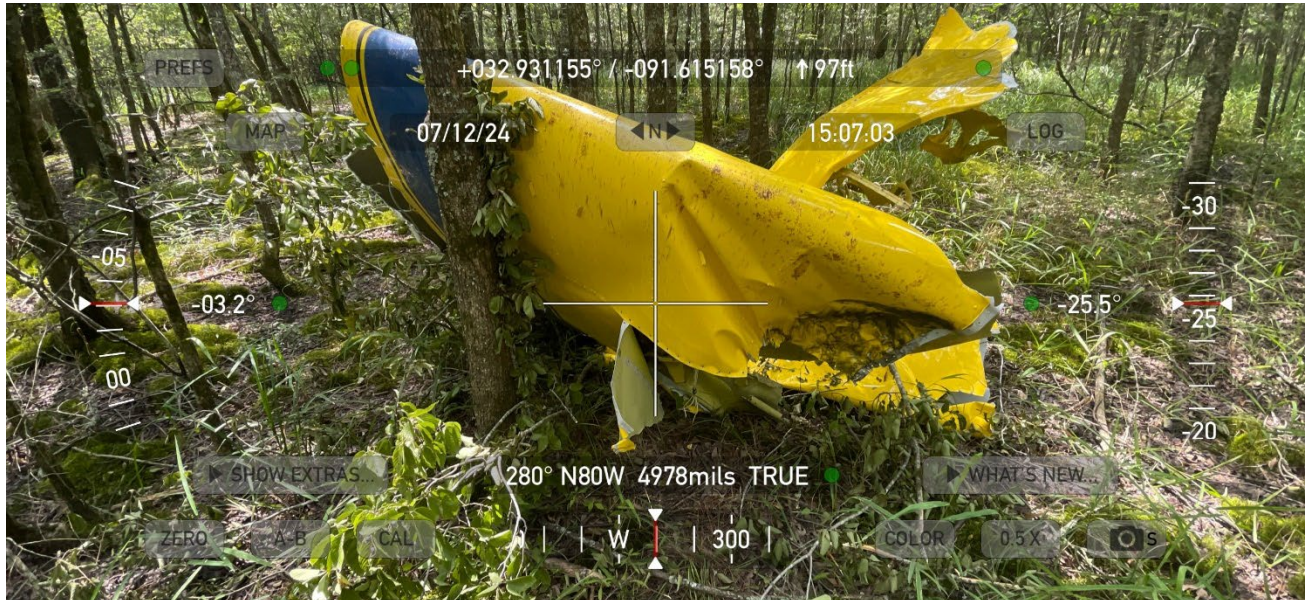
The outboard 72" of left wing structure, to include a portion of the aileron, a boom hangar, and miscellaneous aluminum skin and fiberglass were located in the wooded terrain, about 800 ft northeast of the initial ground impact. The separated wing structure exhibited a semi-circular impact and black rubber transfer, consistent with a main landing gear wheel from N795LA (See figures 10 and 11.). The left horizontal stabilizer, about mid-span and mid-chord, was deflected upward with black rubber transfer consistent with the size of N795LA tail wheel tire.

Figure 10. N6177J separated outboard left wing structure located in wooded terrain. (Source: Federal Aviation Administration)

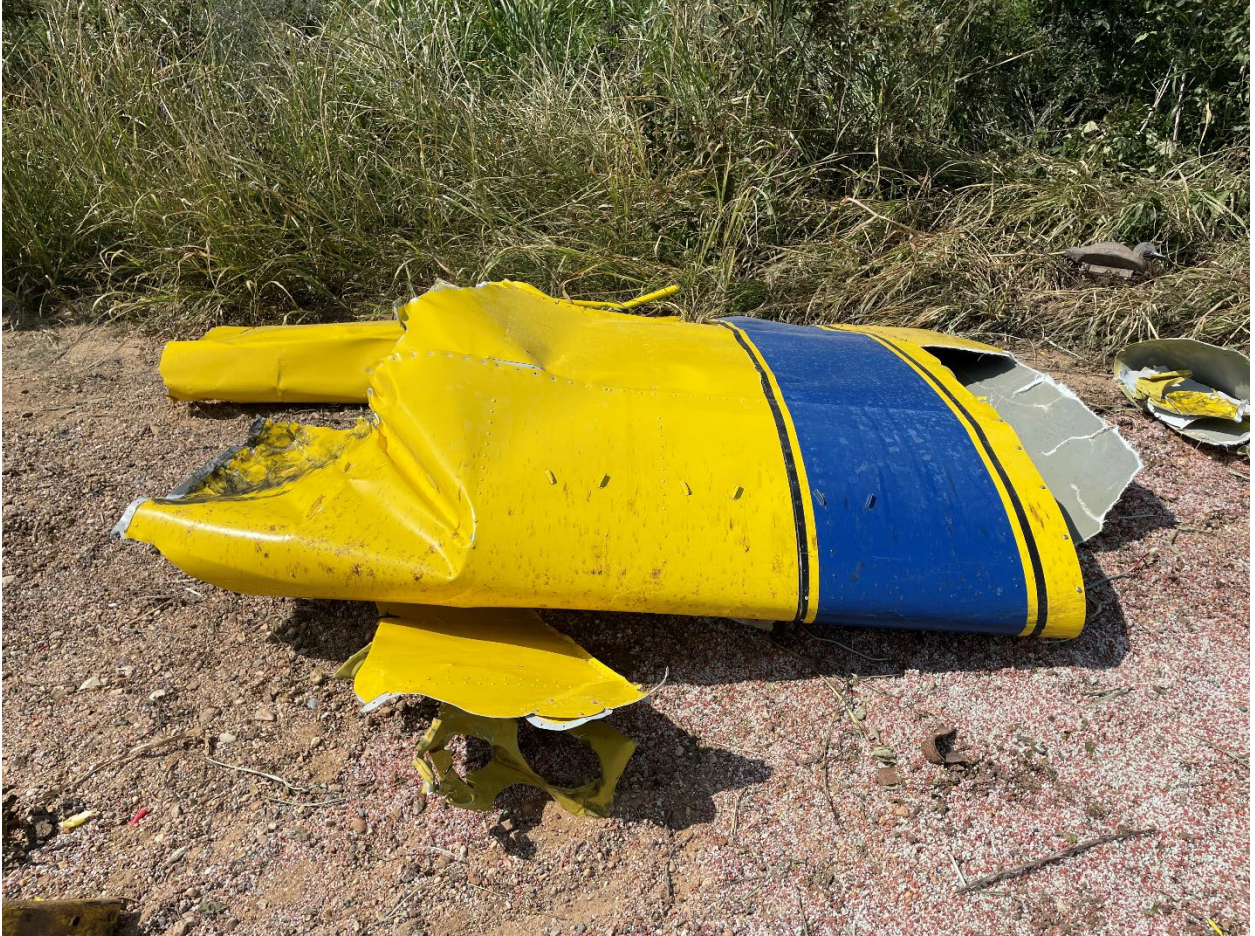
Figure 11. N6177J separated outboard left wing structure.

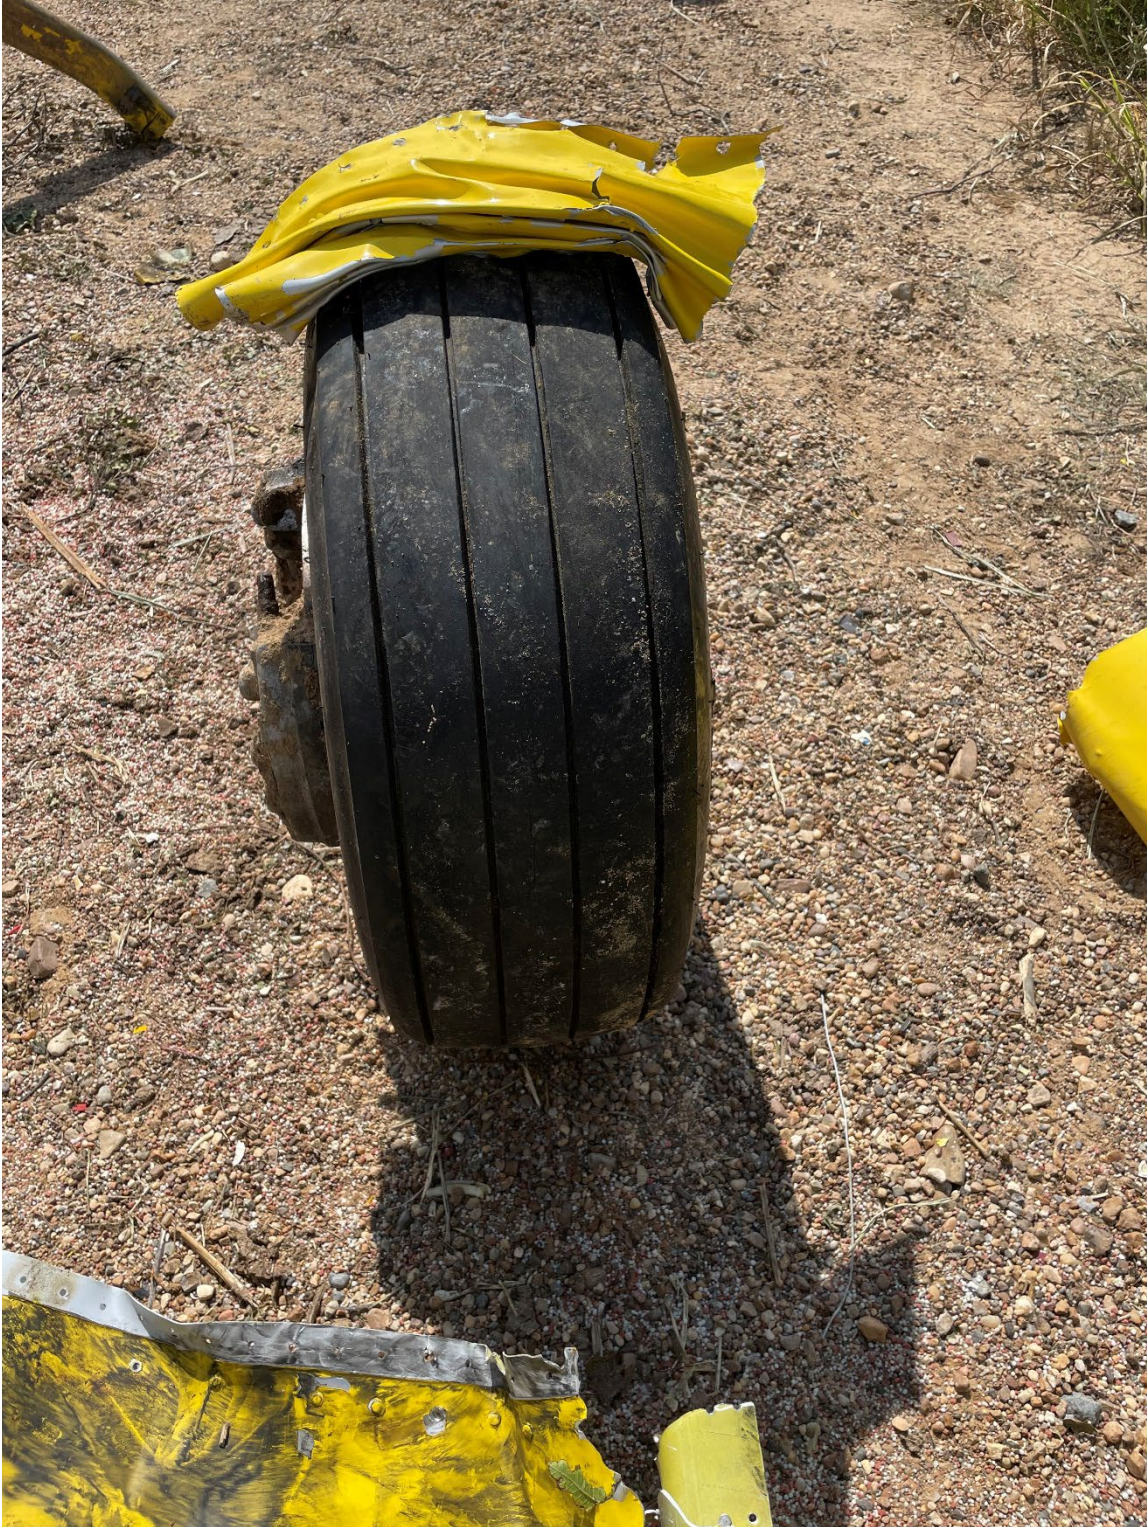
Figure 12. N6177J separated left wing structure with exemplar Air Tractor main landing gear wheel/tire.

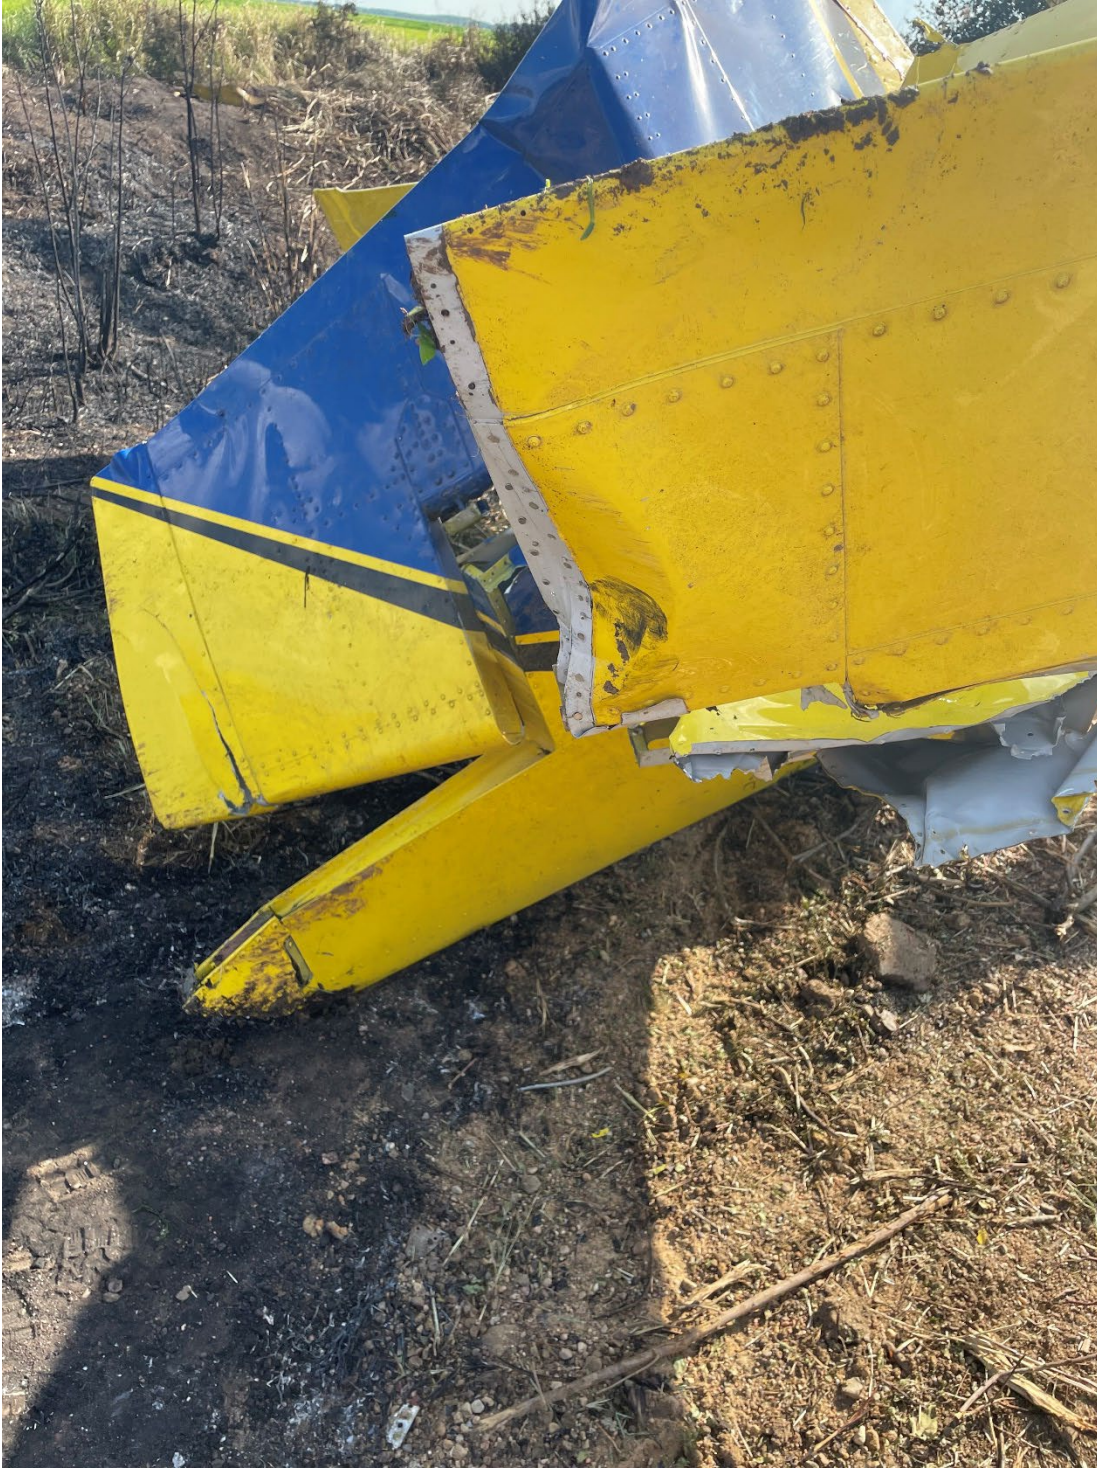
Figure 13. N6177J left horizontal stabilizer with black rubber transfer mark.
