# National Transportation Safety Board

CEN24FA277

## **EXAMINATION SUMMARY STATEMENT**

Location: Oshkosh, Wisconsin  
Date: July 22, 2024  
Time: 1213 CDT  
Airplane: Lancair ES

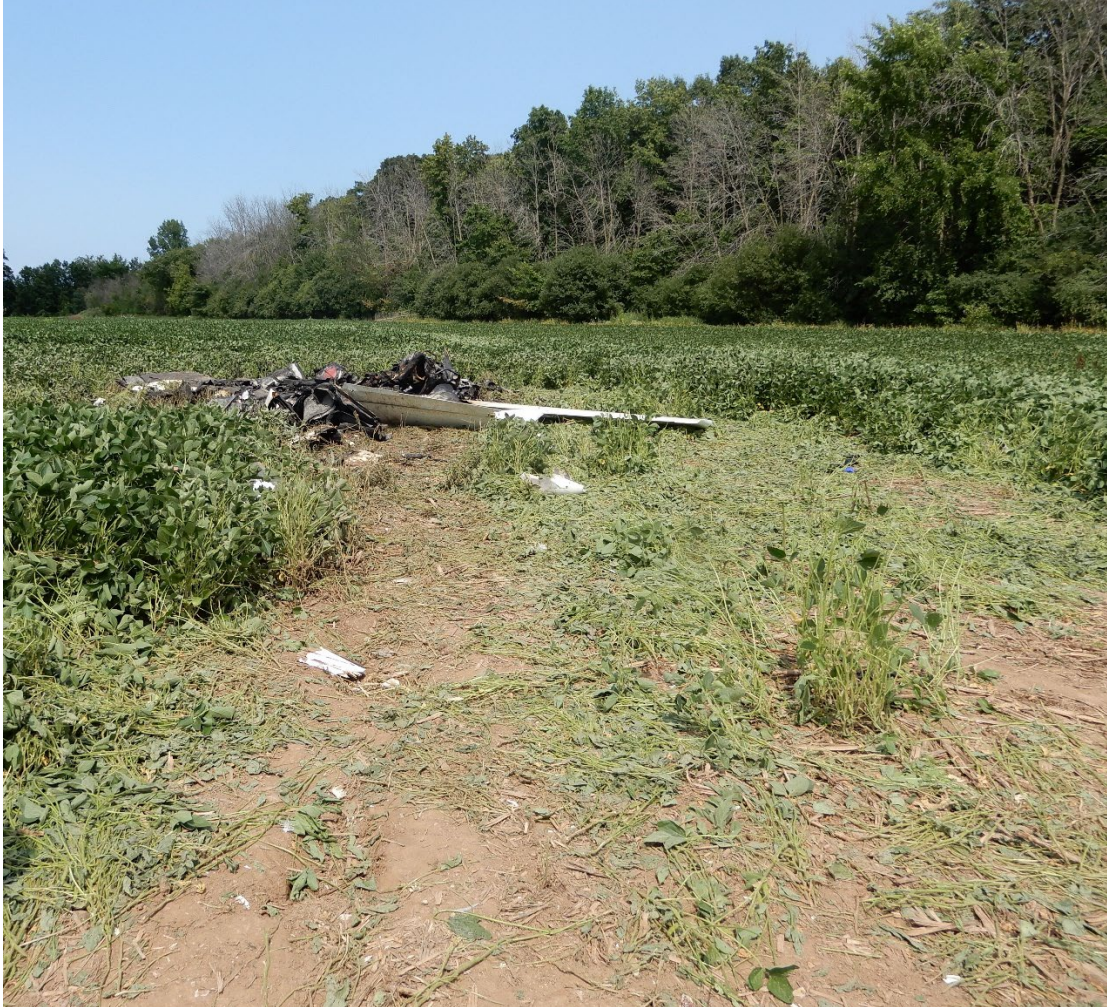
**Figure 1. Main Wreckage and Debris Field**

The airplane impacted a soybean field south of Road N, about 1.5 miles from the approach end of runway 36L.

A debris extended from the initial impact point, about 35 ft to the main wreckage. The debris field included a position light from left wing, torn fiberglass, the pitot tube, wooden splinters from the propeller, and fragmented pieces from the elevator. The soybean vegetation in the field was depressed and torn from the ground in the direction of impact.

The airplane came to rest upright on a heading of about 060°. A postimpact fire ensued.

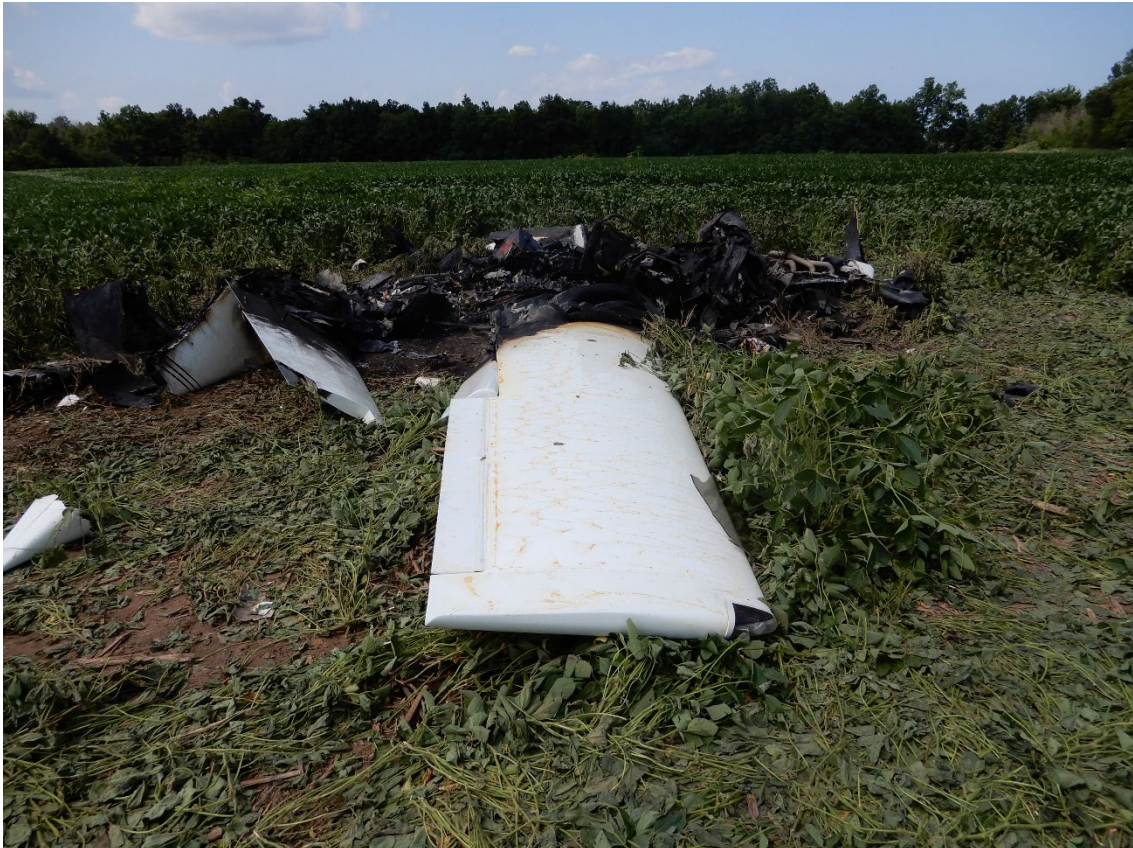
**Figure 2. Right Wing**

The right wing assembly included the wing, the right flap, and right aileron. Right aileron control continuity was confirmed from the right aileron inboard to the

cabin flight control yoke. The right wing flap was partially separated. The inboard portion of the right wing exhibited damage consistent with exposure to heat and fire.

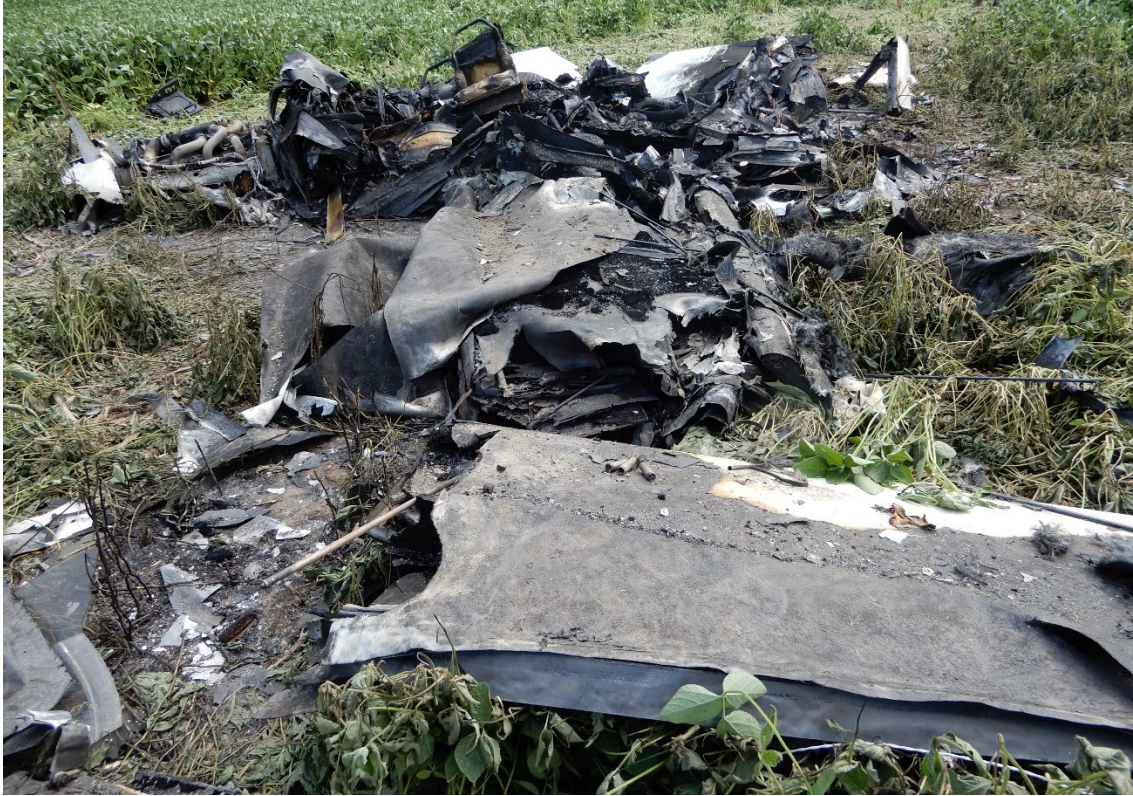
**Figure 3. Left Wing**

The left wing assembly included the wing, left flap, and the left aileron. The left wing was impact separated about midspan and exhibited damage consistent with exposure to heat and fire. Left aileron control continuity was confirmed, through impact damage, from the left aileron inboard to the cabin flight control yoke. The aileron was impact separated and fire damaged. The left wing flap exhibited impact and fire damage.

The flap jack screw measured about 5 7/8" which was consistent with the flaps extended to 10°.

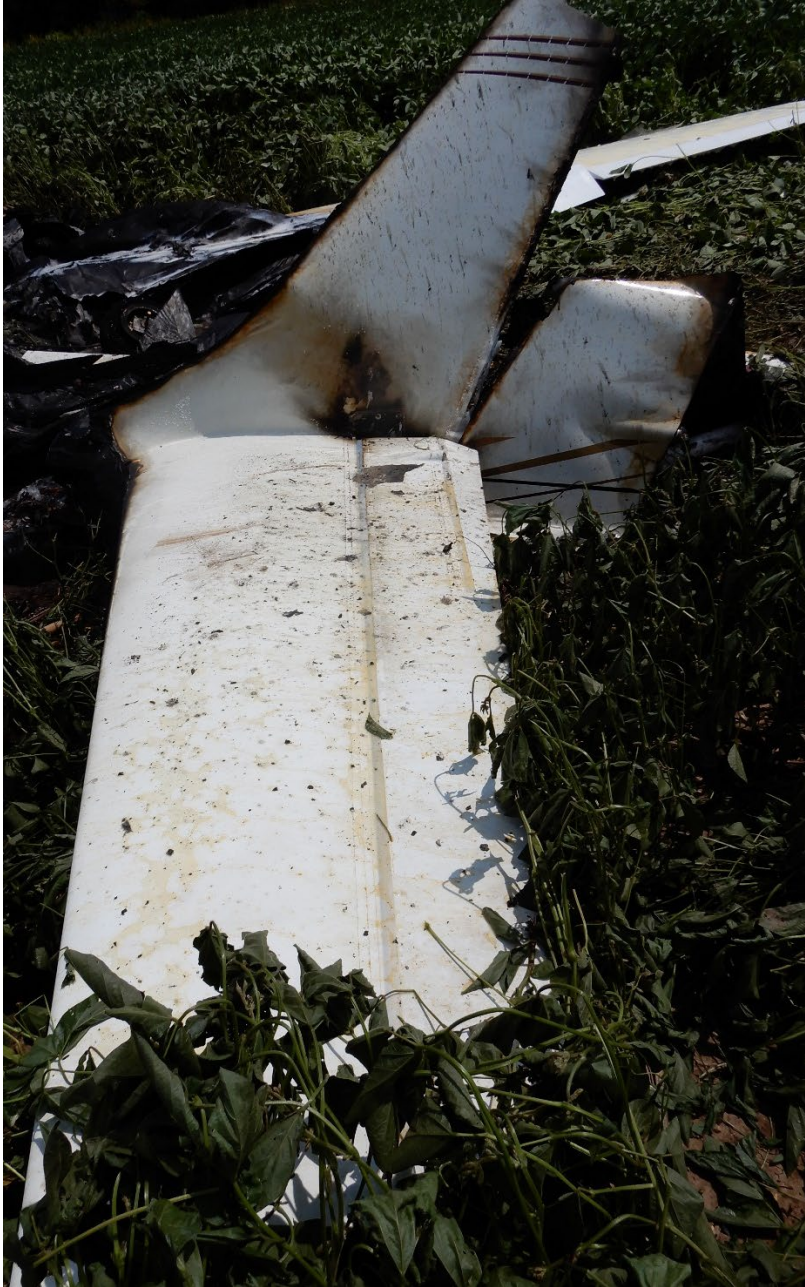
**Figure 4. Empennage**

The empennage included the horizontal stabilizer, rudder, vertical stabilizer, and elevator. The entire assembly exhibited impact and fire damage. The rudder control cables were continuous from the rudder control horn forward to the rudder pedals in the fuselage. The elevator push-pull tube was impact separated at the horn and exhibited impact and fire damage from the elevator control forward to the flight control yoke.

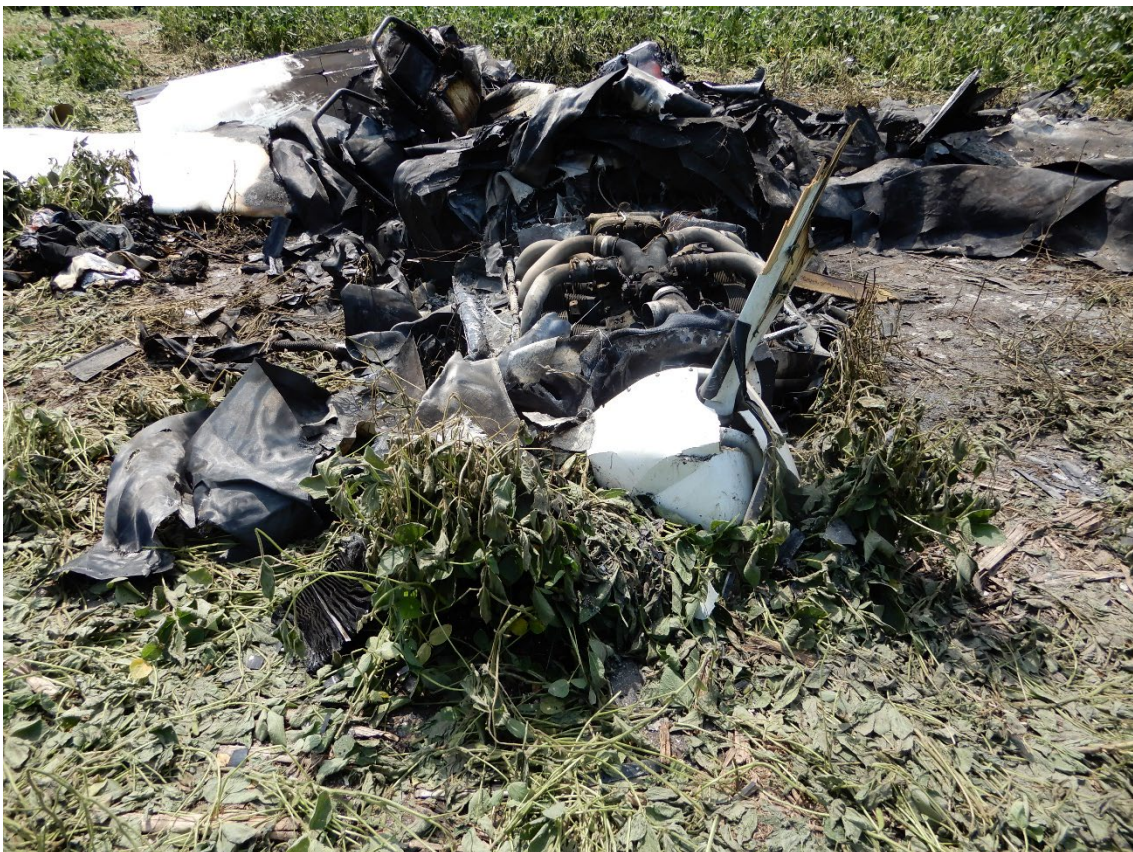
**Figure 5. Engine and Propeller Assembly**

The Continental IO-550 N (7) sn 1045957 engine and 3-blade wooden propeller remained attached to the fuselage and exhibited impact and fire damage.

The oil pan was crushed up and the oil pan and oil filter were void of oil. The fuel servo was impact and fire damaged and could not be functionally tested.

The upper bank of spark plugs and valve covers were removed and the engine was rotated through at the propeller assembly. Continuity was observed at the engine accessory end. Intake and exhaust valve movement was observed and air movement was noted on all cylinders.

The sparkplugs exhibited normal lean signatures. The spark plug ignition leads were fire damaged and could not be functionally tested.

One propeller blade was impact-separated entirely at the hub. One propeller blade was impacted-separated with about 7 inches of splintered wood that remained at the hub. One propeller blade was impact-separated with about 24 inches of splintered wood that remained at the hub.
