# National Transportation Safety Board

CEN24FA278

## INVESTIGATION SUMMARY

Location: Oxford, Indiana  
Date: July 22, 2024  
Time: 1830 EDT  
Airplane: Air Tractor AT-602, N602WR

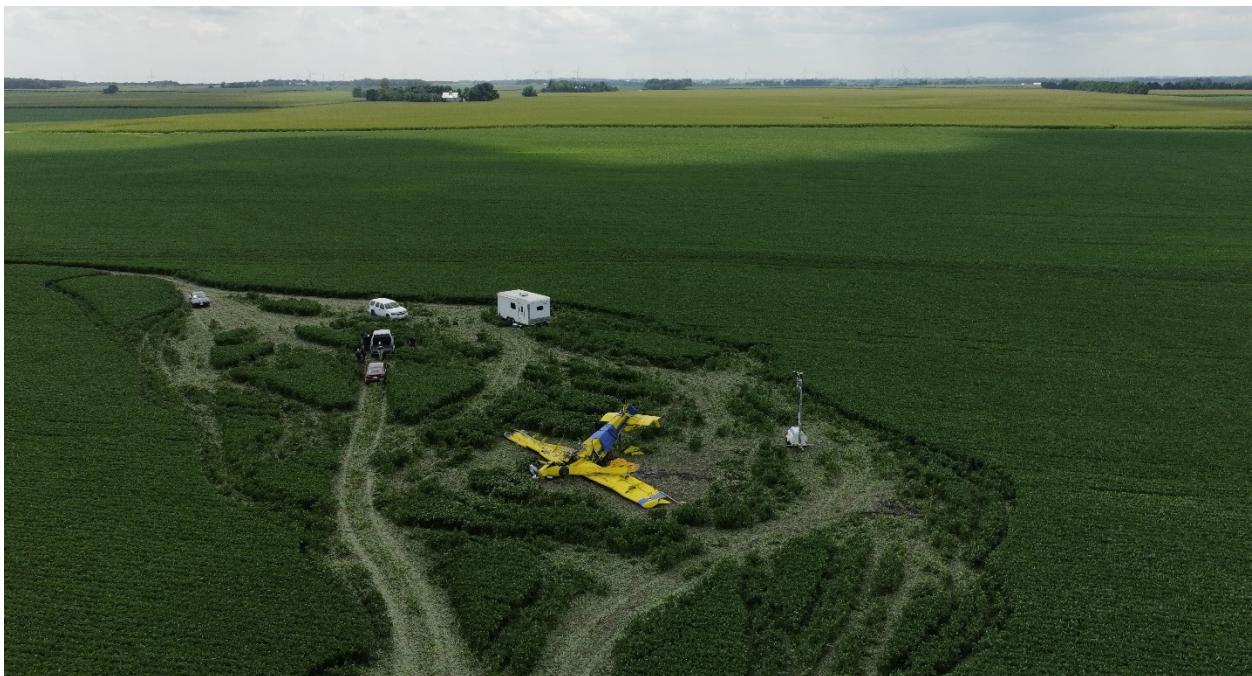
Figure 3. Aerial view of the accident site.

The airplane was found inverted in a flat soybean field about 2.5 miles southwest of Oxford, Indiana (figure 3). The soybean crop was about 3 ft tall. The airplane was inverted, and all four corners of the airplane were located at the site. A post impact fire resulted in thermal damage to the aft portion of the engine compartment and immediately aft of the firewall, with no spread noted to other portions of the wreckage. There was sooting on the left horizontal stabilizer and elevator that is consistent with PT6A engine soot accumulated during Air Tractor engine operations. Then fire was extinguished by first responders.

The airplane was on a heading of about 137 degrees magnetic. Left behind from the pilot extrication activities, the aircraft was supported aft of the cockpit area with a stack of wooden and plastic cribbing and a lifting strap was attached to the tail of the aircraft. The wings and all control surfaces were located in the immediate area of the wreckage. There were no horizontal ground scars or crop disturbances noted.

There were no power lines, towers, or guy wires noted in the immediate vicinity of the accident scene. The nearest obstacles that were noted were a line of trees near a house about 900 ft to the south and southwest of the wreckage. Also noted were power distribution lines that ran along the northern edge of E 800 S street, about  $\frac{1}{4}$  mile to the south of the wreckage. No wire strike marks or tree strike marks were noted on the leading edges of the wings, prop blades, horizontal stabilizers, or main landing gear. The main landing gear were fitted with aftermarket wire cutters. No nicks or evidence of strikes were noted on these wire cutters.

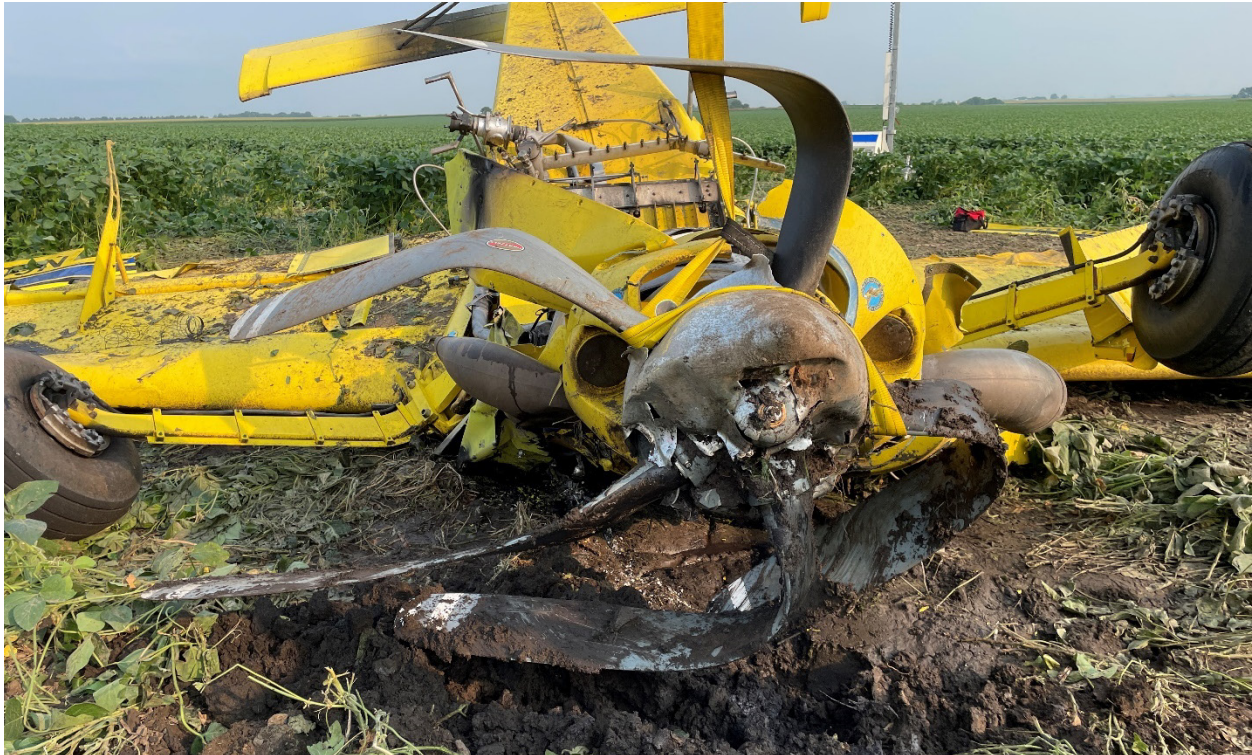
Figure 2. Damaged propeller blades after removal from the ground.

The engine was equipped with five-bladed constant speed, fully reversible propeller. The propeller was attached to the engine propeller flange and reduction gearbox. Each of the blades remained attached to the hub. The propeller assembly was mostly embedded in the ground with 2 blades visible while the other 3 were buried in the ground. The blades exhibited compound bend and twist progression from forward to aft in the sequence of rotation consistent with producing thrust at initial impact.
