CEN24FA298

## INVESTIGATION PHOTOGRAPHS

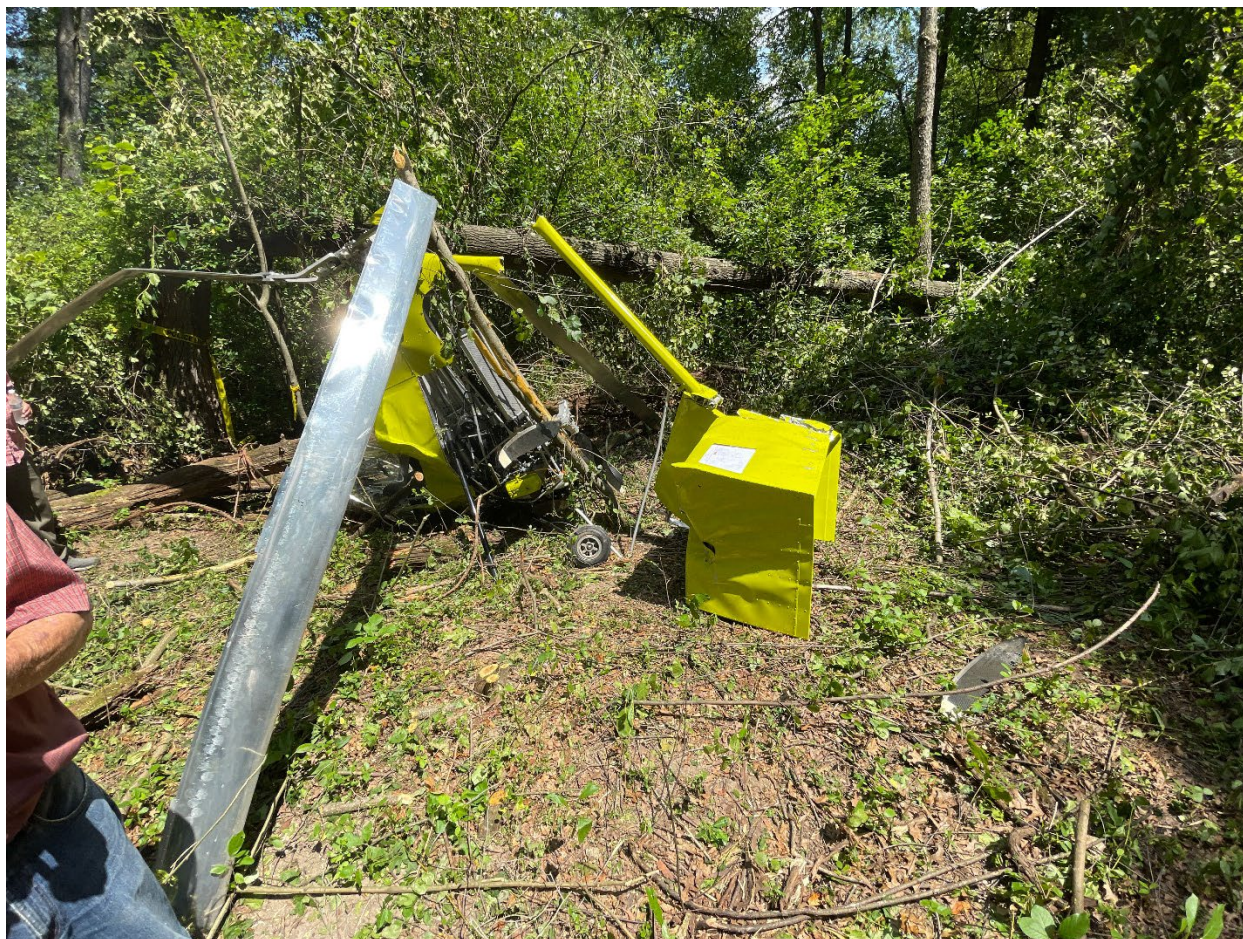
**Photograph 1 - Entire aircraft during examination (NTSB Photo)**

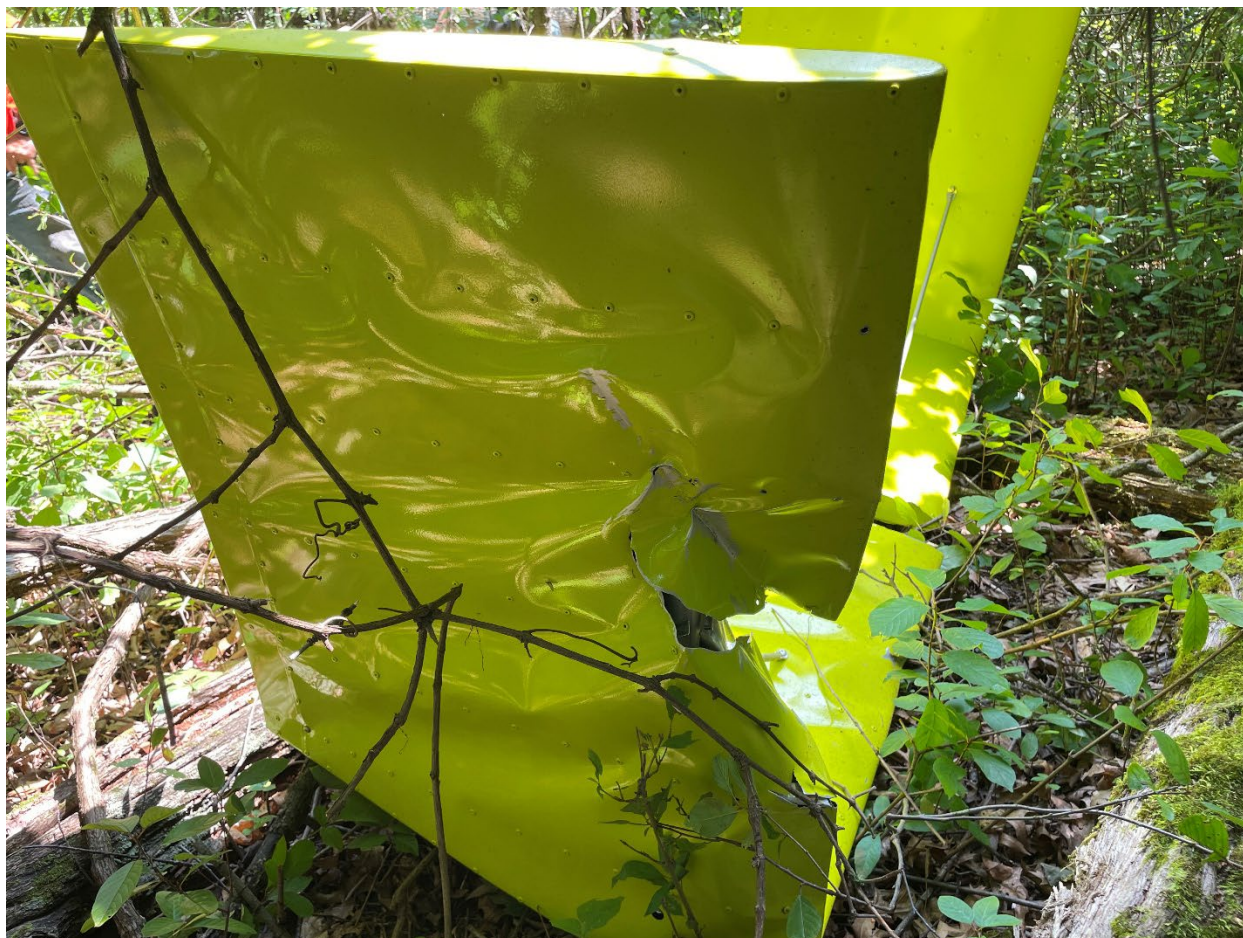
**Photograph 2 - Tail surfaces showing rotor impact mark (NTSB Photo)**

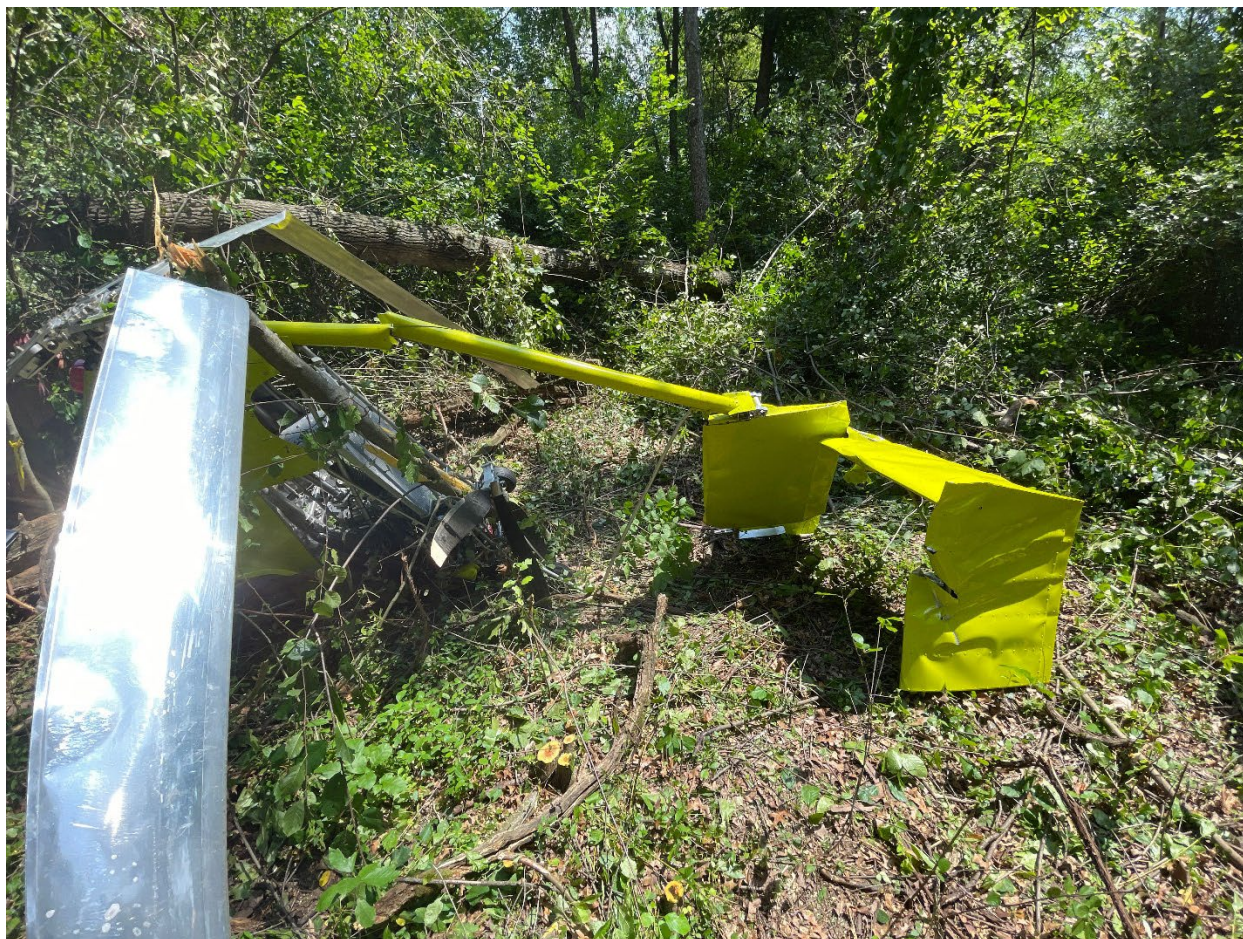
**Photograph 3 - Tail boom and tail surfaces (NTSB Photo)**

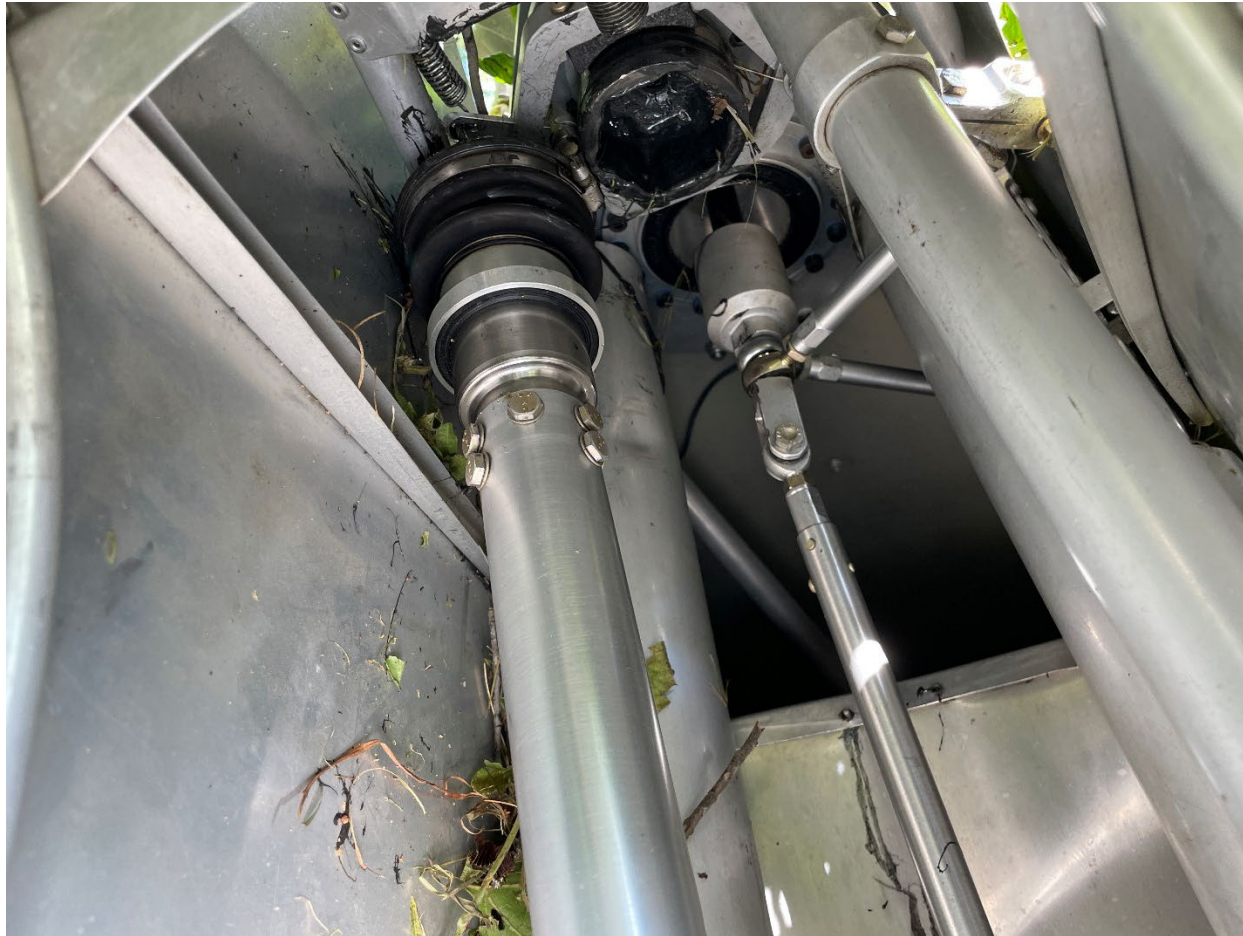
**Photograph 4 - Separated rotor drive coupling (NTSB Photo)**

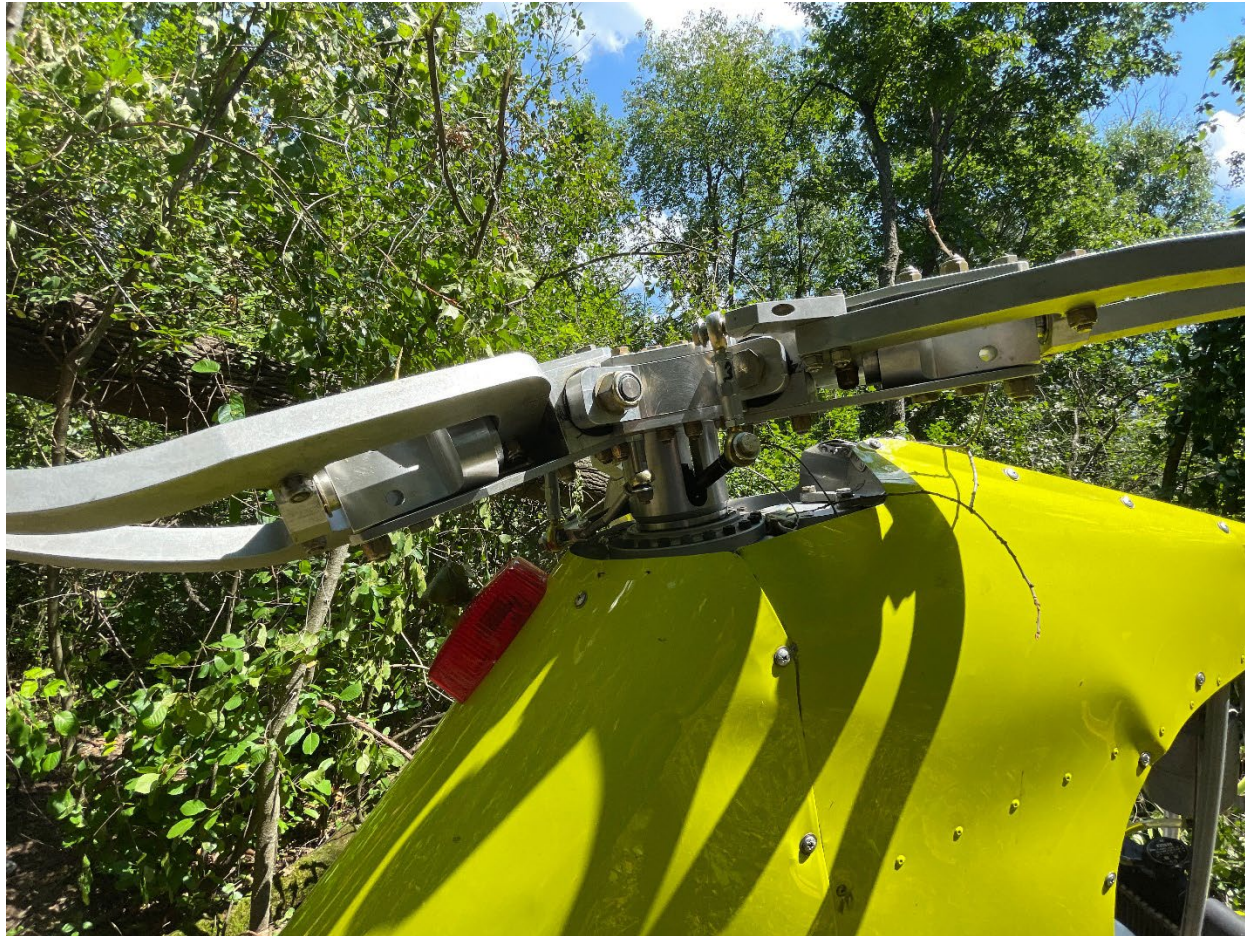
**Photograph 5 - Rotor head during examination (NTSB Photo)**

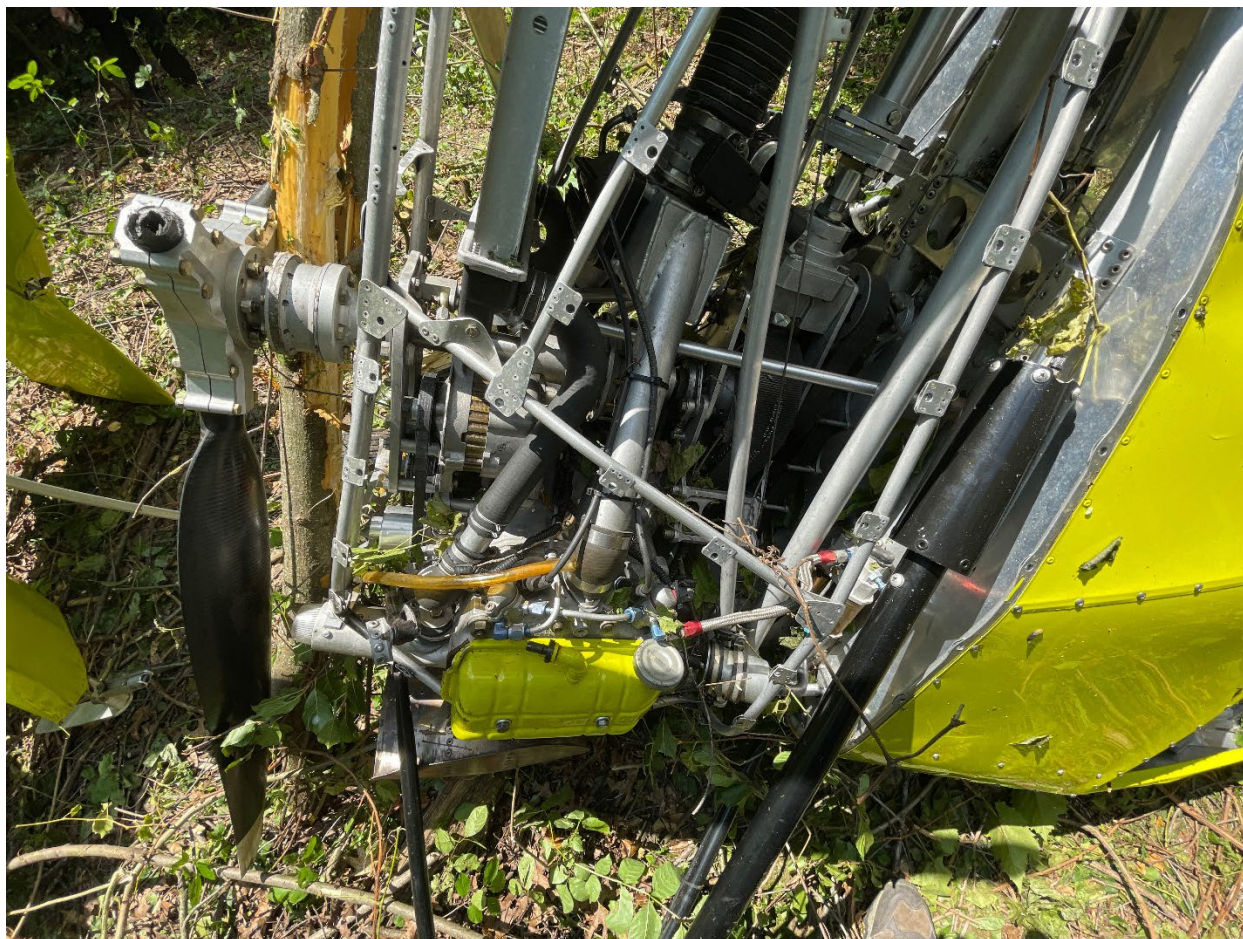
**Photograph 6 - Engine during the examination (NTSB Photo)**
