# National Transportation Safety Board

CEN24FA298

## EXAMINATION SUMMARY

Gyroplane: N140DG, DeGraw DeBird

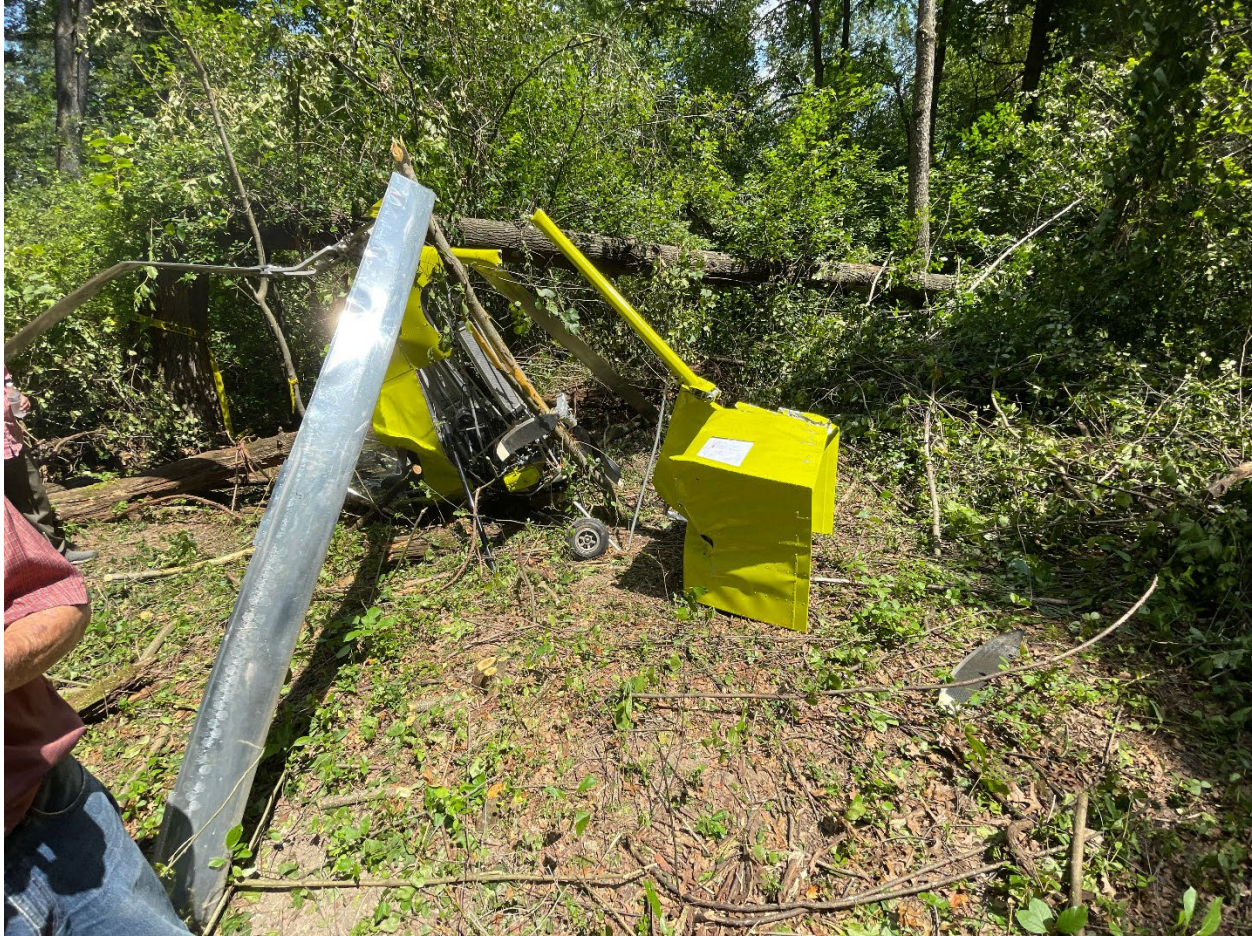
The gyroplane was upright but leaning to its left side and was supported by trees. There was crushing of the forward and left side of the fuselage. The left main landing gear was fractured.

Figure 2. The entire Gyroplane at the accident site.

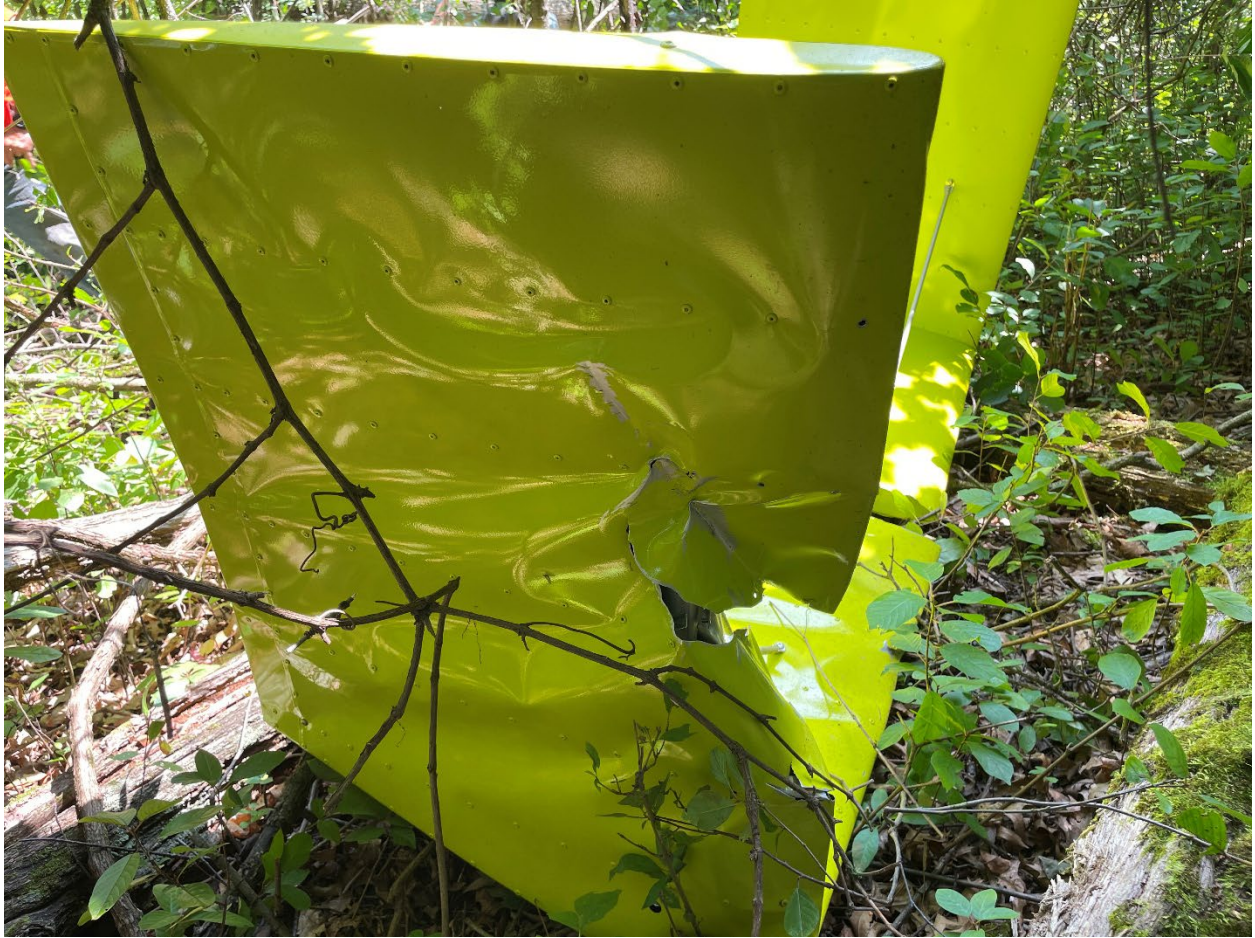
The horizontal and fixed vertical tail surfaces were found a short distance away from the fuselage on opposite sides of surrounding trees. The location of the tail surfaces at the accident site was consistent with separation before the gyroplane descended into the trees. The tail surfaces had two separate areas of damage with features consistent with having been impacted by the main rotor. Examination of the main rotor blades revealed yellow paint transfer that was also consistent with the main rotor impacting the tail of the gyroplane. The tail boom of the gyroplane was partially separated from the fuselage and only remained attached by the two rudder cables. The fracture of the tail boom was consistent with the aft end of the boom bending toward the right prior to failure. This was consistent with a potential rotor strike to the tail considering the counterclockwise rotation direction of the main rotor blades as viewed from above.

Figure 3. The gyroplane's tail surfaces with rotor impact mark.

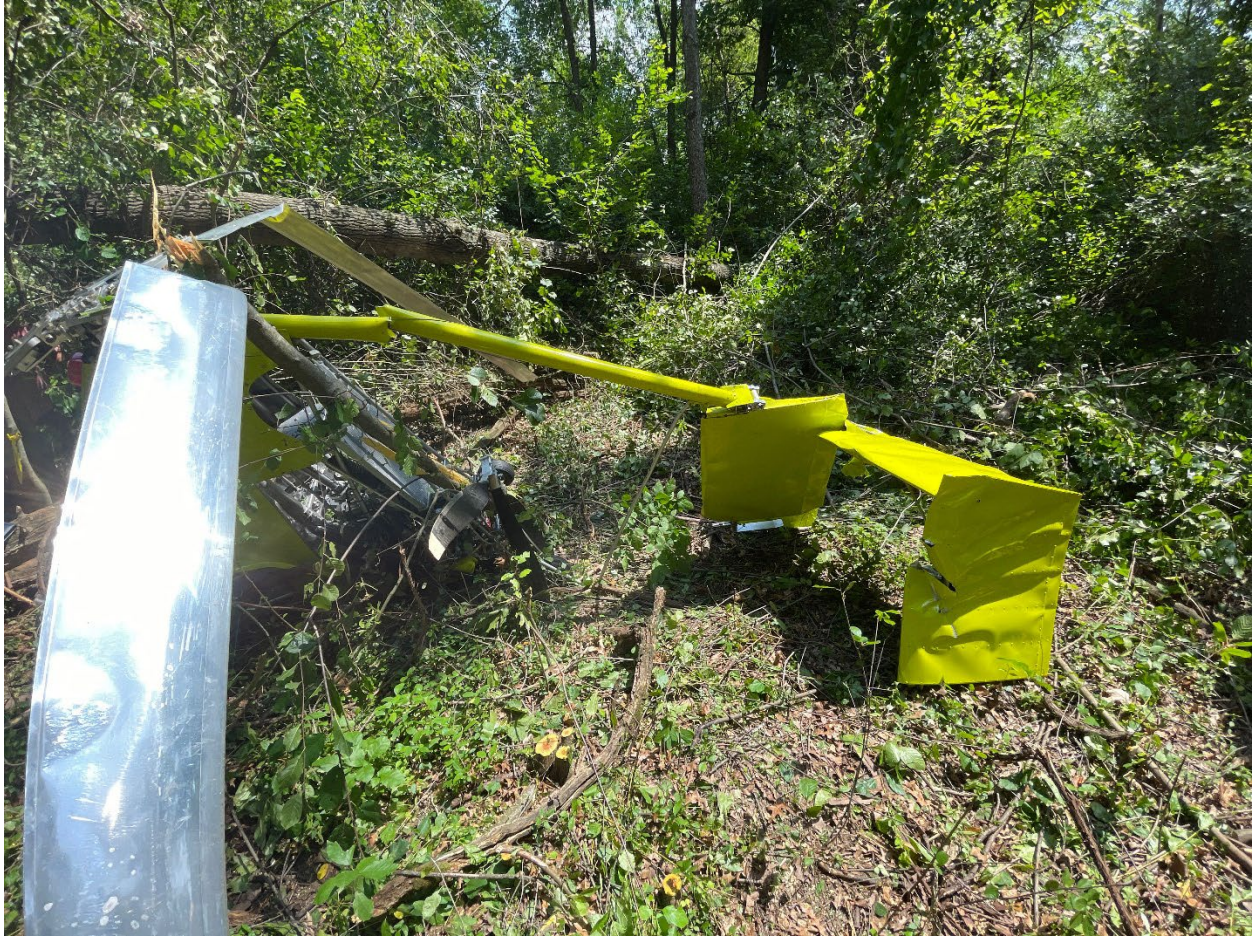
Figure 4. Tail surfaces and tail boom placed in pre-impact location.

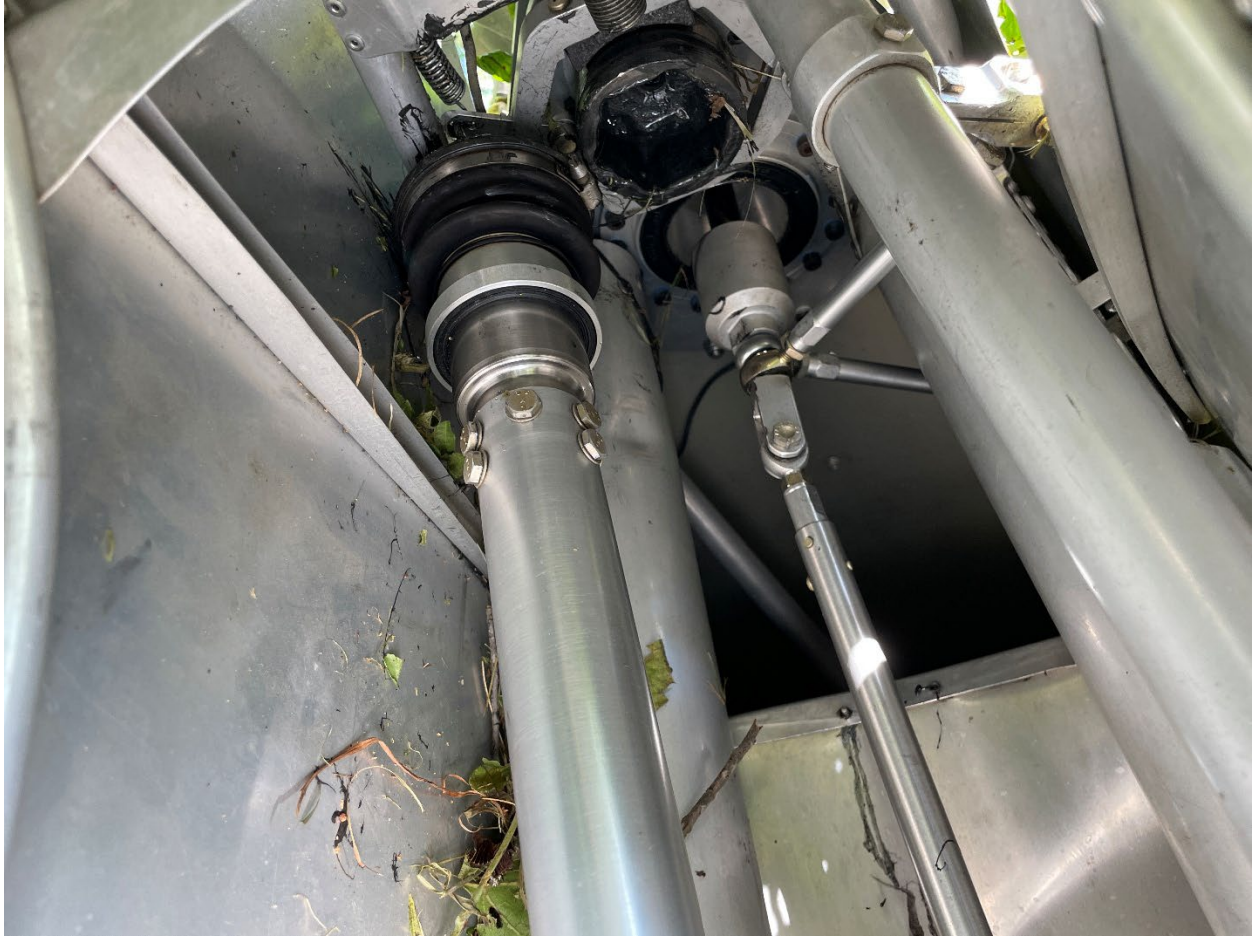
The rotor drive system was intact except for a separation of the drive coupling in the top of the fuselage (Figure 5). All three main rotor blades were intact from root to tip but with bending at various locations along their length due to impact. All of the main rotor system components were intact with all damage consistent with impact damage.

Figure 5. Failed rotor drive coupling.

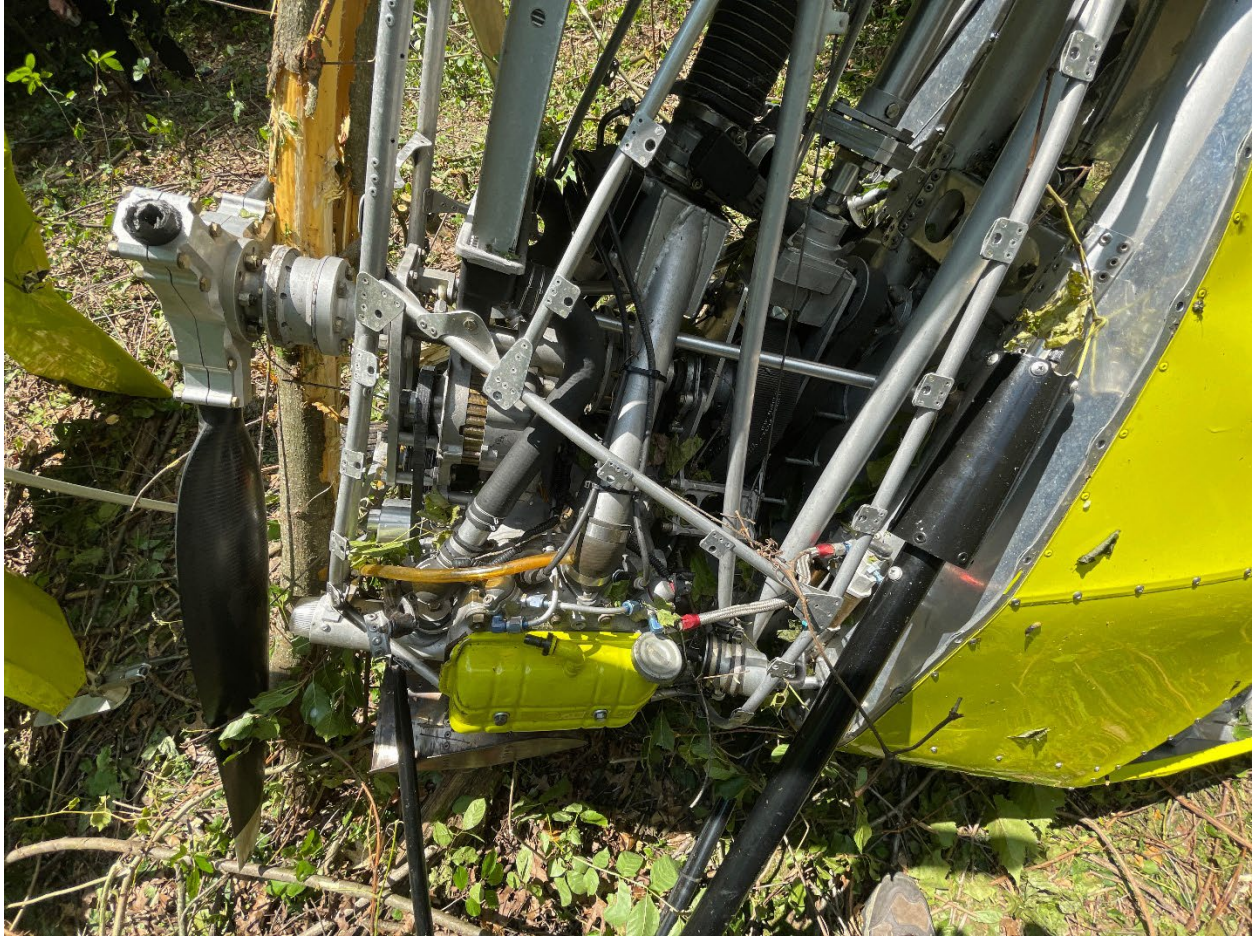
Examination of the gyroplanes engine was limited but continuity of the reciprocating and valve train system was verified by rotating the engine. During rotation, compression could be felt on all cylinders. No preimpact anomalies were found during the examination.

Figure 7. Engine during examination.
