CEN24FA305

## INVESTIGATION PHOTOGRAPHS

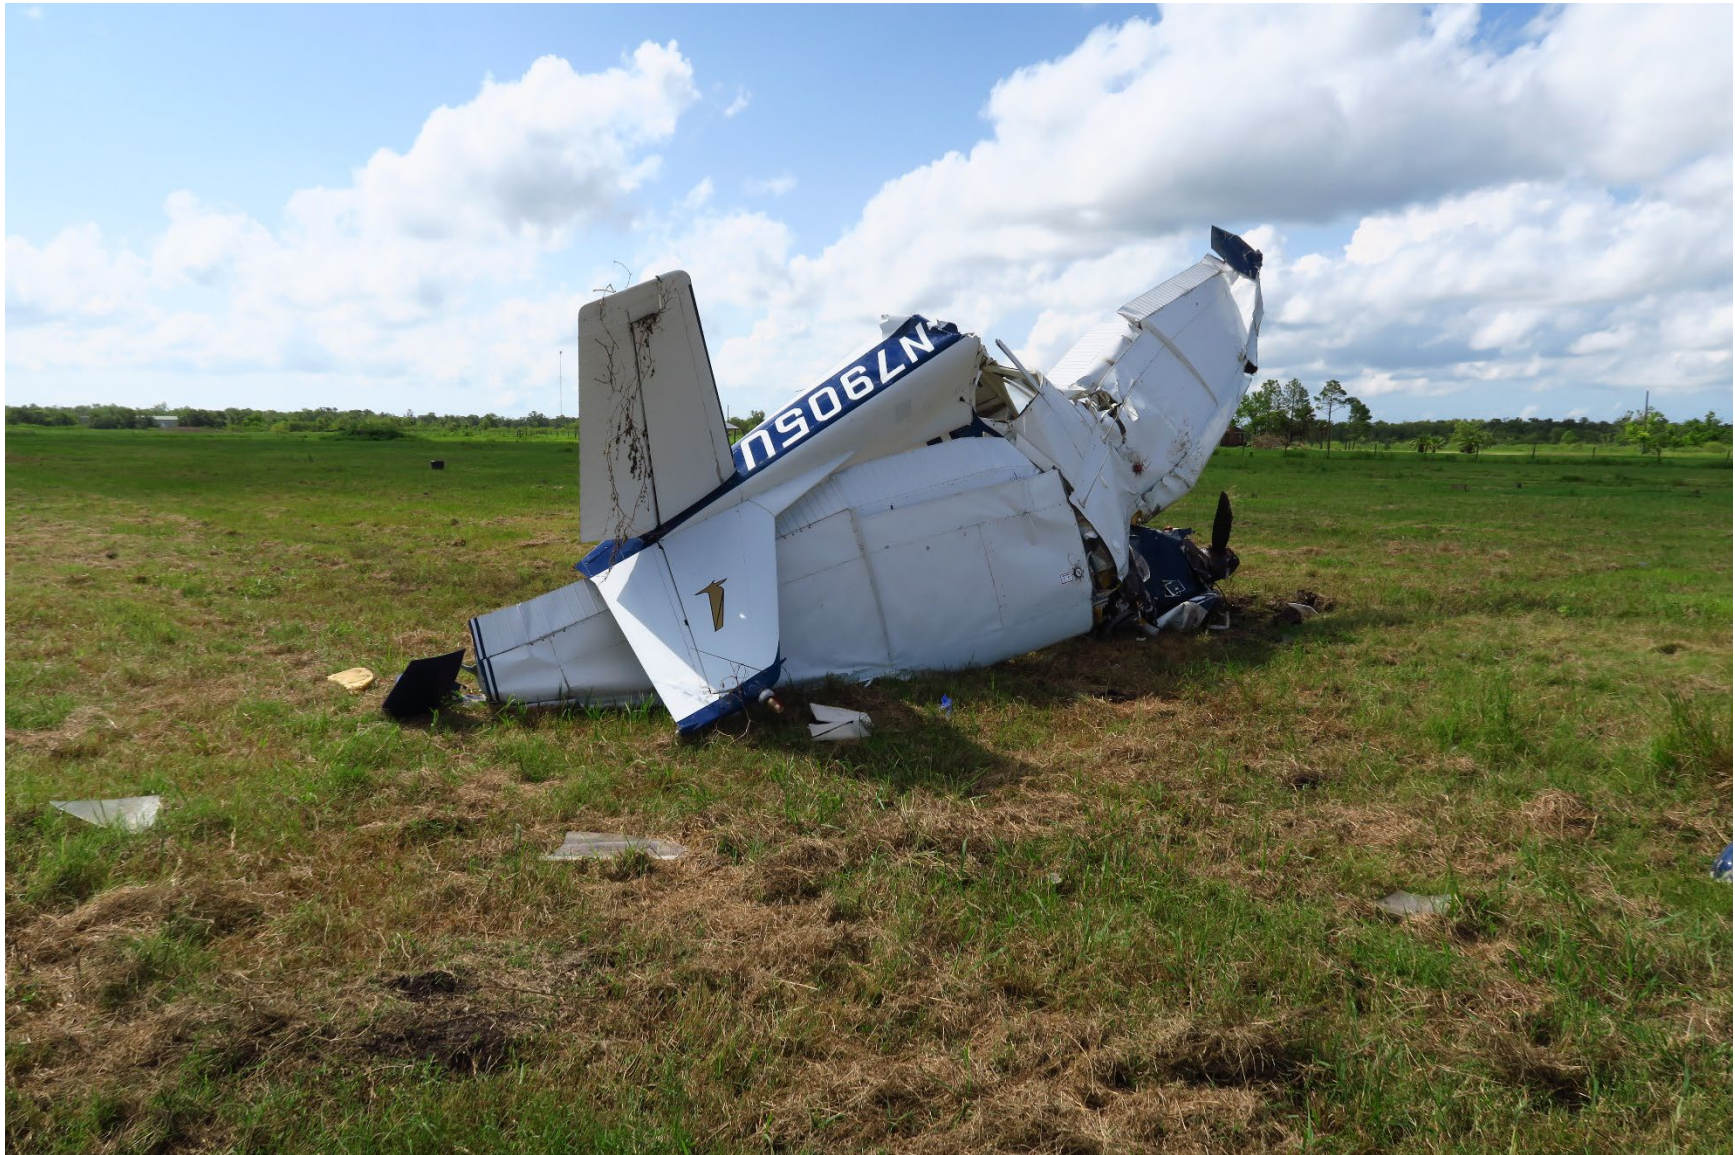
**Photograph 1 - View of accident site location (Source: Textron Aviation)**

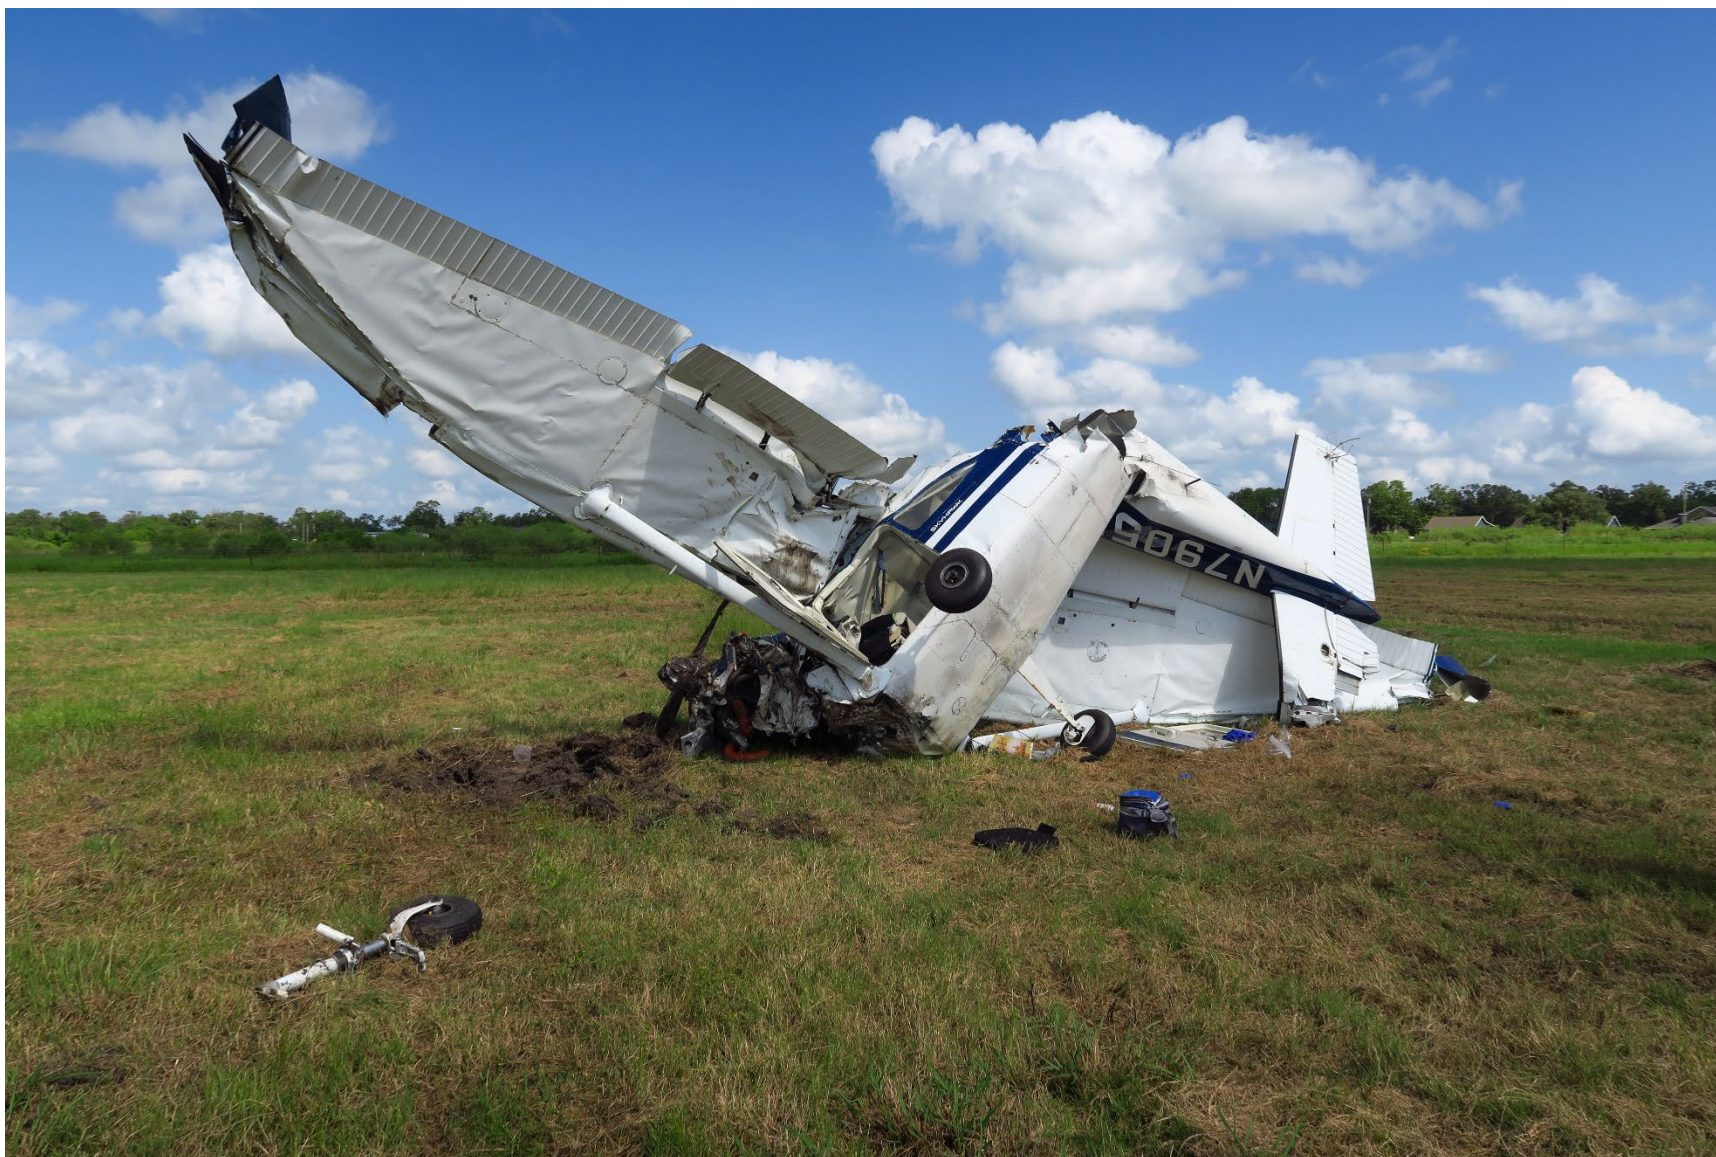
**Photograph 2 - View of Accident Site Location (Source: Textron Aviation)**

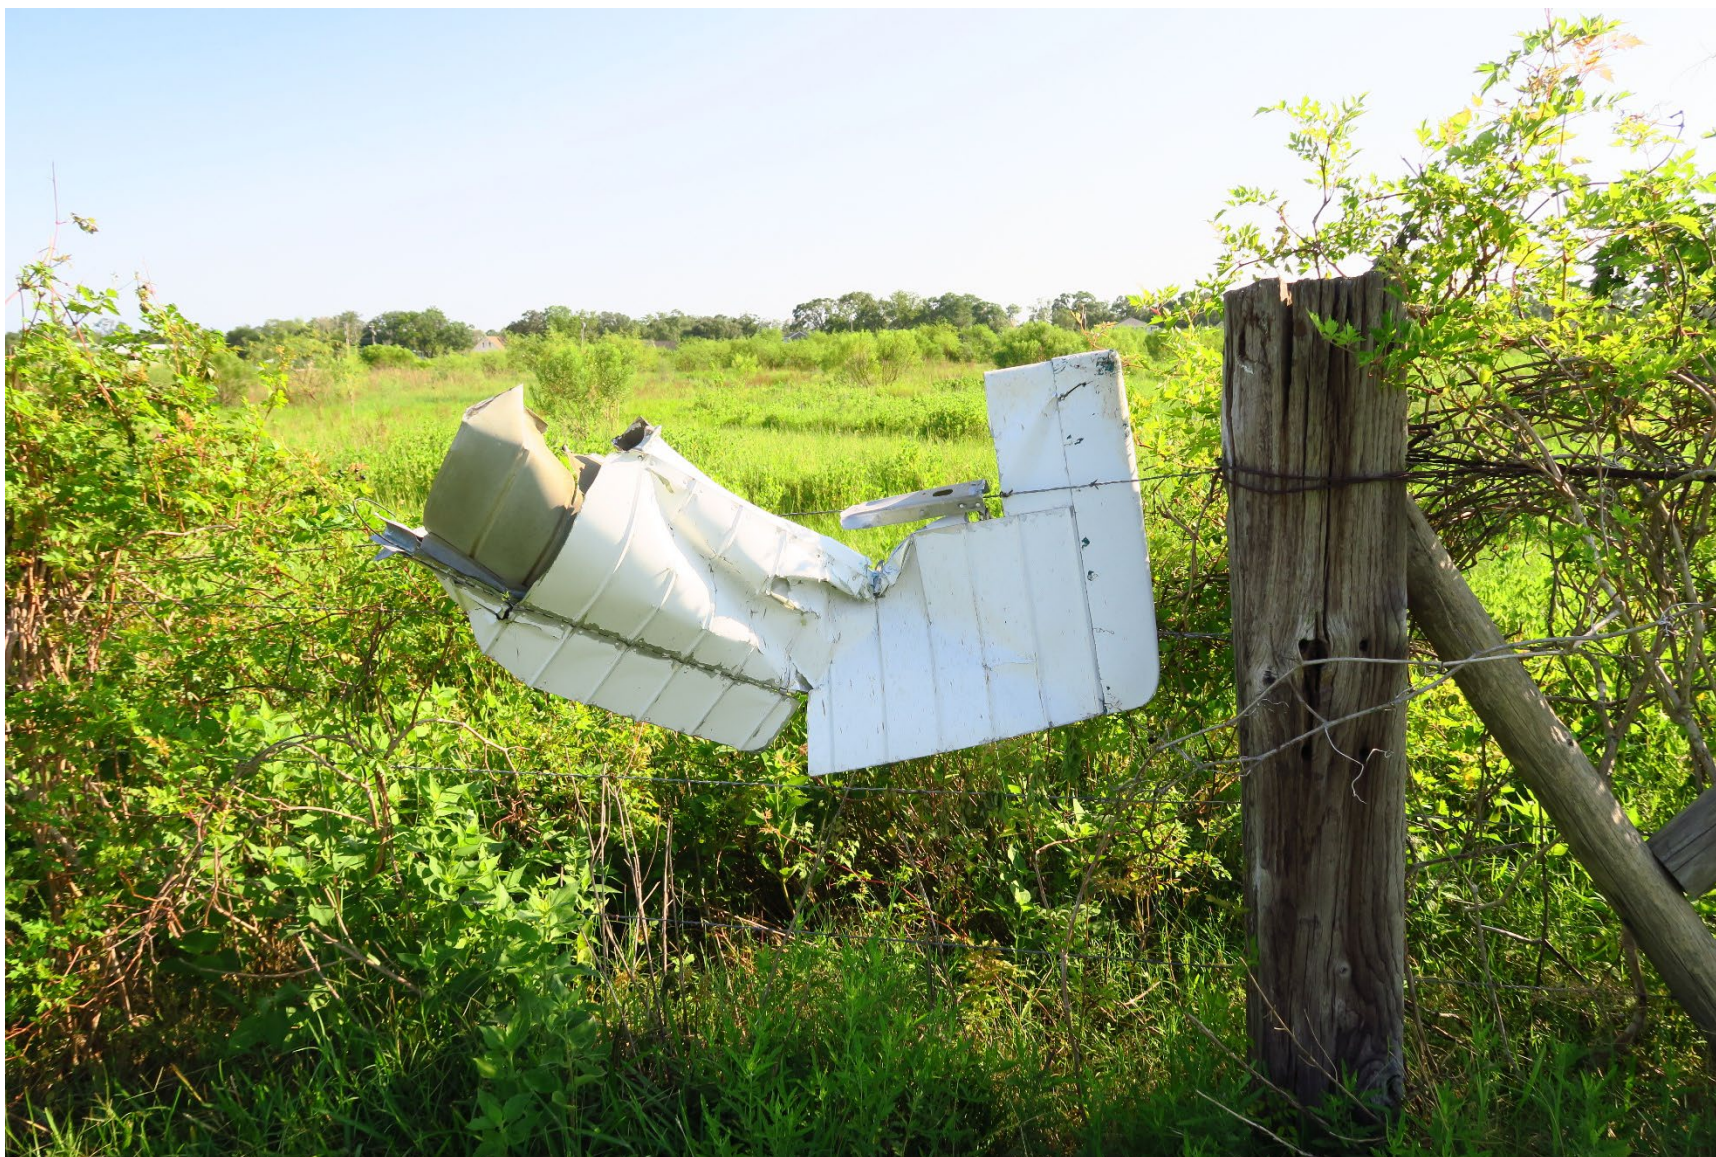
**Photograph 3 - Separated Elevator Section (Source: Textron Aviation)**

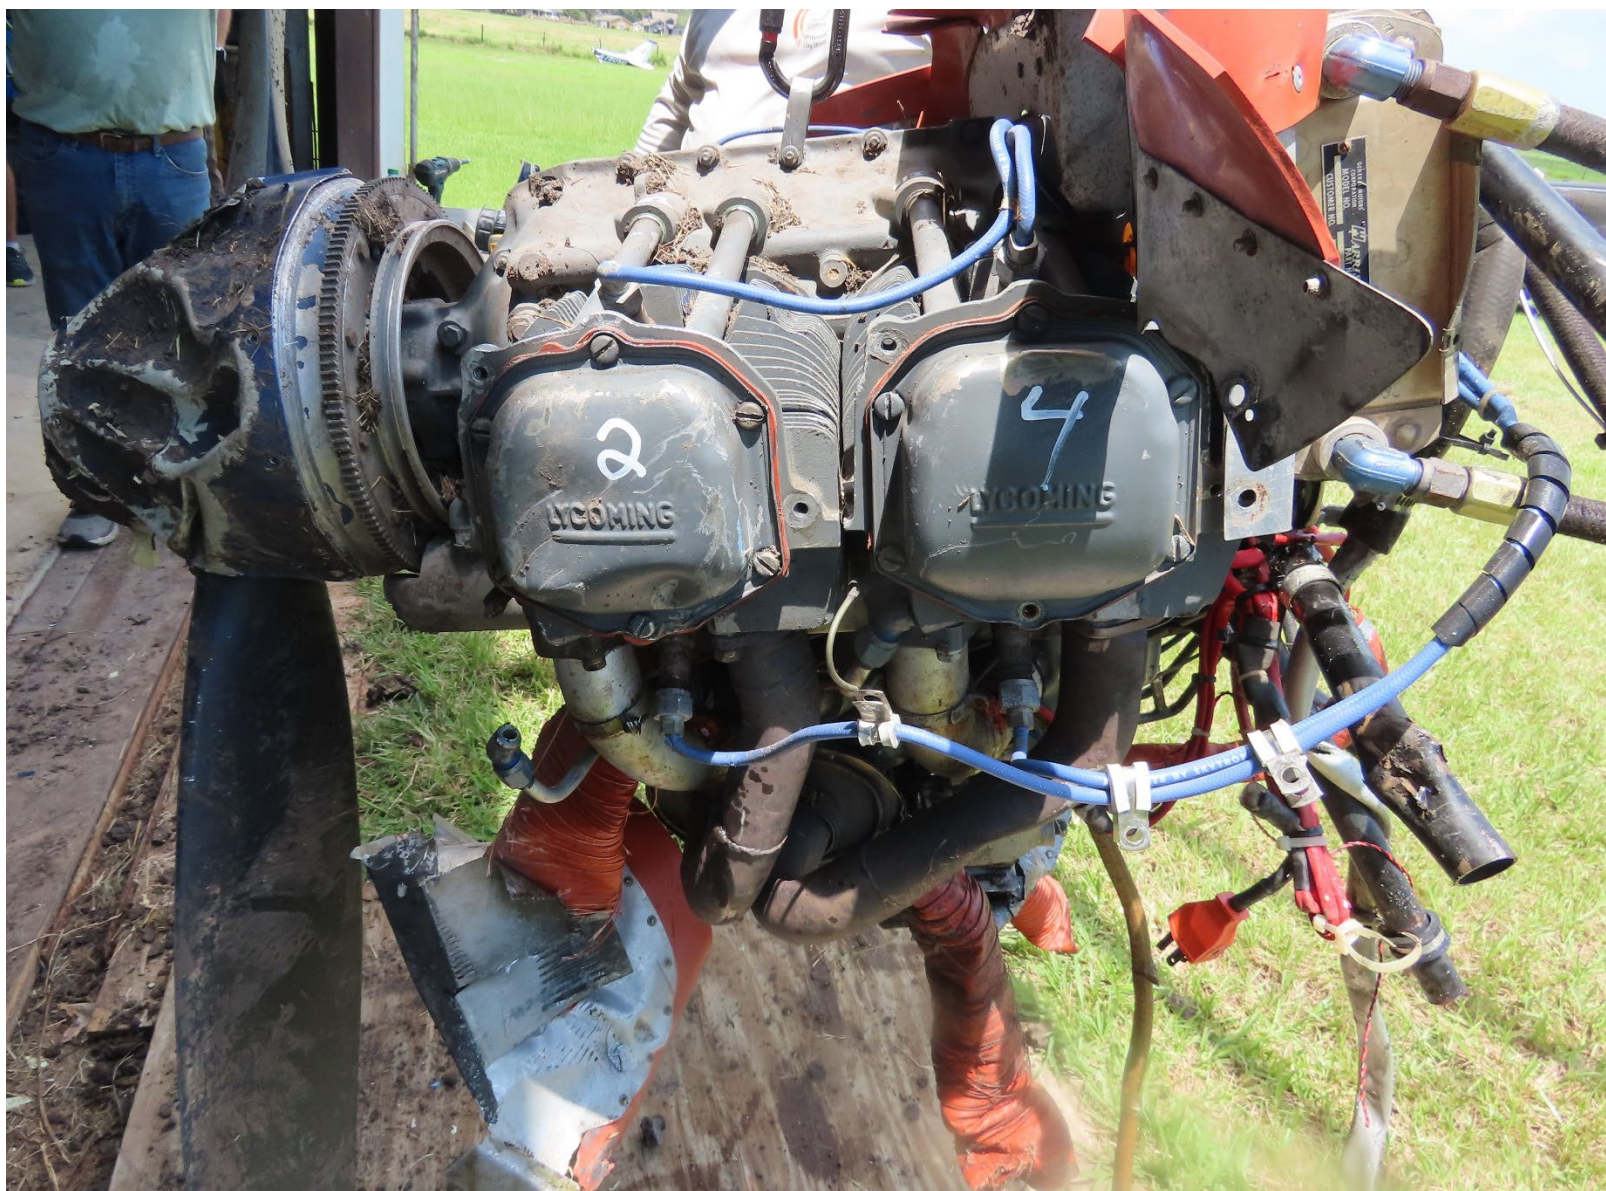
**Photograph 4 - Left Side View of Engine (Source: Lycoming)**

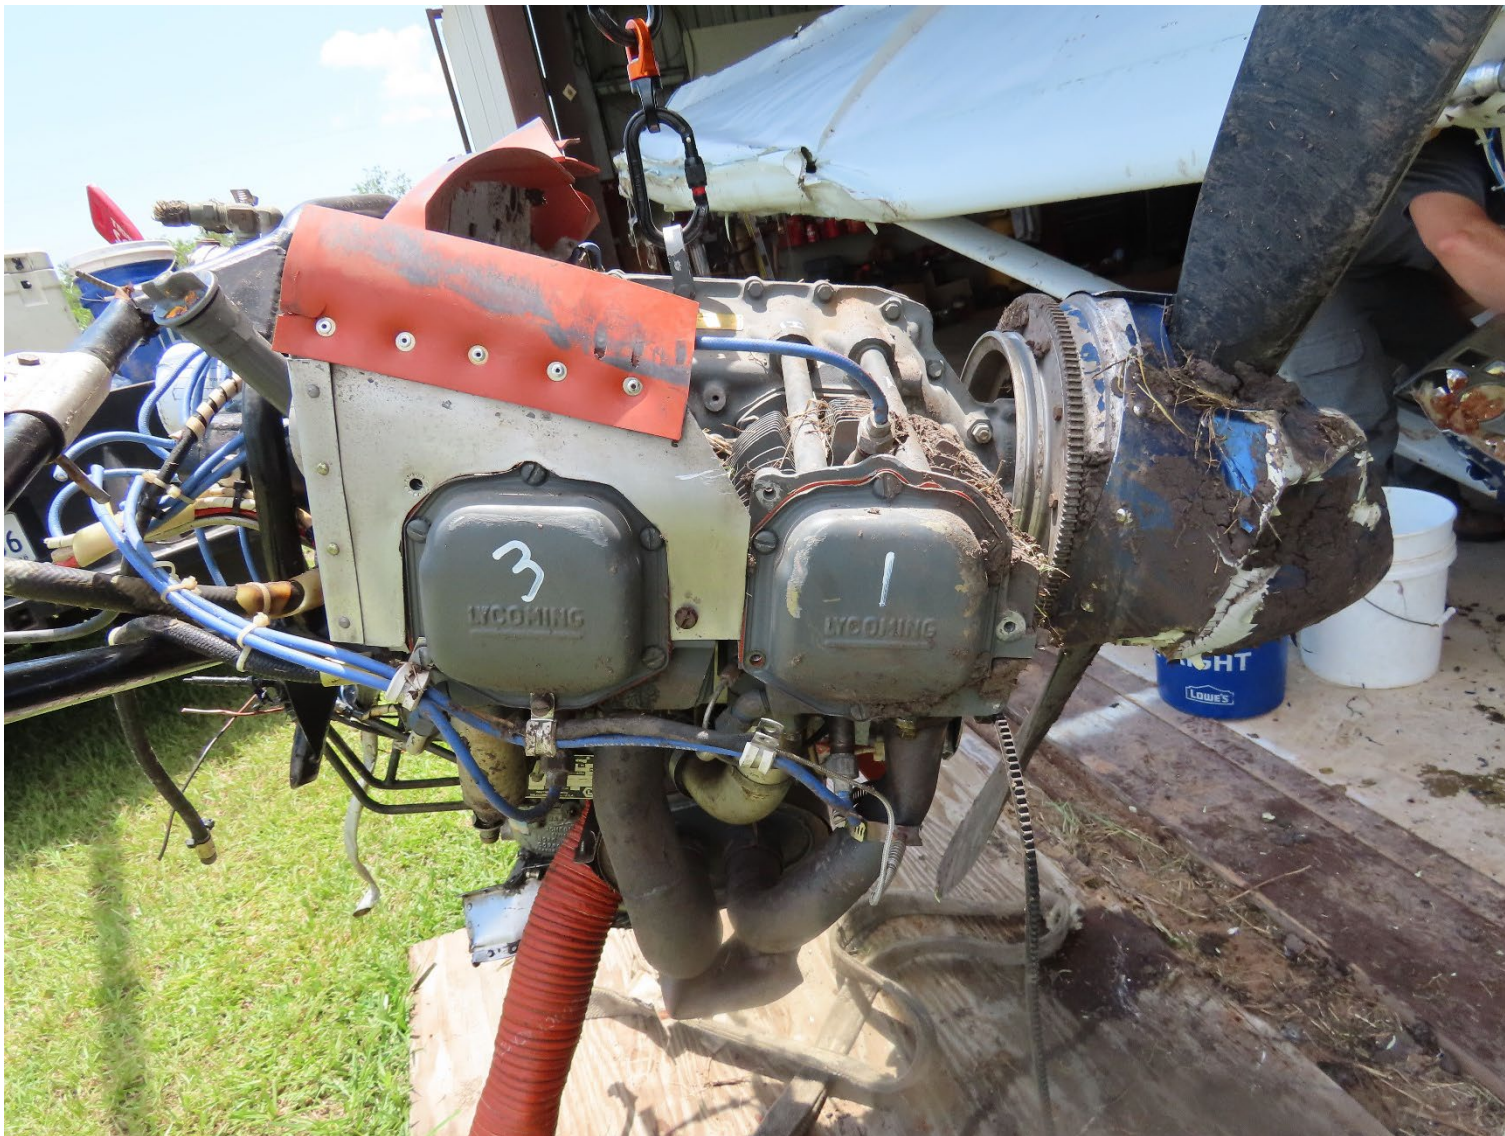
**Photograph 5 - Right Side View of Engine (Source: Lycoming)**

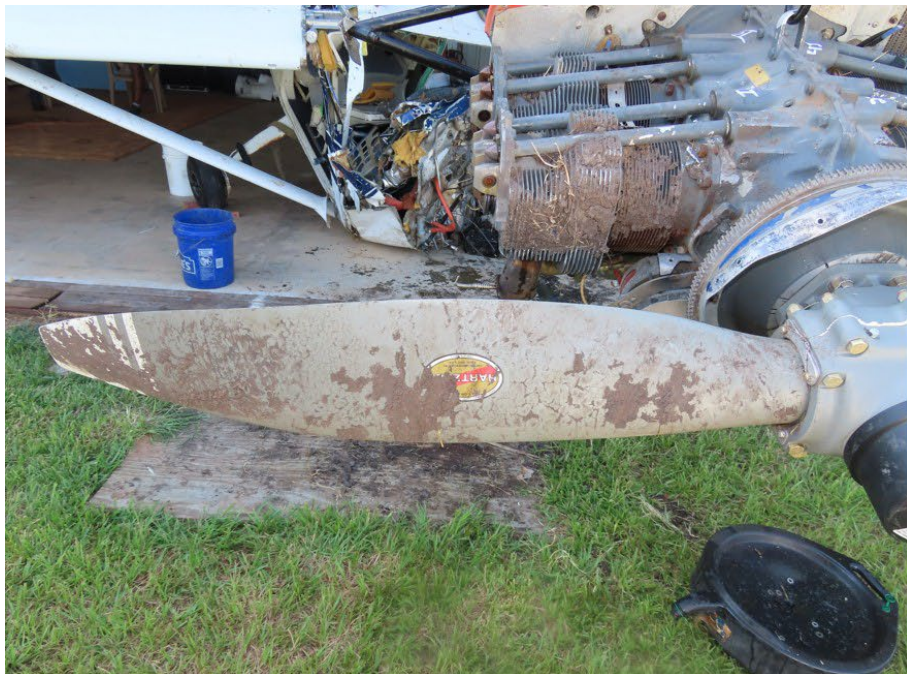
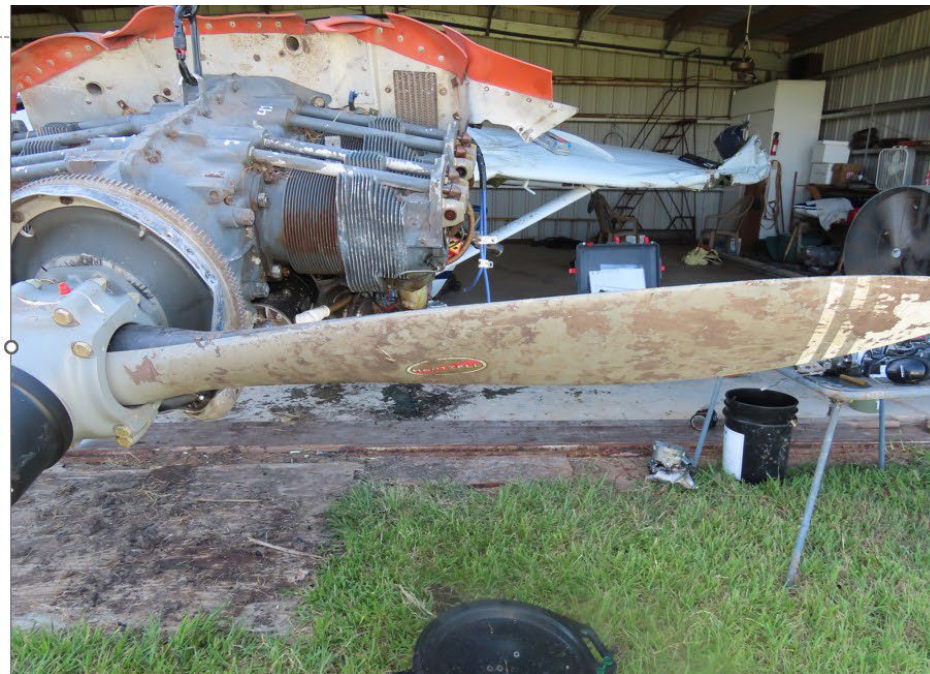
**Photograph 6 - View of Propeller Blades (Source: Lycoming)**
