# National Transportation Safety Board

CEN24FA305

## EXAMINATION SUMMARY

Location: Brazoria, TX  
Date: 08/06/2024  
Time: 18:20 CDT  
Aircraft: Cessna 172F; N7905U

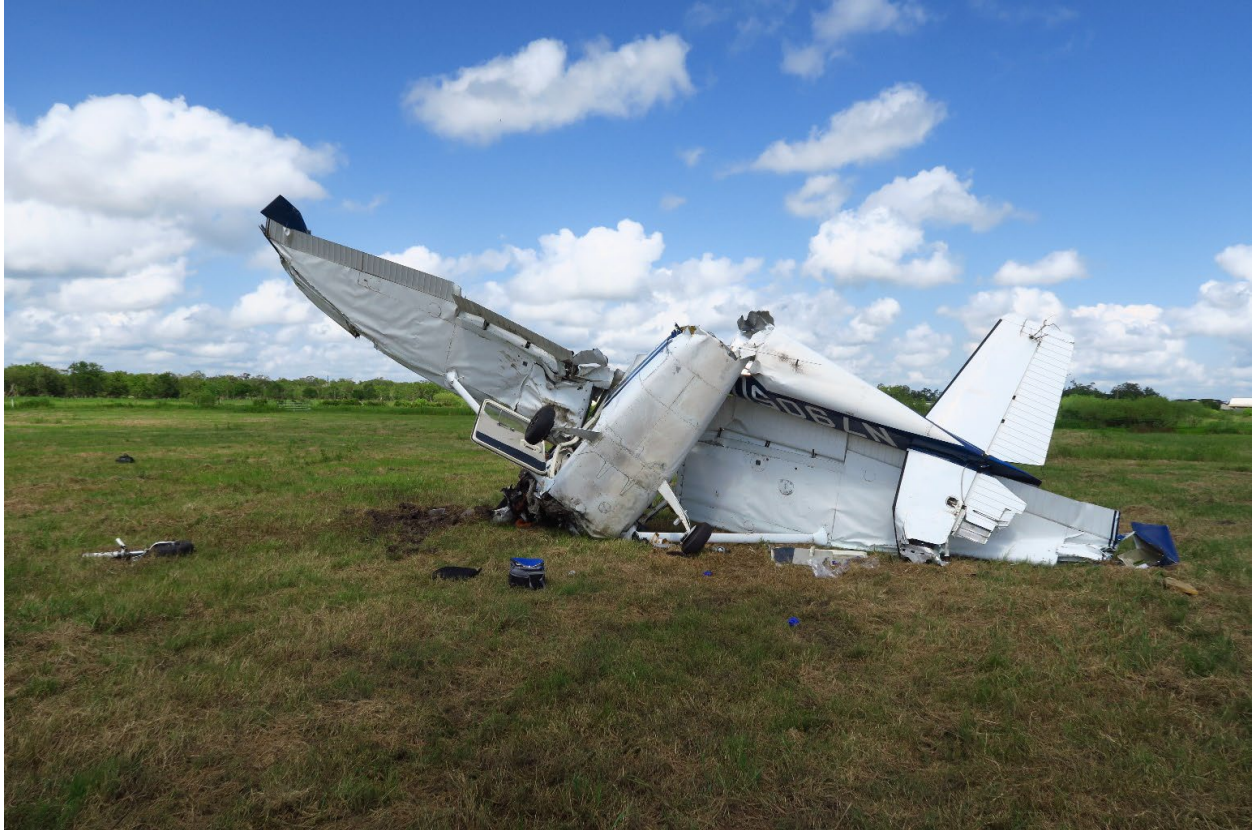
According to witness information and on-scene examination, the aircraft turned slightly left during the takeoff roll from the turf on Runway 11 and departed the mowed turf and entered tall grass. The aircraft then lifted off the surface and struck a 4' tall barb wire fence post. The outboard four feet of the right elevator was separated from the aircraft and was found entangled in the barb wire. According to witnesses, the aircraft pitched up abruptly and then descended into the adjacent field. The aircraft impacted a grass field in a left-wing-low, nose-down flight attitude. The left wing struck the ground first and the aircraft cartwheeled about the nose. The right wing then struck the ground and the tail partially fractured and bent to the right aft of the rear bulkhead.

Figure 1. Main wreckage (Courtesy: Textron Aviation)
