# National Transportation Safety Board

CEN24FA326

## EXAMINATION SUMMARY

Location: Crofton, Nebraska  
Date: August 26, 2026  
Time: 0841 CDT  
1341 UTC  
Airplane: Rans S19 – N519JR, S/N 090800032

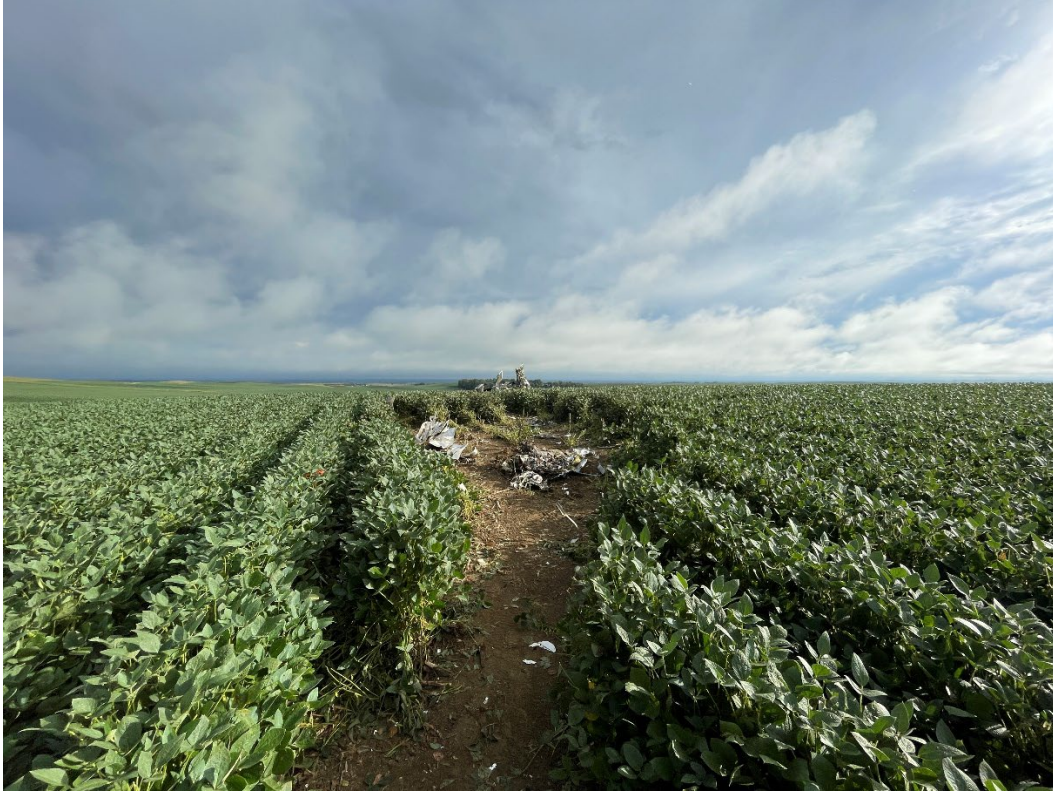
Figure 1. Left Wing Initial Impact

The airplane impacted terrain (Lat/Long: +42° 41'47.05" / -097° 33'03.61") in a mature soybean field. The airplane came to rest in a vertical profile about 023° and 85 ft past the initial impact site. The entire airplane was located at the accident site with no post-crash fire. The debris field included the main impact point out to radius of about 200 ft with further debris out to 500 ft. A ground scar imprint of both wing leading edges was present in the terrain. Location of the leading-edge impression is consistent with the airplane in a nose down left wing low near vertical-to-vertical orientation at impact. The initial impact point consisted of a shallow circular ground impression surrounded by left wing tip fragments. (See Figure 1).

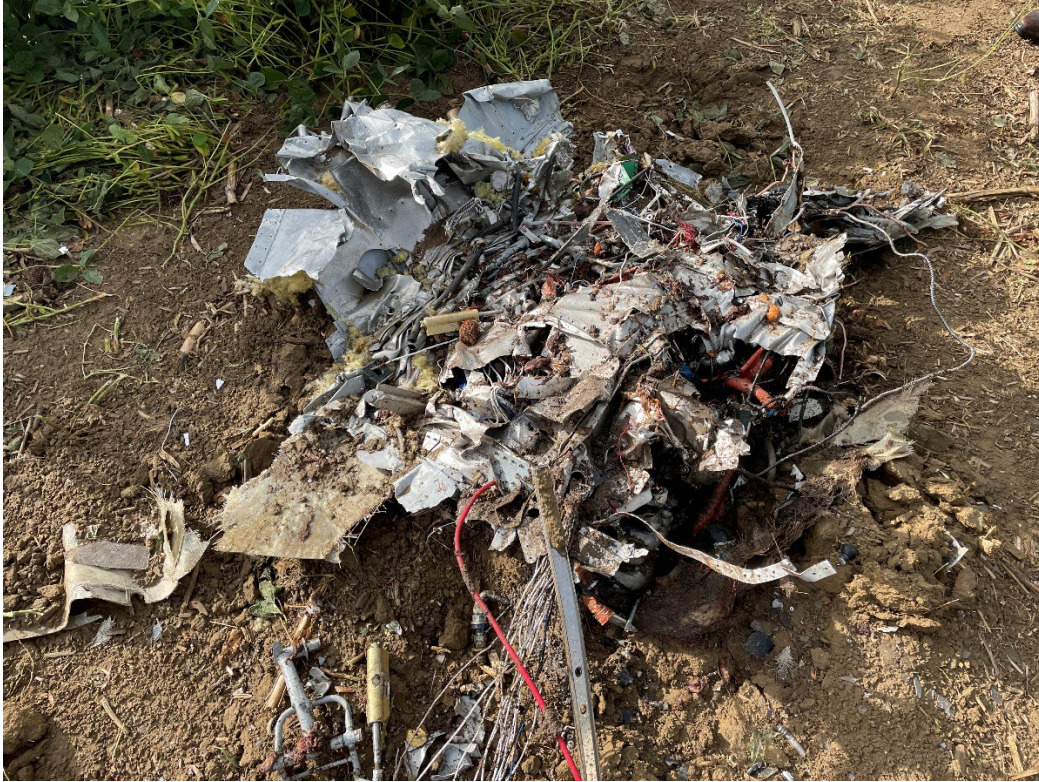
Figure 2. Forward Fuselage and Cockpit

The fuselage came to rest upright in a nose down position with crush damage and separation of the forward fuselage at the cockpit area. The forward fuselage was heavily fragmented and longitudinally crushed consistent with a high energy near vertical impact. Various debris from the forward fuselage were found in the surrounding field. The rest of the fuselage was separated and about 85 ft from the forward section. This section was also crushed longitudinally to the empennage. (See Figure 2)

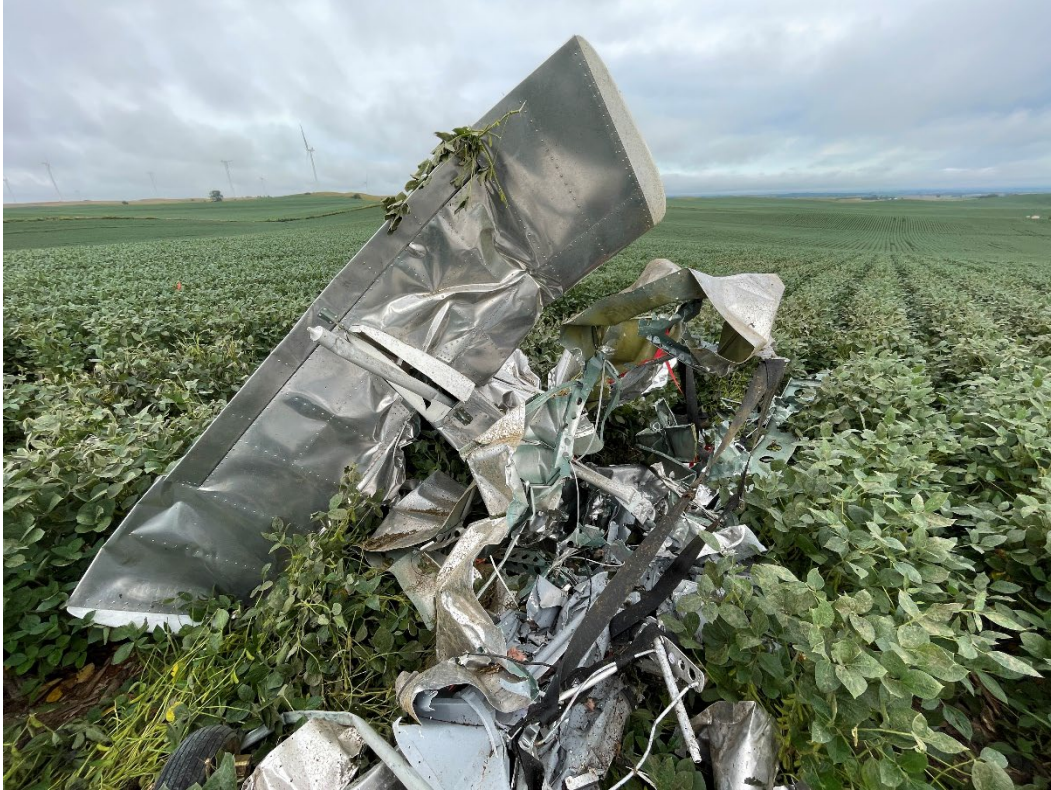
Figure 3. Empennage

The empennage came to rest still attached to the fuselage with crush damage to the vertical stabilizer. The horizontal and vertical stabilizer had bending of the structure with various areas of crush damage. Flight control continuity was established from the elevator and rudder to the fuselage separation. Continuity from the cable separations to the control stick and rudder pedals could not be determined due to crush damage and fragmentation of the forward fuselage. (See Figure 3)

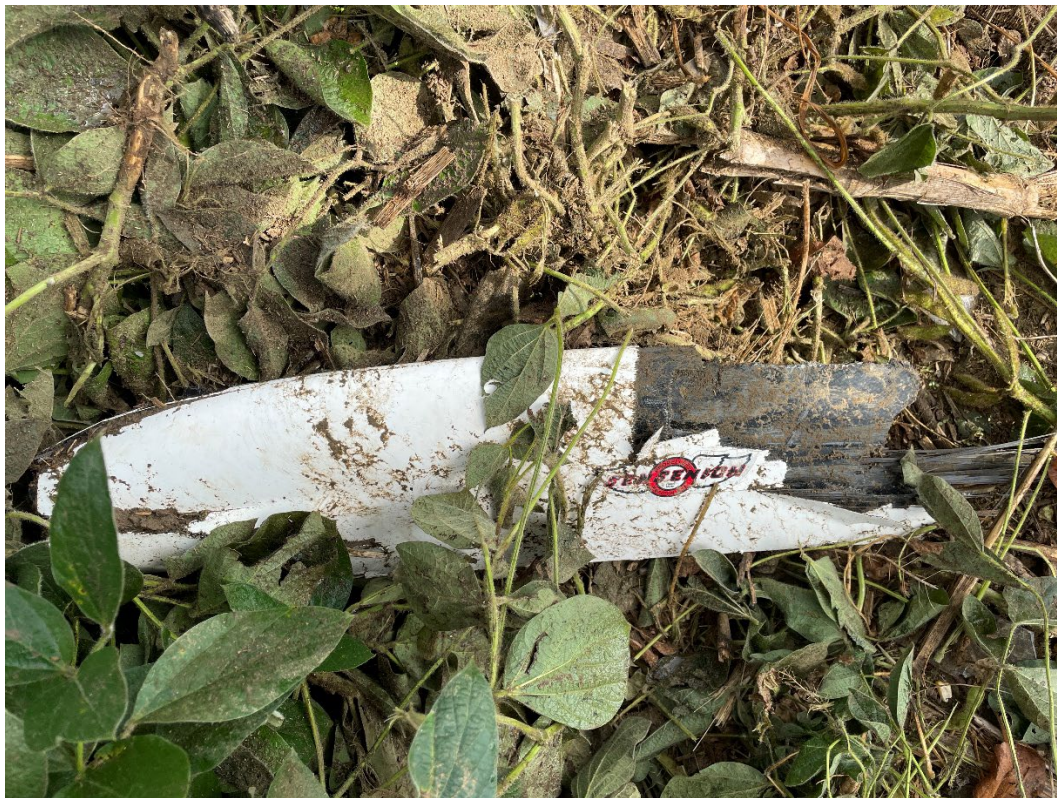
Figure 5. Propeller

The propeller was found fragmented and scattered in the debris field. All blade sections recovered had impact and rotational damage. (See Figure 5)
