National Transportation Safety Board

CEN24LA327

## **INVESTIGATION PHOTOGRAPHS**

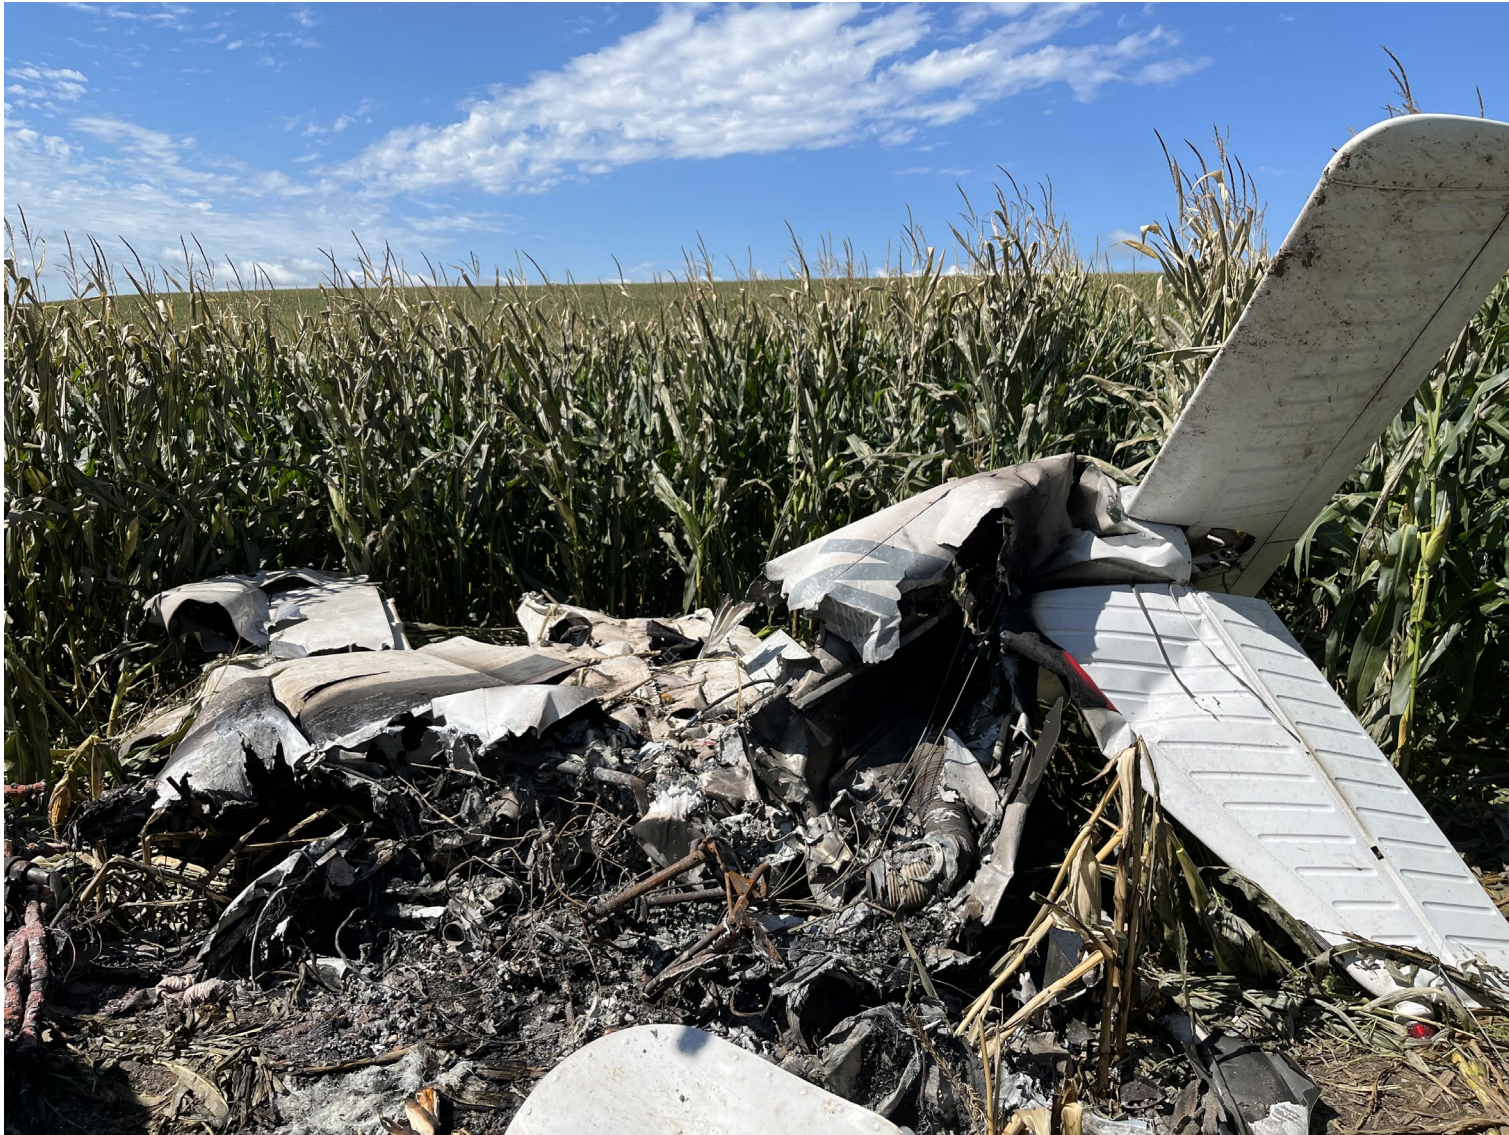
**Photograph 1 - Main wreckage**

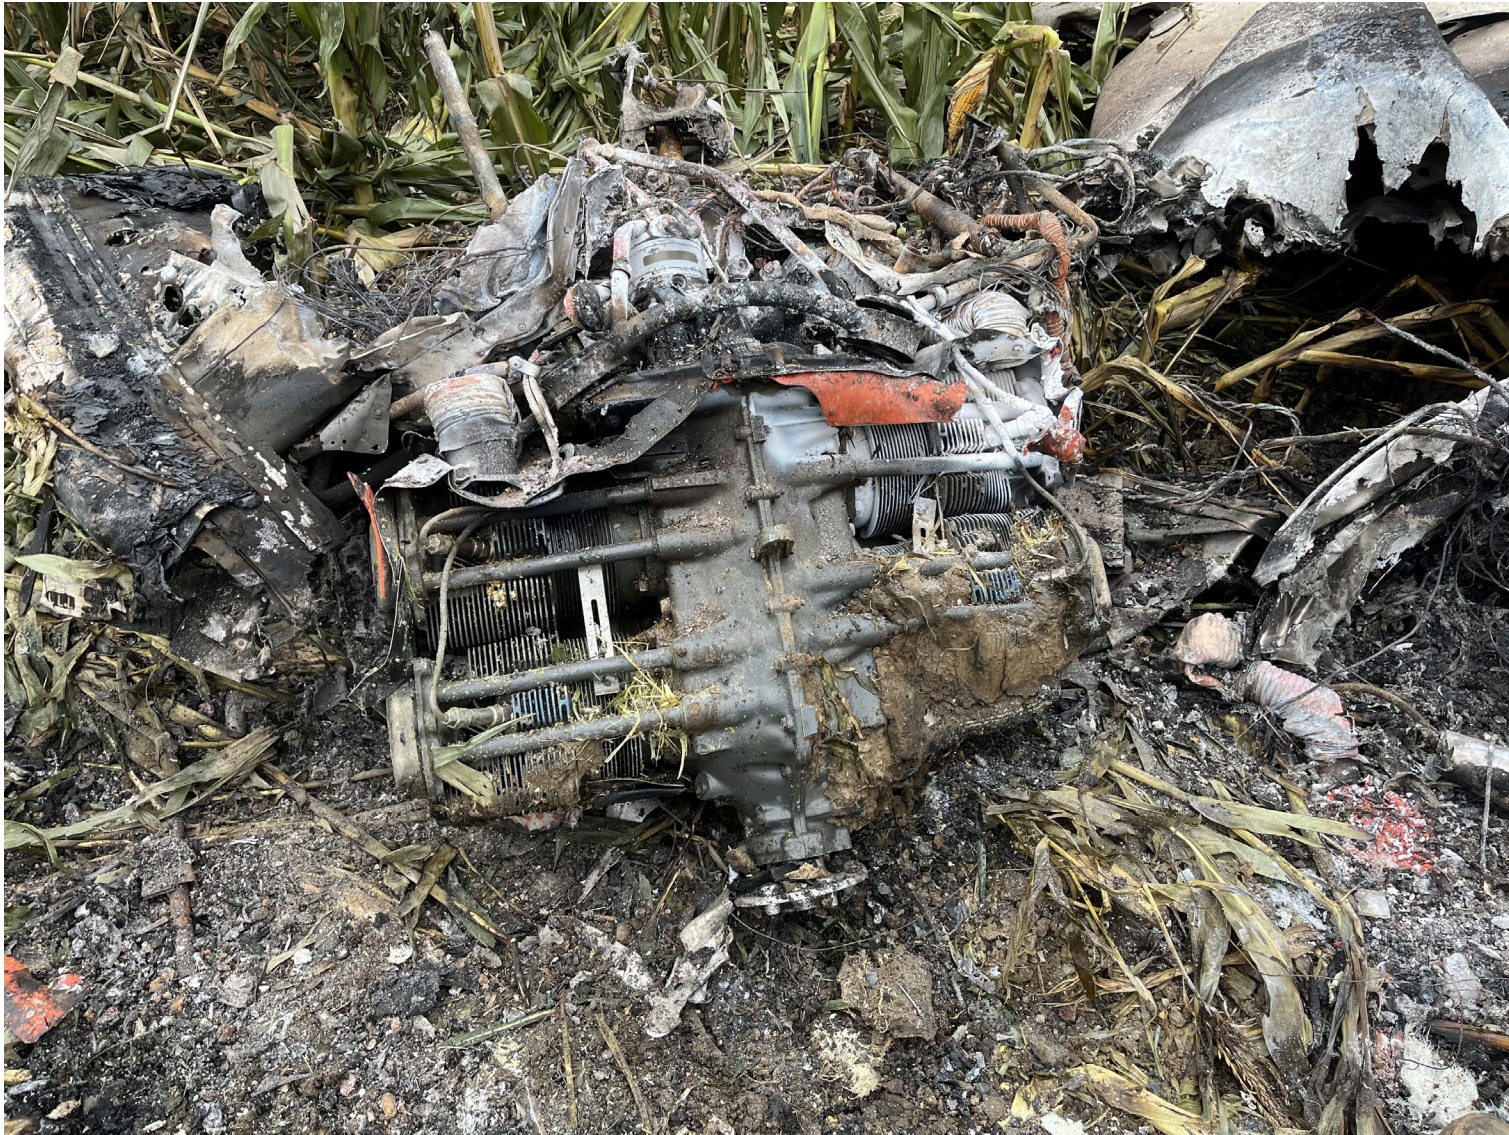
**Photograph 2 - Engine**

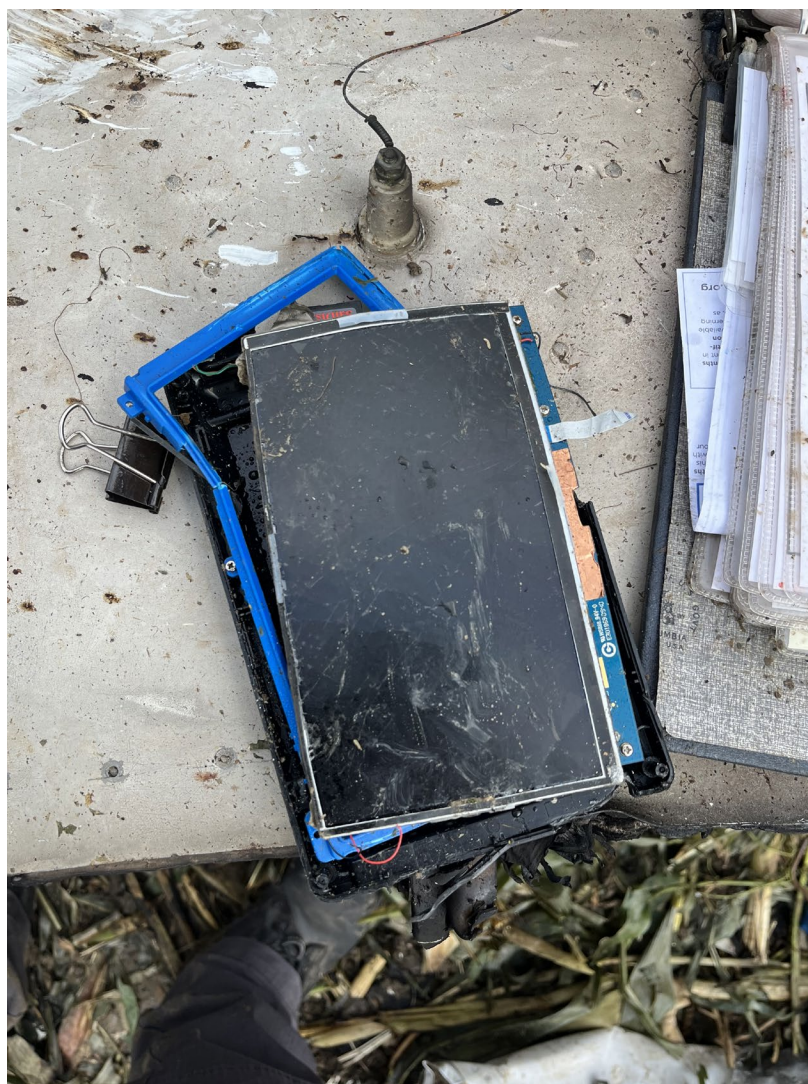
**Photograph 3 - AV8OR personal electronic device**

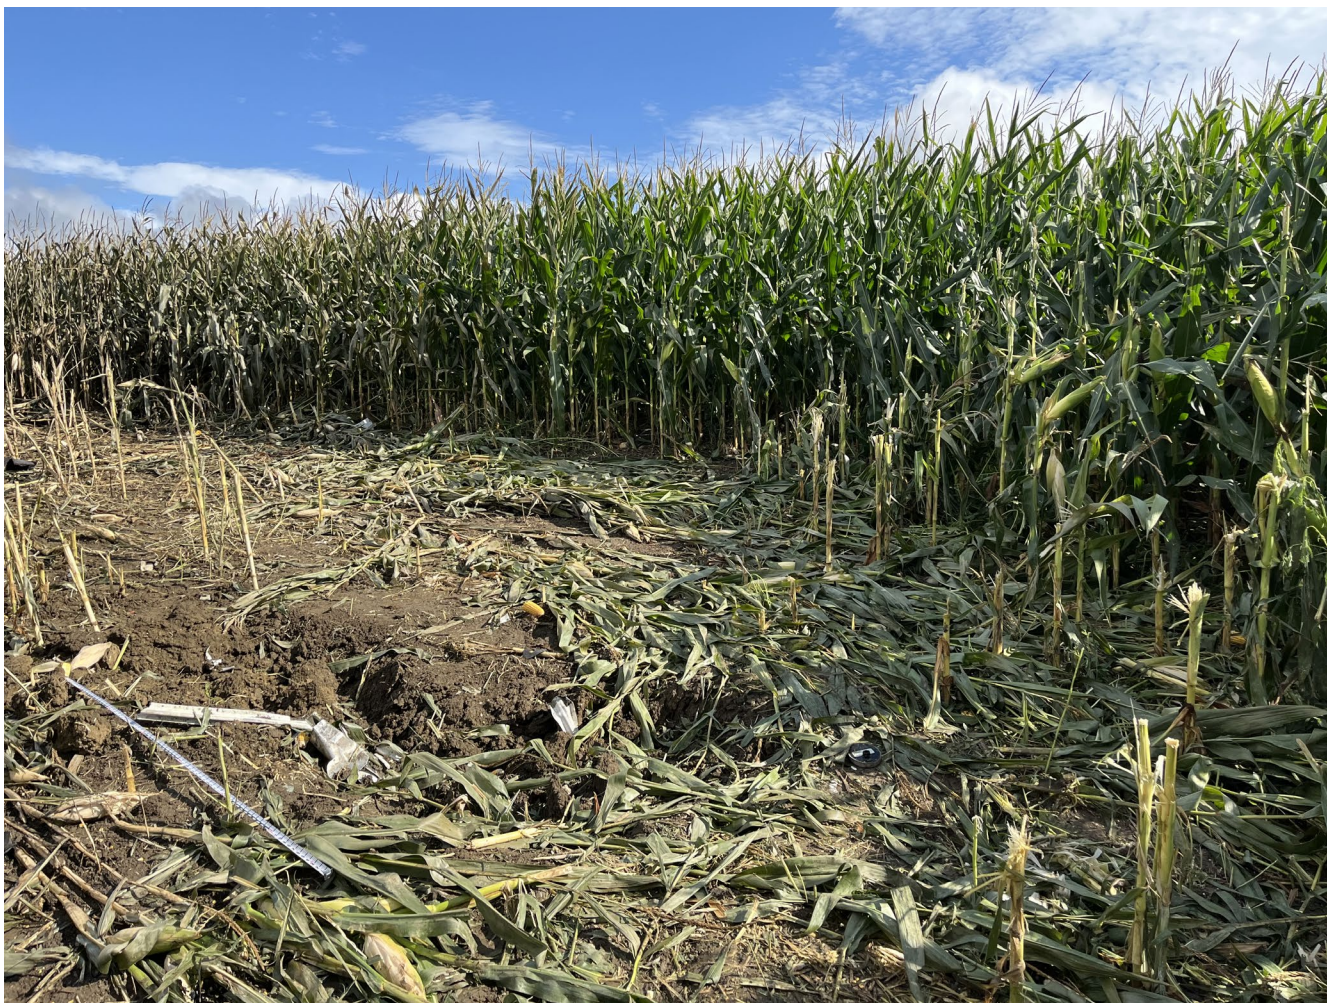
**Photograph 4 - Initial point of impact**

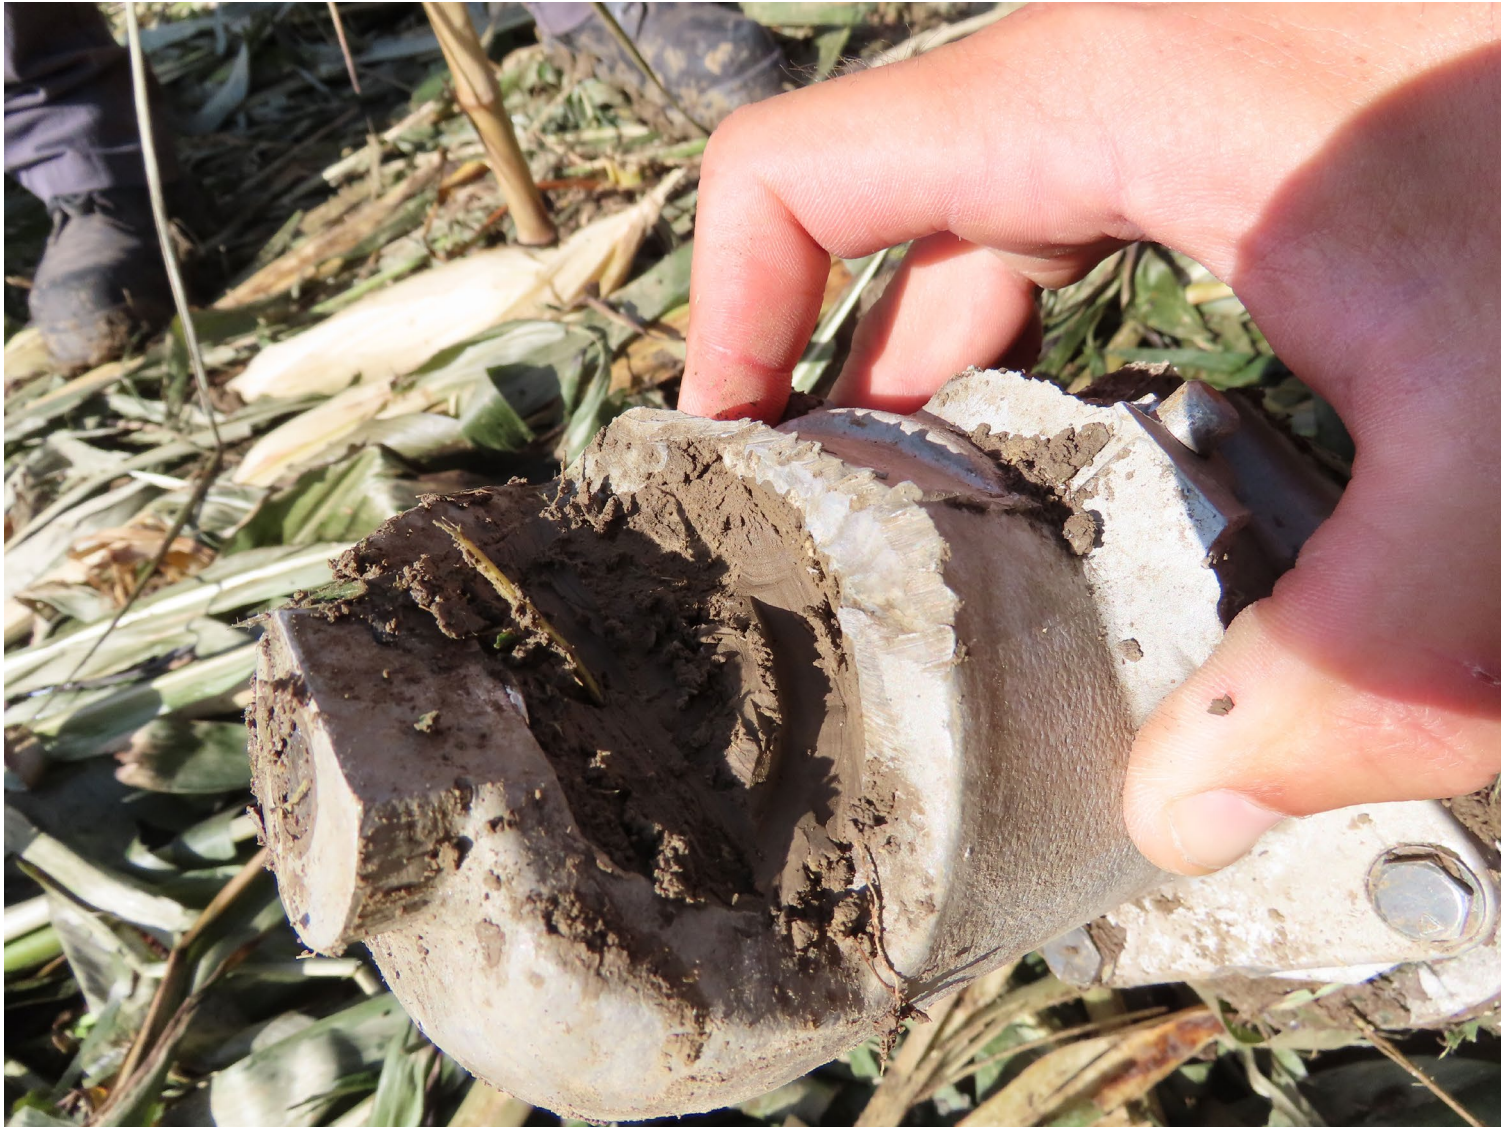
**Photograph 5 - Starter motor impact signature**

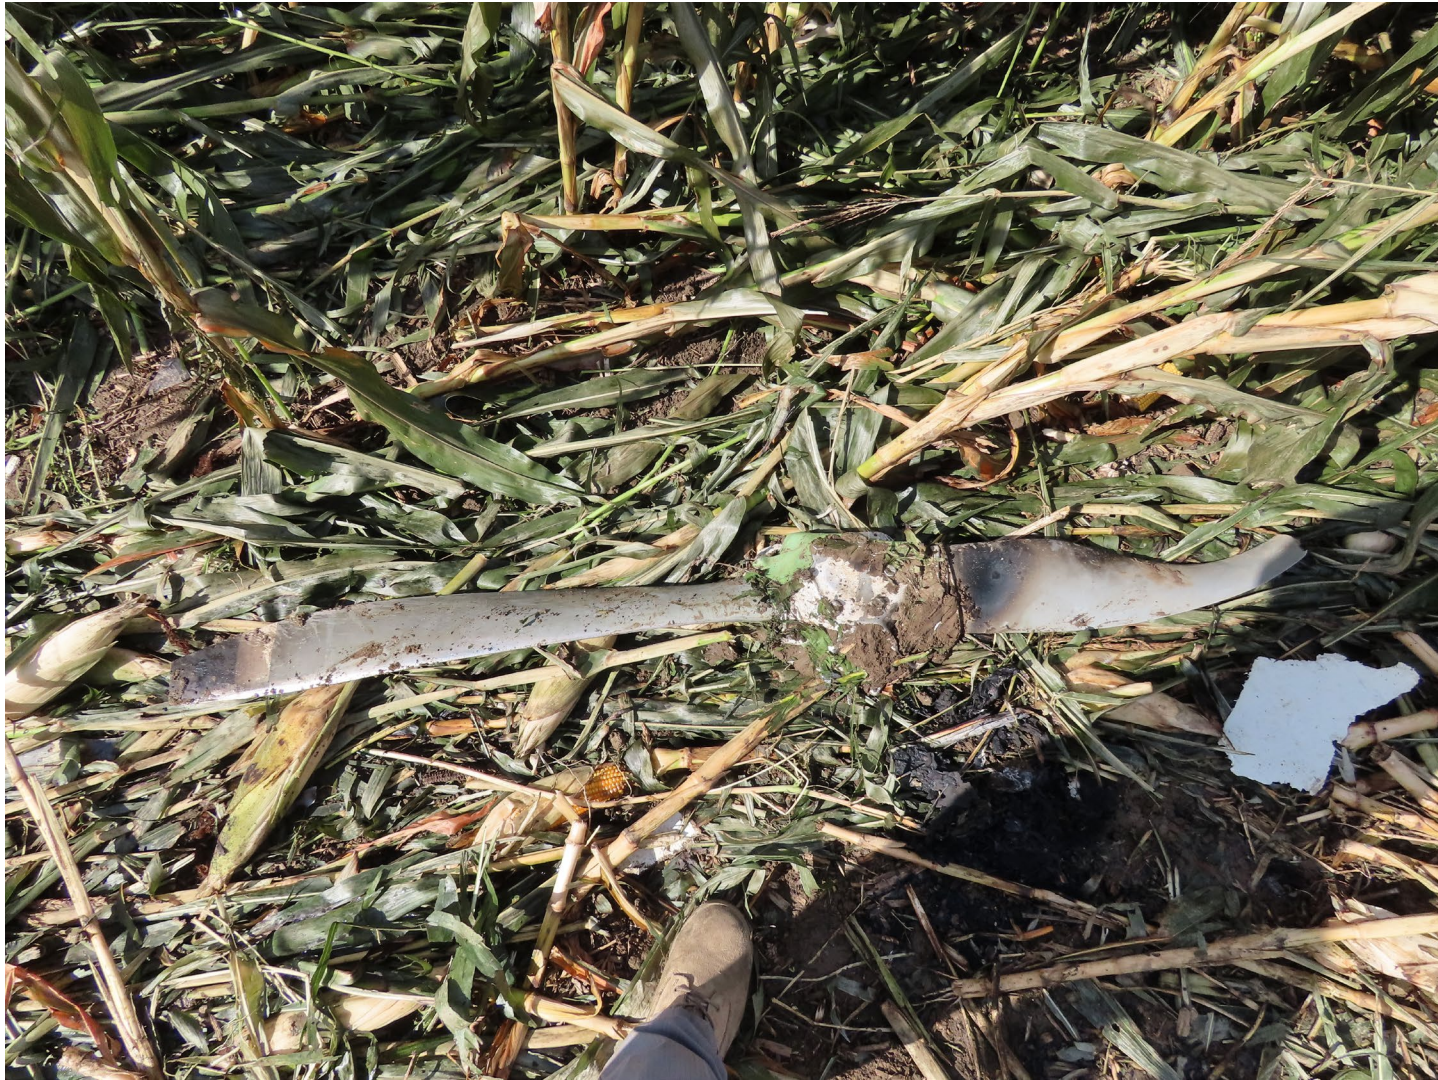
**Photograph 6 - Propeller**

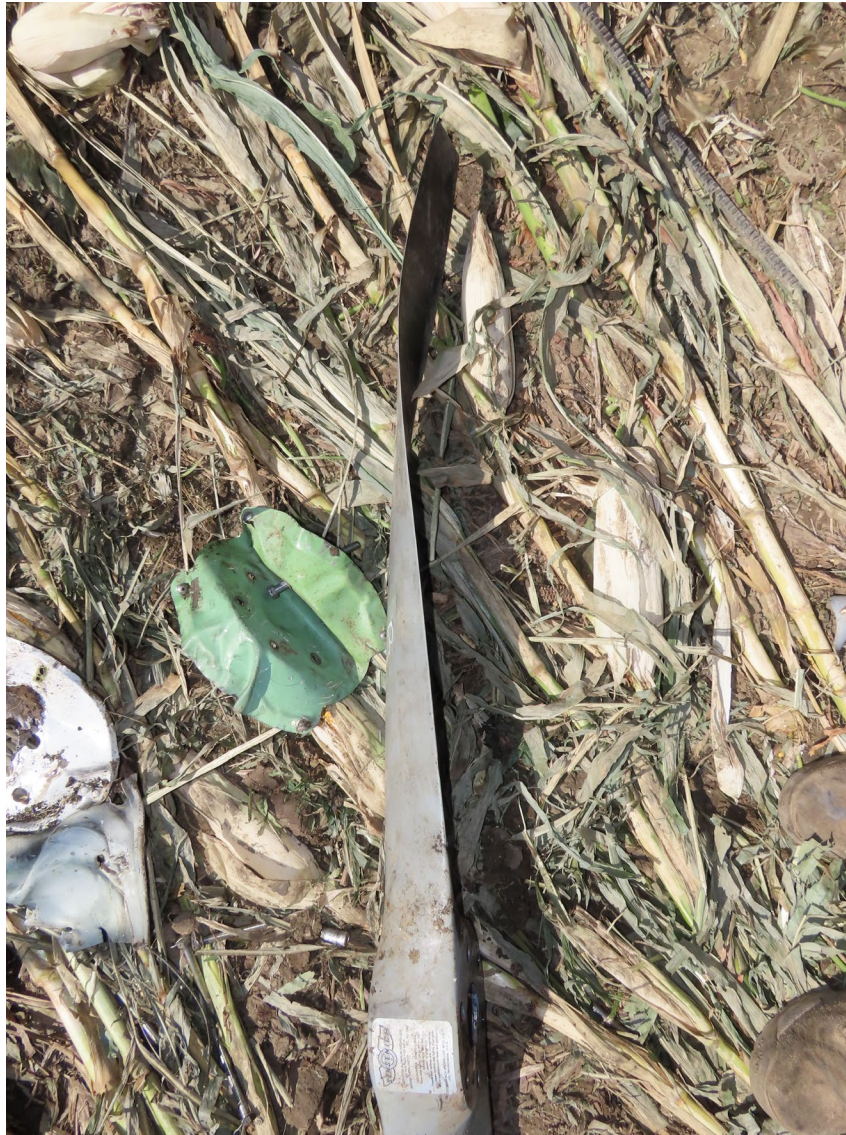
**Photograph 7 - Propeller blade**

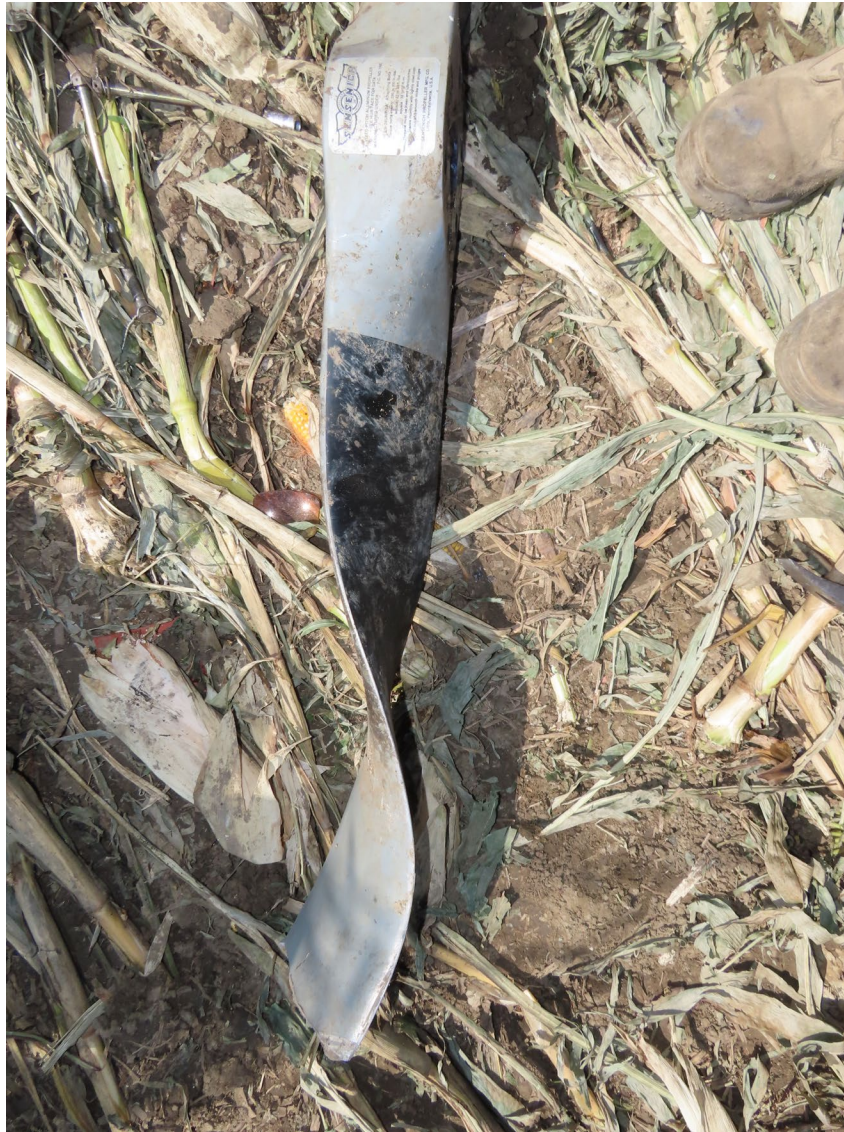
**Photograph 8 - Propeller blade**
