# National Transportation Safety Board

CEN24FA338

## **WRECKAGE EXAMINATION SUMMARY**

Location: Camden, Colorado  
Date: September 5, 2024  
Time: 1014 mountain daylight time  
Airplane: Air Tractor AT-602, Registration No. N602BA

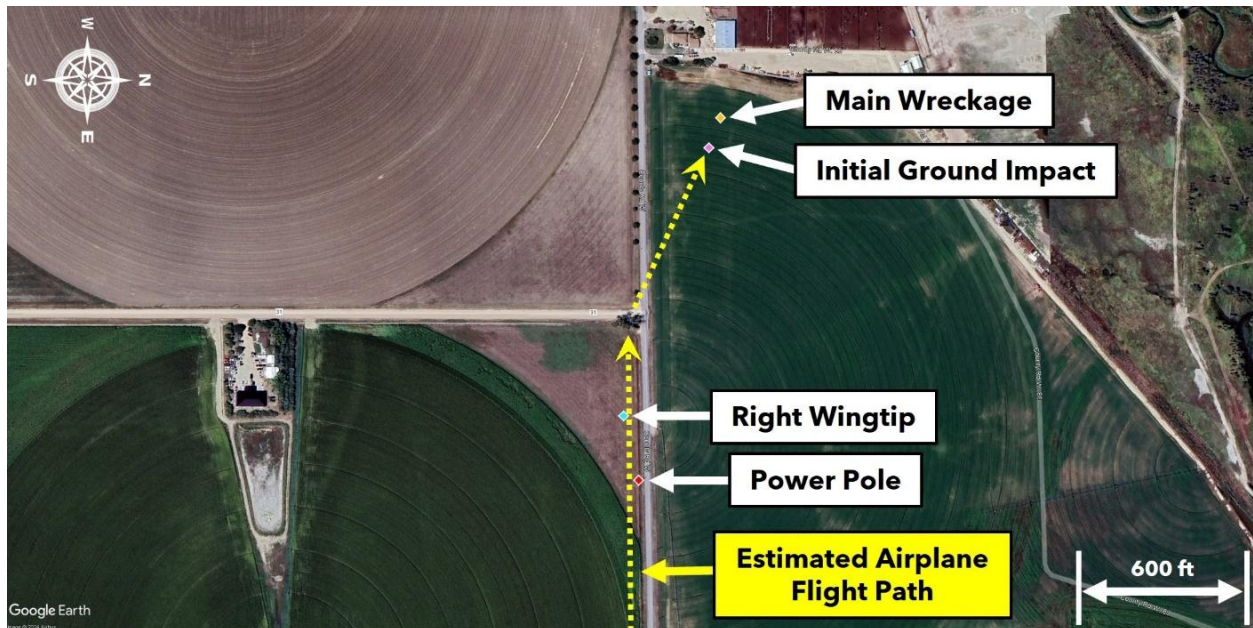
Based on the wreckage distribution, the airplane was flying west along the north edge of the field when the right wing struck the power transformer, as shown in figure 1. According to the power company, the power pole's first cross support was about 37 ft above ground level (agl) and the second cross support was 39 ft agl, as shown in figure 2. The power transformer exhibited evidence of impact-related damage, as shown in figure 3, consisting of dents, yellow paint chips, and yellow paint transfers.

**Figure 1** - Estimated airplane flight path and impact sequence.

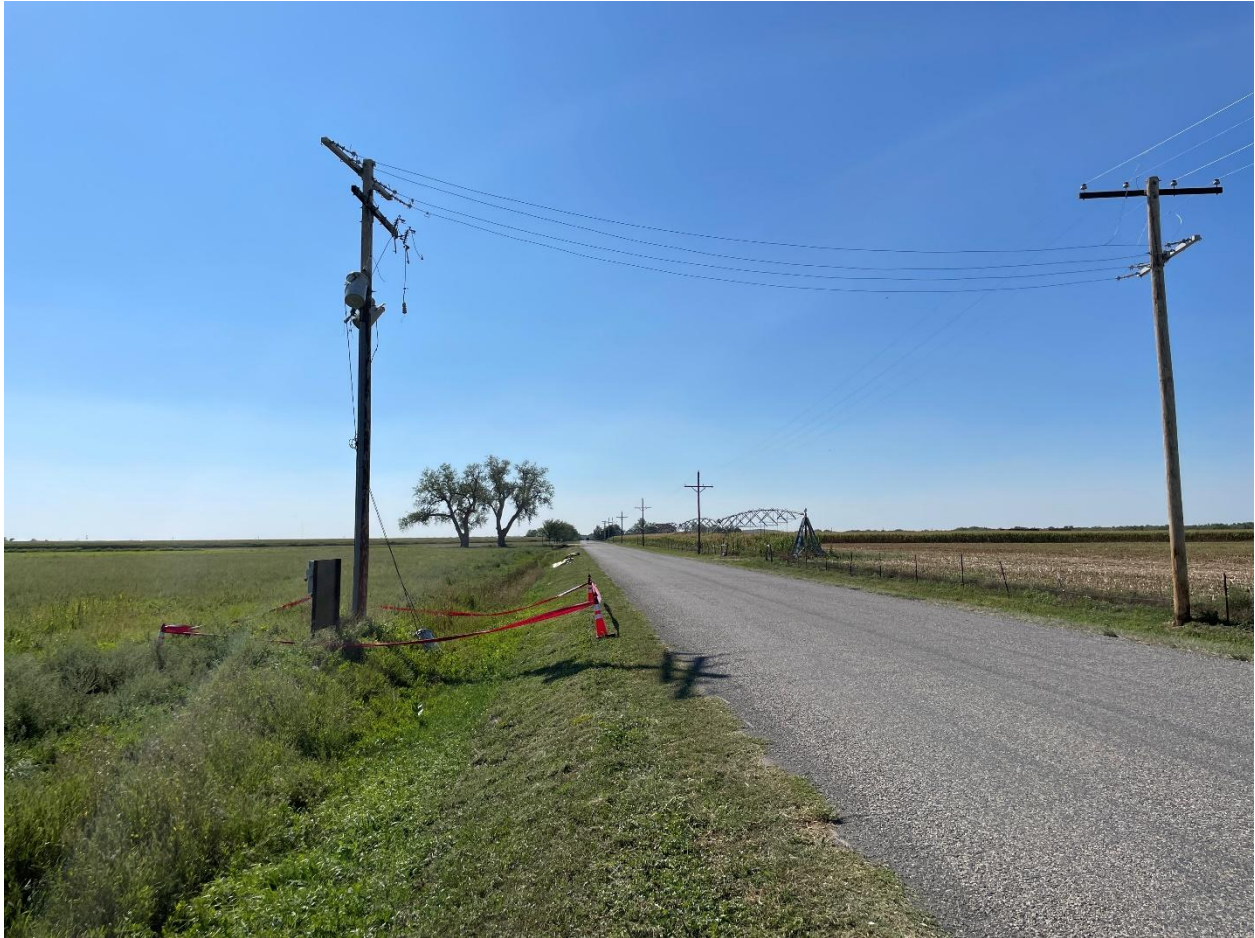
**Figure 2** - Location of power pole as seen facing west along County Rd W.

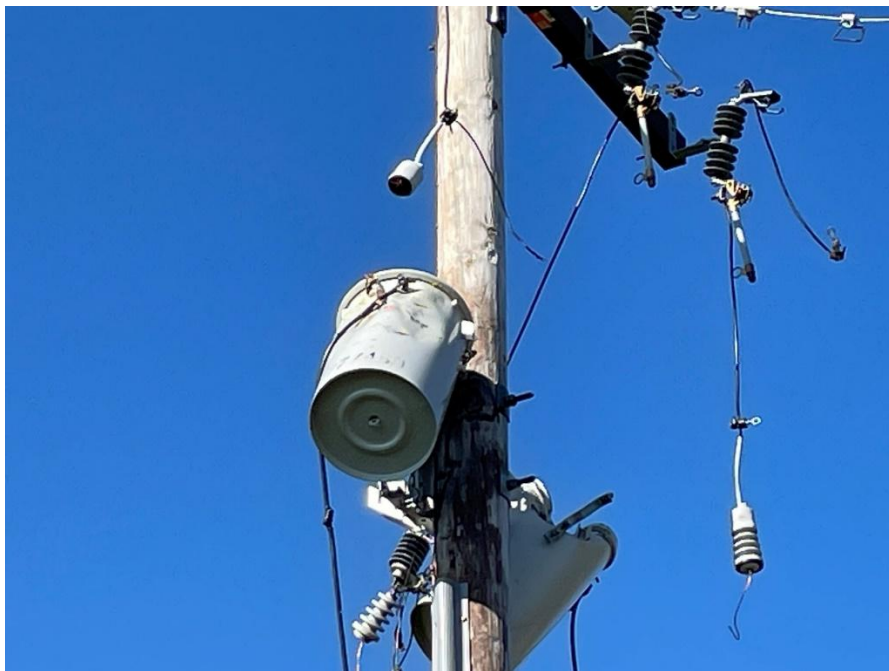
**Figure 3** - Damaged power transformers.

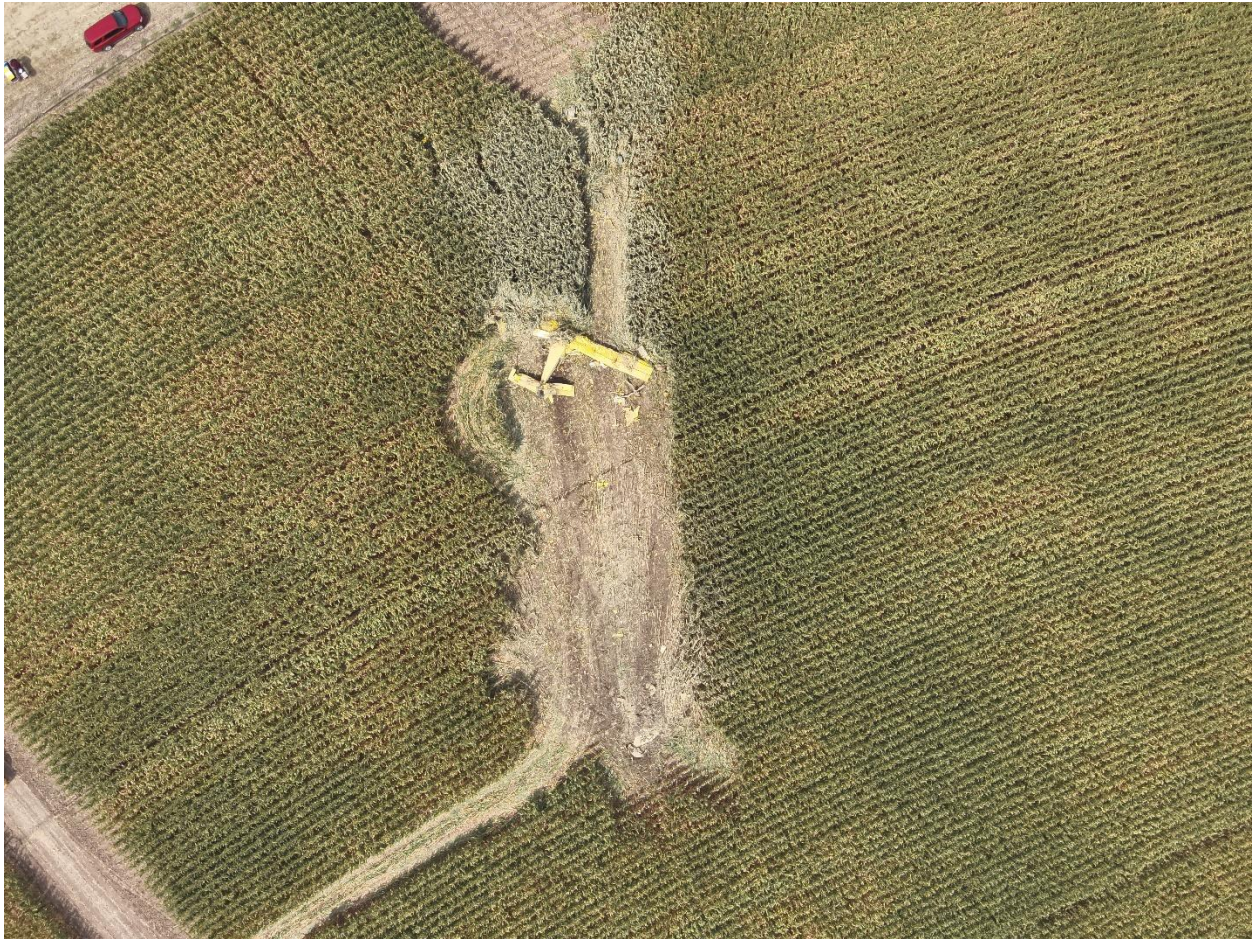
After the airplane struck the power transformer, it continued 1,232 ft to the west-northwest (282°) where it impacted inverted in a cornfield, as shown in figure 4. The airplane remained inverted and slid 116 ft to the west-northwest (290°). There was no evidence of a postimpact fire.

**Figure 4** - Overhead photo of the initial ground impact and main wreckage. (Photo courtesy of Morgan County Sheriff's Office)

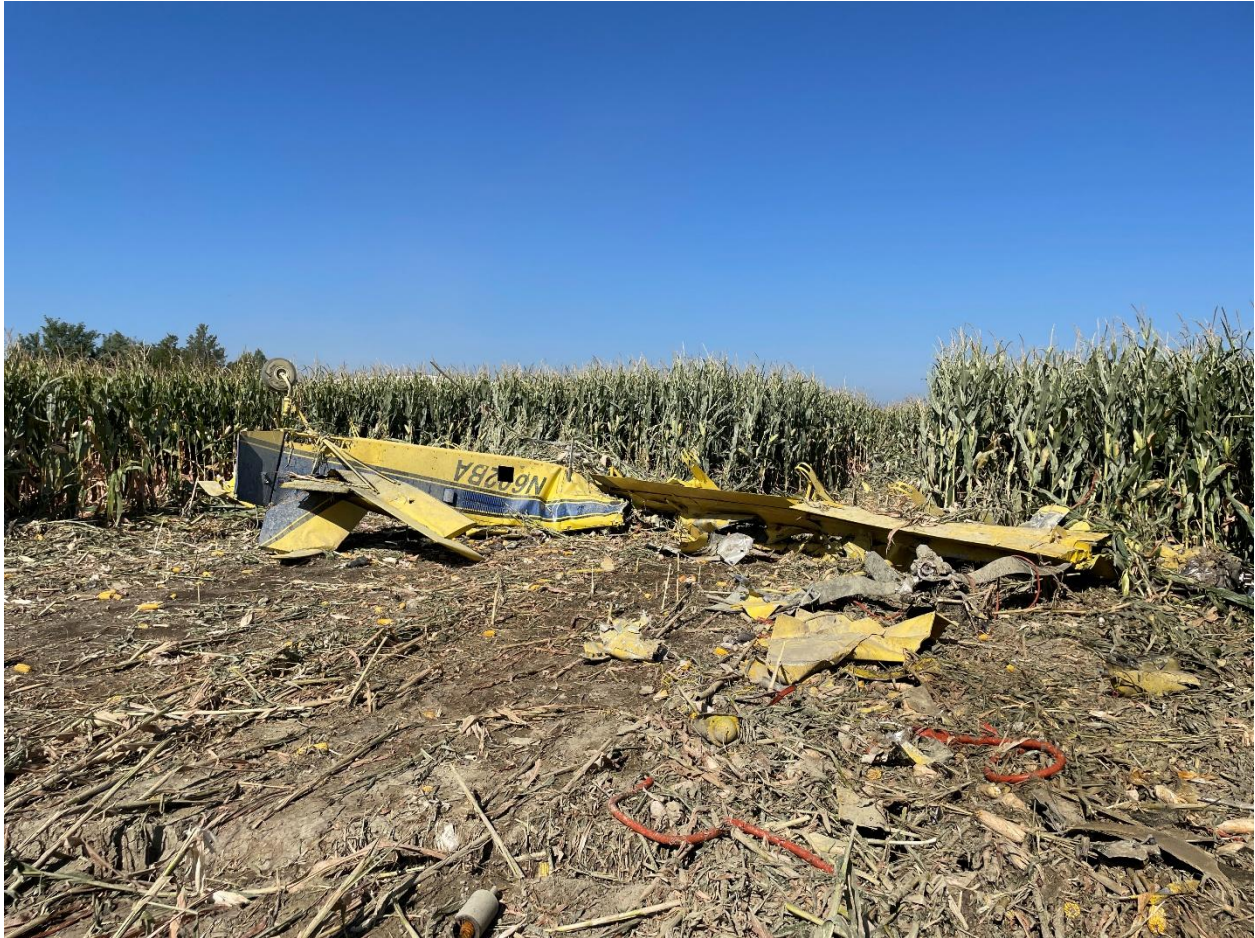
The main wreckage came to rest about 1,350 ft west-northwest of the power pole, as shown in figure 5. The airplane came to rest at 40.320997° north latitude, 103.567581° west longitude, at 4,188 ft msl.

**Figure 5** - Main wreckage at the accident site.

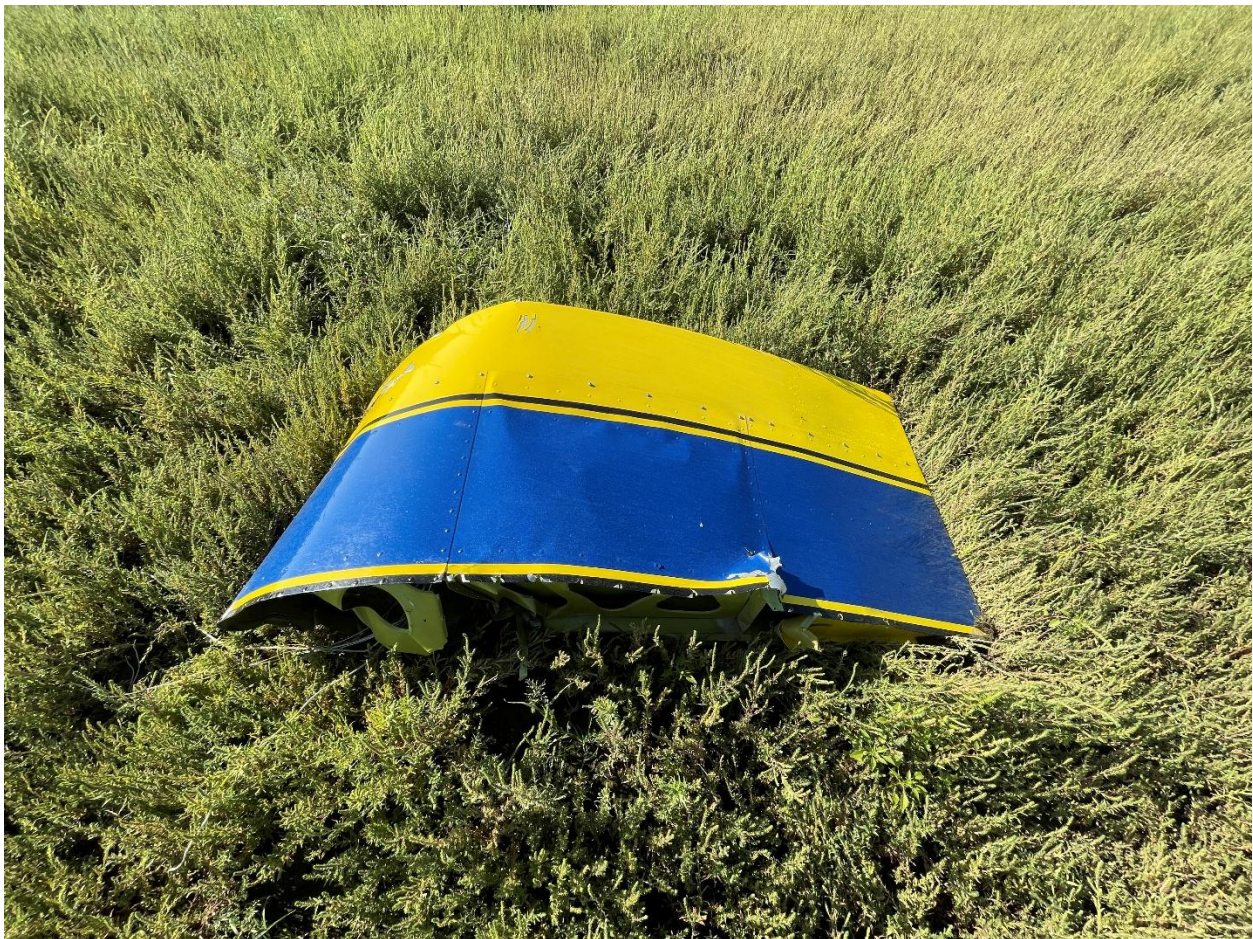
As discussed previously, the right wingtip was in the debris field near the power pole, as shown in figure 6. The outboard 3 ft section of right aileron was in the debris field near the power pole, as shown in figure 7. The right aileron counterweight was in the debris field near the power pole. The inboard section of the aileron was located with the right wing and main wreckage. The right-wing flap remained in its proper location. The leading edge of the right wing had downwards and aft crush damage.

**Figure 6** - Right wingtip as found along the wreckage debris path.

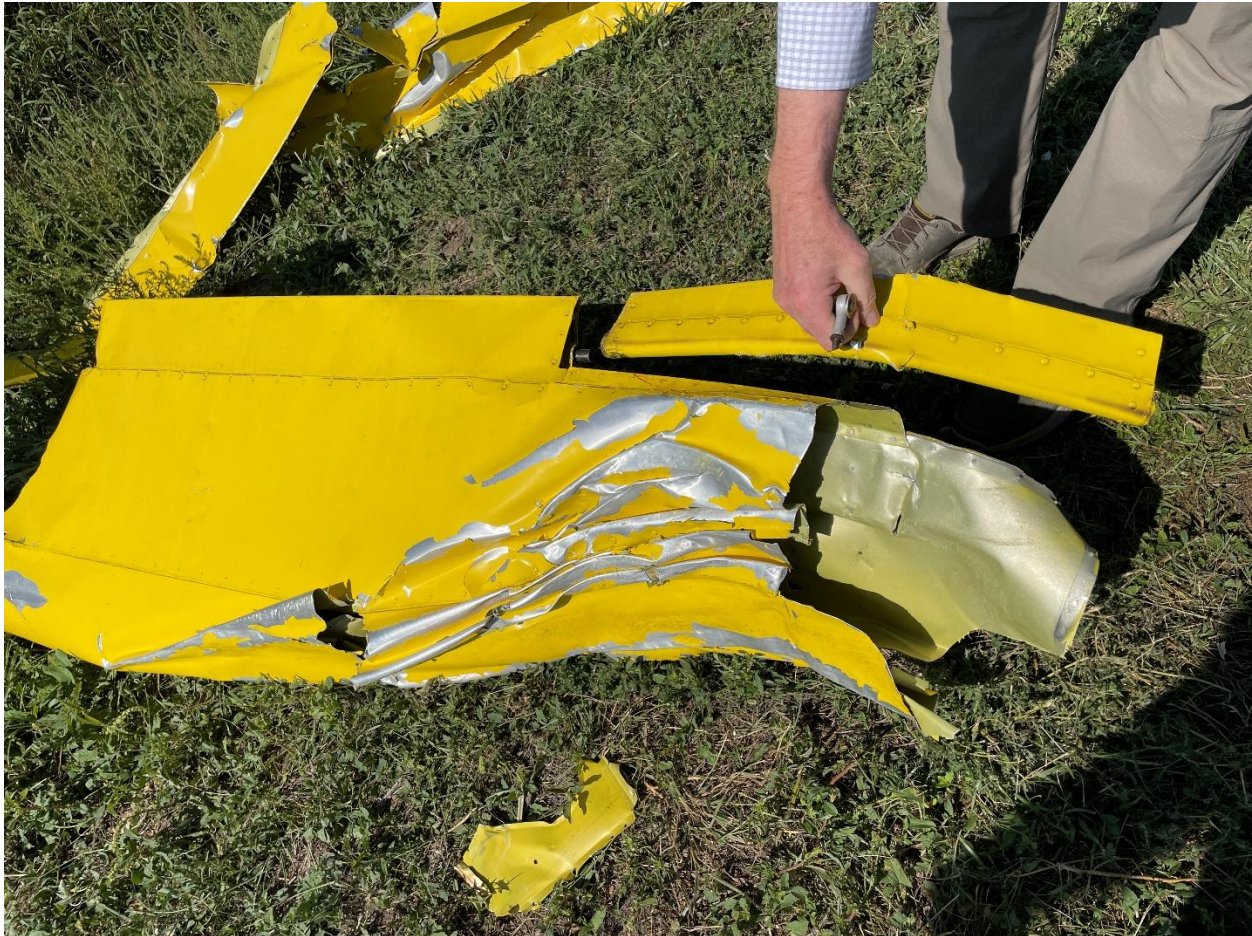
**Figure 7** - Outboard 3 ft of right aileron and the aileron trim surface.

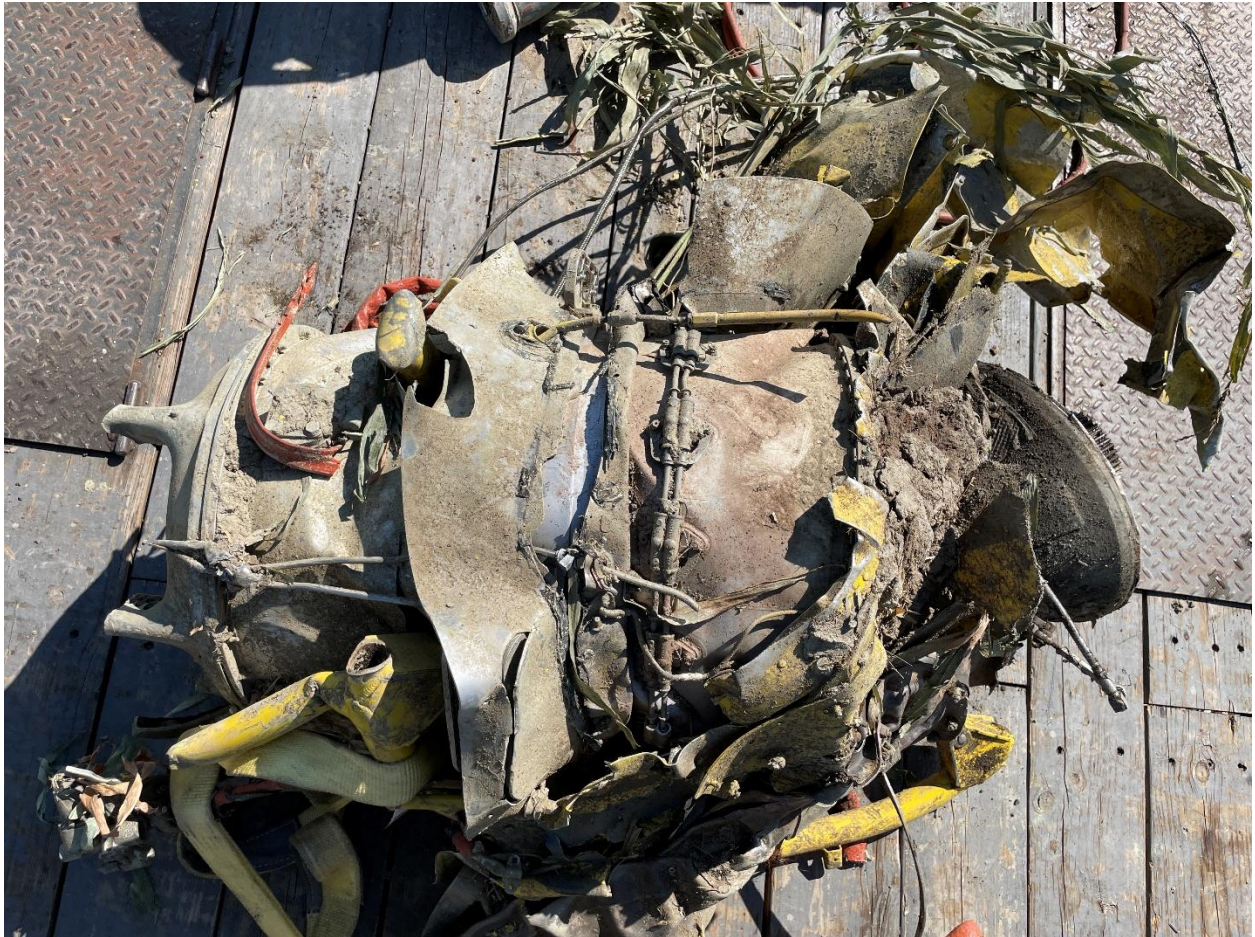
The engine was confirmed to be a Pratt & Whitney PT6A-65AG engine, serial number PCE-PN0099. The gas generator s/n was GG-PN0099 and the power section s/n was PS-PN0099. The engine and engine mount were separated in multiple places. The engine exhibited significant impact-related damage, as shown in figure 8.

**Figure 8** - Overview of the engine after recovery from the accident site.

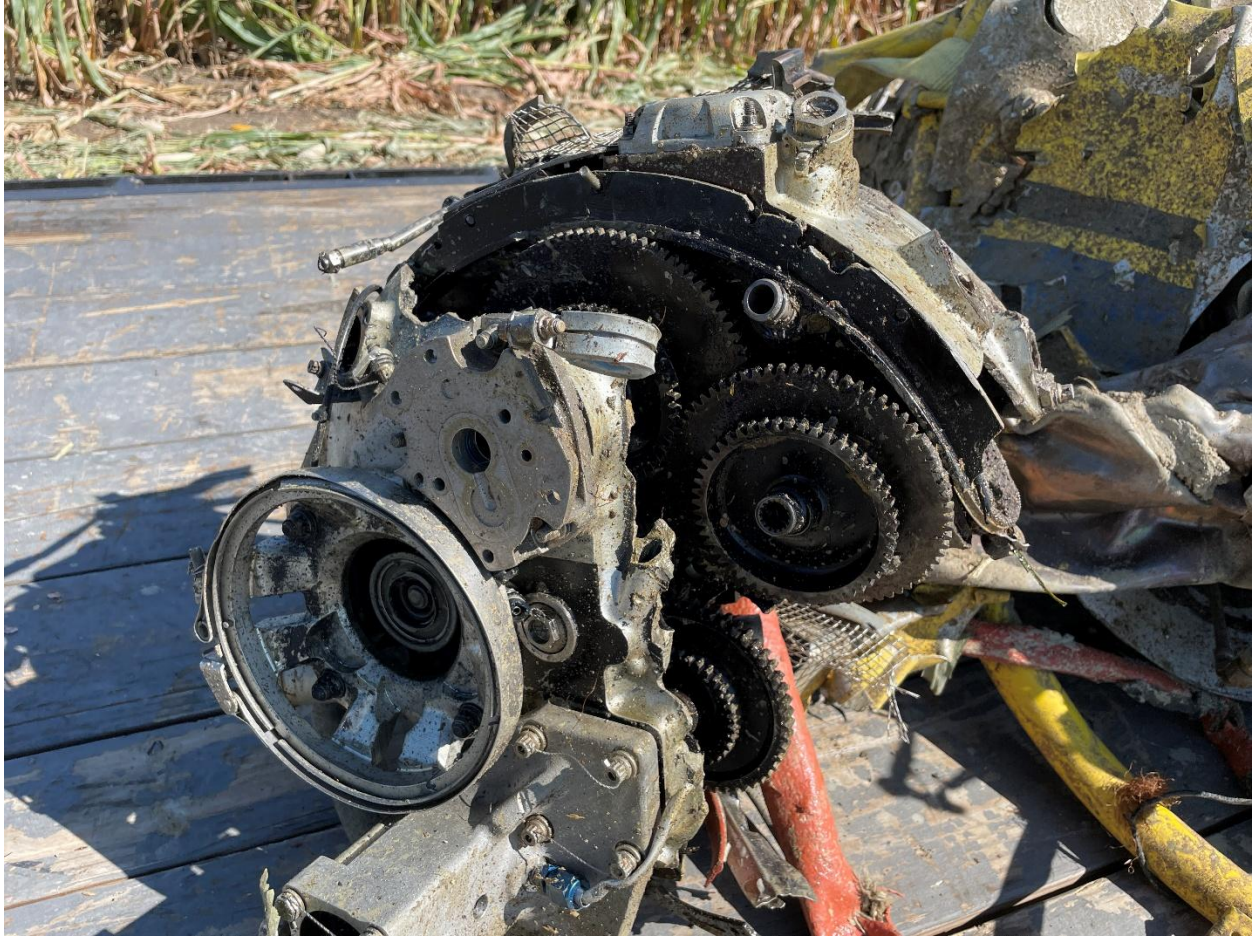
The engine was also separated at the inlet struts near the aft end of the engine. The accessory gearbox was found separated and heavily damaged with the internal gears easily visible, as shown in figure 9. The gearbox accessories such as the FCU/high pressure pump, starter/generator, oil and fuel pumps were separated from the accessory gearbox and were found in multiple places within the debris field between the initial impact location and the location of the accessory gearbox.

**Figure 9** - Engine accessory gearbox.

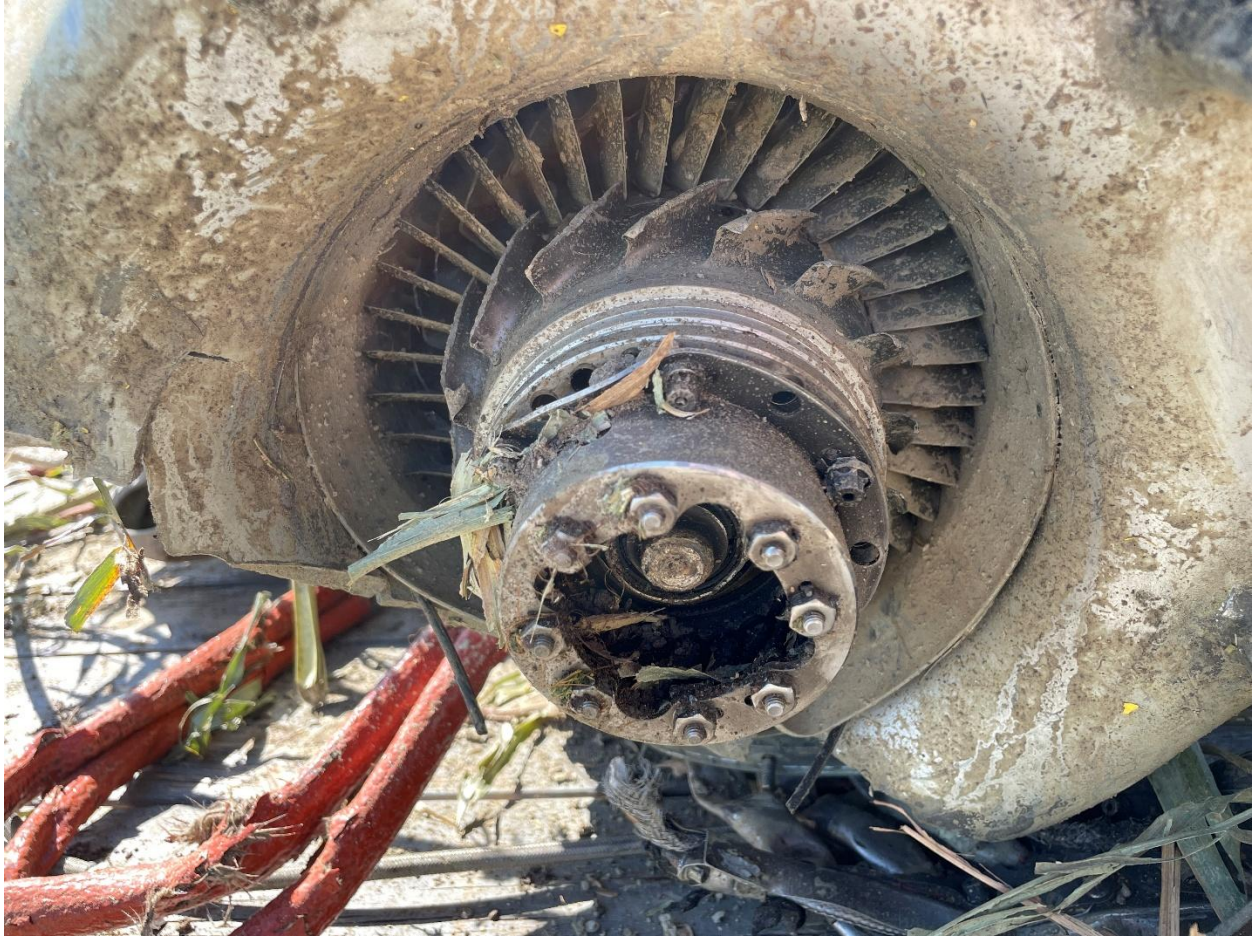
engine case. A view of the first stage compressor blades appeared to be consistent with operation under power at the time of the impact, as shown in figure 10.

**Figure 10** - Engine first stage compressor section.

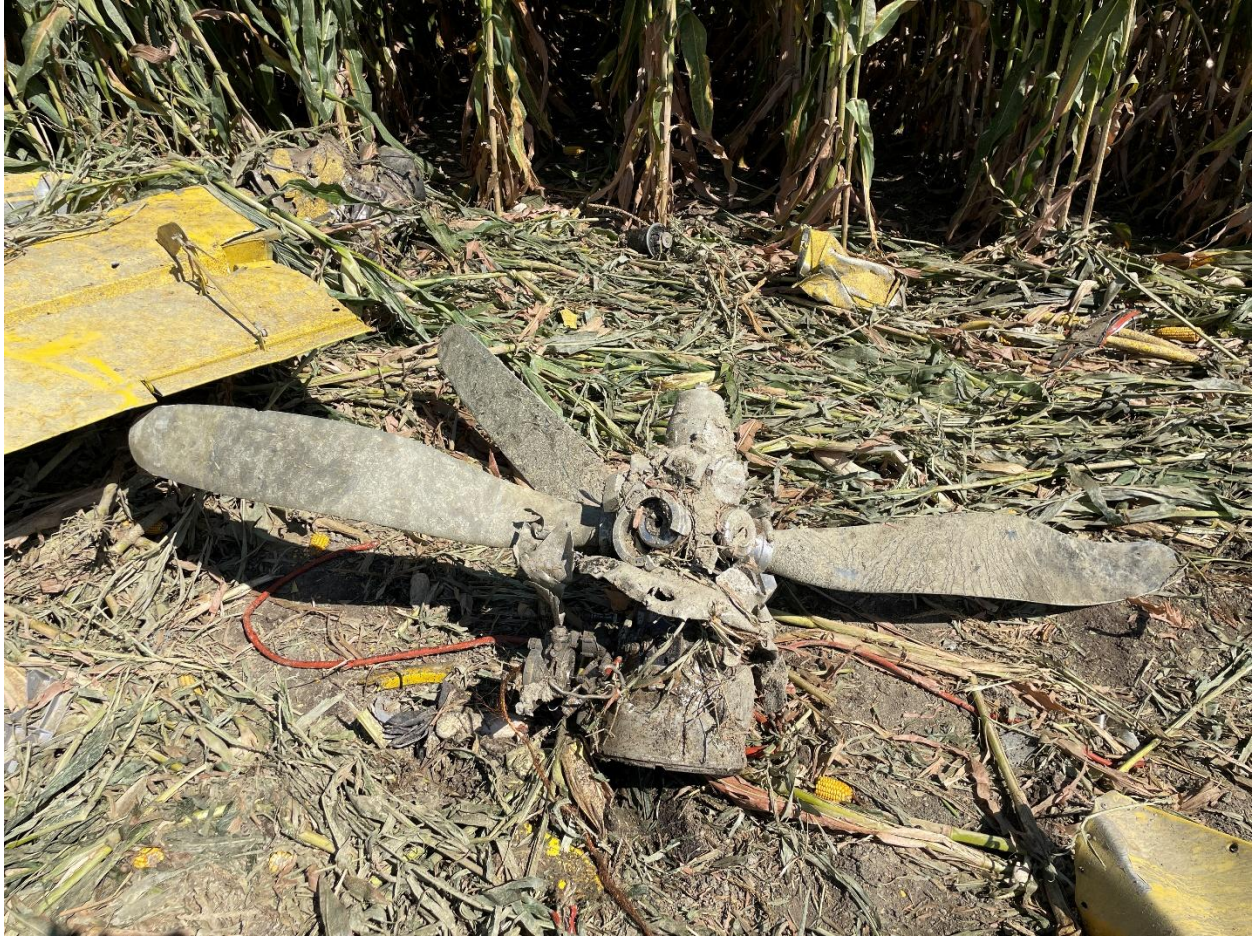
The propeller assembly remained attached to the engine reduction gearbox which separated from the engine during impact, as shown in figure 11. Two blades impact-separated from the propeller hub, but only one of the separated blades were found in the debris field. One of the three blades that remained attached to the assembly exhibited forward-bending in the thrust direction, twisted towards high pitch. Two of the three blades that remained attached to the hub assembly exhibited S-shaped bending. All recovered propeller blades exhibited varying degrees of chordwise/rotational scoring, burnishing, and leading-edge gouging, as shown in figures 12-14.

**Figure 11** - Propeller hub assembly with 3 blades at the accident site.

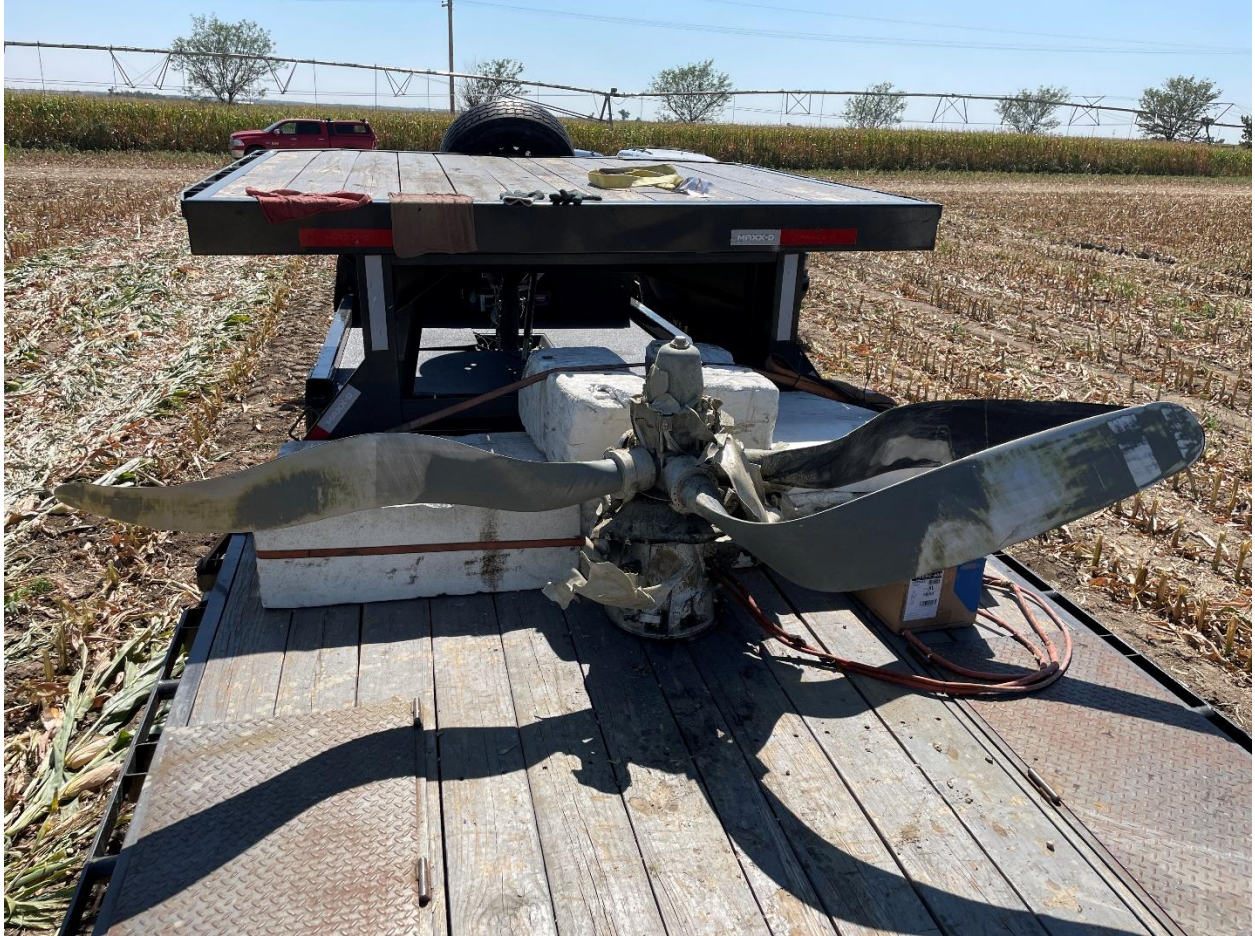
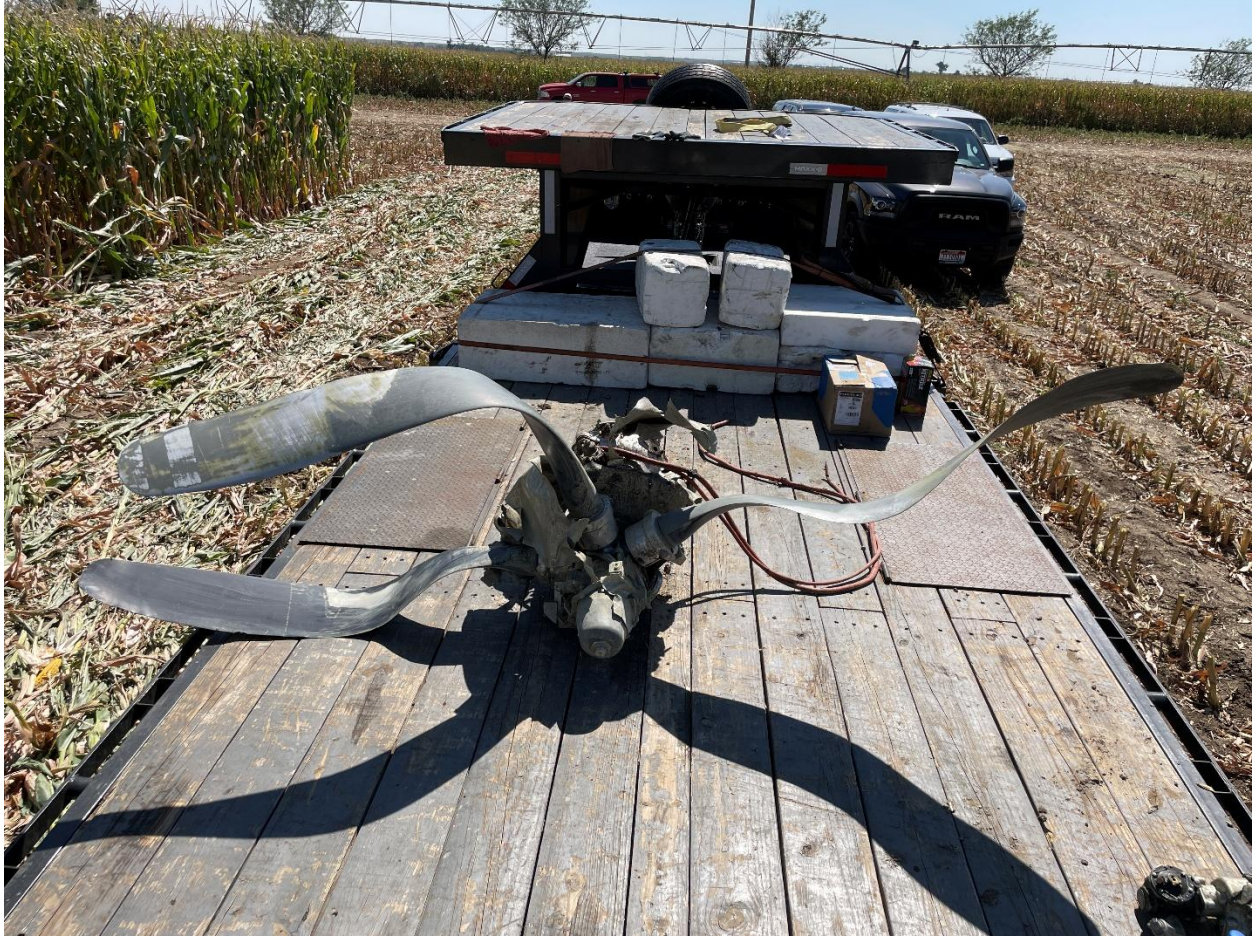
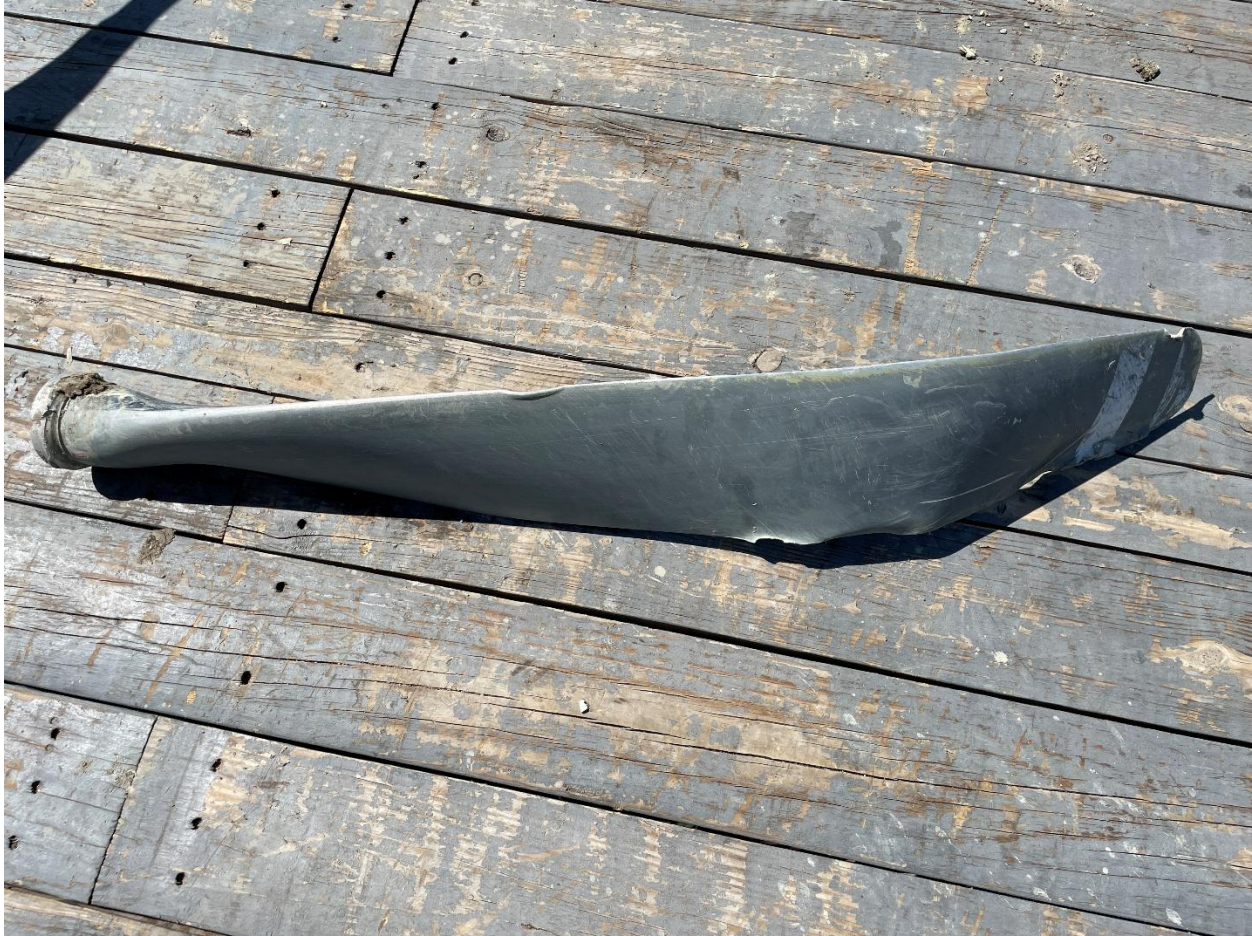
**Figure 12** - Propeller hub assembly with 3 blades after recovery.

**Figure 13** - Propeller hub assembly with 3 blades attached after recovery.

**Figure 14** - Propeller blade found separated from hub assembly.
