# National Transportation Safety Board

CEN24LA004

## EXAMINATION SUMMARY

Location: Hochatown, Oklahoma  
Date: October 1, 2023  
Time: 1230 central daylight time  
Airplane: Robinson Helicopter R44, N379SH

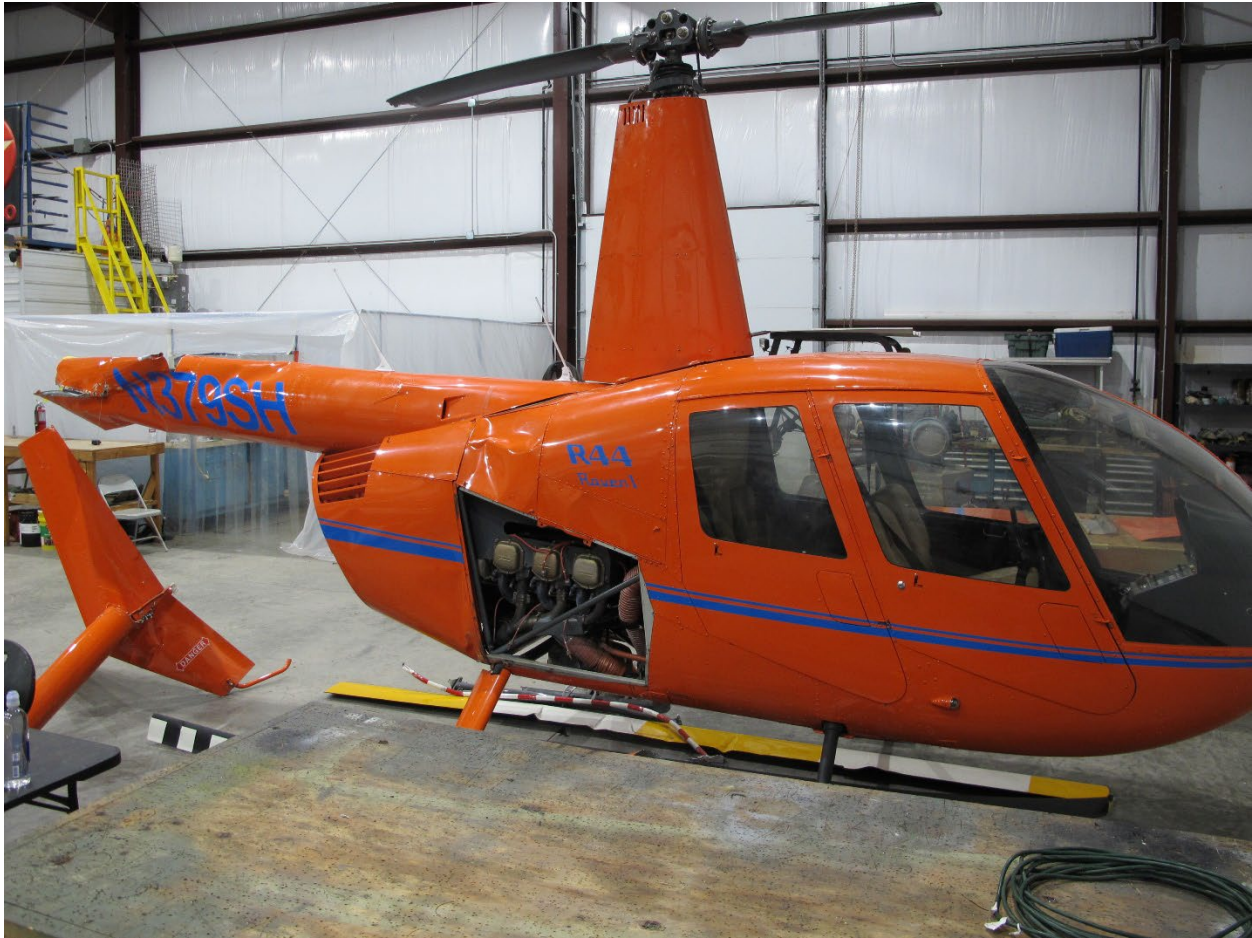
The engine was still within the air frame (Figure 1). The main rotor blades were still attached to the hub, but cut about 4 ft from the hub to facilitate transport. The main rotor blades showed some damage due to ground and tailcone contact. A bolt head from the tail rotor hub was embedded into the leading edge of one of the main rotor blades (Figure 2).

Figure 1: Helicopter and engine as presented for examination.

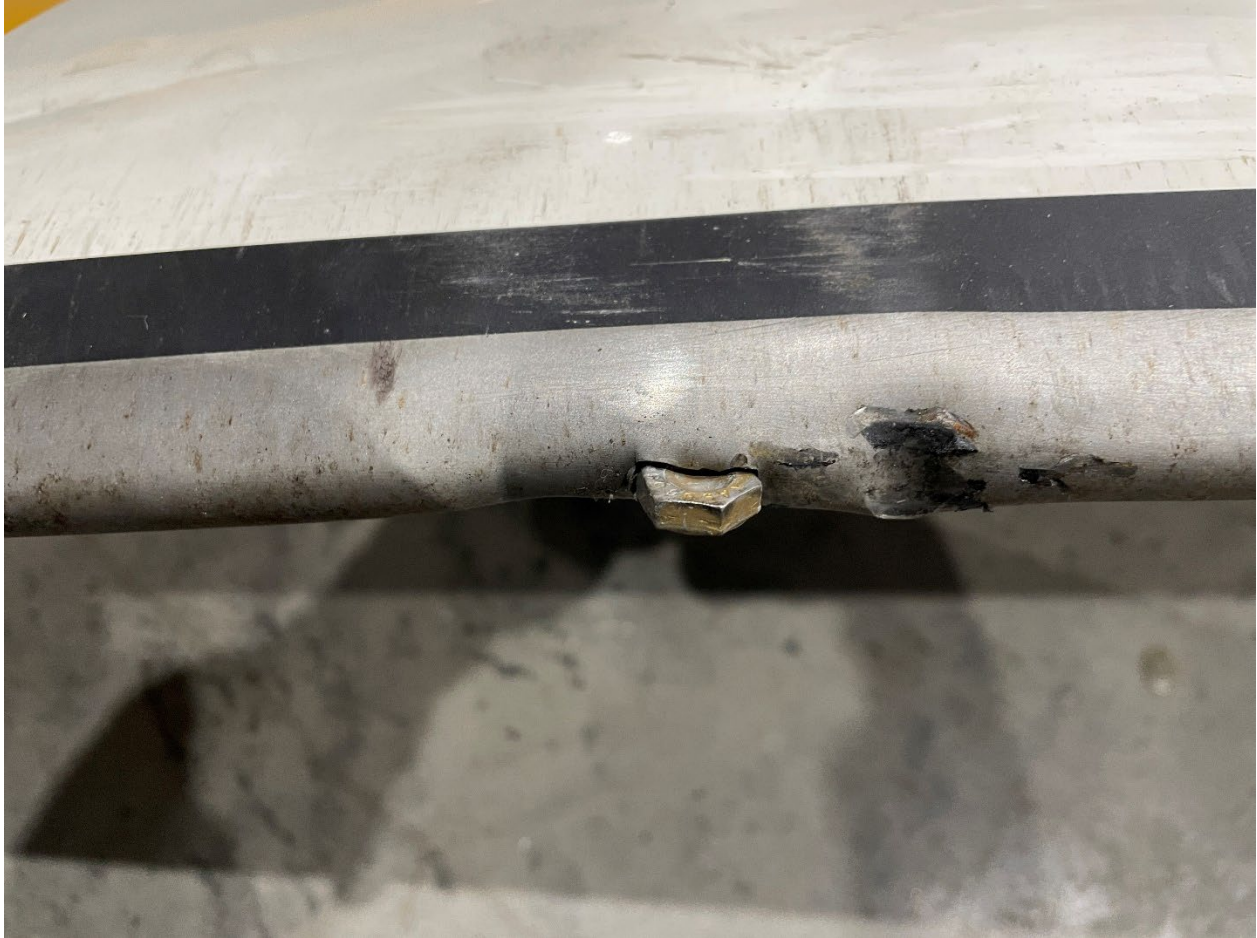
Figure 2: Bolt Head from tail rotor embedded in main rotor blade

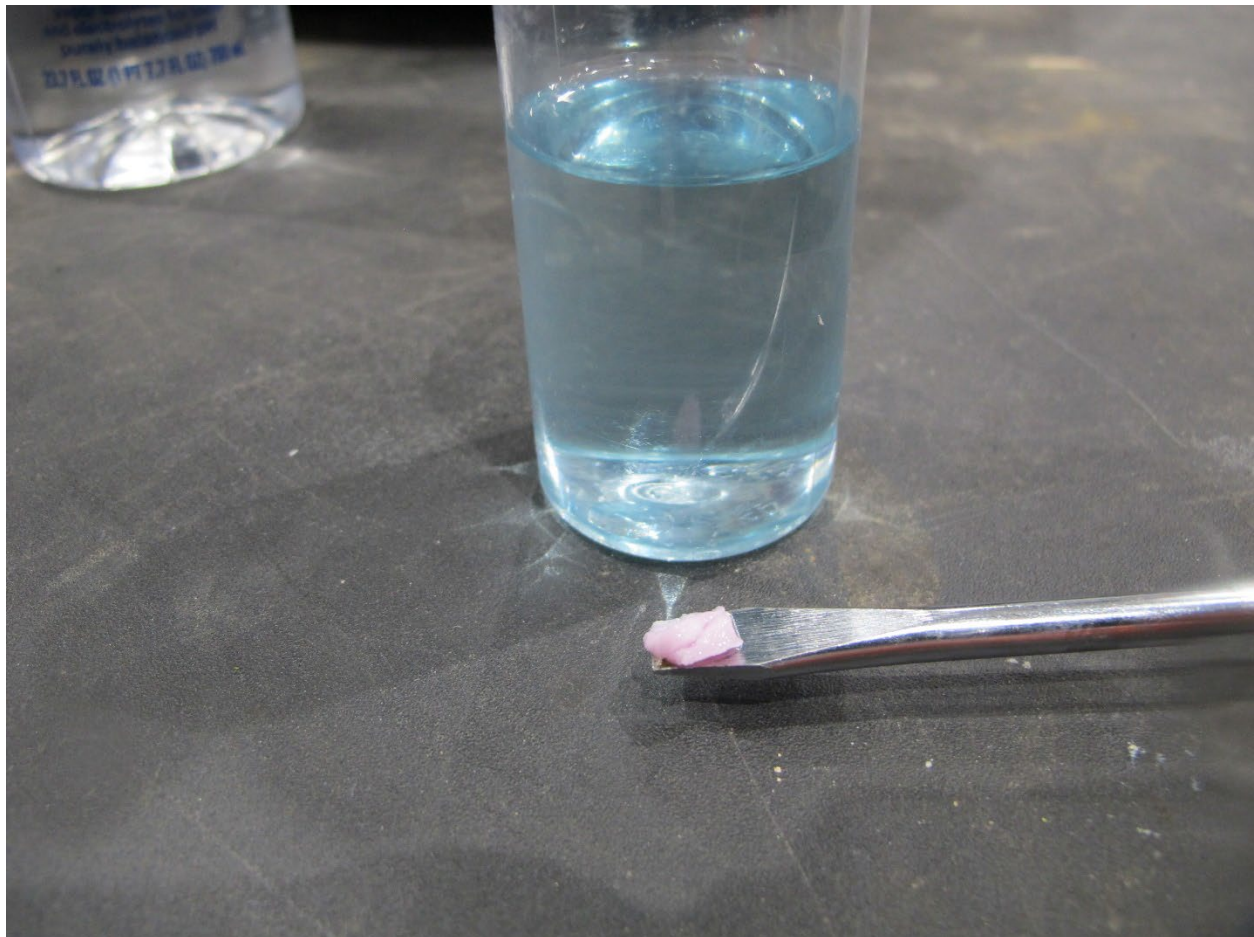
Fuel from gascolator and main tank was clean, clear, and free of water when checked with water finding paste (figures 4 and 5).

Figure 4: Fuel from gascolator

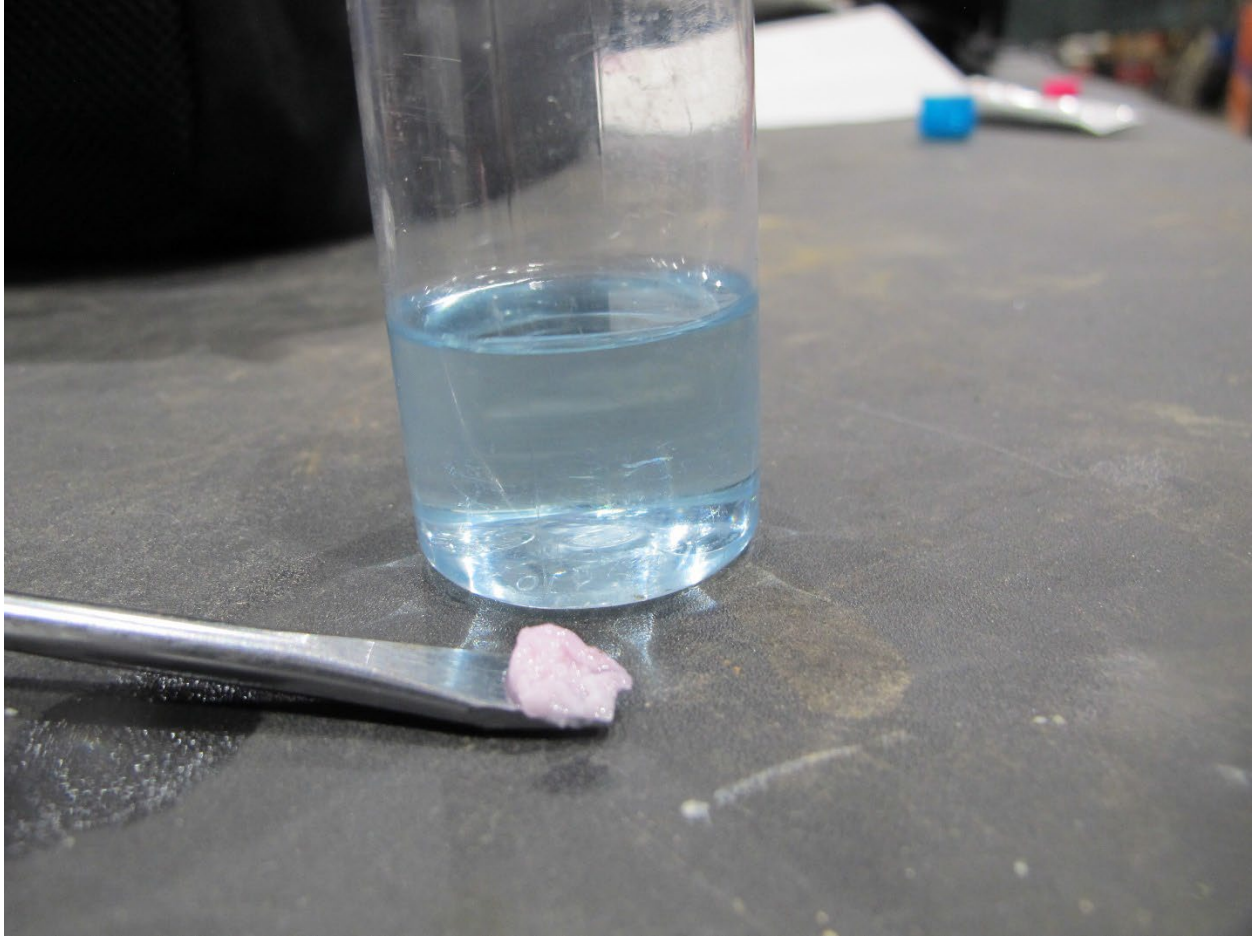
Figure 5: Fuel from the main tank.

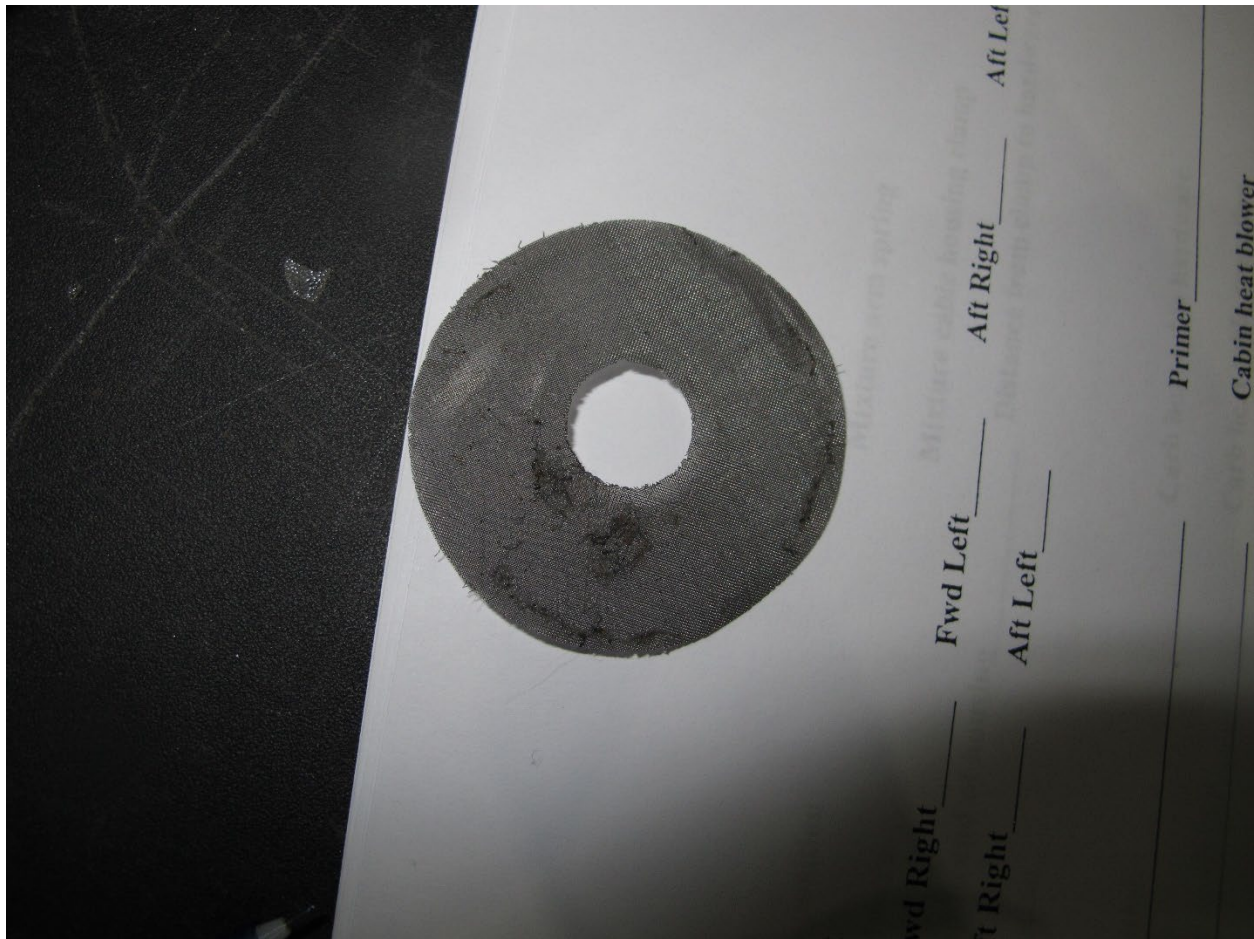
The gascolator screen was removed and found 5-10 percent of the screen was covered with a fibrous material (Figure 6).

Figure 6: Gascolator screen

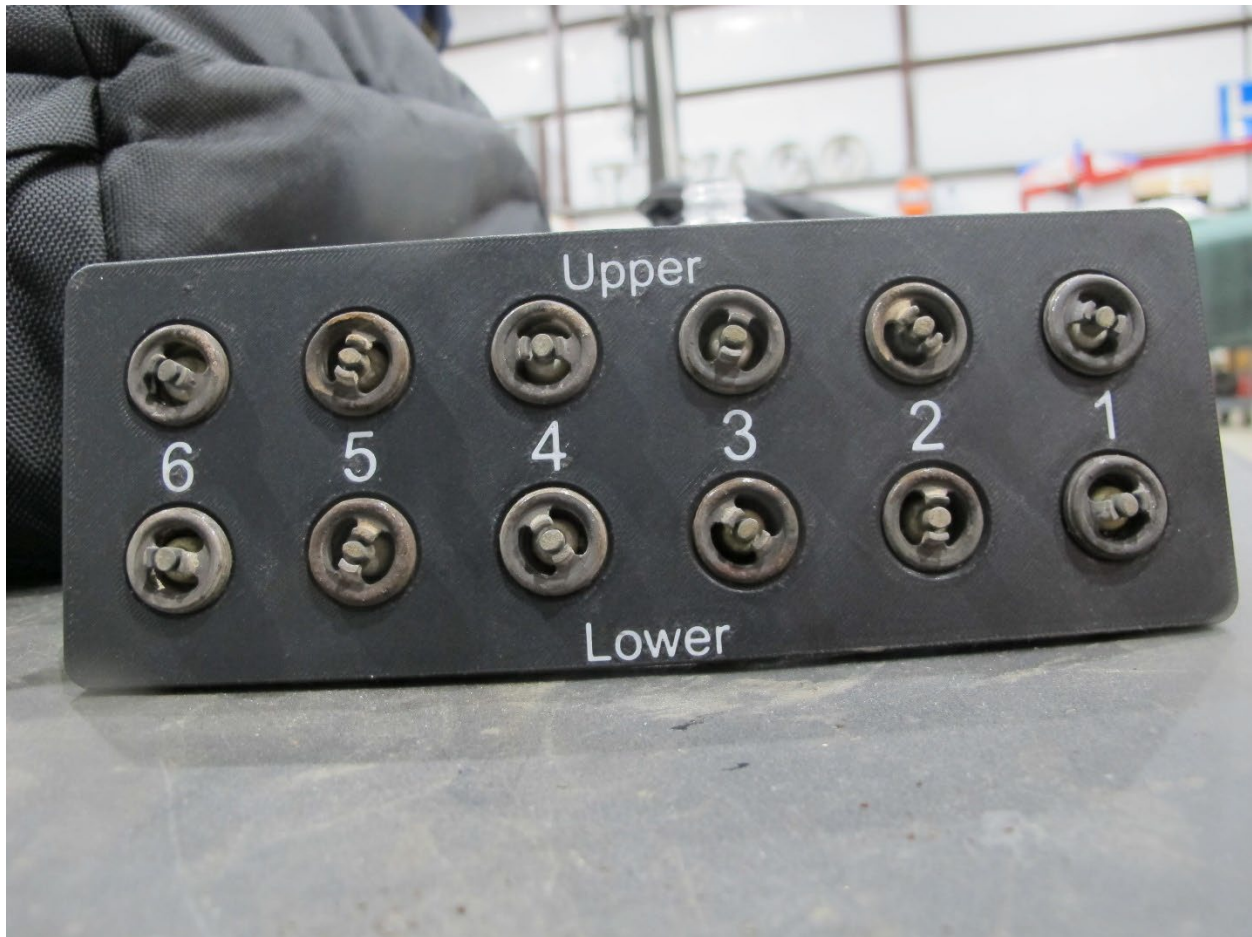
All spark plugs were removed. All spark plugs were consistent with normal wear and color when compared to Champion Check-a-Plug chart (Figure 7).

Figure 7: Spark plugs

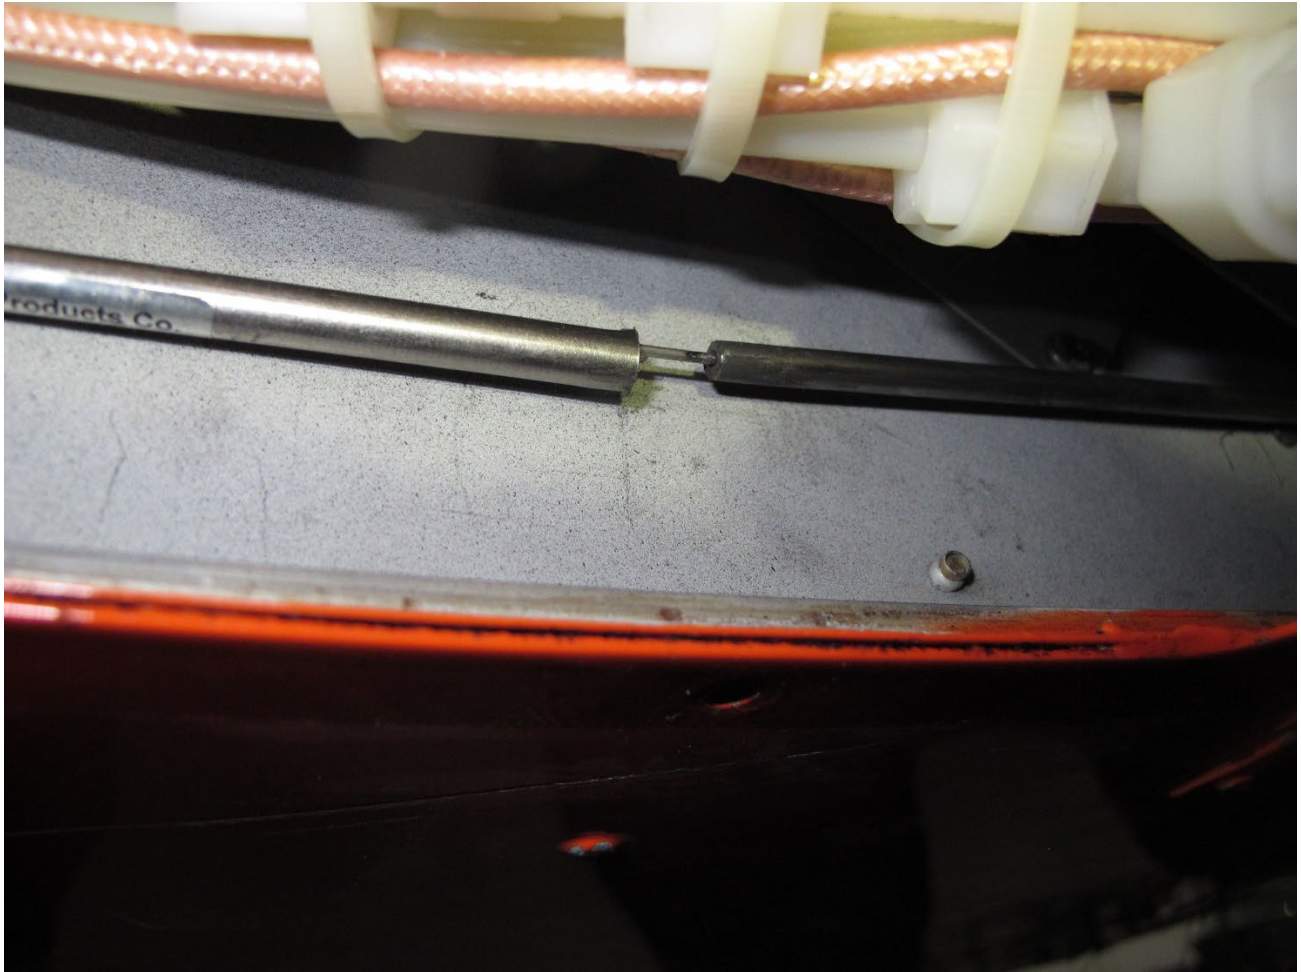
The mixture and throttle control cables moved freely stop to stop. The carburetor heat control knob was jammed in the full heat position. Further examination revealed improper rigging of the carburetor heat control cable (Figure 8). The rigging of the carburetor heat control cable caused binding when fully actuated.

Figure 8: Carburetor Heat control cable.
