# National Transportation Safety Board

CEN24LA011

## **MATERIALS LABORATORY**

Factual Report 24-038

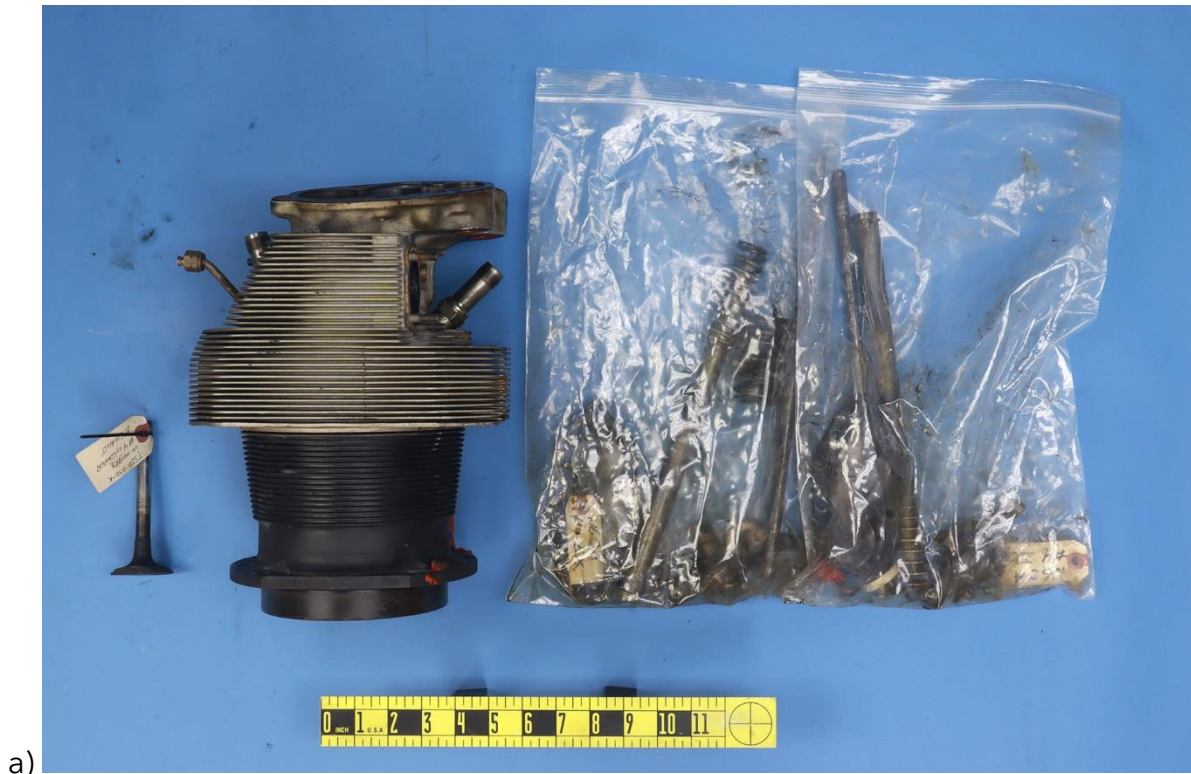
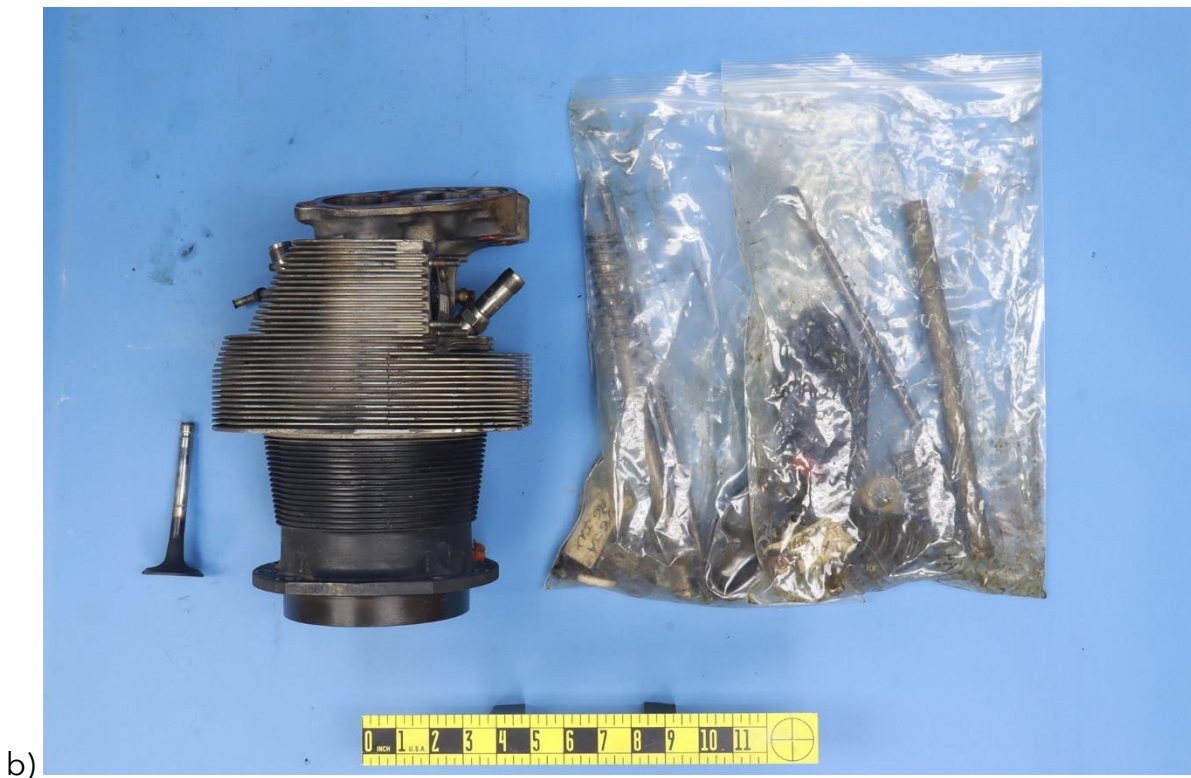
The numbers 4 and 6 cylinder assemblies from a Continental Motors TSIO-550-K1B aircraft engine were submitted to the NTSB Materials Laboratory for examination, as shown in figures 1a and 1b. The exhaust valves had been removed from the cylinders and the intake and exhaust valve train components up to but not including the tappets were also included. The number 4 exhaust valve head was fractured, and the number 6 exhaust valve had an asymmetric color pattern on its combustion face. The valve train components were examined and contained no notable features unless noted otherwise.

**Figure 1.** Exhaust valves and cylinder assemblies with intake and exhaust valve train components: a) number 4 and b) number 6.

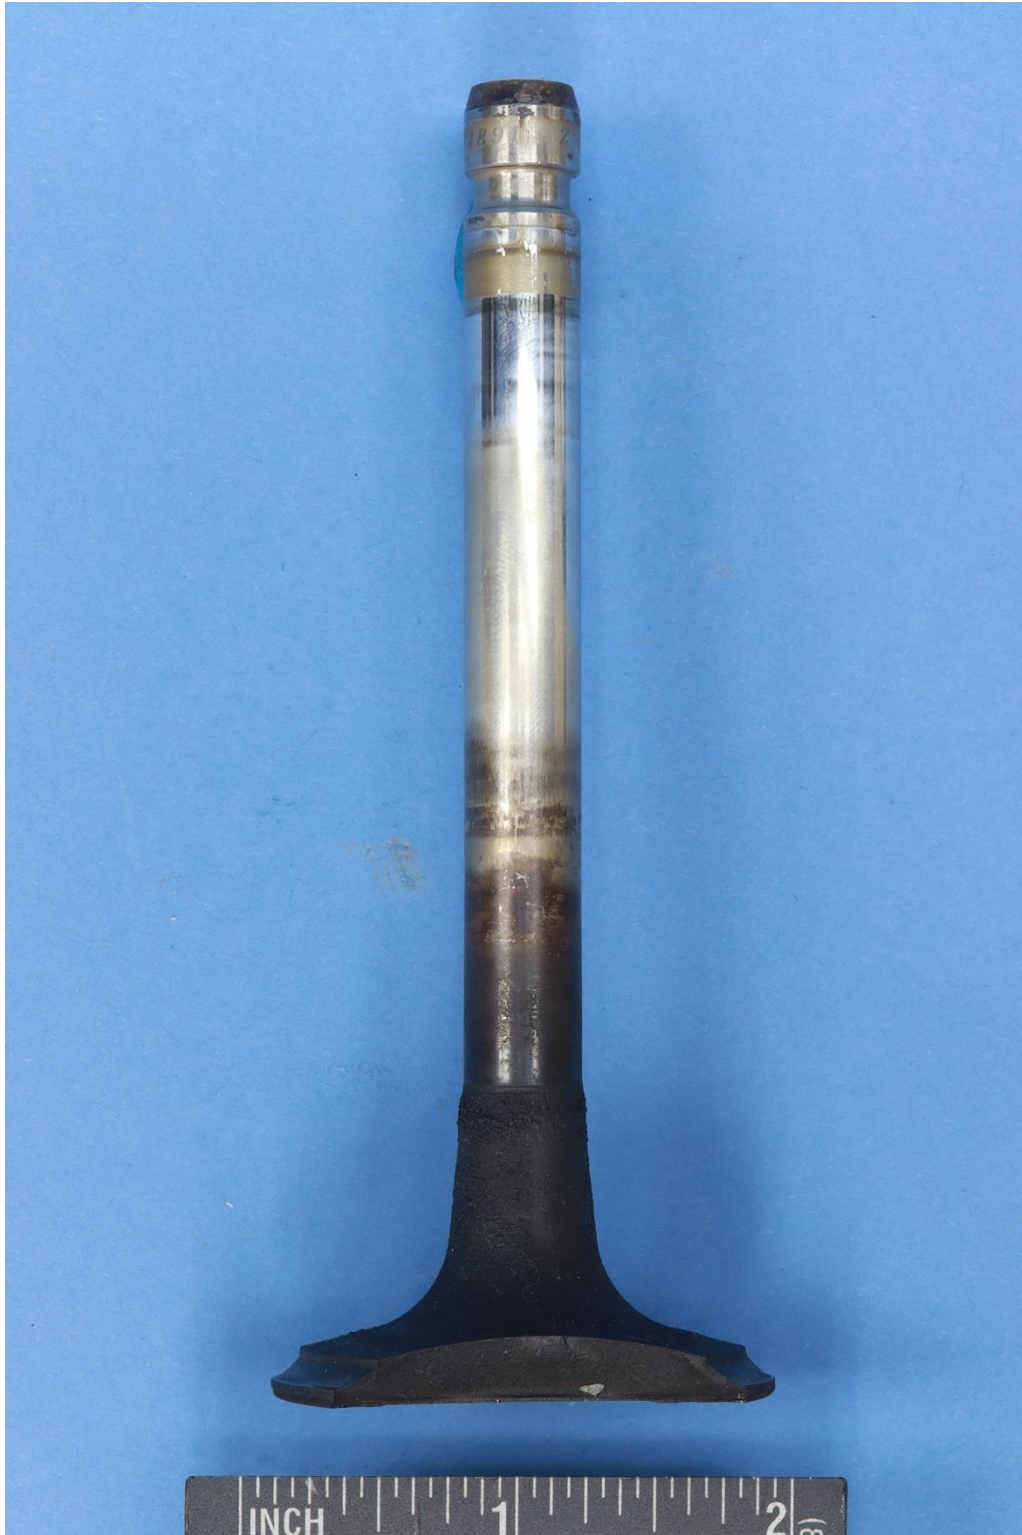
The number 4 exhaust valve head was fractured (figure 2a). The combustion face was covered with combustion products and some regions exhibited a red/purple tint (figure 2b). The fracture had initiated in the fillet on the downstream-facing side of the valve head and progressed through the head to the combustion face (figure 3a). The fracture was approximately 1.5 inch wide by 0.25 inch through the thickness of the head. Closer examination revealed a thumbnail-shaped fatigue crack at the origin that was 0.212 inch wide and 0.054 inch deep (figure 3b). The origin sustained some post-fracture impact damage, but there were no apparent pre-existing anomalies at the crack origin. The valve head's seat face was worn (figure 3a) and the valve head was dished/mushroomed. The valve stem displayed a buildup of combustion products below the region that engaged the valve guide (figure 4).

**Figure 2.** Number 4 exhaust valve: a) stem and fractured valve head and

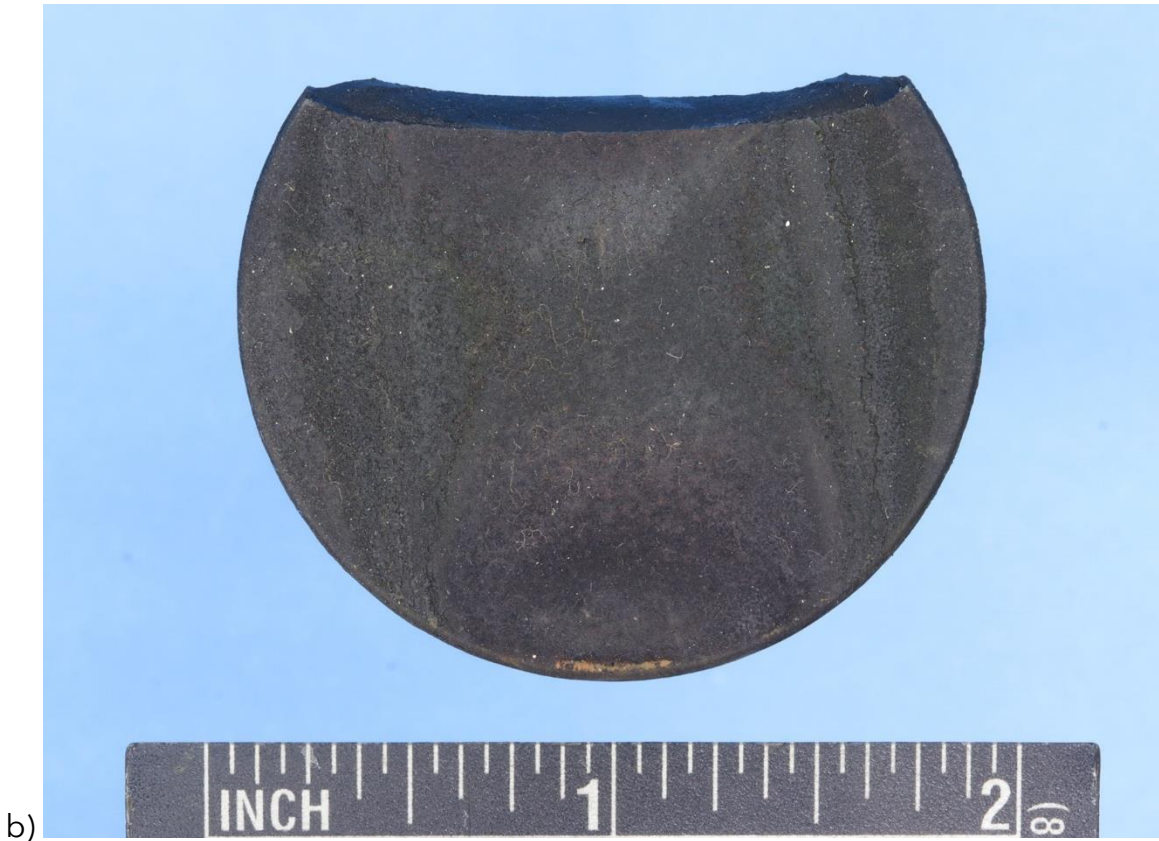
**Figure 2 (cont.).** b) Image of combustion face.

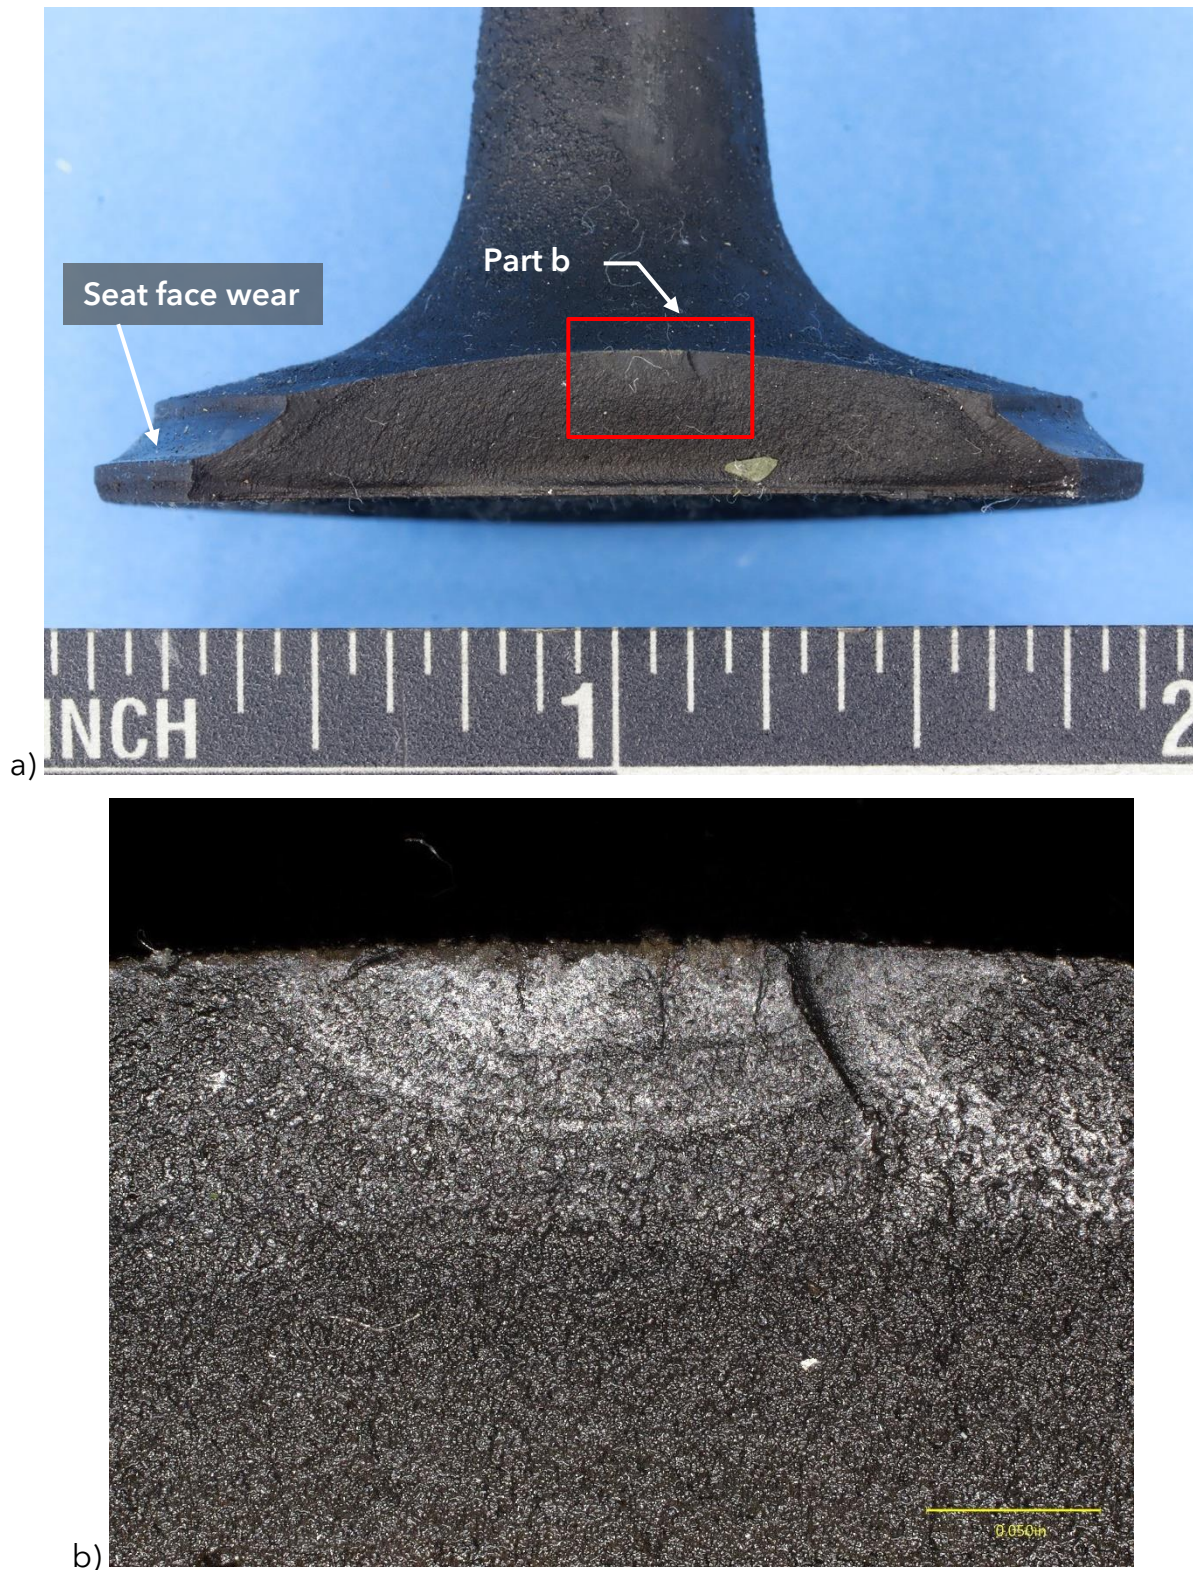
**Figure 3.** Images of number 4 valve fracture: a) fractured valve head with origin on fillet-side of head and valve seat wear and b) thumbnail-shaped fatigue crack near the transition radius between the stem and the head. The crack was 0.212 inch wide and 0.054 inch deep.

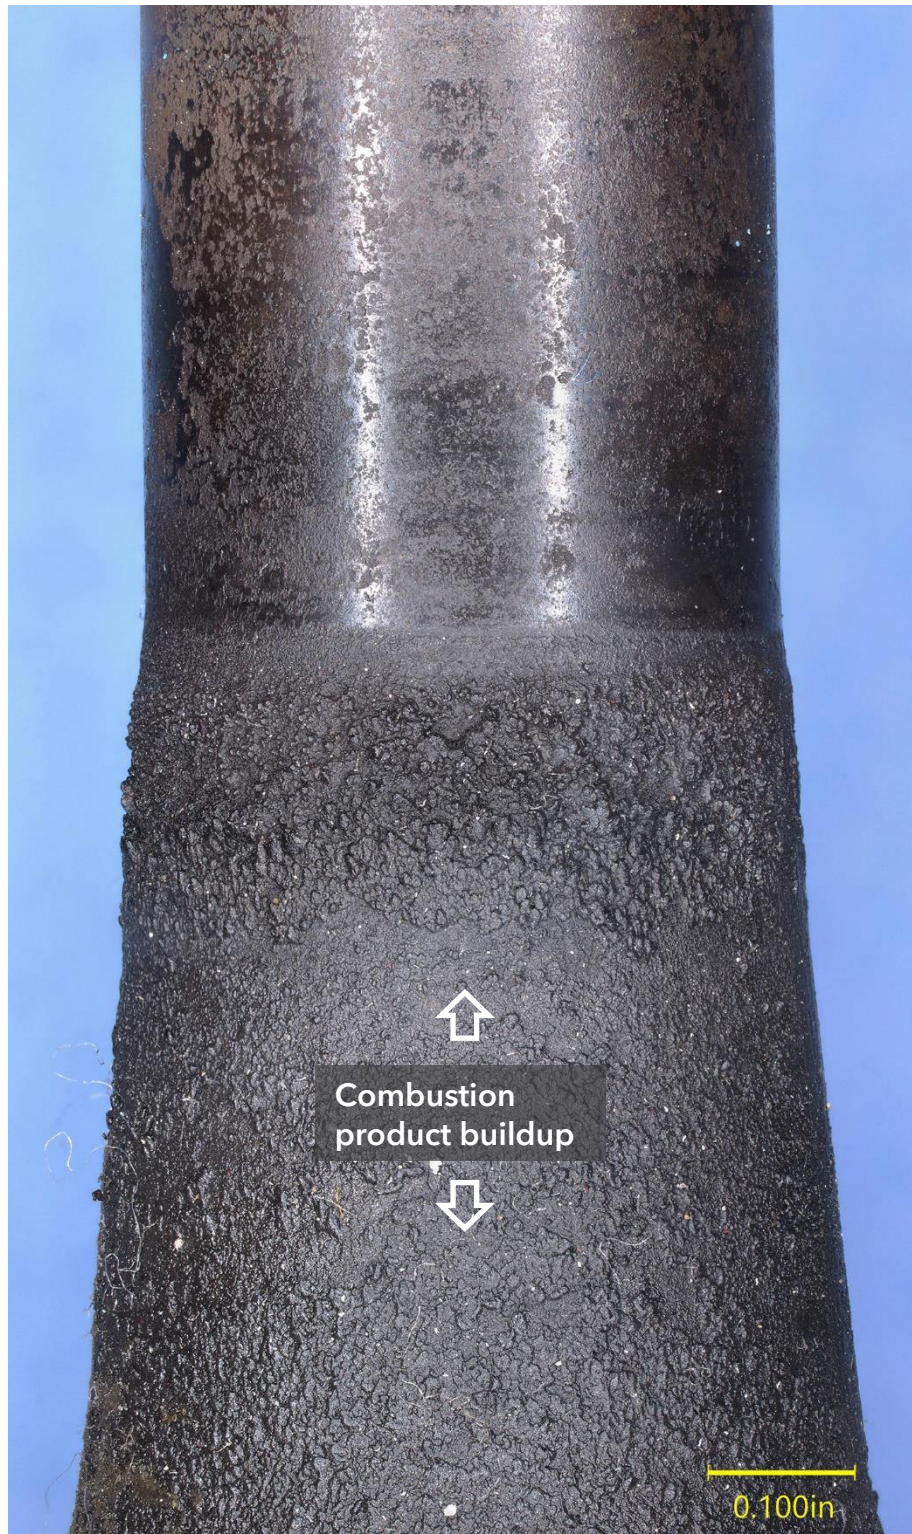
**Figure 4.** Buildup of combustion products on the number 4 exhaust valve stem outside the area that engaged the valve guide.

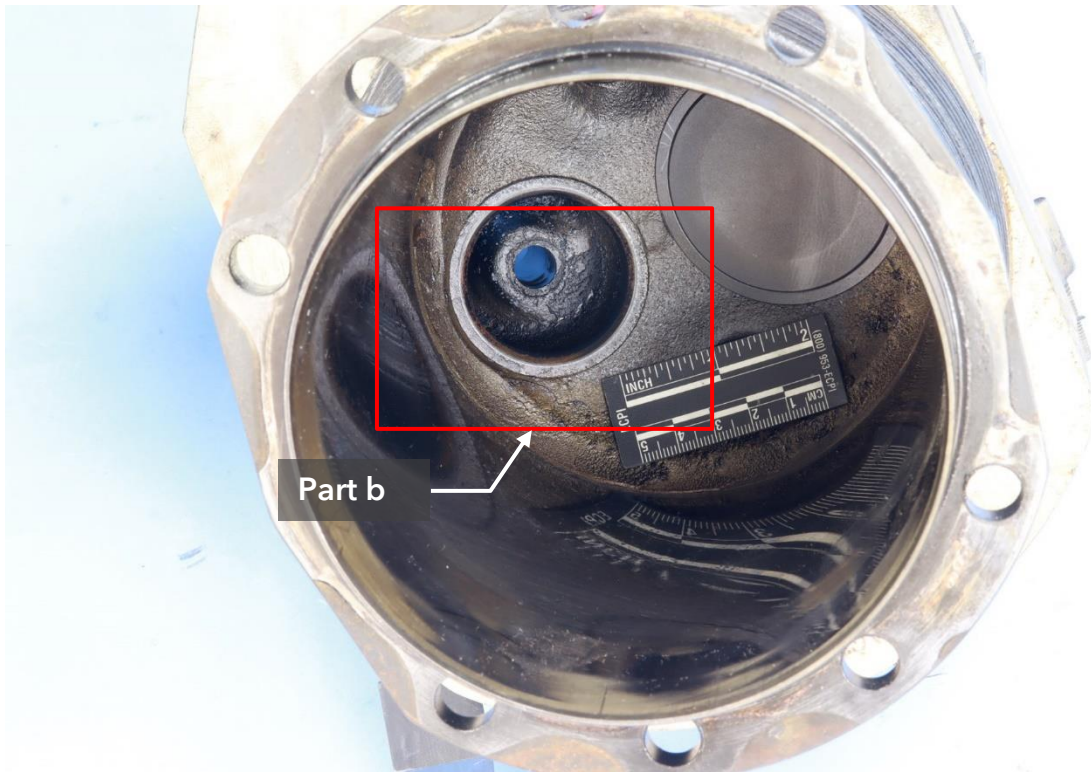
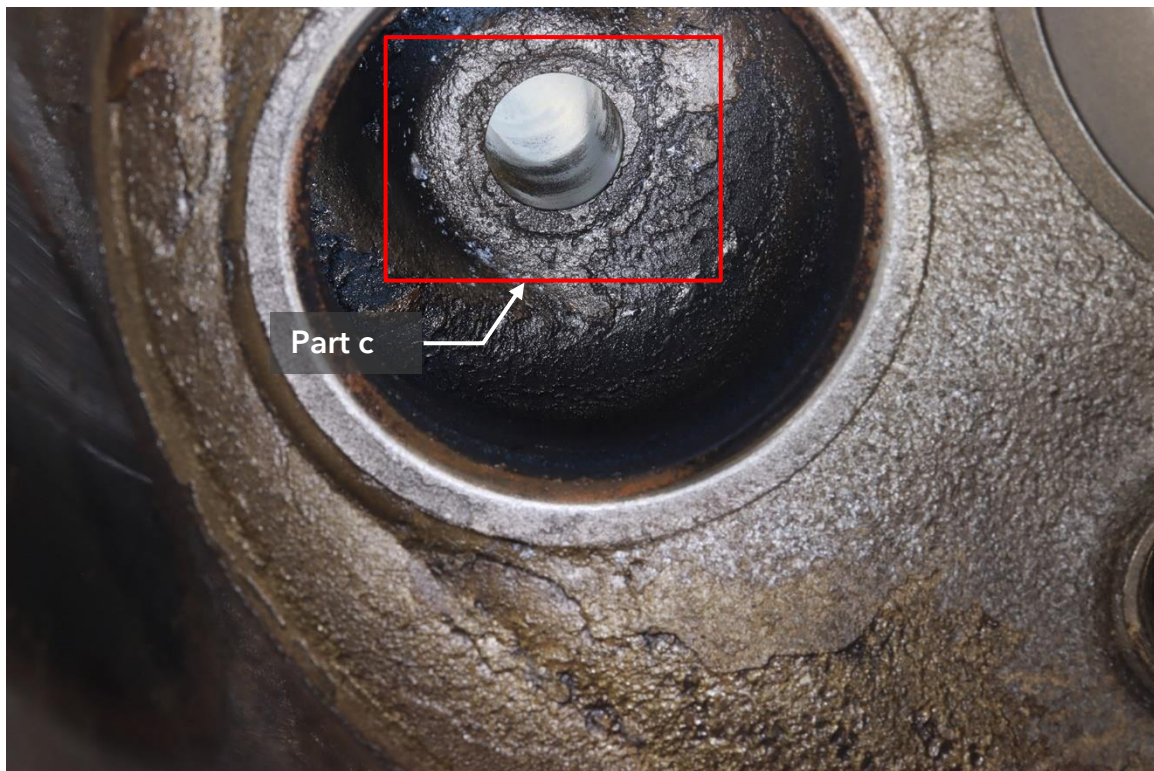
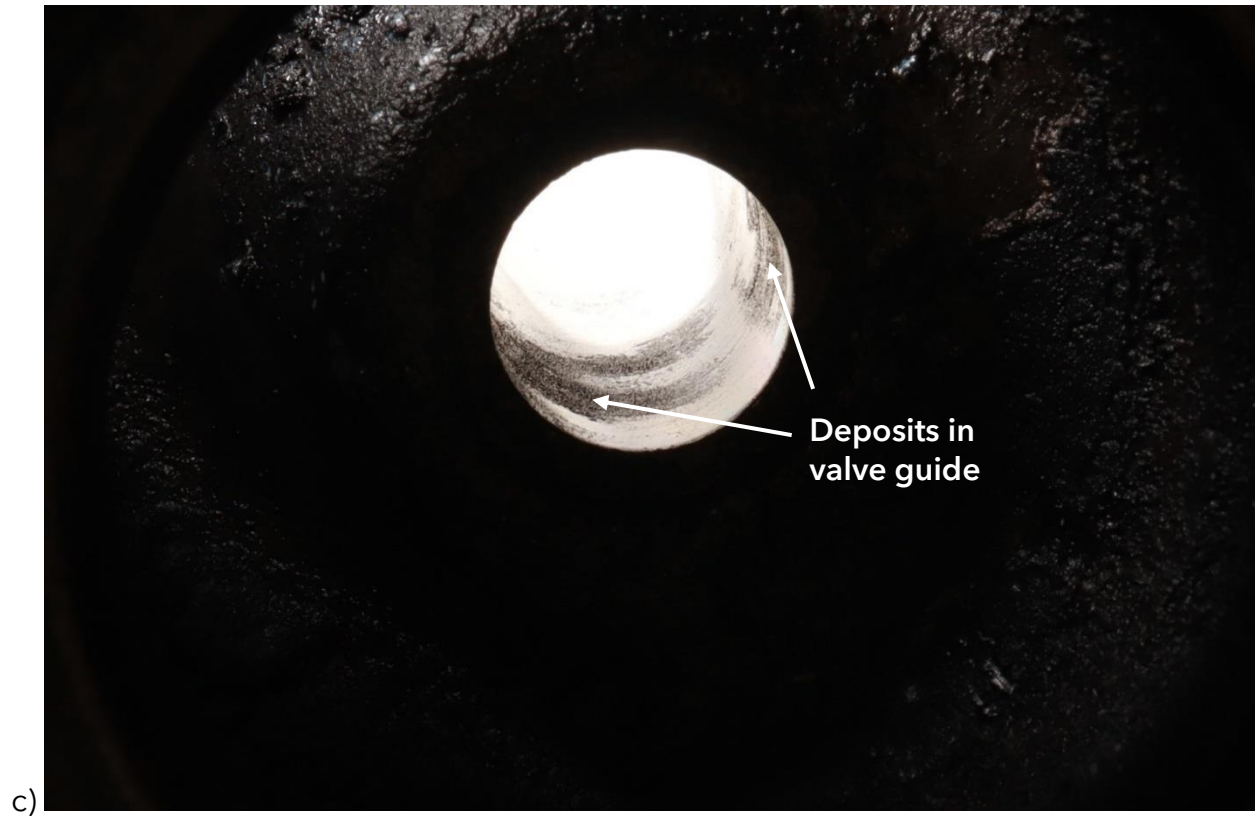
Combustion products were also observed on the inner surface of the valve guide (figures 5a - c).

Neither valve met the minimum service limits for stem diameter or diametrical clearance. The stem diameters on both exhaust valves were below the minimum service limit of 0.4330 inch between 1.5 inch and 3.0 inch above the valve head. The valve-in-guide diametrical clearance for the number 4 exhaust valve ranged from a high of 0.0189 inch in the middle third to a low of 0.0041 inch at the upper opening. For the number 6 exhaust valve, the values for the same locations ranged from 0.0190 inch to 0.0039 inch. The valve-in-guide service limit was 0.0062 inch.

**Figure 5.** Number 4 cylinder combustion chamber showing condition of valve guide: a) image of chamber with region indicated for part b; b) closer image of valve seat and valve guide with region indicated for part c; and

**Figure 5 (cont.).** c) backlit image of exhaust valve guide. Arrows indicate the locations of deposits on the barrel of the guide.

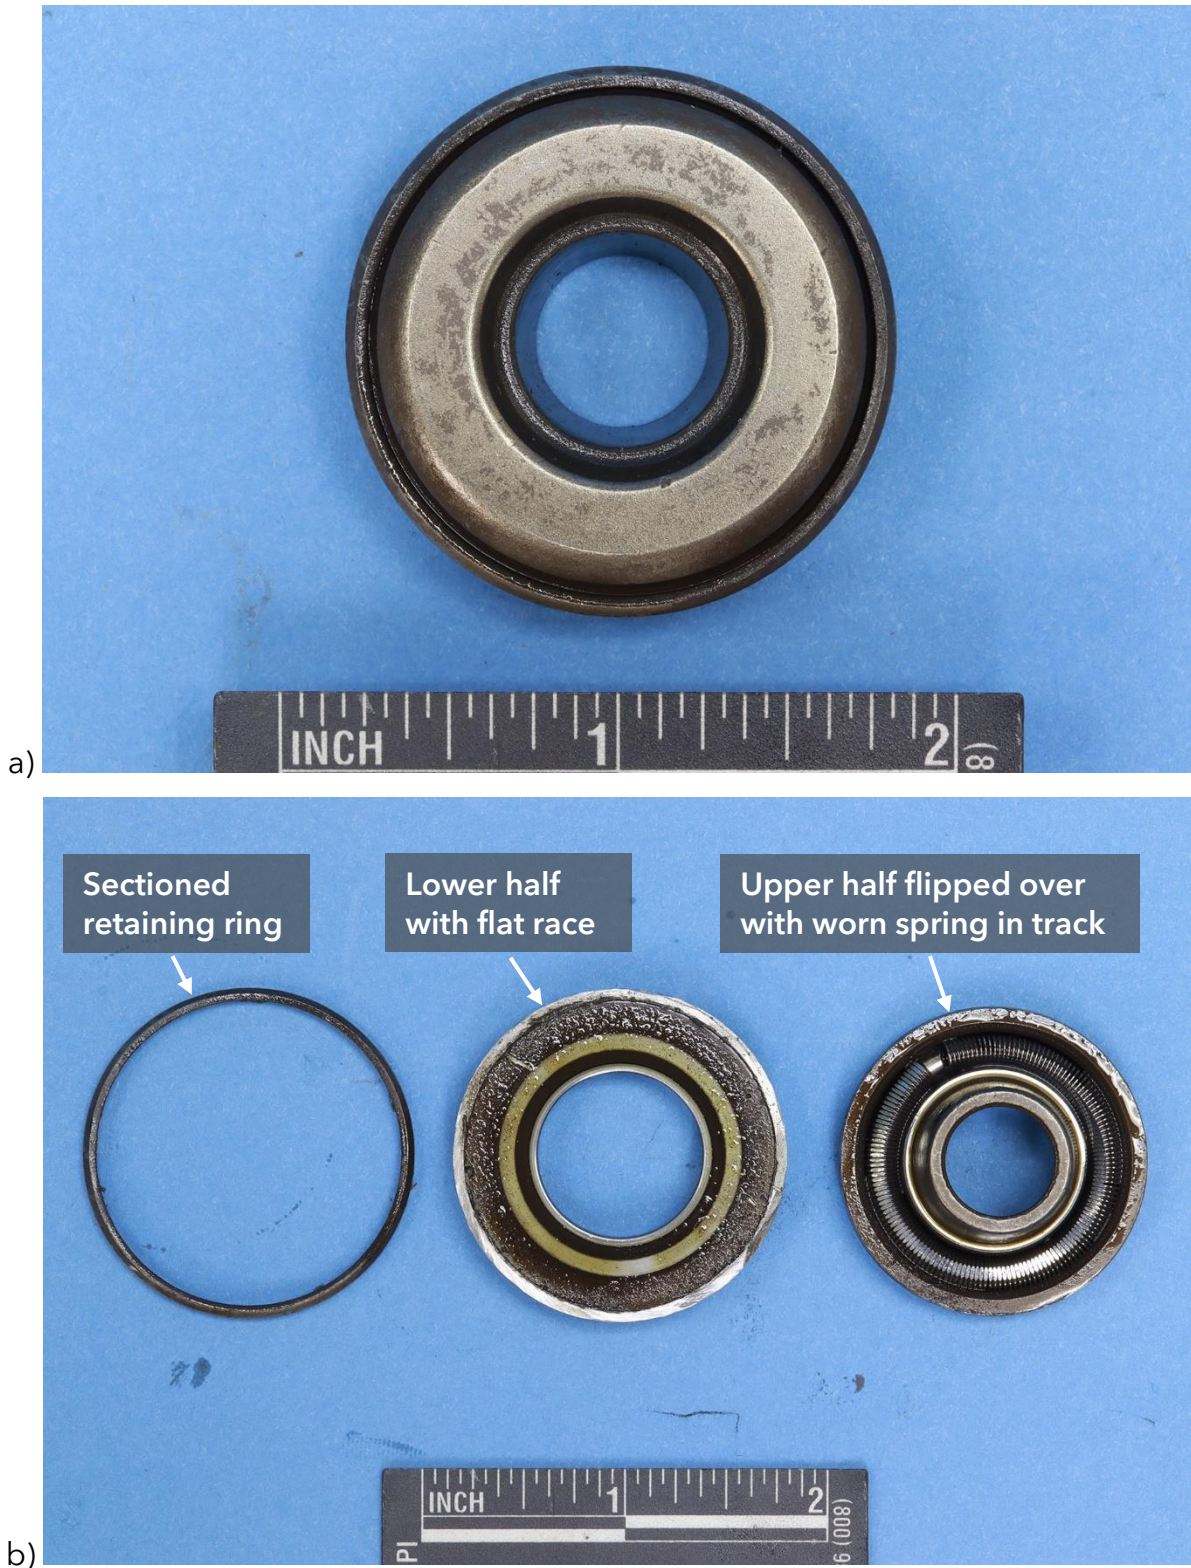
The number 4 exhaust rotocoil was worn. The rotocoil (figure 6a) was disassembled using a rotary cutting tool and the top and bottom halves were separated (figure 6b). The lower half contained a flat washer that served as a flat race for the spring to ride against. The race was covered in cooked oil except for a 0.080-inch wide annular track that the spring contacted (figure 6c). The spring was worn flat on the side that contacted the washer (figure 6d).

**Figure 6.** Number 4 exhaust valve rotocoil: a) As received before disassembly; b) post disassembly;

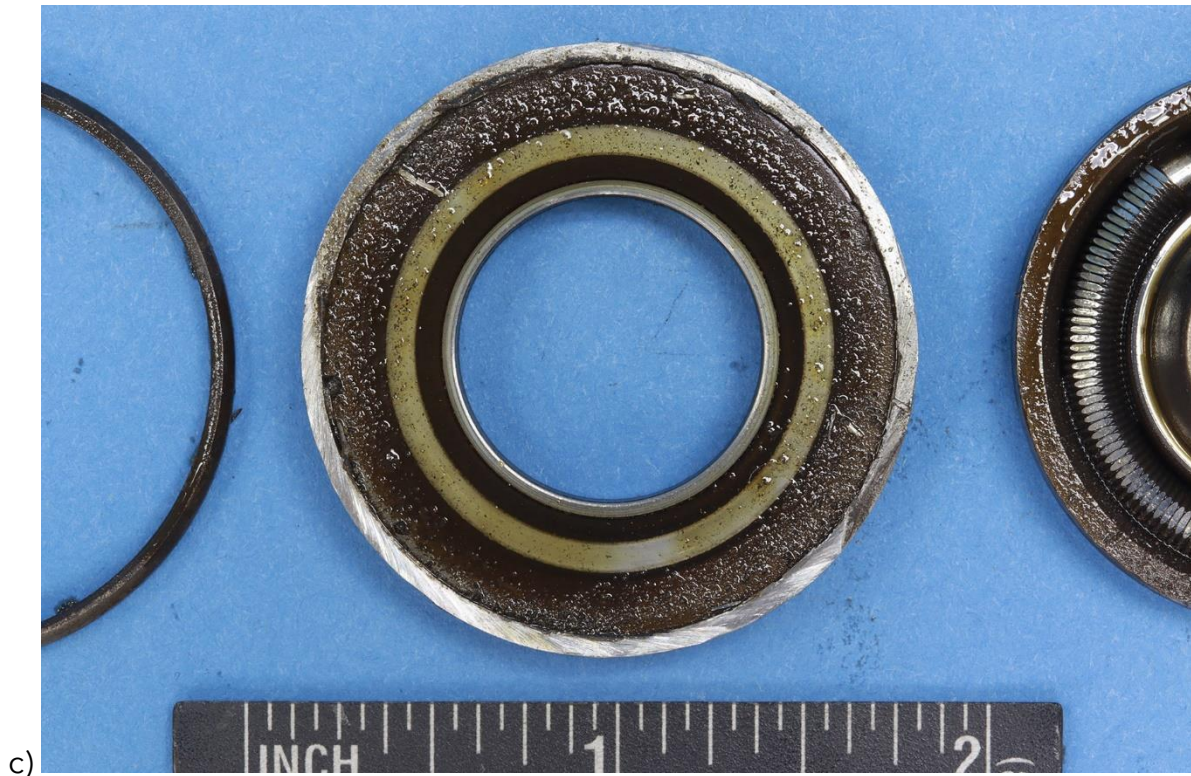
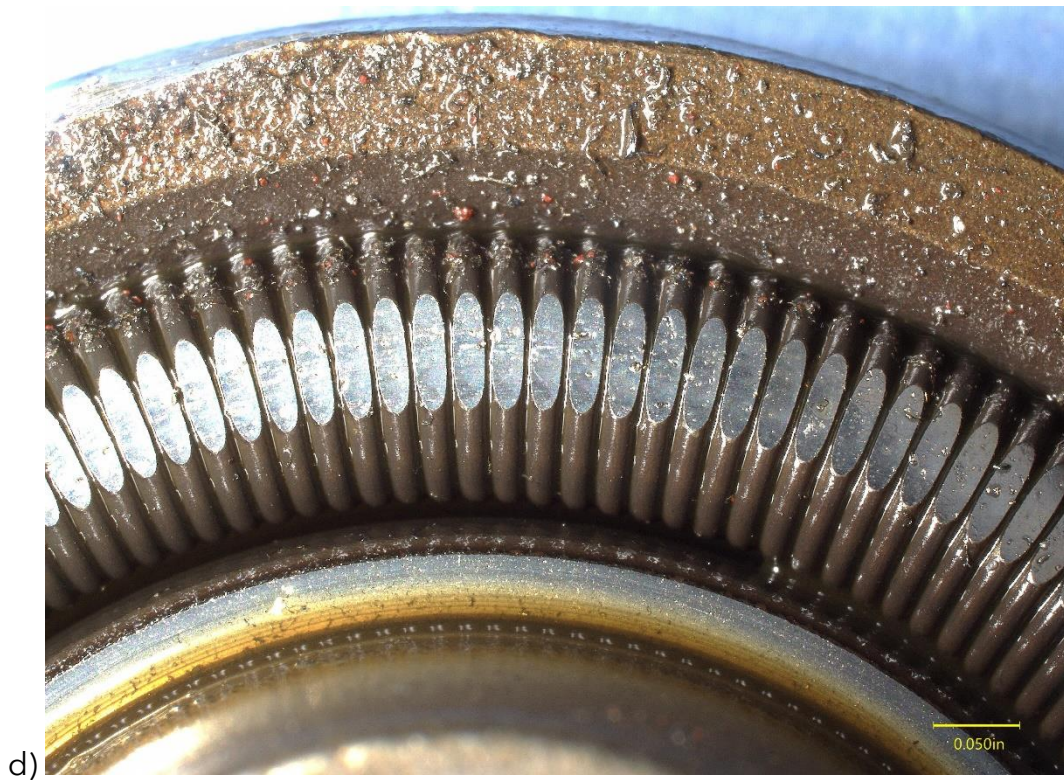
**Figure 6 (cont.).** c) spring washer showing the spring's flat race; and d) spring sitting in annular channel showing wear of the spring surface that was in contact with the flat washer.

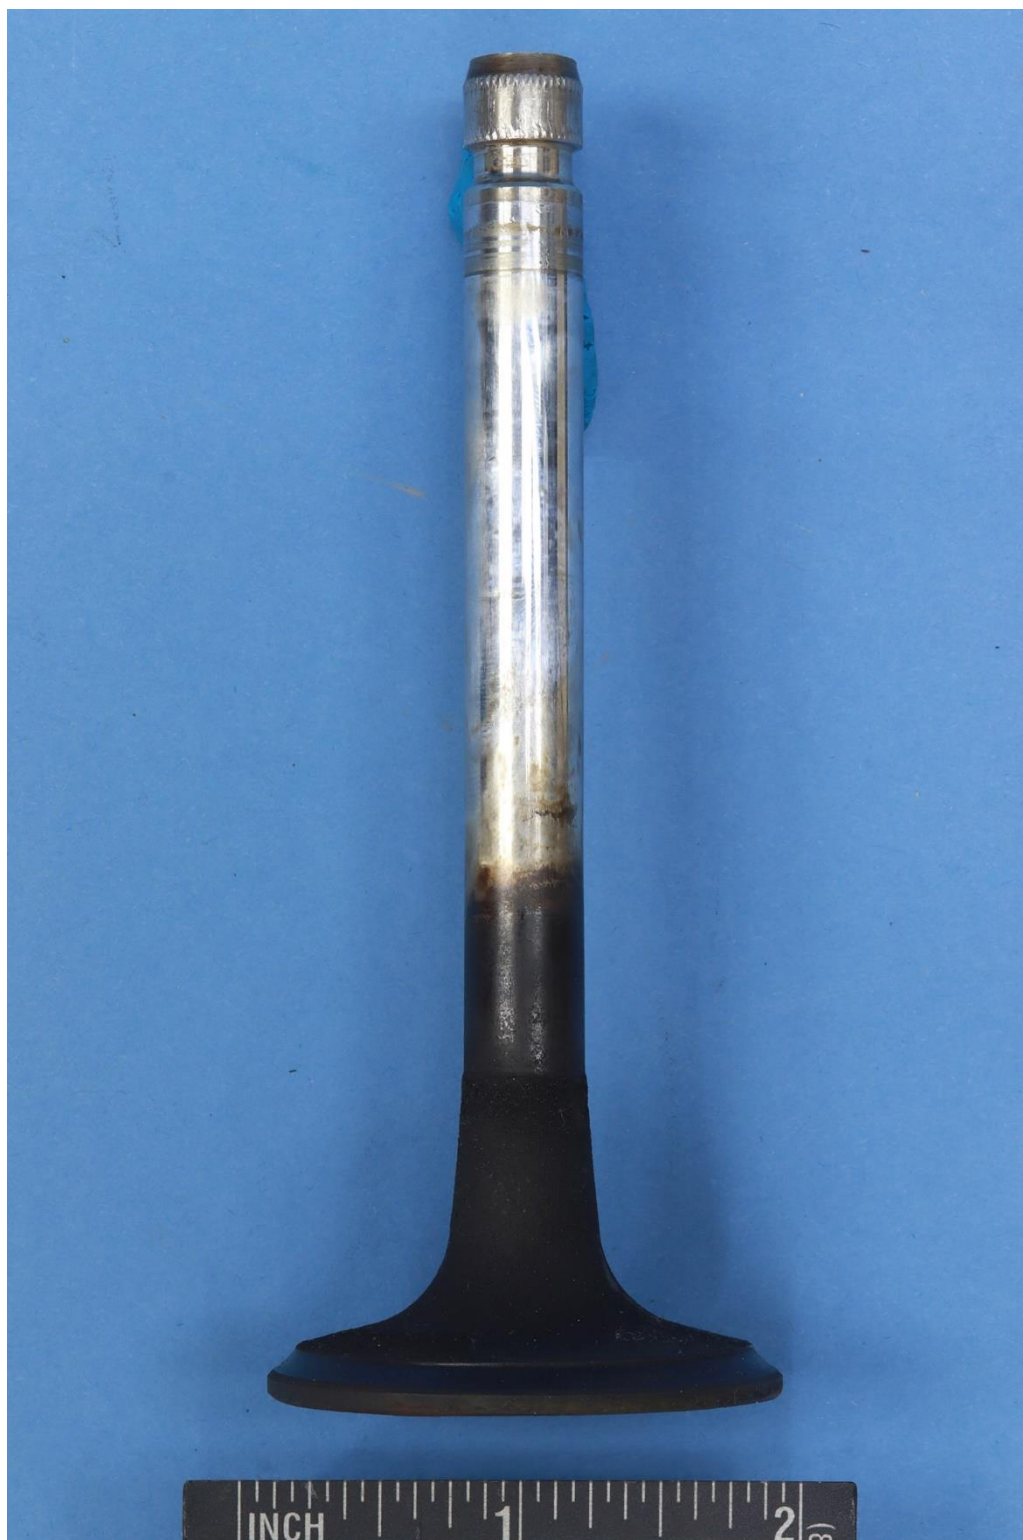
The number 6 exhaust valve is shown in figure 7a. The valve head combustion face exhibited an asymmetric burn pattern (figure 7b). As shown in the figure, the 12 and 6 o'clock positions had a slight green tint while the center, 9 o'clock, and 3 o'clock positions had a red color. The combustion face was covered with exhaust deposits except at the 12 o'clock position. At the same clock position, the valve head's margin showed signs of incipient erosion (figure 7c). Just as with the number 4 exhaust valve, the valve head's seat face was worn (figure 7c) and the head was dished/mushroomed (figure 7d). The valve stem displayed a buildup of combustion products below the region that engaged the valve guide (figure 8). Combustion products were also observed on the inner surface of the valve guide (figures 9a - c).

**Figure 7.** Images of number 6 exhaust valve: a) overall image;

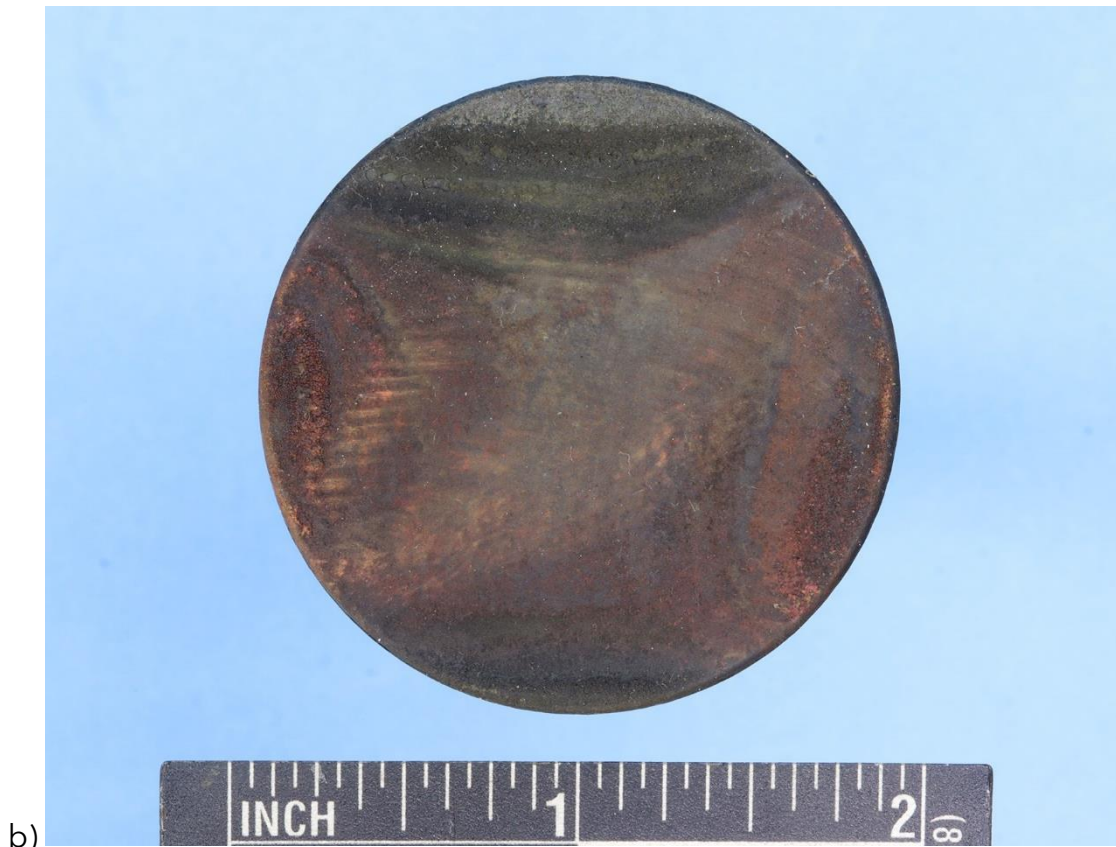
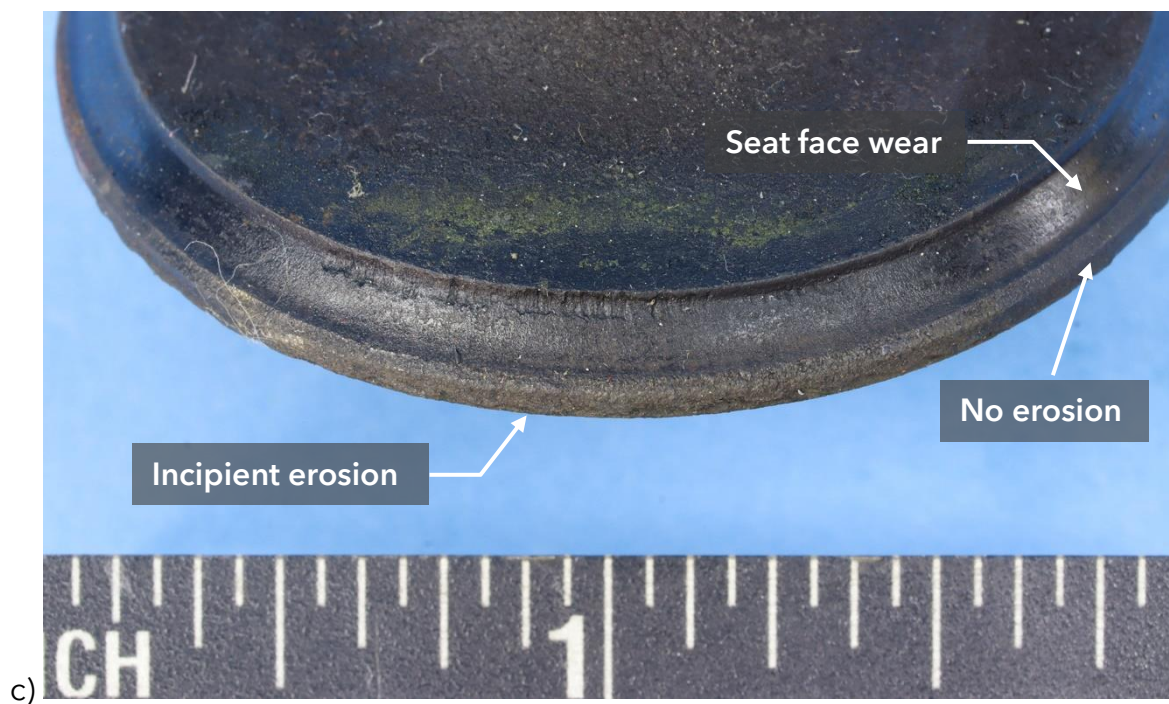
**Figure 7 (cont.).** b) valve combustion face showing asymmetric heat pattern; and c) seat face showing seat wear and incipient erosion along the margin.

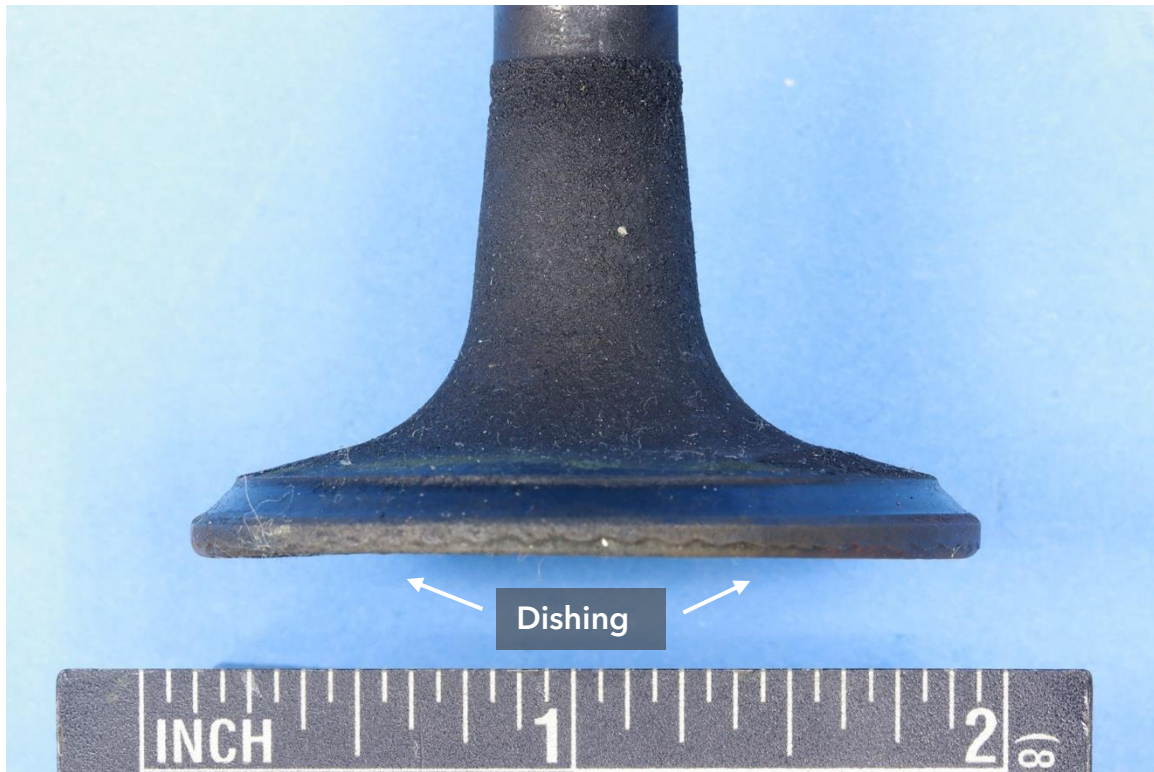
**Figure 7 (cont.).** d) side view of valve head with signs of dishing indicated.

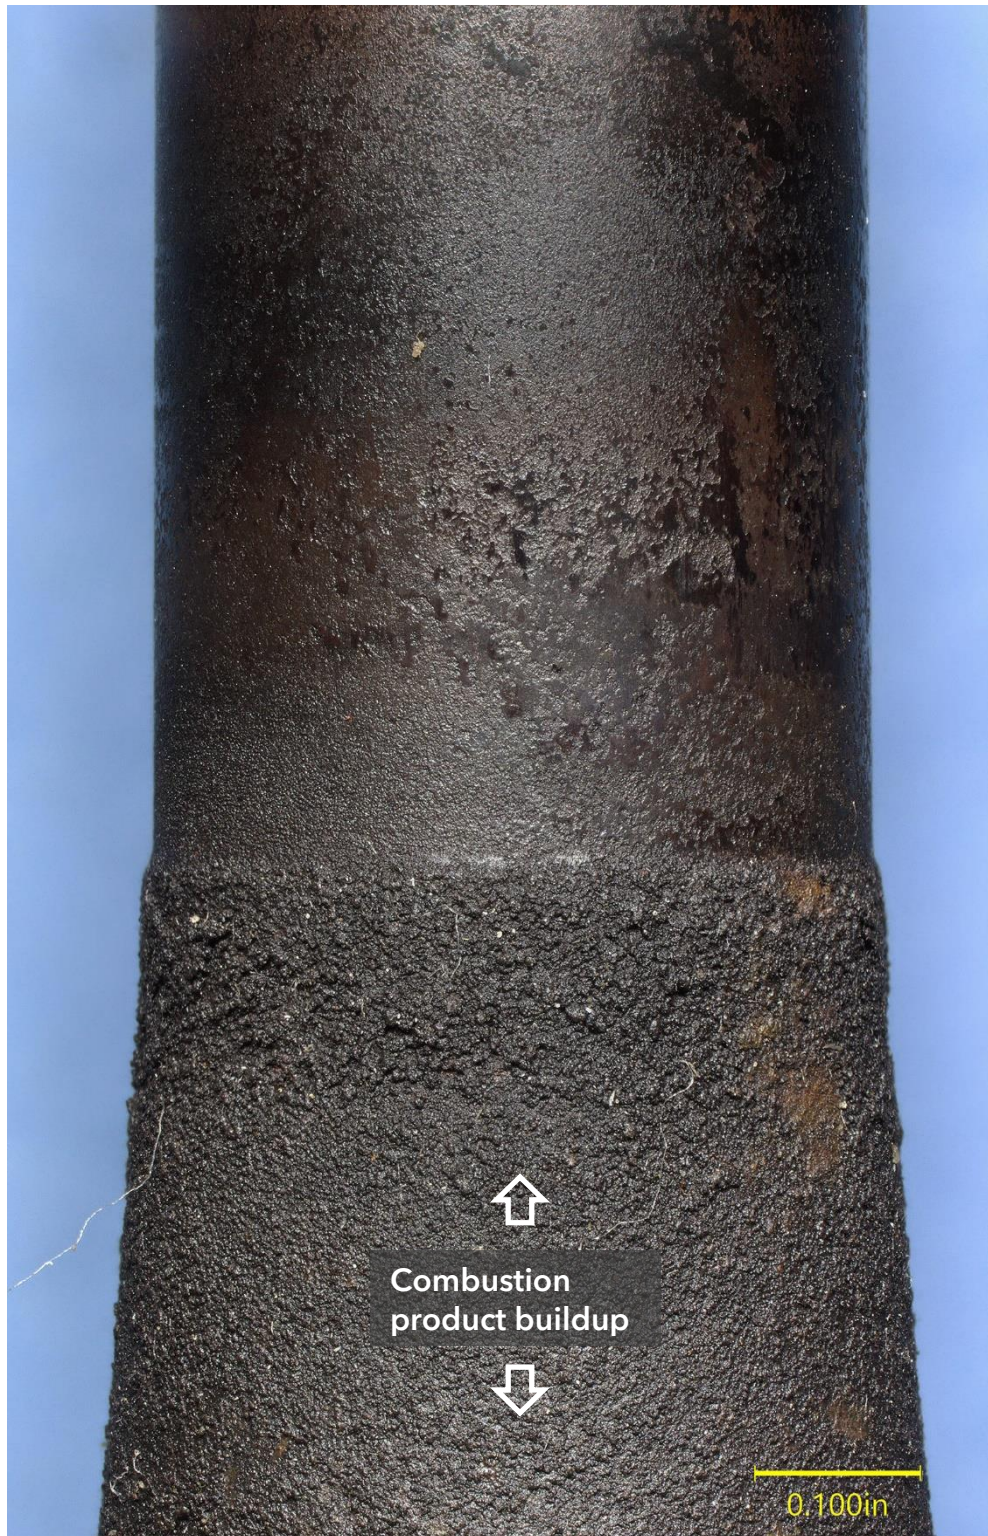
**Figure 8.** Number 6 valve stem showing buildup of combustion products outside the area that engaged the valve guide.

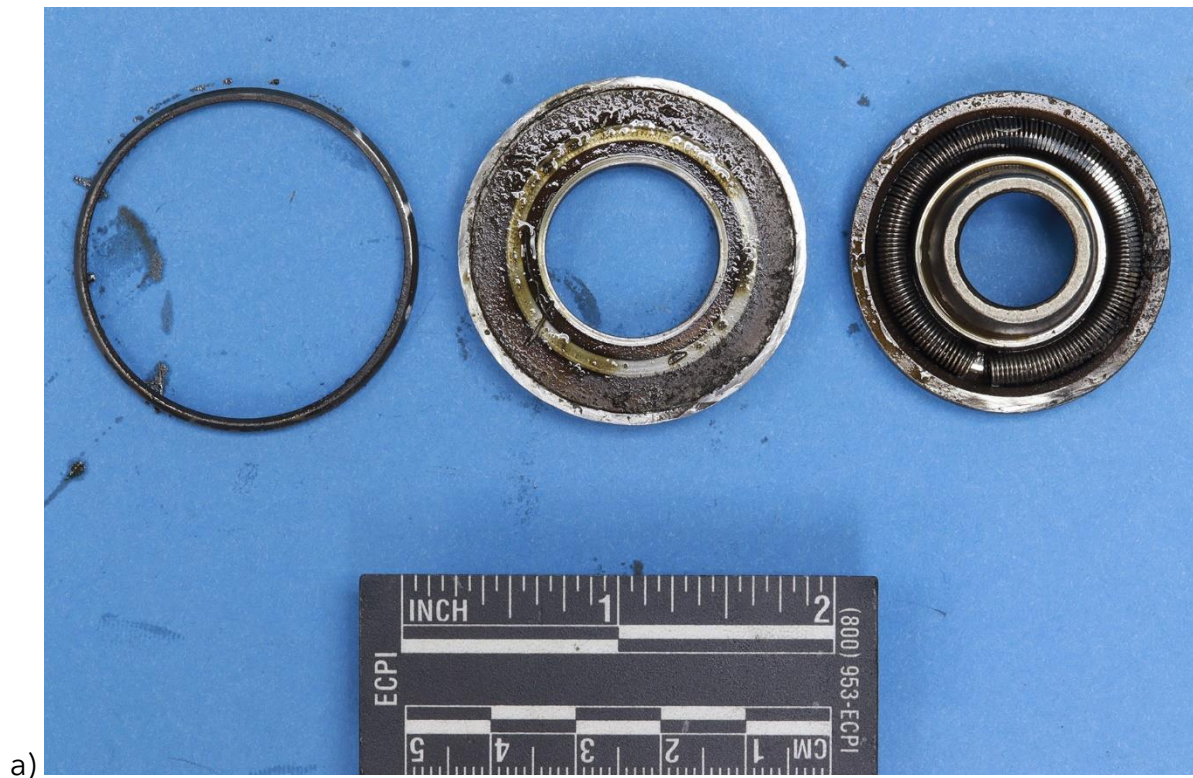
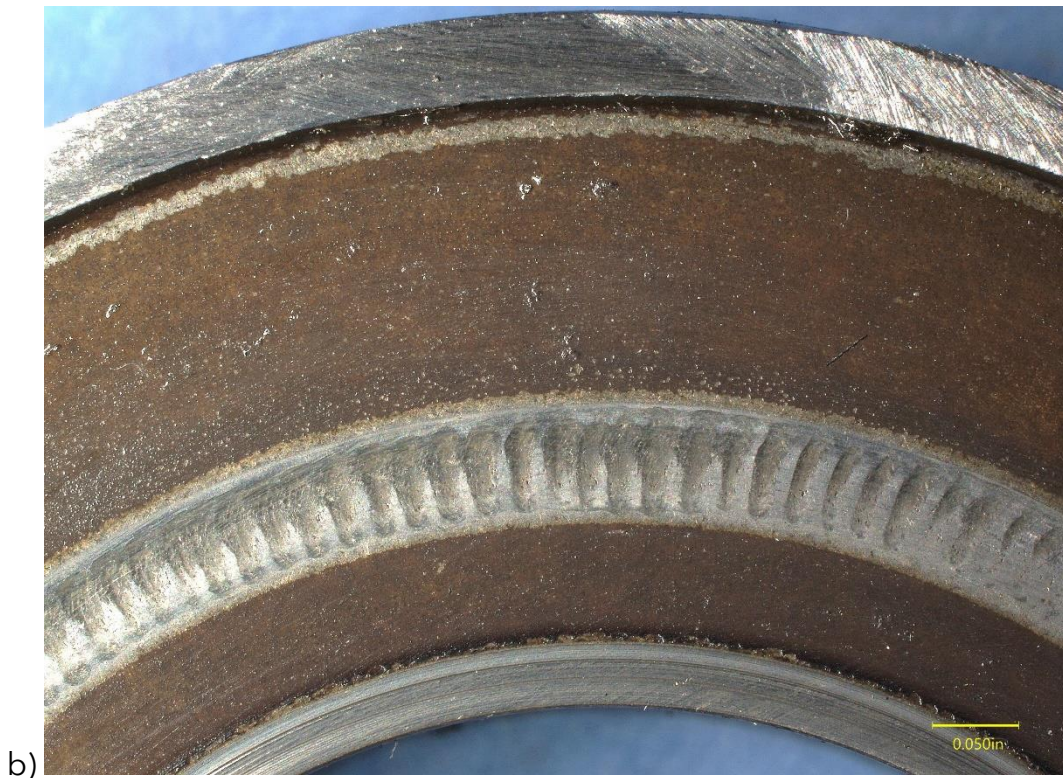
The number 6 exhaust rotocoil was worn, similar to the number 4 rotocoil. The rotocoil was disassembled using the same method (figure 10a). The spring exhibited a similar wear pattern as with the number 4 rotocoil. The flat race also exhibited an annular track but, in contrast with the number 4 rotocoil, impressions of the spring were visible in portions of the track (figure 10b).

**Figure 10.** Number 6 exhaust valve rotocoil: a) post-disassembly and b) wear of flat race leaving behind impressions of the spring.
