# National Transportation Safety Board

CEN24LA011

## **ENGINE FOLLOW-UP EXAMINATION**

Location: Red Oak, Iowa  
Date: October 15, 2023  
Time: 0951 Local  
Airplane: N6JA - Cirrus SR-22T

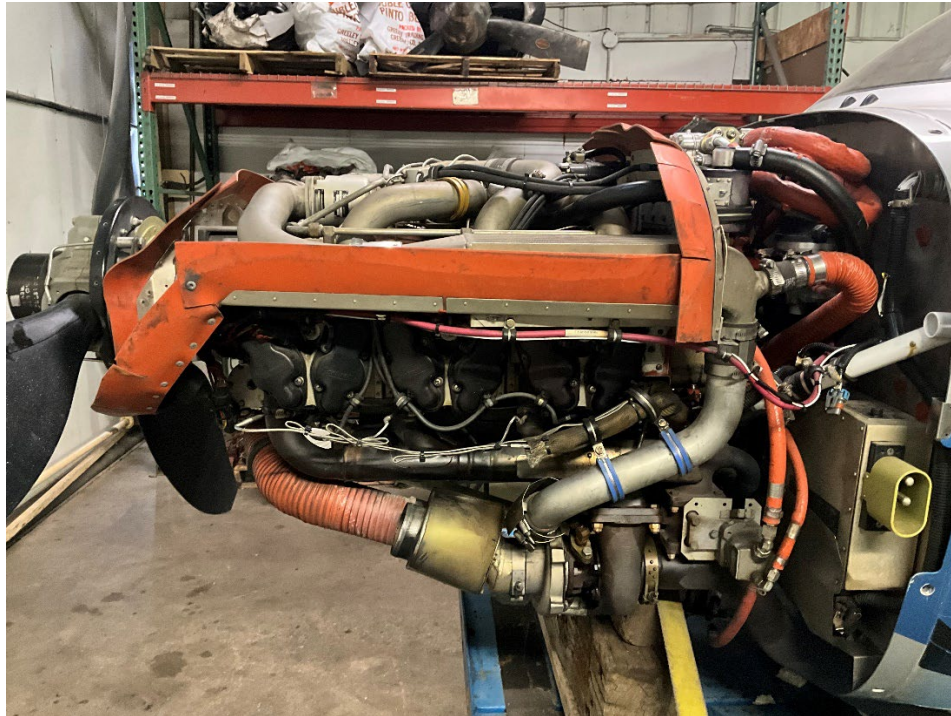
Visual examination of the engine prior to teardown showed no issues or abnormalities. All engine control cables, fluid lines, and instrumentation cables were found secured with no abnormalities present. The engine was clean with no oil observed on the exterior of the engine. The cowling was secured with no damage or abnormal fluid deposits observed.

Figure 1. Engine prior to examination teardown

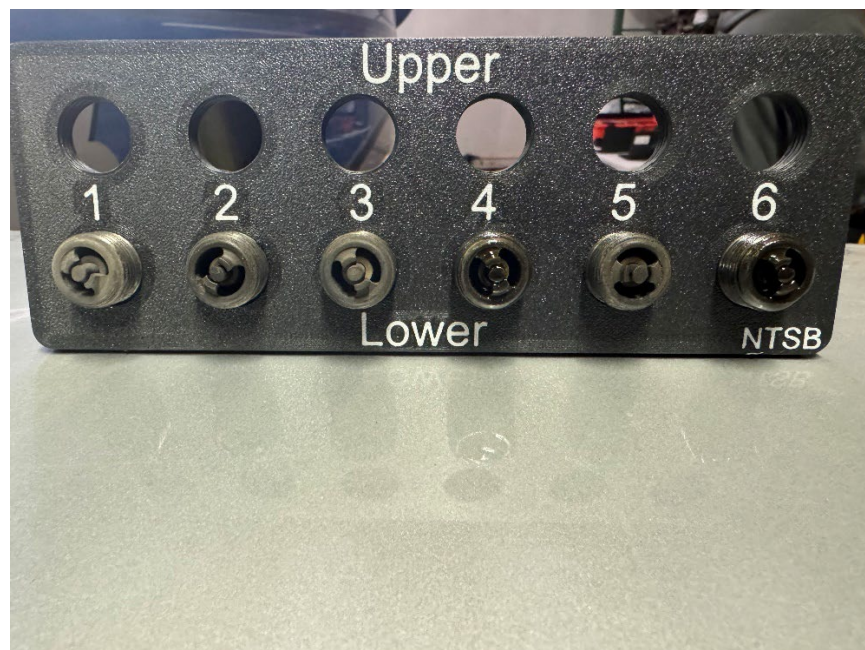
The lower spark plugs were removed and observed to be all normally worn, except the spark plugs of Cylinder #4 and #6, as compared with the Champion Spark Plug Card. The spark plugs from Cylinder #4 and #6 had debris and oil fouling.

## Figure 2. Spark Plugs

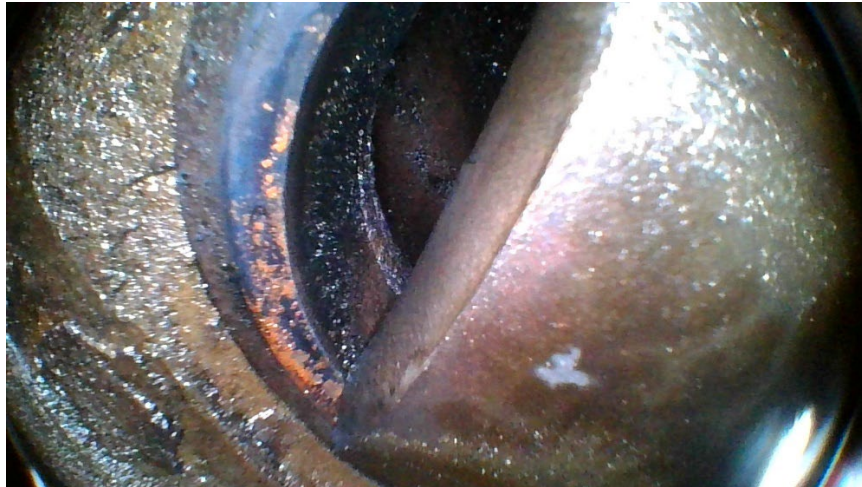
The engine was rotated by hand with the propeller and the engine continuity to the accessory section was observed. Normal valve movement was observed on all cylinders. A thumb compression test was performed on all cylinders using the lower spark plug hole with the #4 Cylinder having no observable compression.

The #4 Cylinder was borescoped and the exhaust valve was found to be missing part of the valve face. Due to the observed damage, the other cylinders were borescope to gather a baseline for the condition of the valves.

Figure 3. #4 Cylinder Exhaust Valve.

Based on the findings of the thumb compression test and borescope, the #4 and #6 Cylinders and associated components were removed by a salvage facility A&P mechanic at a later date. The assemblies were then retained and shipped to the NTSB Materials Laboratory for further examination.

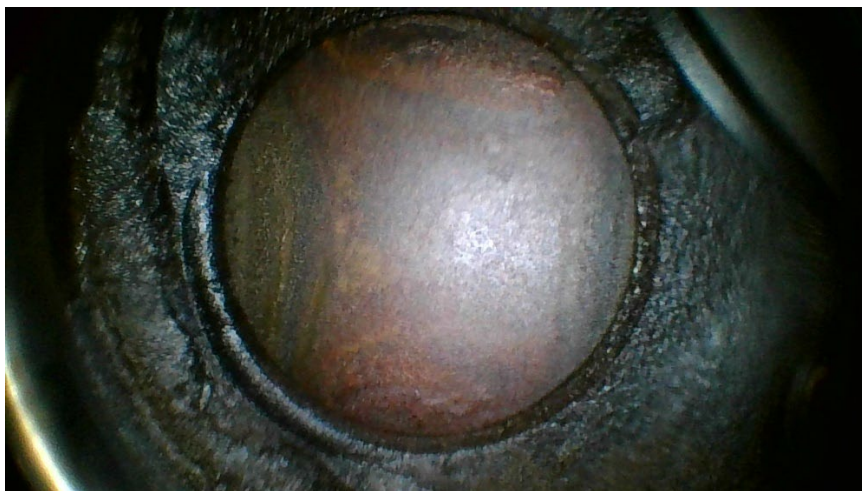
An additional exhaust valve. #6 Cylinder, was found to have heat damage, when compared to the AOPA Anatomy of a Valve failure poster Figure # 6.

Figure 4. #6 Cylinder Exhaust Valve Face

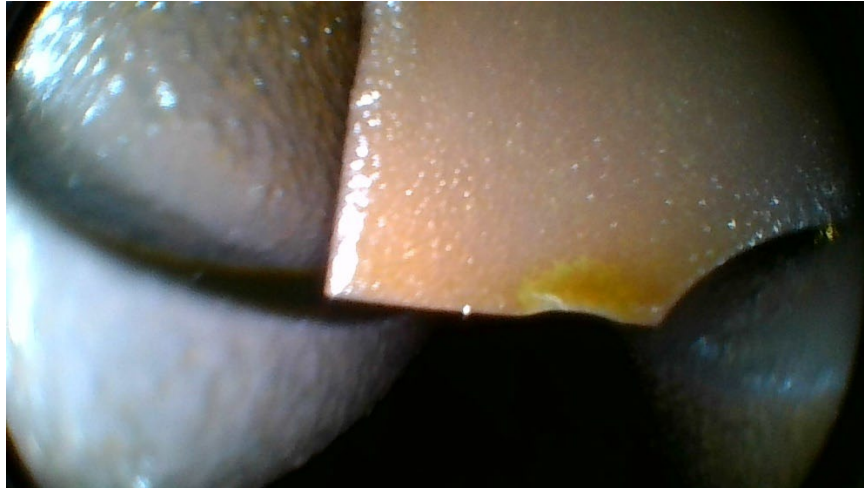
Figure 5. Broken Turbocharger Turbine Blade
