CEN24LA012

## INVESTIGATION PHOTOGRAPHS

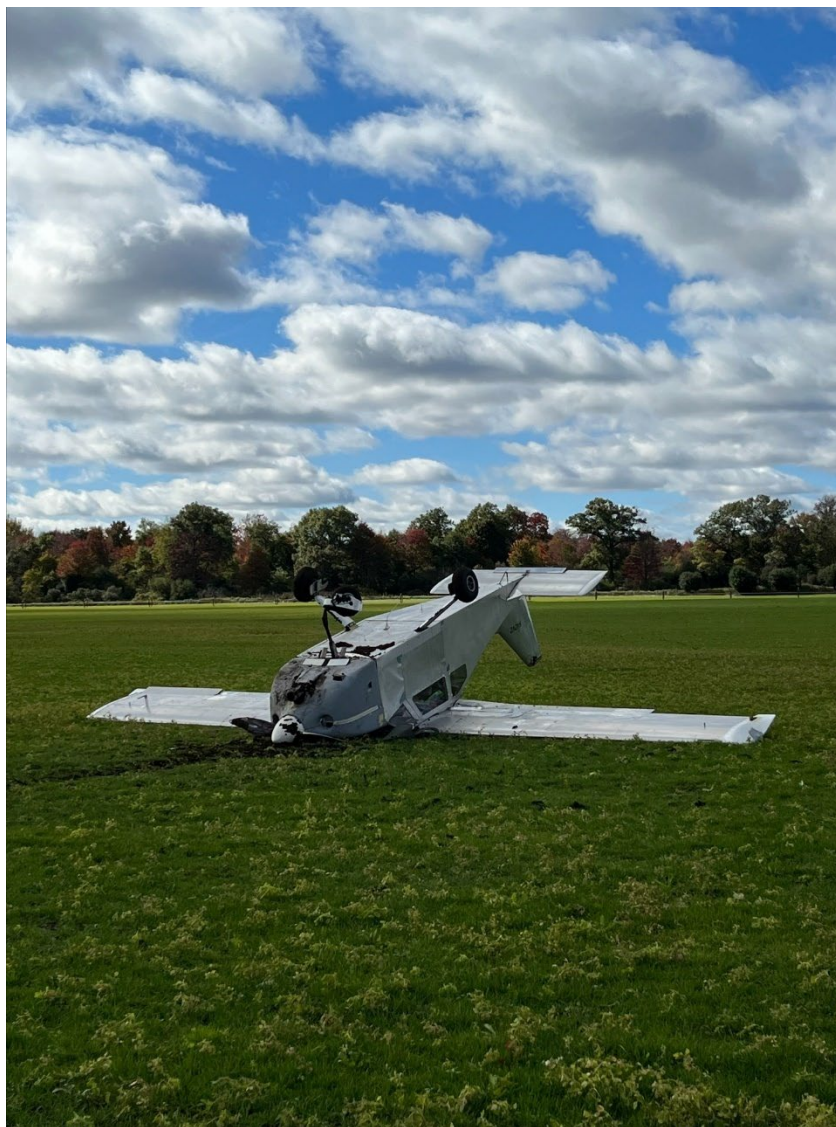
**Photograph 1 - Accident Site (Courtesy of the Federal Aviation Administration)**

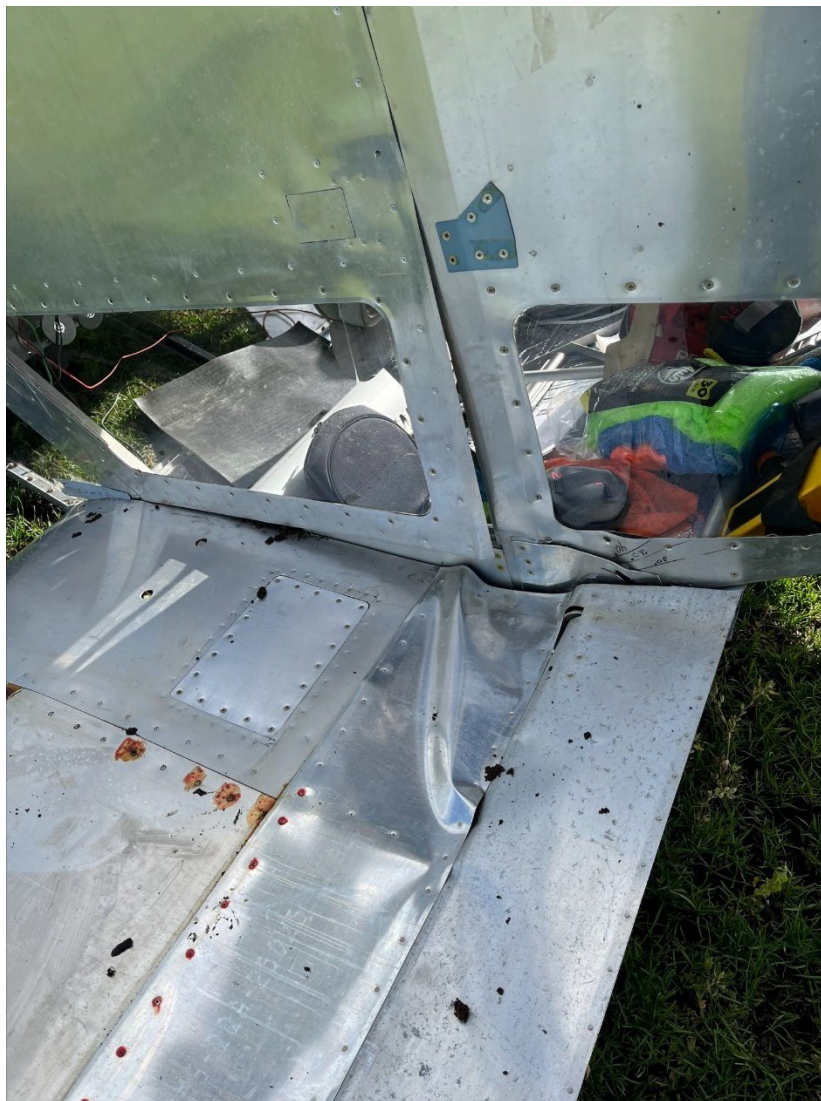
**Photograph 2 - Right Wing Damage (Courtesy of the Federal Aviation Administration)**

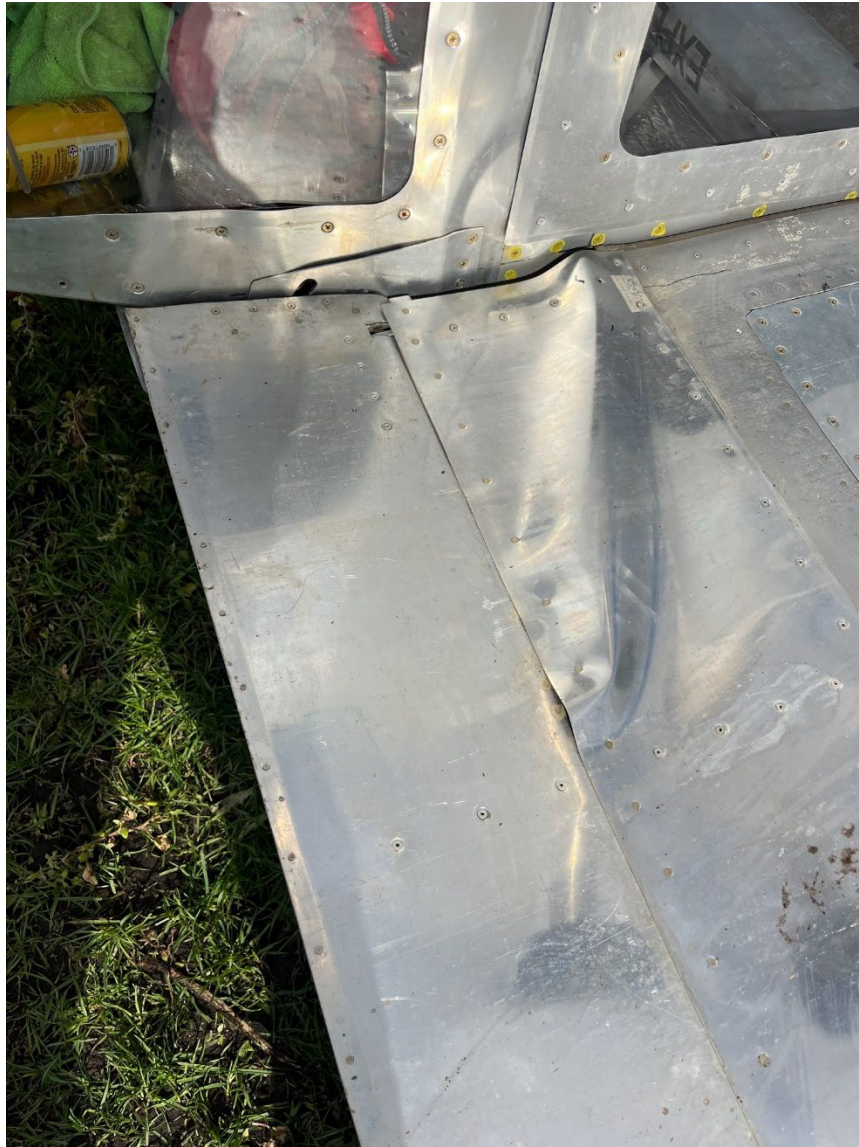
**Photograph 3 - Left Wing Damage (Courtesy of the Federal Aviation Administration)**

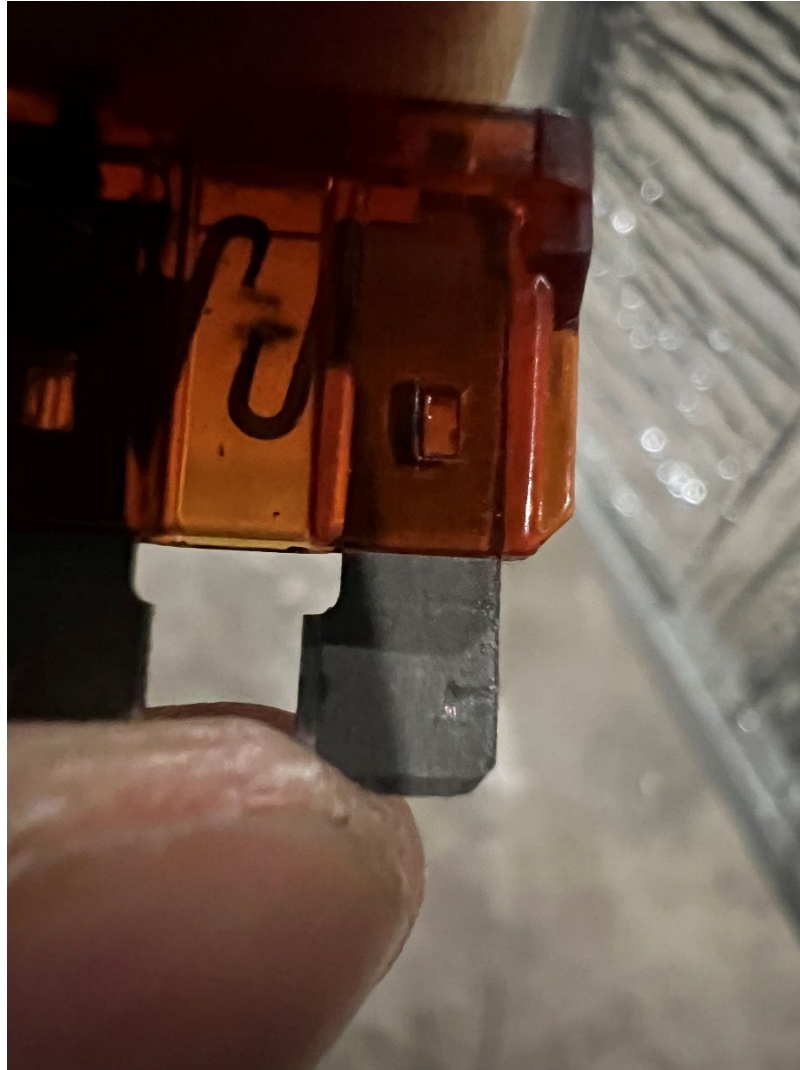
**Photograph 4: Blown Fuse (Courtesy of the Pilot/Aircraft Owner)**
