National Transportation Safety Board

CEN24LA014

## INVESTIGATION PHOTOGRAPHS

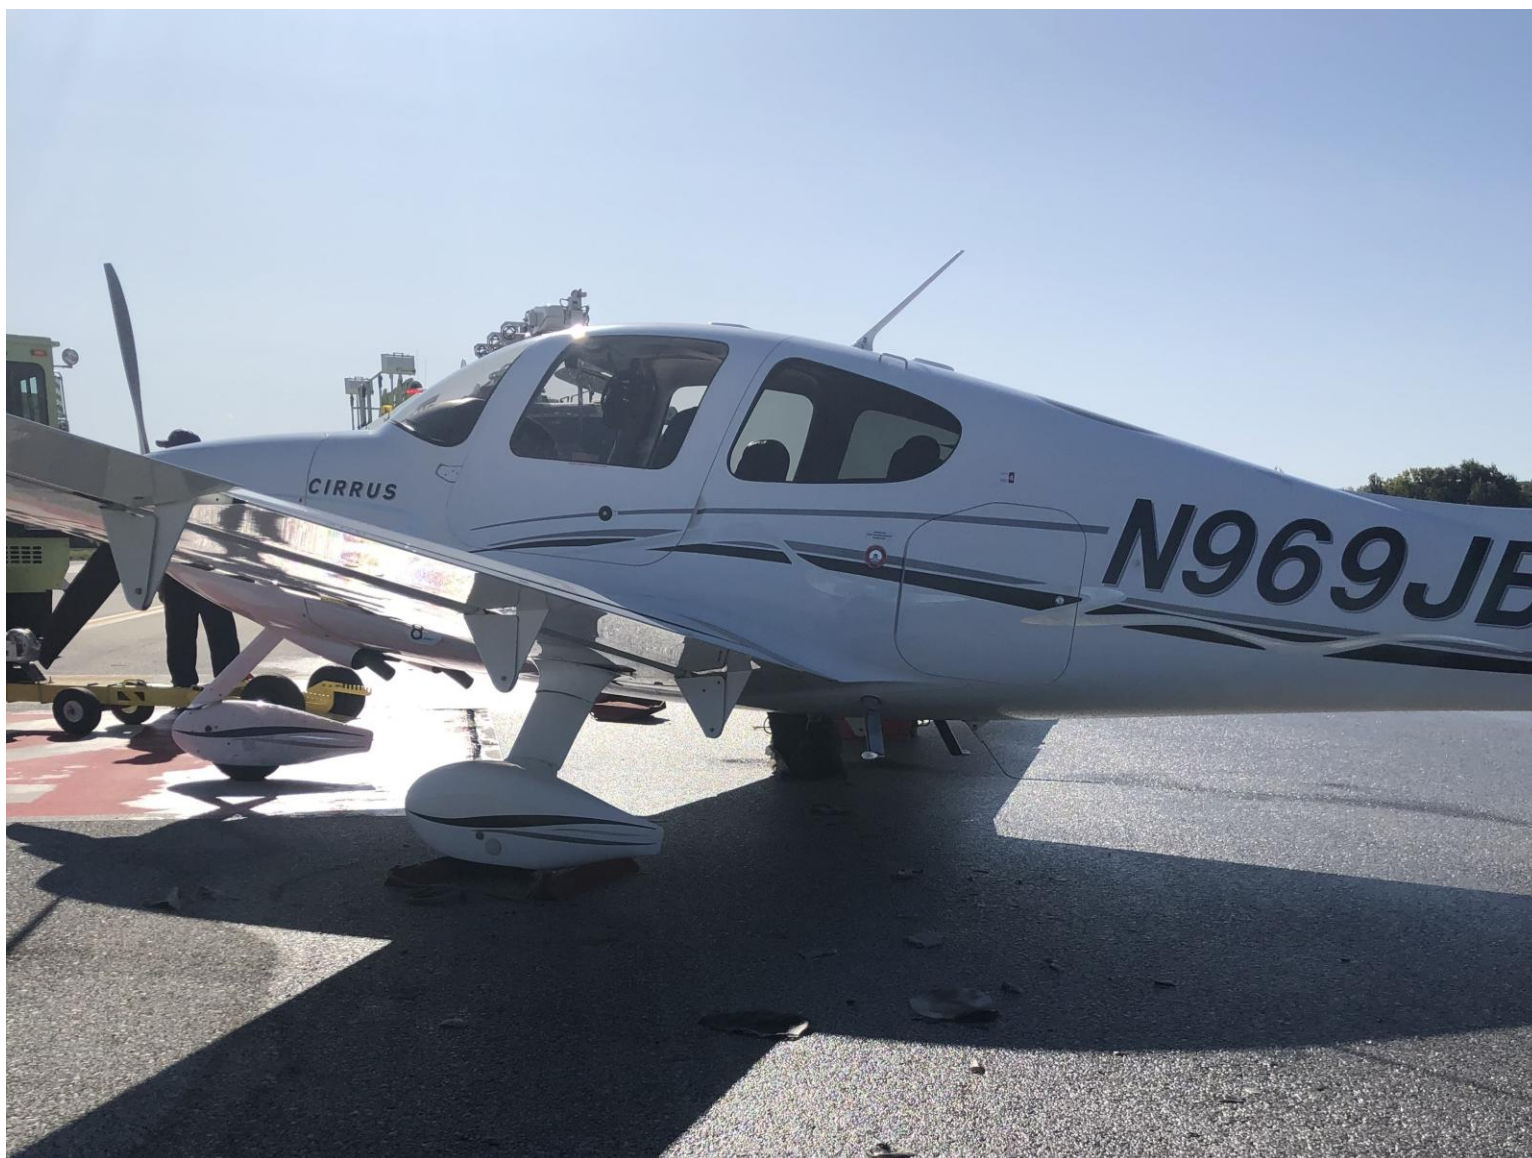
**Photograph 1 - Airplane at Accident Site (Courtesy of Airplane Owner)**

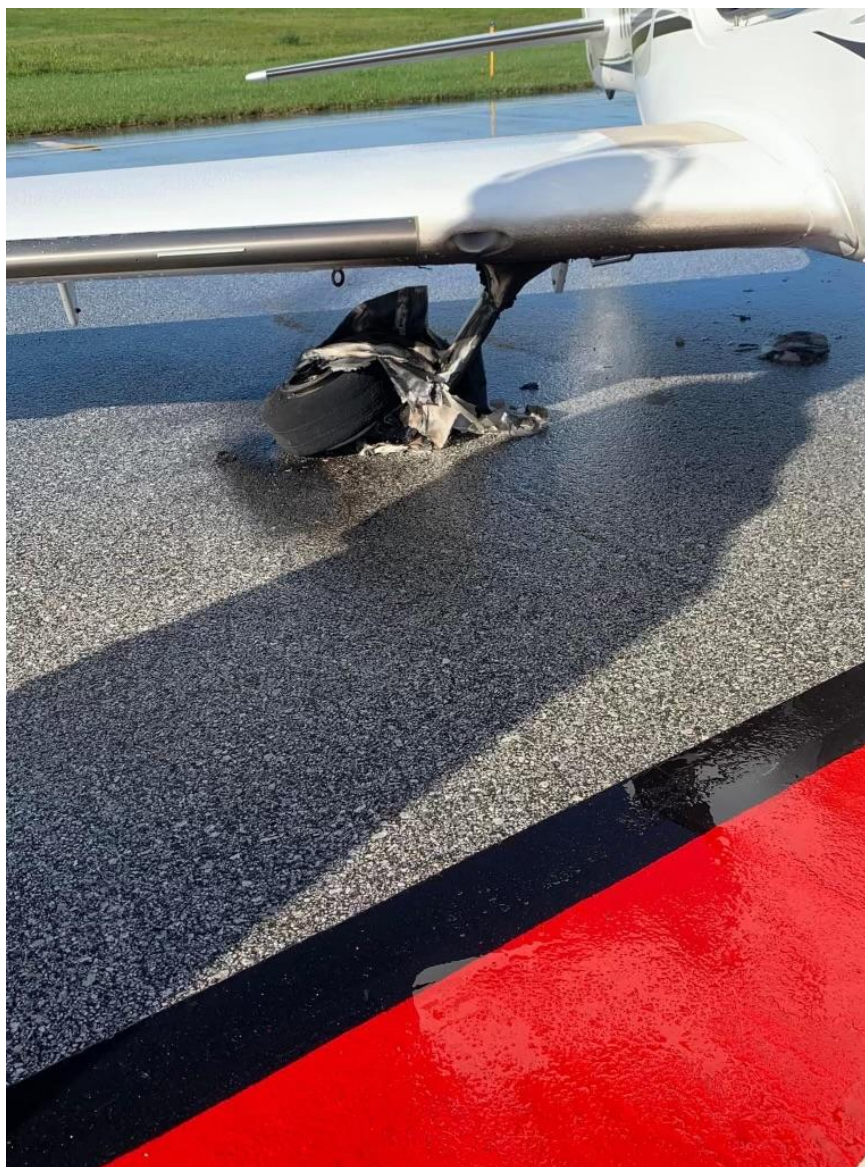
**Photograph 2 - Right Main Landing Gear and Wheel Assembly (Courtesy of Airplane Owner)**

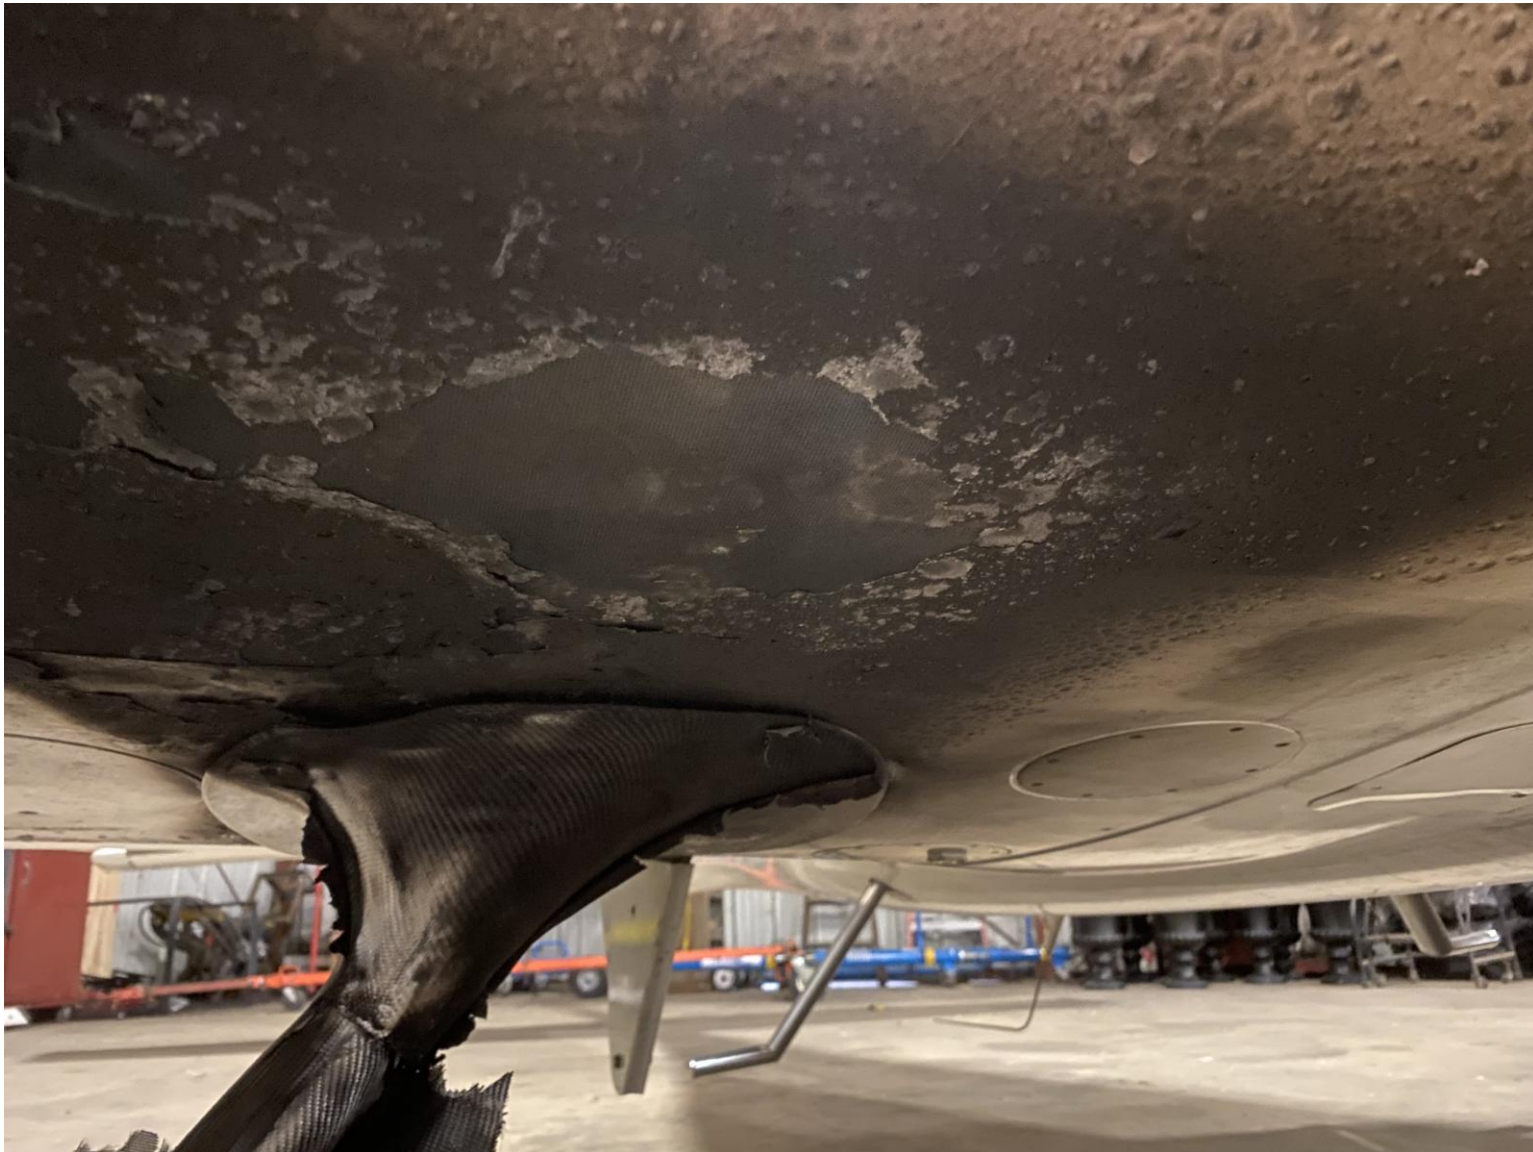
**Photograph 3 - Fire Damage to Lower Right Wing (Courtesy of Airplane Owner)**

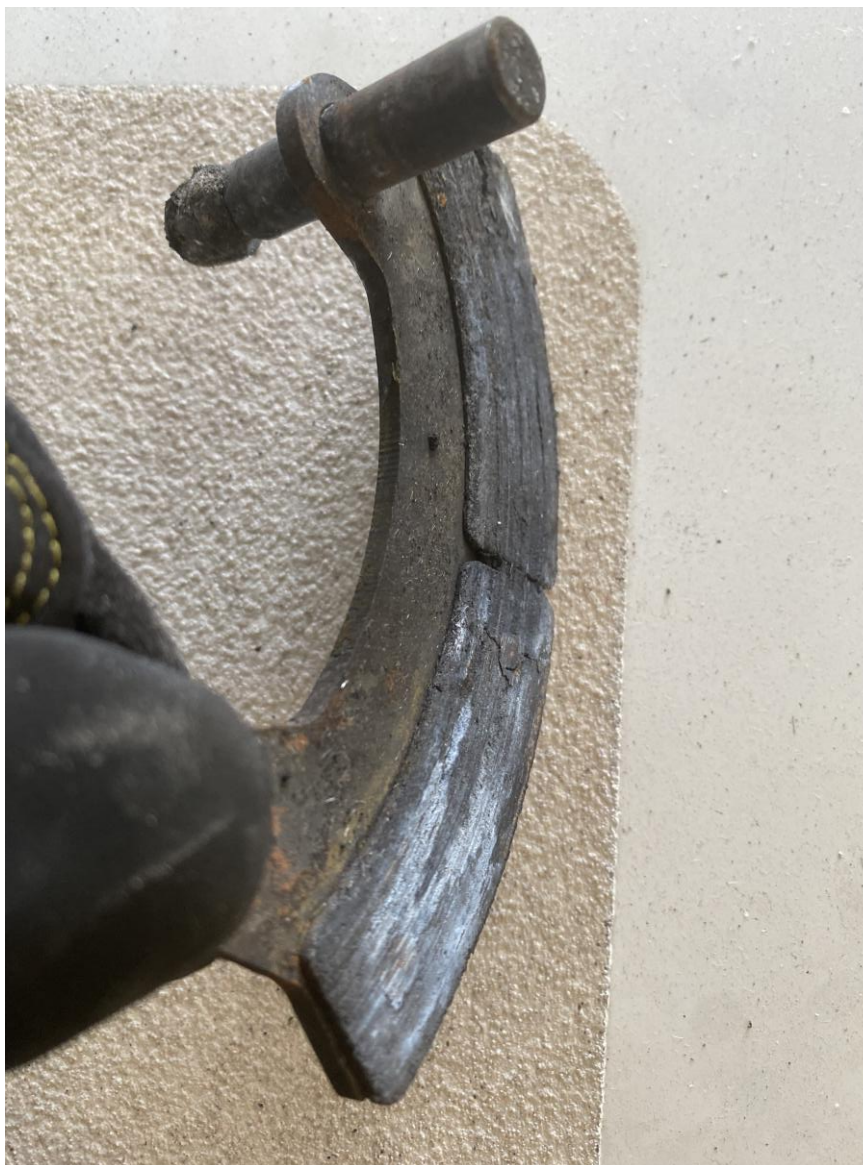
**Photograph 4 - Right Brake Inner Linings with Pressure Plate (Courtesy of Airplane Owner)**

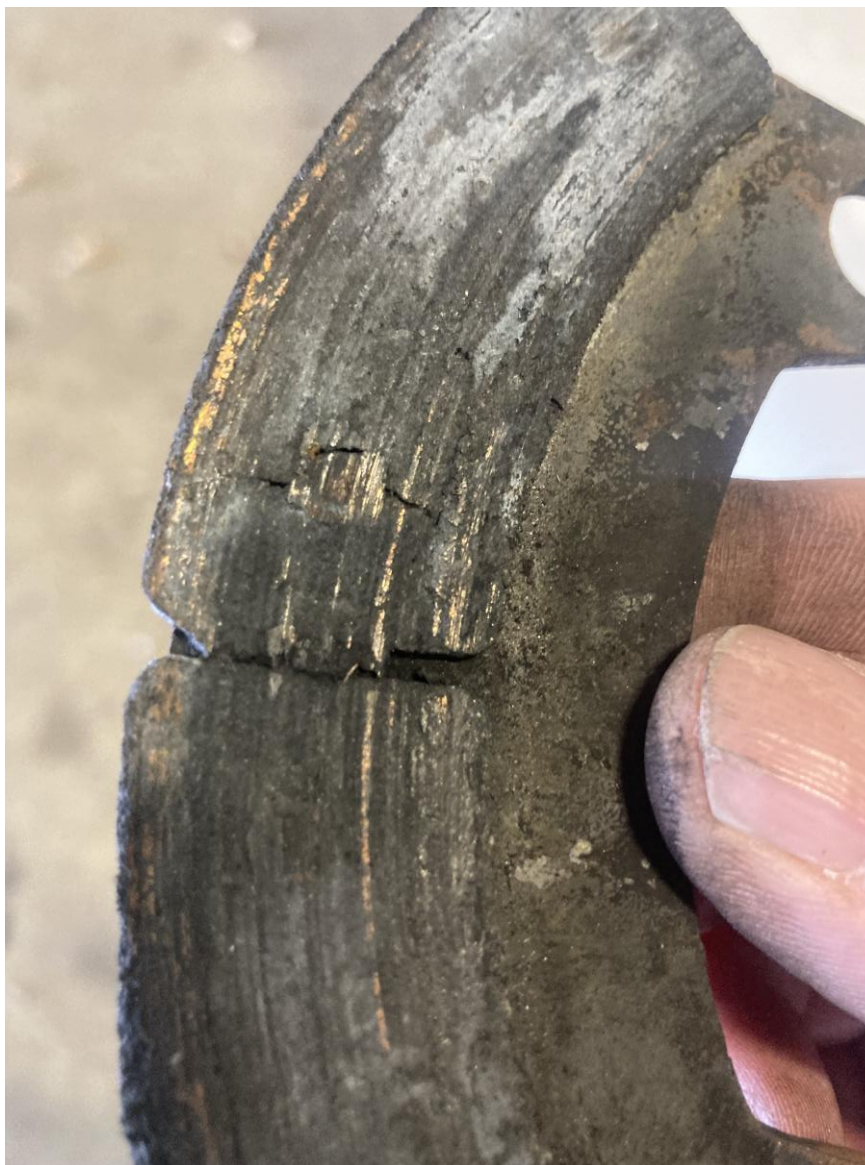
**Photograph 5 - Right Brake Linings (Courtesy of Aviation Mechanic)**

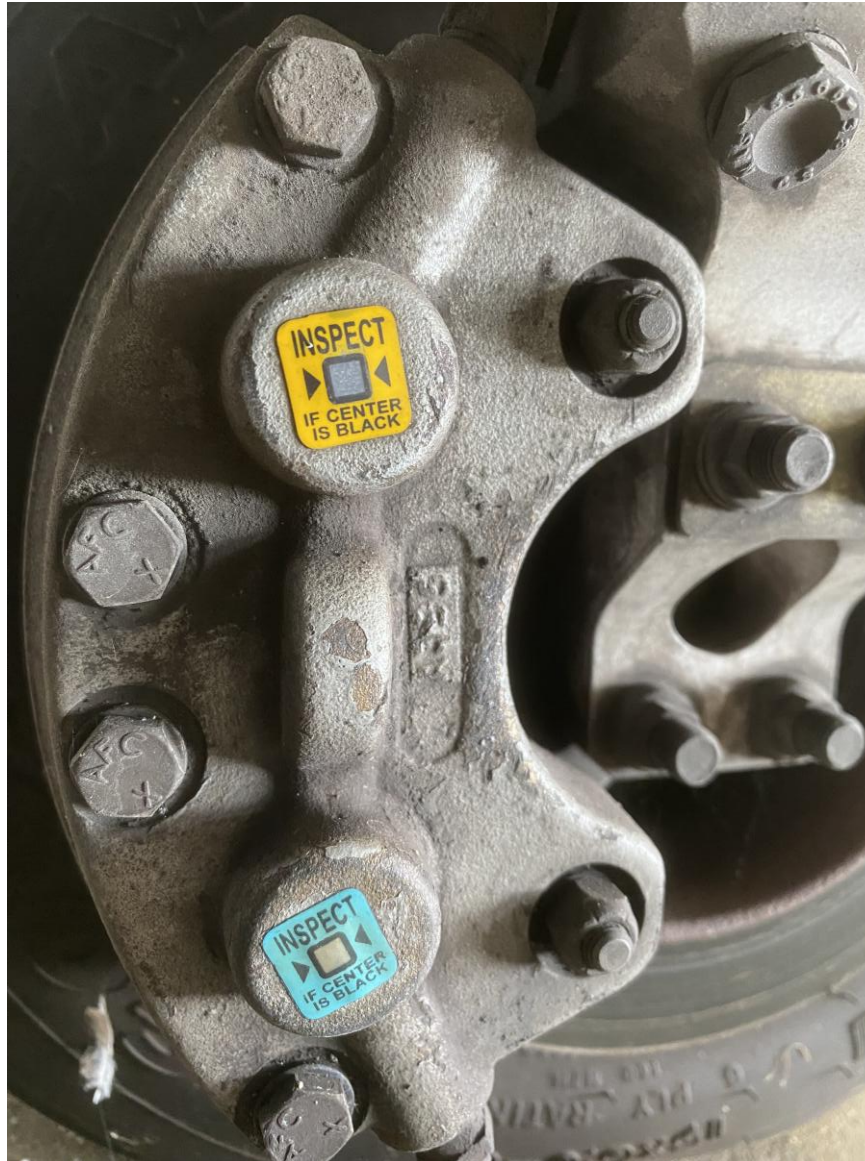
**Photograph 6 - Left Brake Assembly with Temperature Indicators (Courtesy of Airplane Owner)**
