CEN24LA017

## INVESTIGATION PHOTOGRAPHS

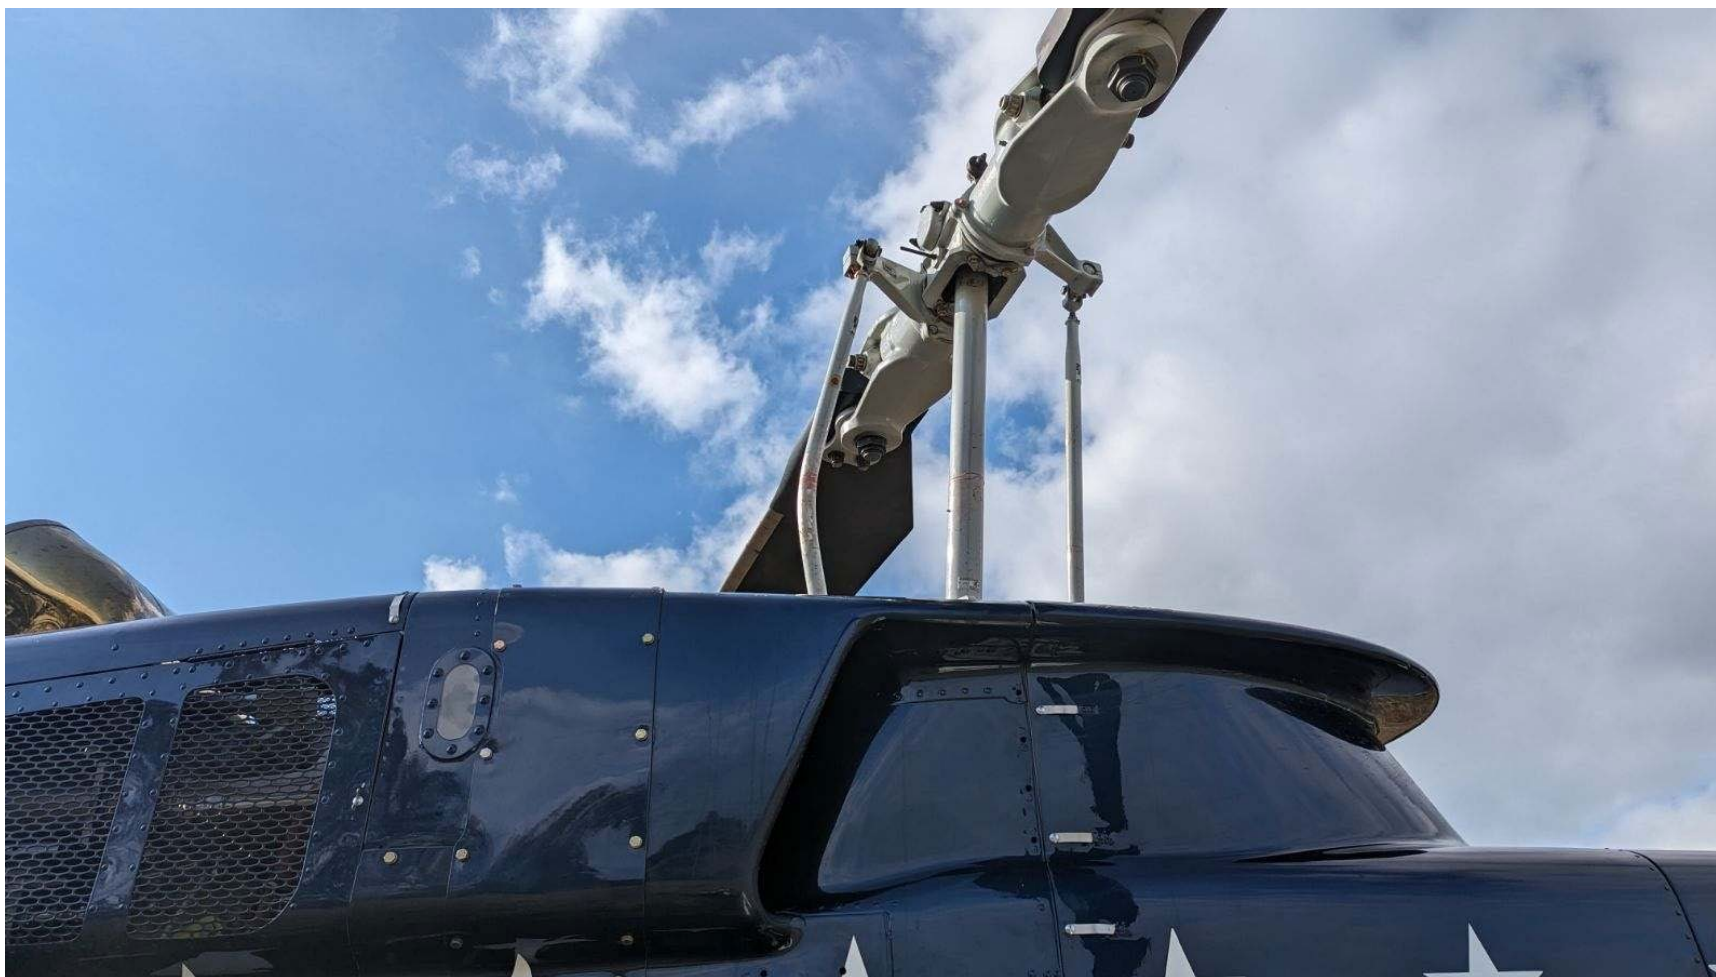
**Photograph 1 - Pitch Change Link Damage (Courtesy of the Operator)**

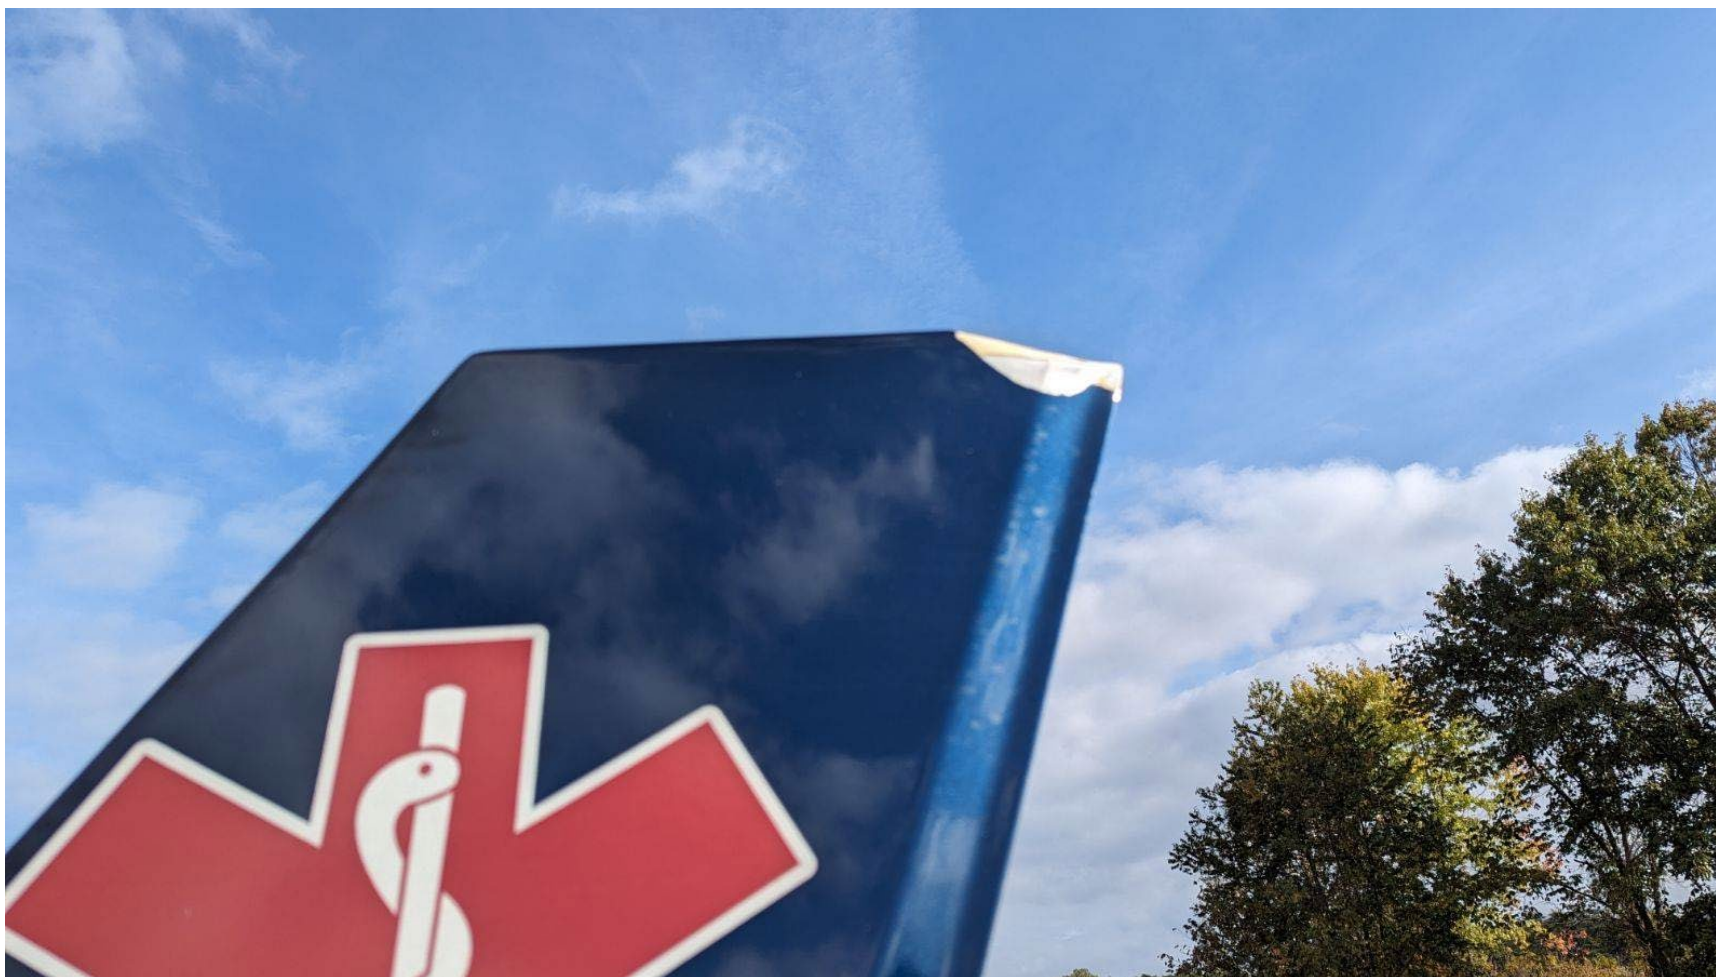
**Photograph 2 - Stabilizer Damage (Courtesy of the Operator)**
